Our ref: 26006.loc.1

15 September 2023

ARBORICULTURAL ASSESSMENT – Pruning of 2 street trees, clearance for scaffolding and hoarding for demolition, CHATSWOOD DIVE, 607 Pacific Highway, Chatswood NSW (the site) Sydney Metro City & Southwest Line-wide Works

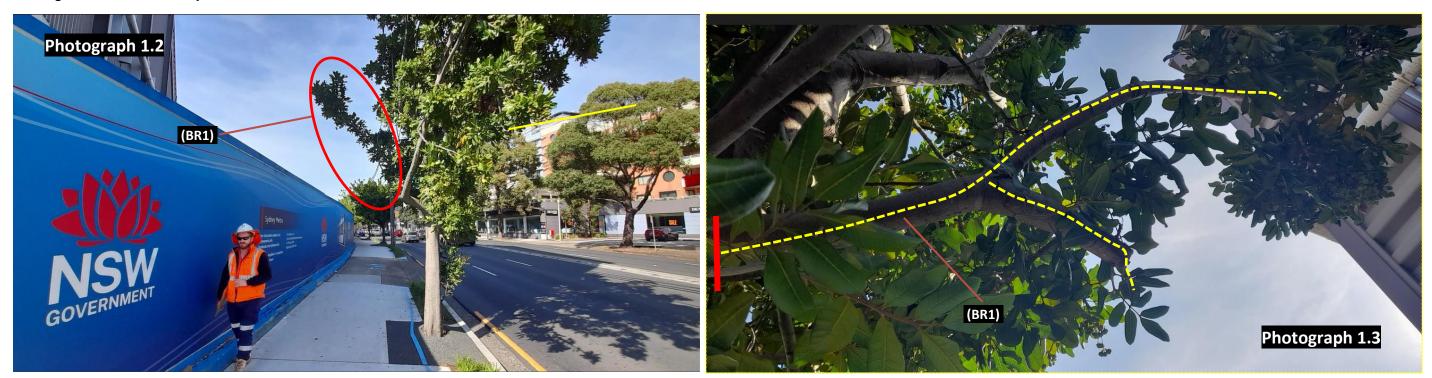
Photograph 1.2

Of the two trees Tree 1 *Cupaniopsis anacardioides* – Tuckeroo, requires minor crown pruning for 2438 mm clearance from the building for scaffolding to provide safe working access during demolition but the option remains to tie the one branch back to the area outside of the scaffold.

b. Crown asymmetrical, bias to street due to previous pruning over the planting with advanced stock. The single branch encroaching into the and hoarding appeared to be 2.5 - 3.5 m long and 25-35 mm diameter. In diameter branches are expected to be flexible and pliable which careful manipulation to negate pruning and to minimise harm to the llation of the A-Class Hoardings and Demolition Rated Scaffold.

Option 1 - Tree 1 Cupaniopsis anacardioides - Tuckeroo showing red encircled branch (BR1) to be tied back to outside of scaffold. If this is not viable minor crown pruning per Option 2 should be conducted.

Tree 1 *C. anacardioides* – Tuckeroo showing red bold line in approximate location of a final cut at branch collar, dotted line showing the subject branch (BR1) to be pruned or tied back.

Tree to be retained with the one branch tied back to the area outside of the scaffold if suitable without cracking or breaking the branch (Appendix C - Pruning Specifications and Pruning Diagrams - Option 2). The proposed works are generally minor in extent and the tree is expected to remain viable and stable. If this is not viable minor crown pruning per Option 2 should be conducted.

Tree to be retained with minor crown pruning (<10%) to provide a 2438 mm horizontal clearance from the building for scaffolding and Class A hoarding to provide safe working access during demolition, and to prevent further crown damage from the installation of the curtain covering of steel chain link and fine mesh over the front of the scaffold from becoming entangled in the crown of each tree, (Appendix C - Pruning Specifications and Pruning Diagrams). The proposed works are generally minor in extent and the tree is expected to remain viable and stable.

Tree 1 - The encroaching branch on Tree 1 should be tied back to clear it from the scaffold and hoarding area – <u>Option 1</u> or pruned if this is not viable – <u>Option 2</u>, as Crown Modification as Reduction Pruning (AS4970, 2009, pp. 13 and 15).

Option 2 - Tree 1 showing red bold line in approximate location of a final cut at branch collar, dotted line showing the subject branch (BR1) to be pruned.

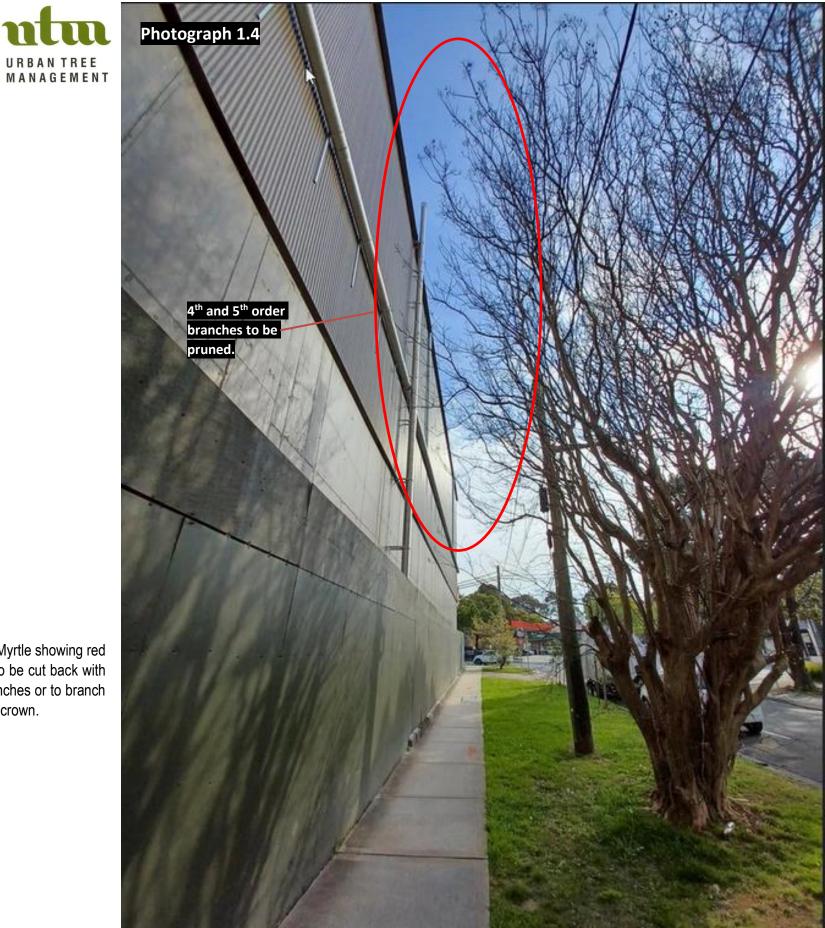
Photograph 1.4

Tree 2 *Lagerstroemia indica* – Crepe Myrtle, requires minor crown pruning for 1268 mm clearance from the building for scaffolding to provide safe working access during demolition but the option remains to tie the one branch back to the area outside of the scaffold.

b. Crown symmetrical. Generally lower 4^{th} and 5^{th} order branches with 25 mm diameter expected to be pruned for the installation of the Bd Demolition Rated Scaffold. Tree to be retained with crown pruning n horizontal clearance from the building for scaffolding to provide safe ring demolition, and to prevent further crown damage from the rtain covering of steel chain link and fine mesh over the front of the ning entangled in the crown of each tree, (Appendix C - Pruning runing Diagrams).

Tree 2 *Lagerstroemia indica* – Crepe Myrtle showing red encircled 4th and 5th order branches to be cut back with final cuts to the junction of lateral branches or to branch collars. Pruning is minor, <10% of the crown.

Tree to be retained with minor crown pruning (<10%) of lower order branches 5-<25 mm diameter to provide a 1268 mm horizontal clearance from the building for scaffolding and Class B hoarding to provide safe working access during demolition, and to prevent further crown damage from the installation of the curtain covering of steel chain link and fine mesh over the front of the scaffold from becoming entangled in the crown of each tree, (Appendix C - Pruning Specifications and Pruning Diagrams). The proposed works are generally minor in extent and the tree is expected to remain viable.

Tree 2 - The encroaching small diameter branches on Tree 2 should be pruned as *Crown Modification* as *Reduction Pruning* (AS4970, 2009, pp. 13 and 15).
