Review of	Construction Monitoring Report Sep 2021-Feb 2022	Document reference:	Construction Monitoring report September 2021 - February 2022 Sydney Metro City & Southwest – Line- wide Works N21063 SMCSWLWC-SYC-CSW-EM-REP-011744 Dated 24 March 2022
Prepared by:	Carl Fokkema Alternate Acoustics Advisor		
Date of issue:	13 May 2022

Construction Monitoring Report September 2021 – February 2022

Sydney Metro City & Southwest – Line-wide Works

Contract Number:	C600
Systems Connect Number	N21063
Document number:	SMCSWLWC-SYC-CSW-EM-REP-011744
Revision date:	24/03/2022
Revision:	0

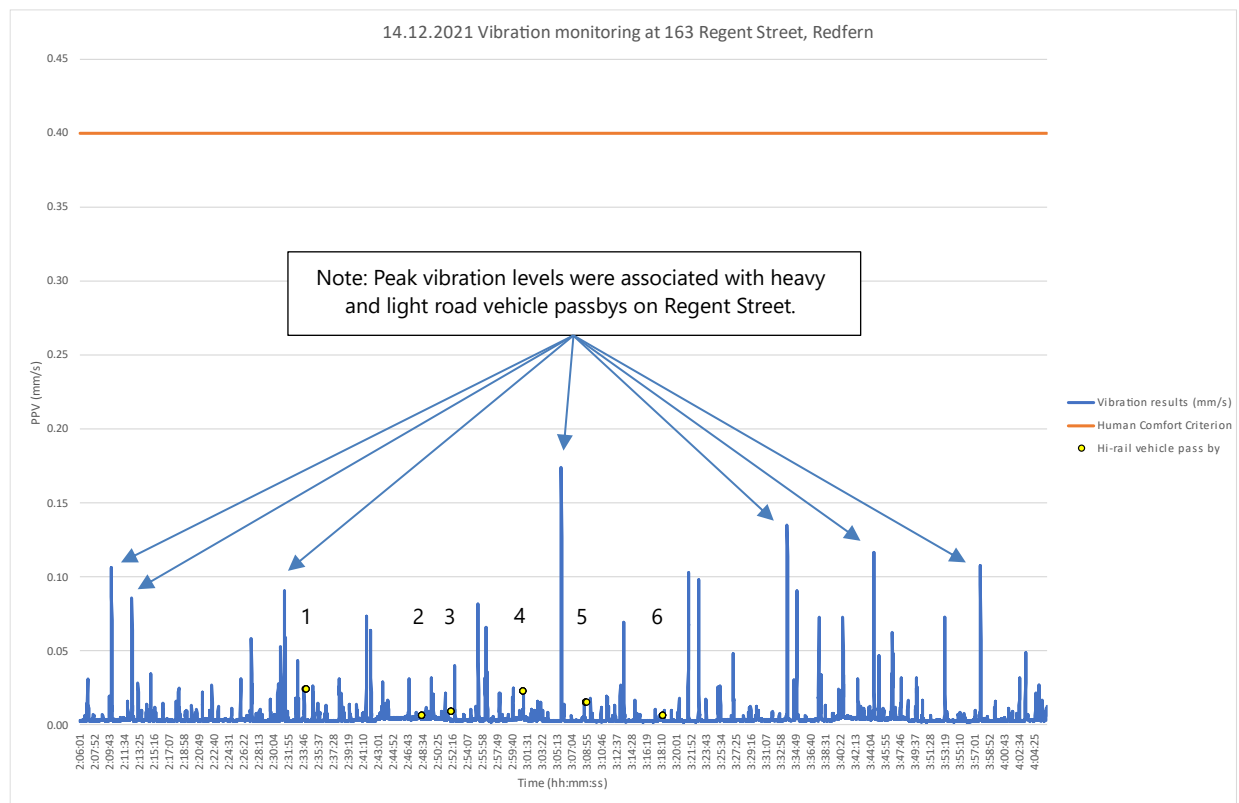
Figure 4-1 – Unattended vibration monitoring results inside residential building

All measurement results are below the initial night-time screening criterion of 0.4 mm/s for residential buildings.

Event ID	Date and Time	Comment
1	14.12.2021 2:33am	At this time, the peak vibration level measured was 0.024 mm/s ppv. Note that during this hi-rail vehicle passby, review of the audio and vibration data confirmed that there was a road traffic passby that occurred. The peak vibration level of 0.024 mm/s was caused by the road traffic passby.
2	14.12.2021 2:48am	At this time, the peak vibration level measured was 0.006 mm/s ppv.
3	14.12.2021 2:51 am	At this time, the peak vibration level measured was 0.009 mm/s ppv.
4	14.12.2021 3:00am	At this time, the peak vibration level measured was 0.023 mm/s ppv. Note that during this hi-rail vehicle passby, review of the audio and vibration data confirmed that there was a road traffic passby that occurred. The peak vibration level of 0.023 mm/s was caused by the road traffic passby.
5	14.12.2021 3:08am	At this time, the peak vibration level measured was 0.015 mm/s ppv. Note that during this hi-rail vehicle passby, review of the audio and vibration data confirmed that there was a road traffic passby that occurred. The peak vibration level of 0.015 mm/s was caused by the road traffic passby.

disturbance to building occupants at night. The peak vibration level was of 0.17 mm/s ppv at 3:05 am, outside of any hi-rail pass-by activity. Review of the audio recordings confirmed that this event was caused by a heavy vehicle passby on Regent Street.

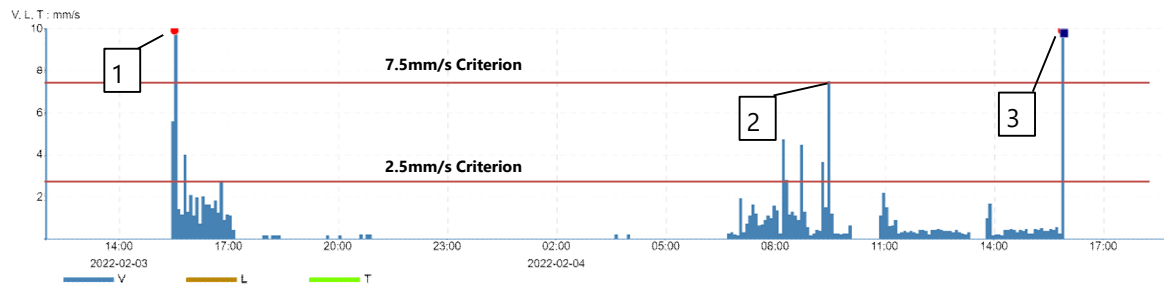
Figure 4-1 – Unattended vibration monitoring results

Where the vibration from rockhammering activity initially exceeded the 2.5 mm/s criterion, the works were paused and the heritage seawall was inspected for any signs of cosmetic damage. When no signs were found, the works proceeded with caution. Where the vibration from rockhammering activity initially exceeded the 7.5 mm/s criterion, the works were paused until the source of the exceedance was identified. Where it was confirmed that this was not due to rockhammering activity, the works continued.

Exceedance ID	Date and Time	Cause of exceedance
1	03.02.2022 03:30pm	At this time, the vibration monitor was mounted on the ground spike to commence monitoring. Exceedance was not caused by the nearby rockhammering activity.
2	04.02.2022 09:26am	At this time, the site engineer confirmed that the instantaneous exceedance was caused by the impact of the walls of the concrete platform being knocked over on site and falling to the ground. Exceedance was not caused by the nearby rockhammering activity.
3	04.02.2022 03:50pm	At this time, the vibration monitor was removed from the ground spike to complete the monitoring. Exceedance was not caused by the nearby rockhammering activity.

It can be seen in Figure 4-1 that the vibration levels produced from the nearby rockhammering activity is generally below 7.5 mm/s. Note that there were events that resulted in an instantaneous vibration level of above 7.5 mm/s. However, these were not caused by the nearby rockhammering activity, as justified in Table 4-4.

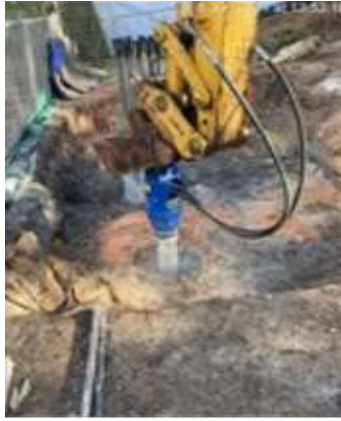
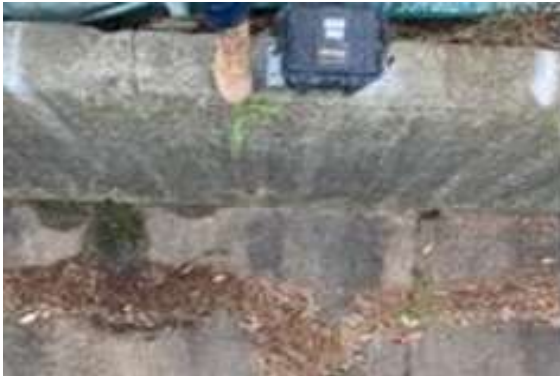
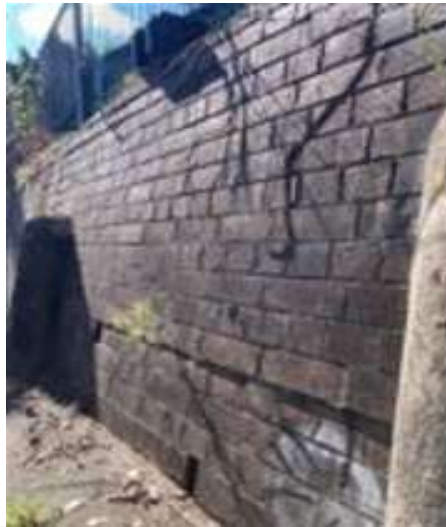
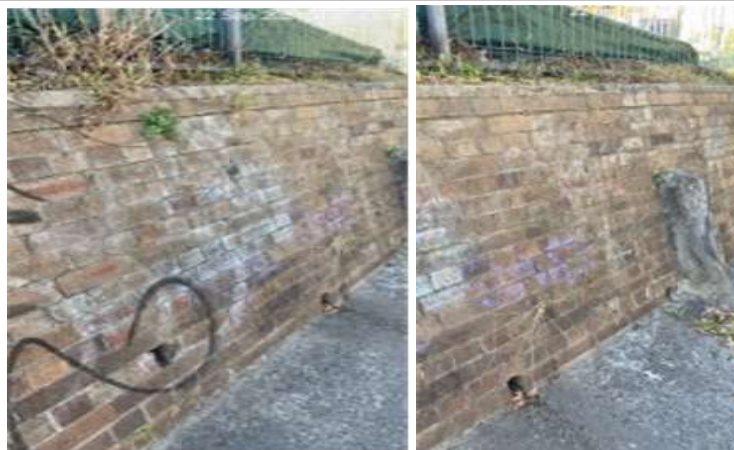
MONITORING LOCATION 1					
LOCATION:	Pat O'Connor Reserve / Cup and Saucer Creek (Ausgrid side)				
DATES:	15-20 September 2021				
ACTIVITIES:	Piling works for bridge foundations				
PLANT:	20t excavator with auger attachment				
STRUCTURE TYPE:	Channel structure for Cup and Saucer and Creek				
VIBRATION CRITERIA:	Unreinforced structure: 10 mm/s				
APPLICABLE MWD:	5m	ACTUAL WORKING DISTANCE:		1.5 m	
VIBRATION MONITOR MOUNTING METHOD:			Steel baseplate stuck with adhesive to concrete channel surface		
EXCEEDENCES OF VIBRATION CRITERIA (Refer to monitoring data for all results)					
Date	Time	V (mm/s)	T (mm/s)	L (mm/s)	Reason
15/09/2021	9:08:00 AM	9.45	9.31	6.53	Turning on monitor
16/09/2021	5:25:00 PM	3.84	2.68	5.92	Auger withdrawal then reinsertion and centering
17/09/2021	4:06:00 PM	7.53	0.72	1.55	Auger removed from borehole to replace teeth
20/09/2021	3:09:00 PM	7.91	0.41	0.85	Auger withdrawal then reinsertion and centering

20/09/2021	3:27:00 PM	6.77	0.34	0.76	Auger piling through hard rock at depth
COMPLIANT WITH VIBRATION CRITERIA:			Yes		
MONITORING COMMENTS OR ACTIONS TAKEN TO ADDRESS EXCEEDENCES OF VIBRATION CRITERIA					
No vibration exceedance above the criteria of 10 mm/s during piling works
