Blues Point Archaeological Monitoring Report

Prepared by AMBS Ecology & Heritage
for Systems Connect

March 2023

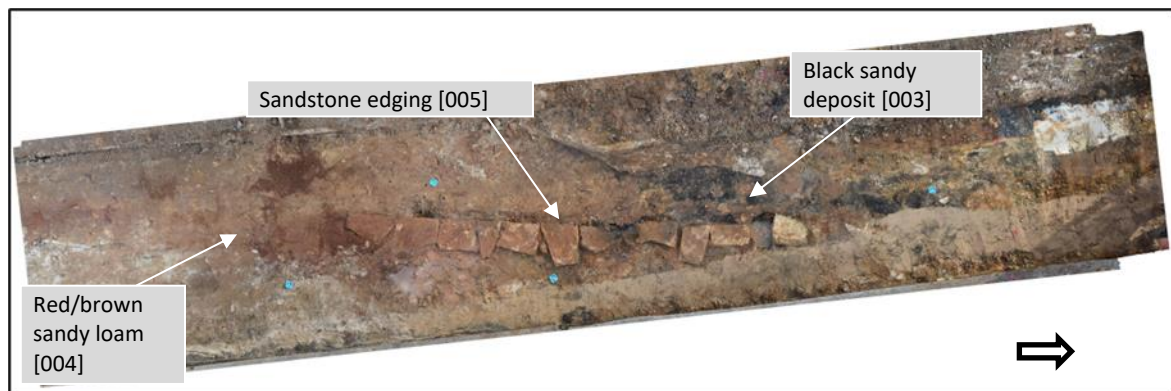
A line of sandstone blocks was first exposed during the preparation for the new road surface on the western side of the site (WZ1B). Once the existing concrete [001] was removed a yellow/brown sandy/silt deposit [002] was evident across much of the area. Under context 002, and at the level required for Systems Connect scope of work, a red/brown/orange sandy loam fill [004] was exposed along with a row of sandstone blocks [005], which extends north-south along the site. A patchy black sandy layer with sandstone inclusions [003] can be seen abutting the row of sandstone blocks and the 1887 wall at the far west of the site. At this level a clear cut to the east of the blocks was evident and filled with a sterile yellow sand [006]. To the west of the blocks the area was heavily disturbed with a large north-south running service pipe encased with concrete [007]. The blocks and the fill [004] can be seen continuing down the site and line up with the sandstone blocks and timber plank found in WZ1A (Figure 3.2). The blocks are positioned with their straight, worked edge on the western side closest to the heritage wall (1250mm), creating a gully/channel for the rainwater reducing the risk of water build up on the road. The top edge of the blocks were levelled and likely prepared for a top layer of either another course of sandstone blocks or a road surface. This was likely removed, during the later stage of the road's modification.

The blocks were irregular in size and shape, with varied lengths between 370mm-670mm. As no further excavations were required in this area the blocks were left insitu. Therefore, it is not known if there was a course under these blocks.

Figure 3.2: Orthophoto of sandstone blocks running north-south down Blues Point Road. Note the straight edge on the western side and the continuation of the red/brown fill. Archsurv Guy Hazell.

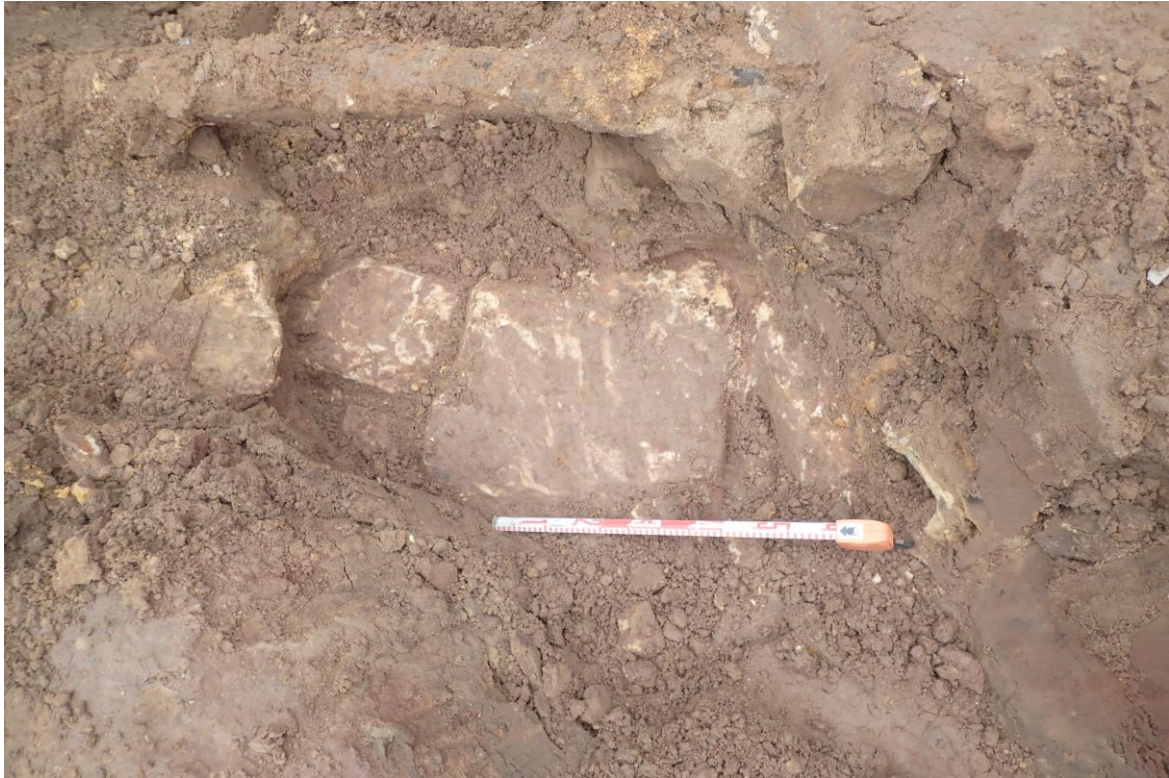
During excavation of WZ1A four sandstone blocks were revealed. Their alignment and fill were the same as context 005 to the north, as such it is evident that the four blocks were the southern termination of the context 005 (Figure 3.1). Two of the blocks had to be removed for the installation of a lamppost. On removal of the blocks, it was determined that there were no courses below. It also revealed a horizontal wooden plank [008] which was positioned floating in the red/brown sandy loam fill [004] that was used for the edging. Below context 004 was a dark grey mottled sand [009] with small sandstone inclusions. This was also observed immediately below the fill of the road base [002] next to the cliff face, suggesting that context 004 was an imported fill for the edging. The colour of the fill indicates that it was not locally sourced or that it has absorbed a mineral from one of the industrial uses on the site. Historic images show that this area of the site has repeatedly been used as an area for storage (Figure 3.6, Figure 3.6).

Figure 3.3: Sandstone blocks revealed at southern end of Blues Point Road, pre-excitation.

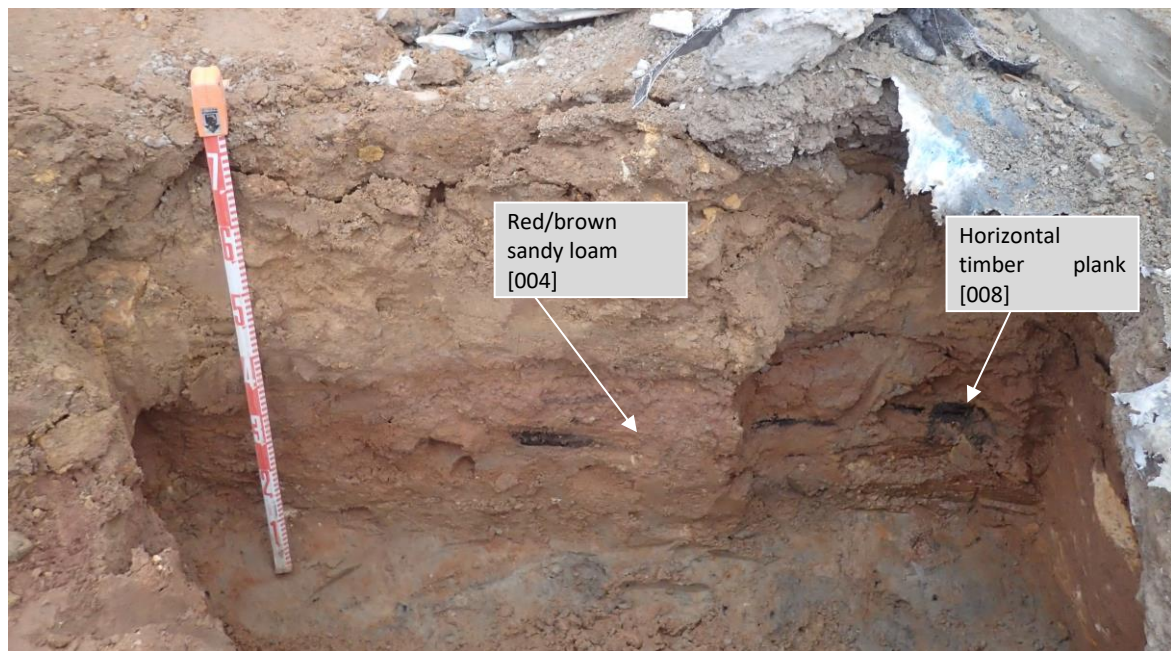
Figure 3.4: View of timber plank [008] in [004] after two sandstone blocks were removed.

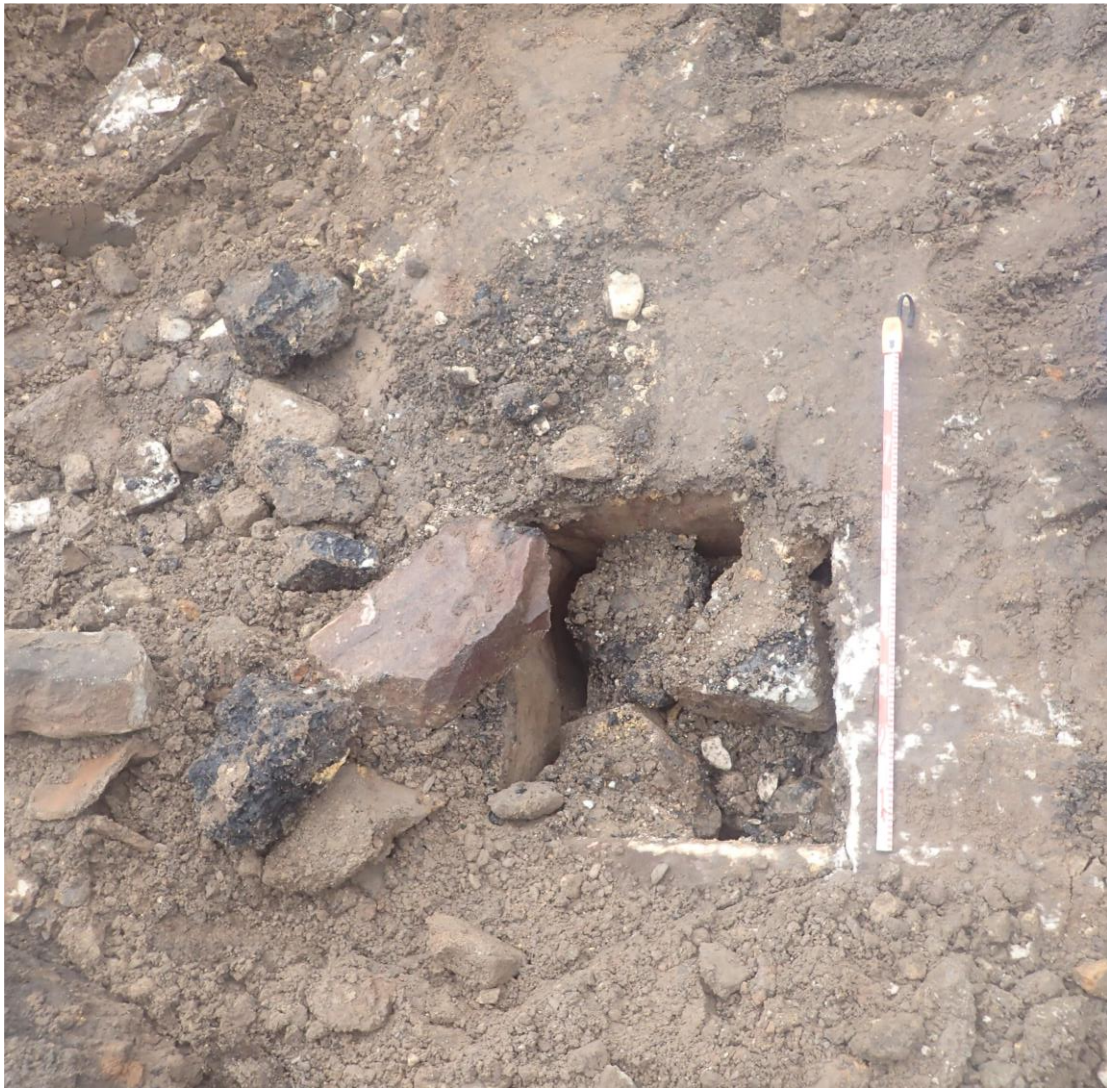
Figure 3.9: View of the brown, sandy/silty fill with large sandstone inclusions [014] on and in the sandstone drain [015].

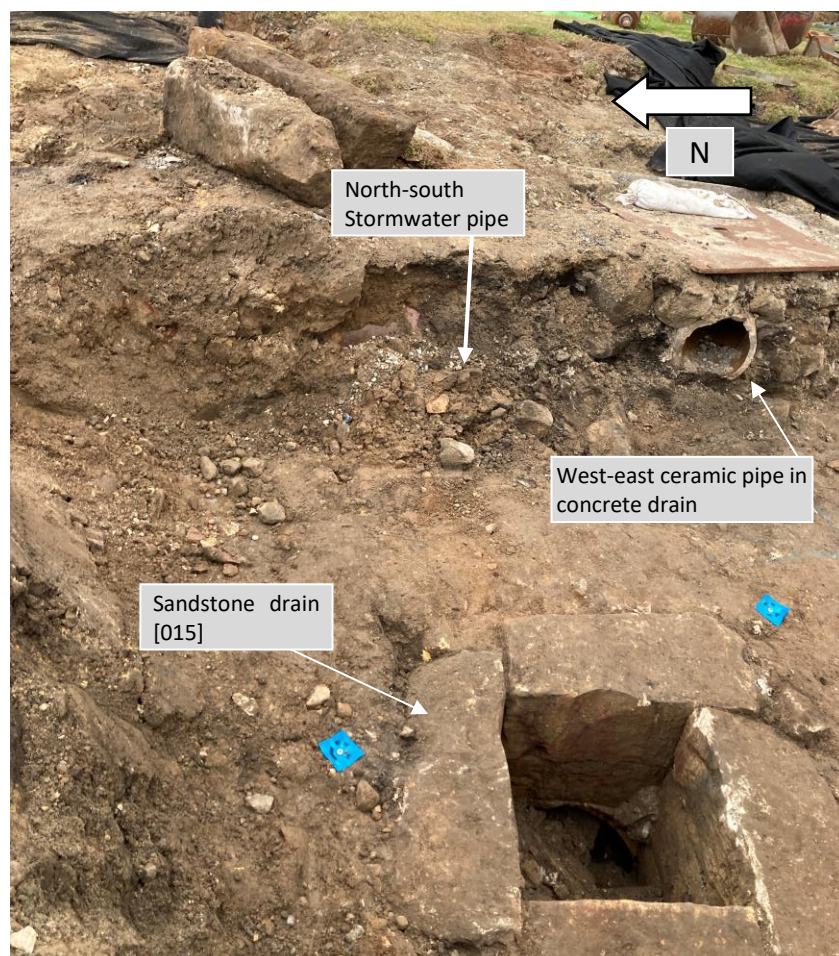
Figure 3.11: Image of the sandstone drain [015] with part of the stormwater drainage pipe in the southeast corner running towards the harbour.

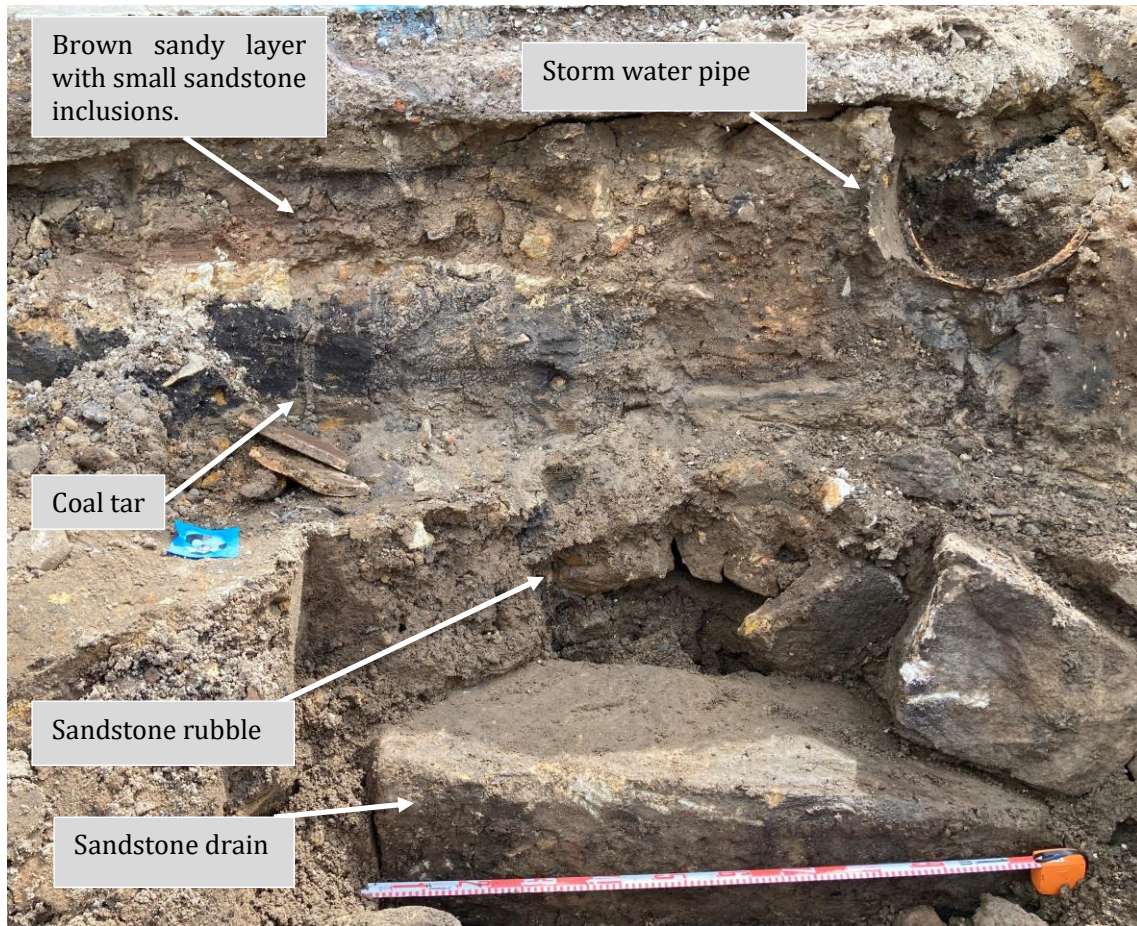
The drain consisted of four sandstone blocks, laid out in an open square shape and measured approximately 1.32m². The top course of blocks measured approximately 900mm to 1200mm in length, 300mm in height and 350mm in width. The blocks on the eastern side of the feature had a curved, worn area that was very smooth with no tool marks evident. This could potentially be attributed to water wear around a vertical drain pipe. The blocks on the southern side of the feature showed tool marks, indicating it had been modified but it is unclear as to why (Figure 3.10). The second course of blocks were approximately 600mm in length, with the curved mark continuing from the top course on the eastern side (Figure 3.10). The fill [014] on top of the drain was also found in the drain (Figure 3.9). Part of the stormwater drainage system for the area can also be seen at the base of the drain on the south-eastern corner. The drain was excavated for the new drainage systems, leaving one block in situ (Figure 3.12).

Figure 3.12 The western lower sandstone block of the drain that was not removed. The sandy/silty fill with large sandstone inclusions is evident in this image. Above this is the coal tar level and above this is the west-east running pipe in a sandy brown layer with small sandstone inclusions.

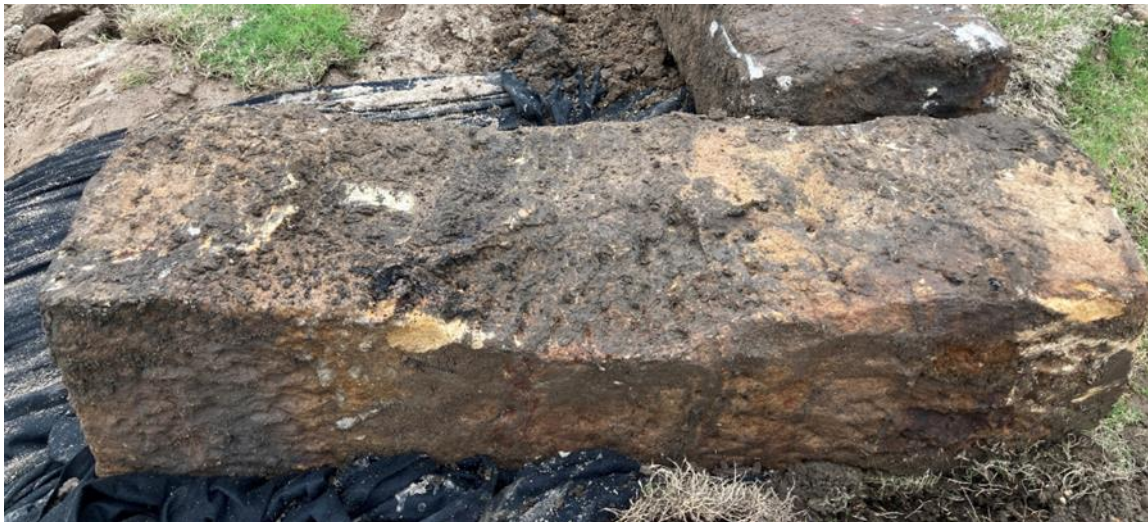
Figure 3.13: Detail of tool marks on the southern block from the drain [015].

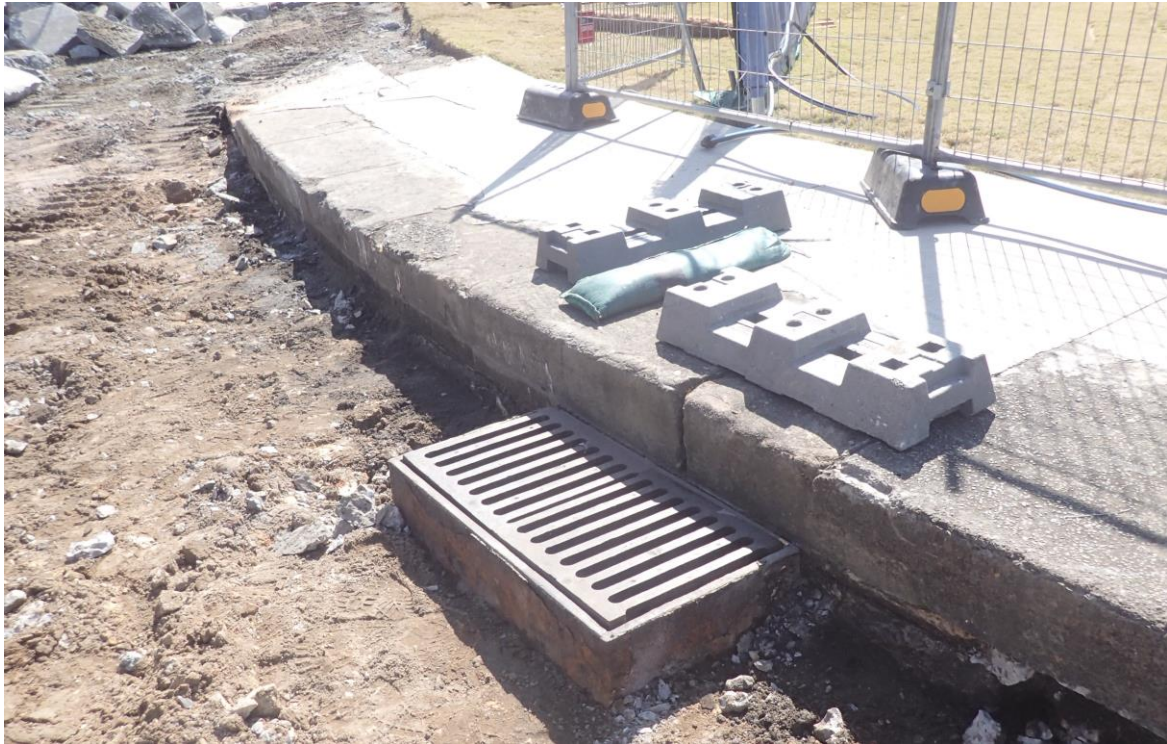
Figure 3.14: Partial footpath along Blues Point Road with sandstone kerbing still in use in 2022.

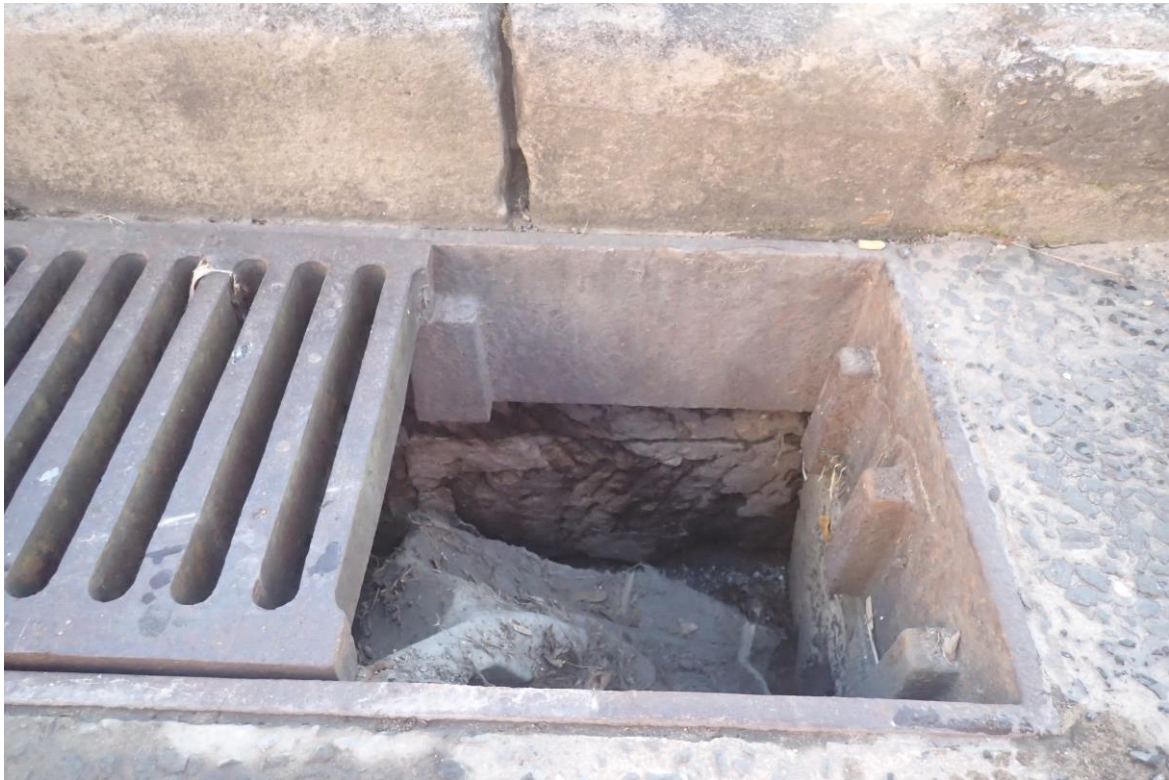
Figure 3.15: The sandstone wall below a course of dressed sandstone used as the footpath running down Blues Point Road.

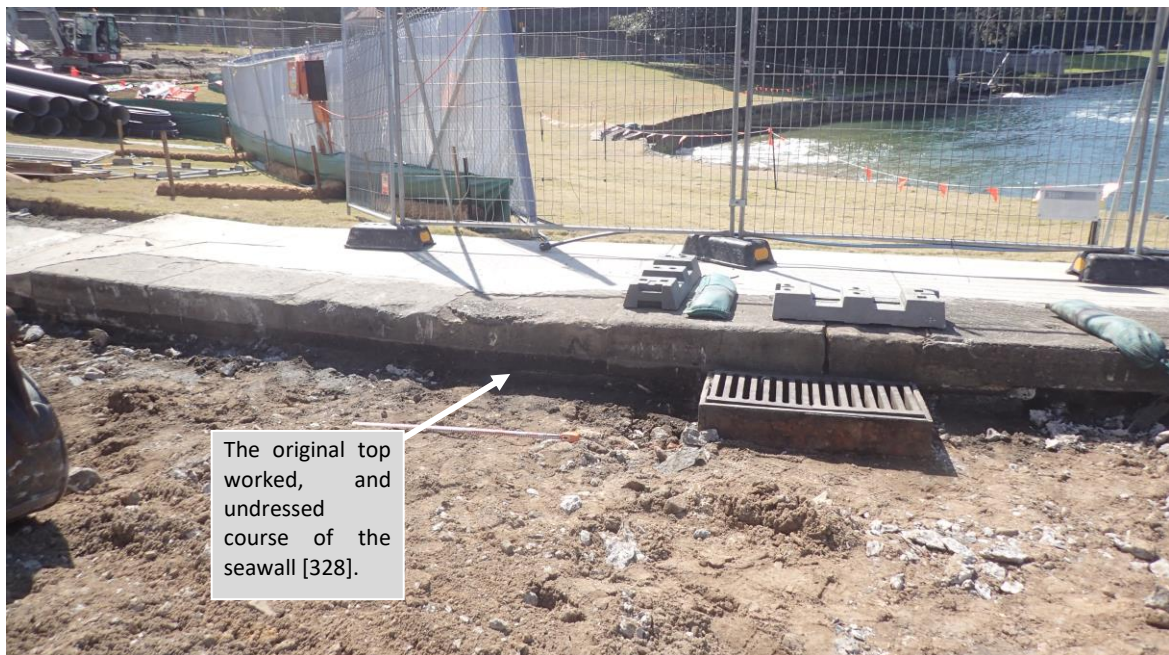
Figure 3.16: A North-eastern view of the footpath with its dressed top course of sandstone blocks incorporated into the footpath with the undressed and worked second course revealed during the removal of concrete.

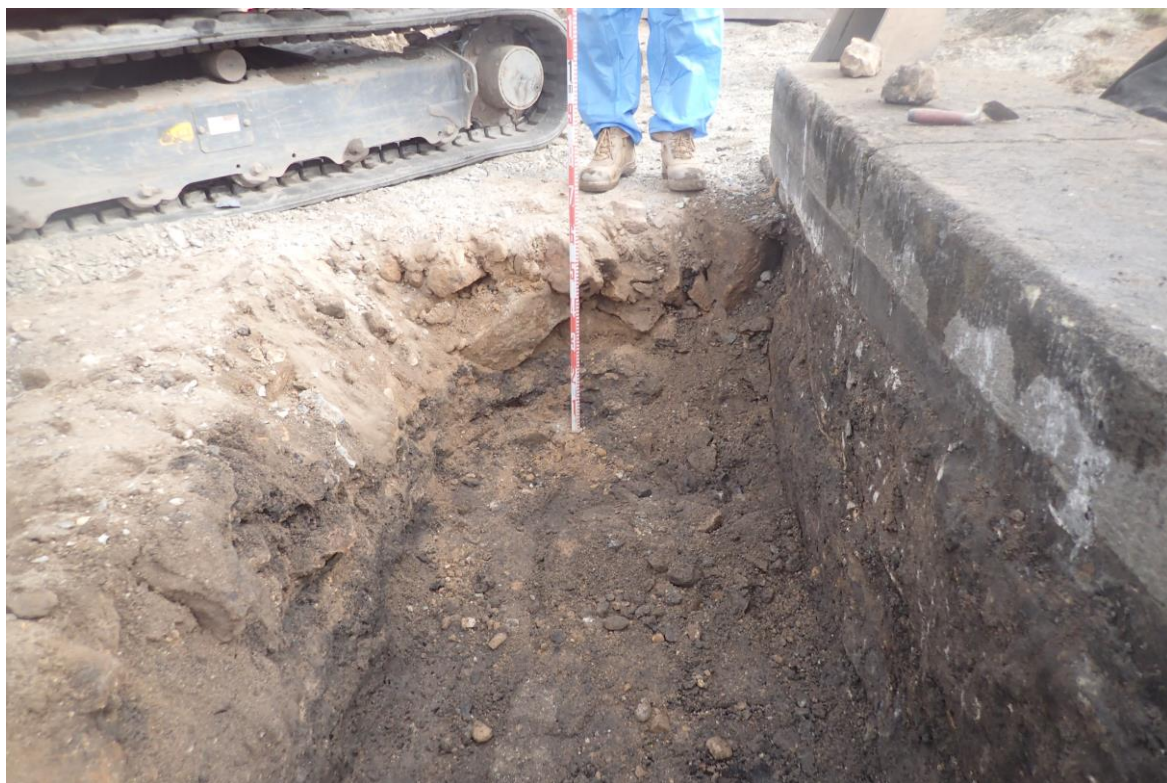
Figure 3.18: The vertical unworked side of the reduced sandstone seawall [328] with the sandstone kerbing above.

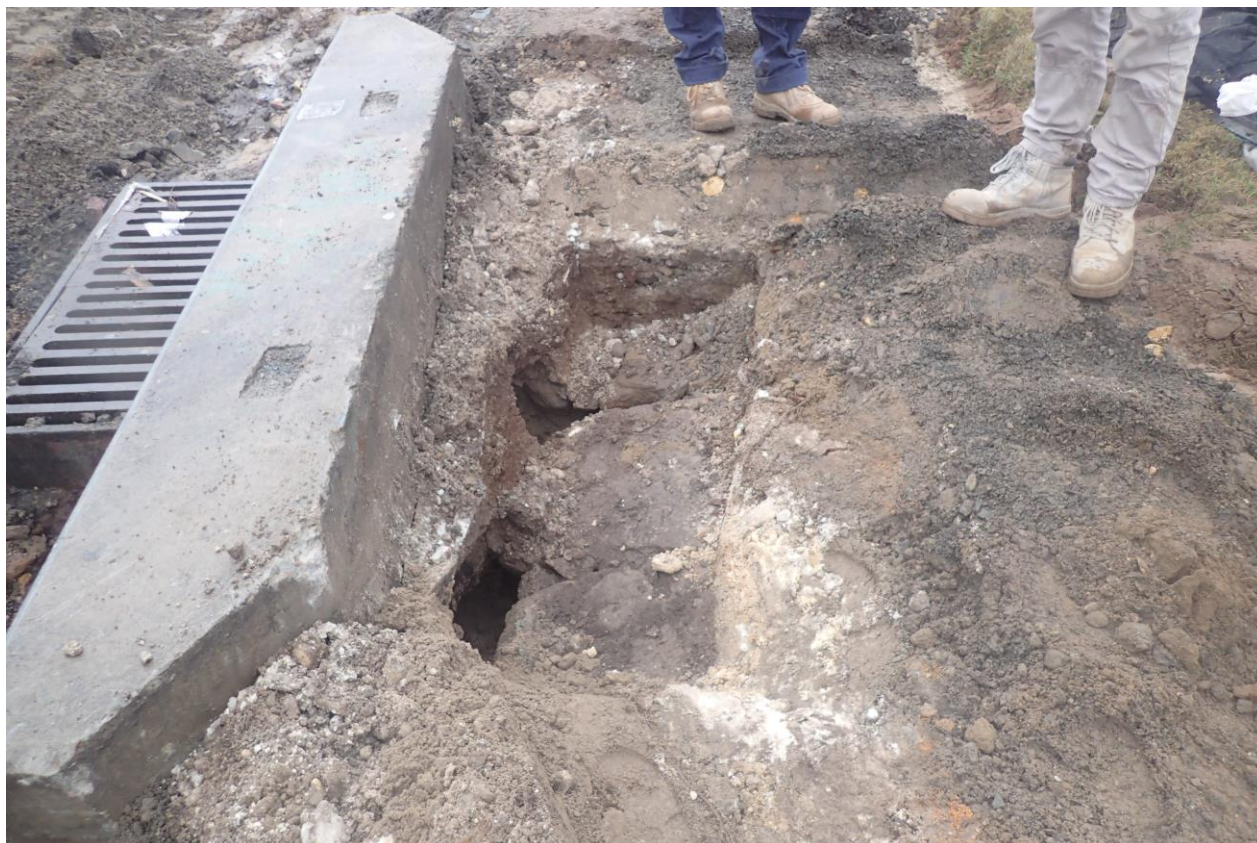
Figure 3.21: A second course of sandstone blocks, lying west-east witnessed below the isolated sandstone block potentially from the early seawall [328].

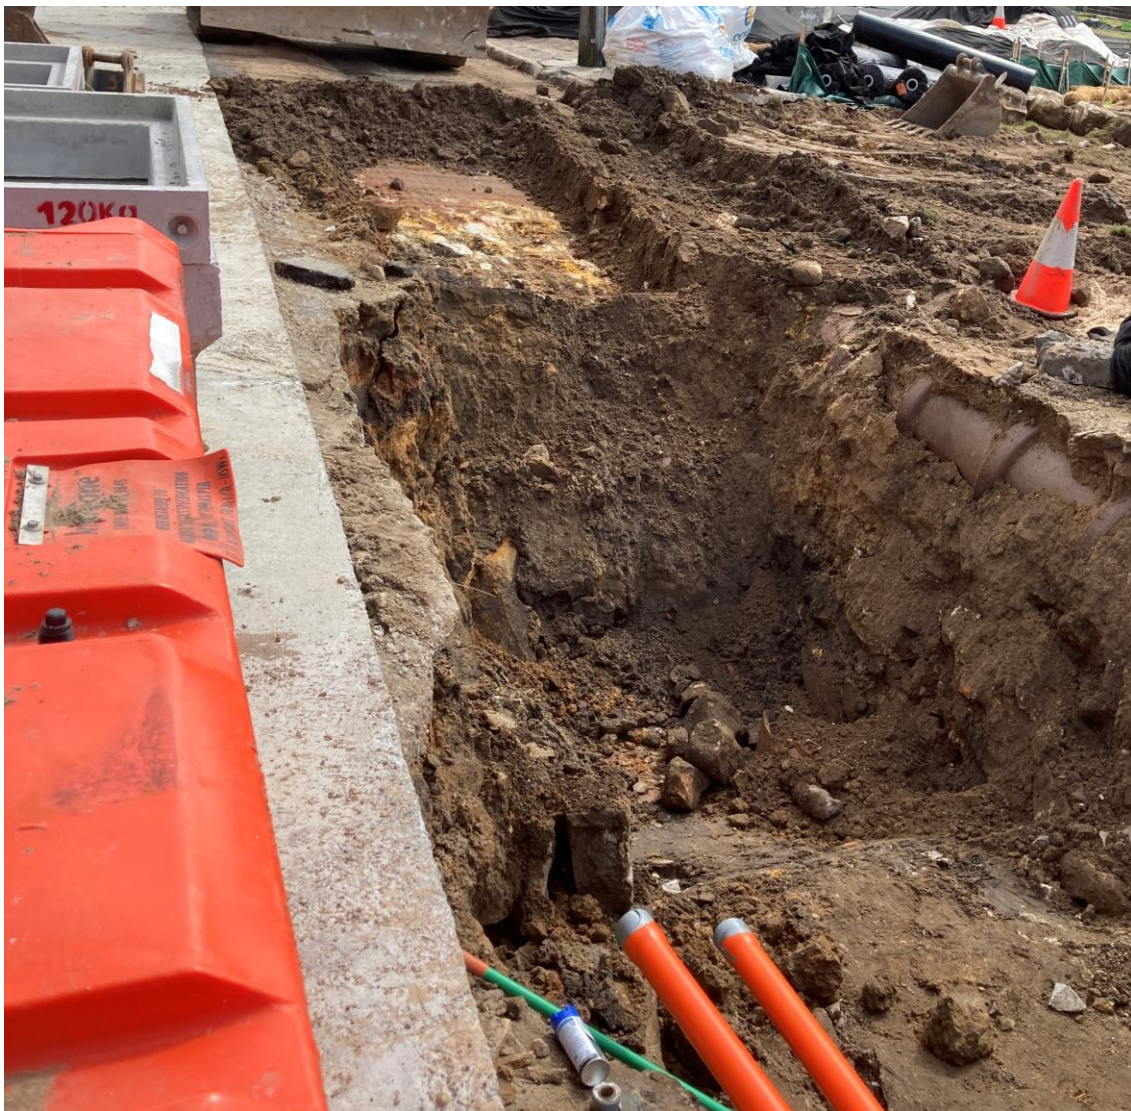
The trench in WZ3D ran alongside an unused terracotta service pipe, exposed during excavation (Figure 3.23). This is the continuation of the stormwater pipe [011] seen in WZ3E demonstrating the need for water management across the site.

Figure 3.23: Trench for a garden bed in WZ3D showing the exposed bedrock at the top of the trench, a service pipe on the right and the steep natural benching of the bedrock.

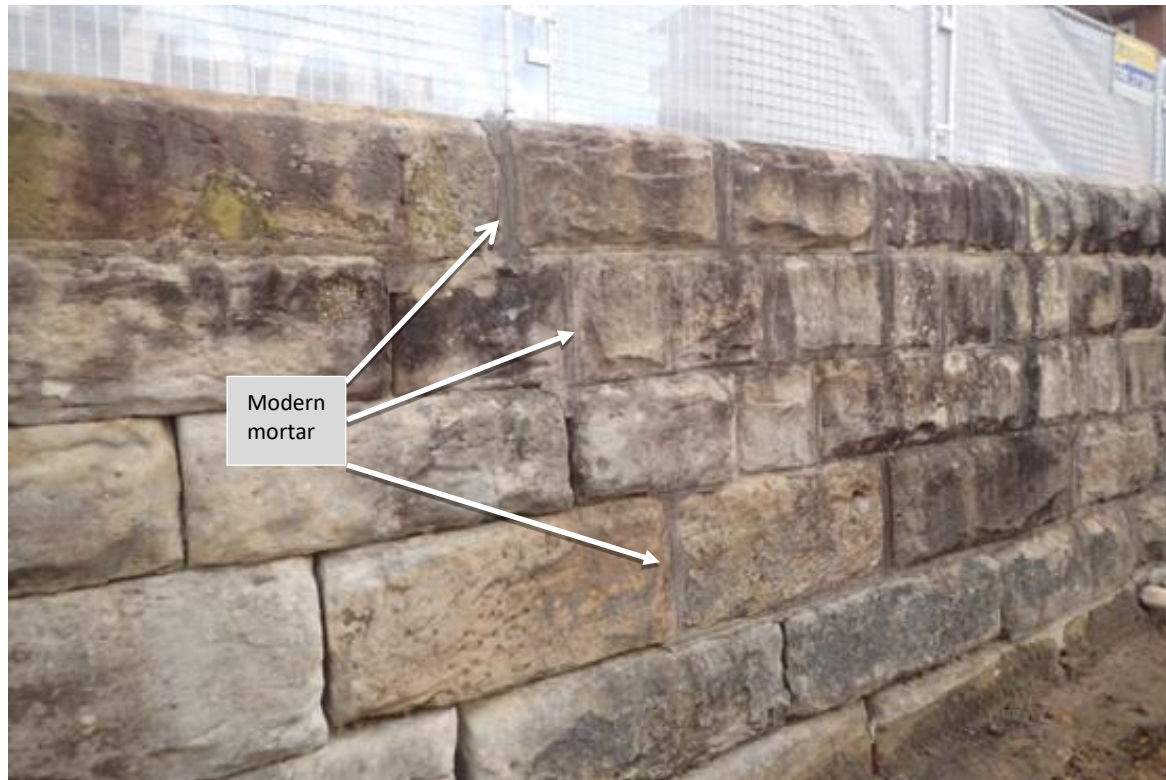
In WZ1D, the removal of a drain connected to the Blues point Tower, exposed the north end of the heritage wall foundations. The heritage wall was erected in 1887 by the Mayor D Munro Esq. On inspection it was noted that sandstone blocks had been robbed from a large section of the wall, the pipe inserted, the concrete drain installed and mortared to the Heritage wall. The wall was

replaced with mortar used to secure the blocks. Next to the concrete drain were partial remains of a wooden telegraph pole (Figure 3.24, Figure 3.25, Figure 3.26). The ongoing development of Blues Point and the construction of Blues Point tower in 1962 increasing the population of the area necessitated increased service installation.

Figure 3.24: Section of the 1887 wall that was removed and replaced for the installation of a service pipe and drain. The modern mortar used to rebuild the wall highlights the modification.

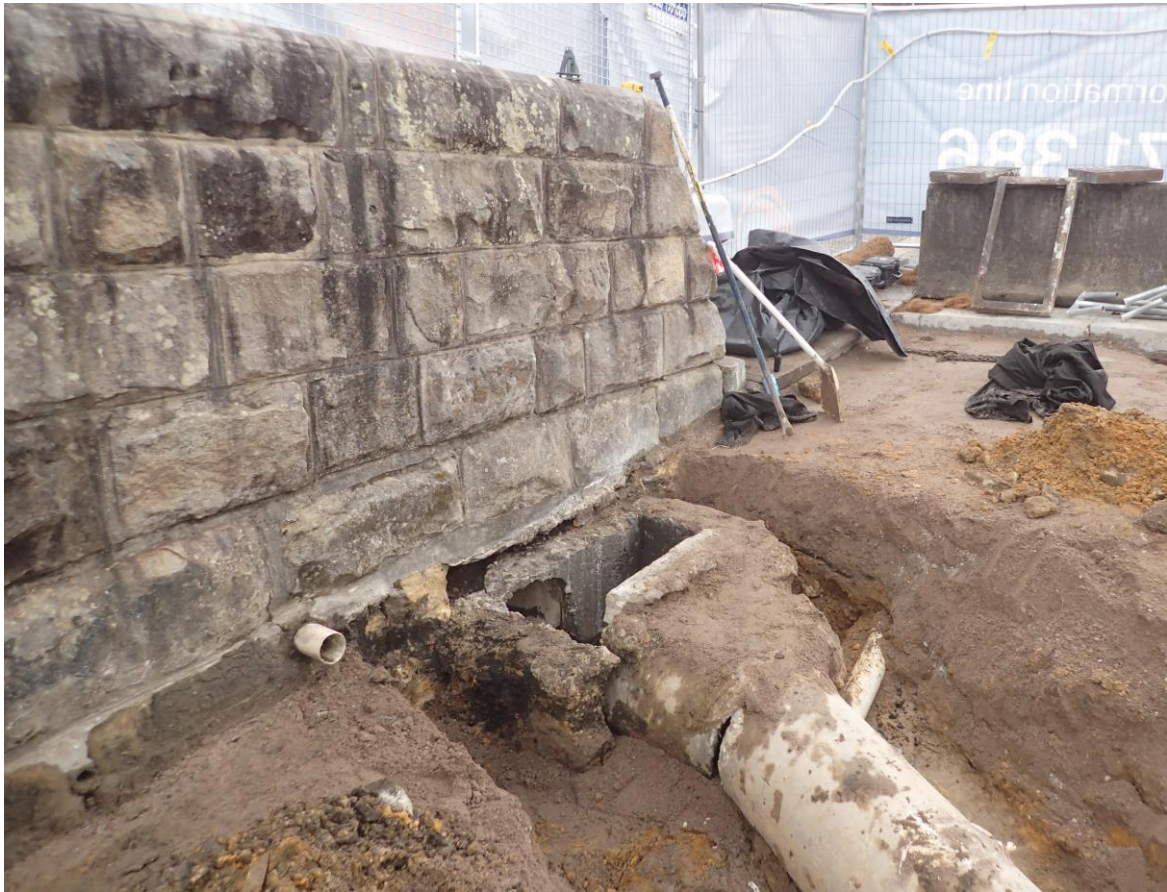
Figure 3.25: The concrete drain and connecting pipe laid under the northern most section of the heritage wall.

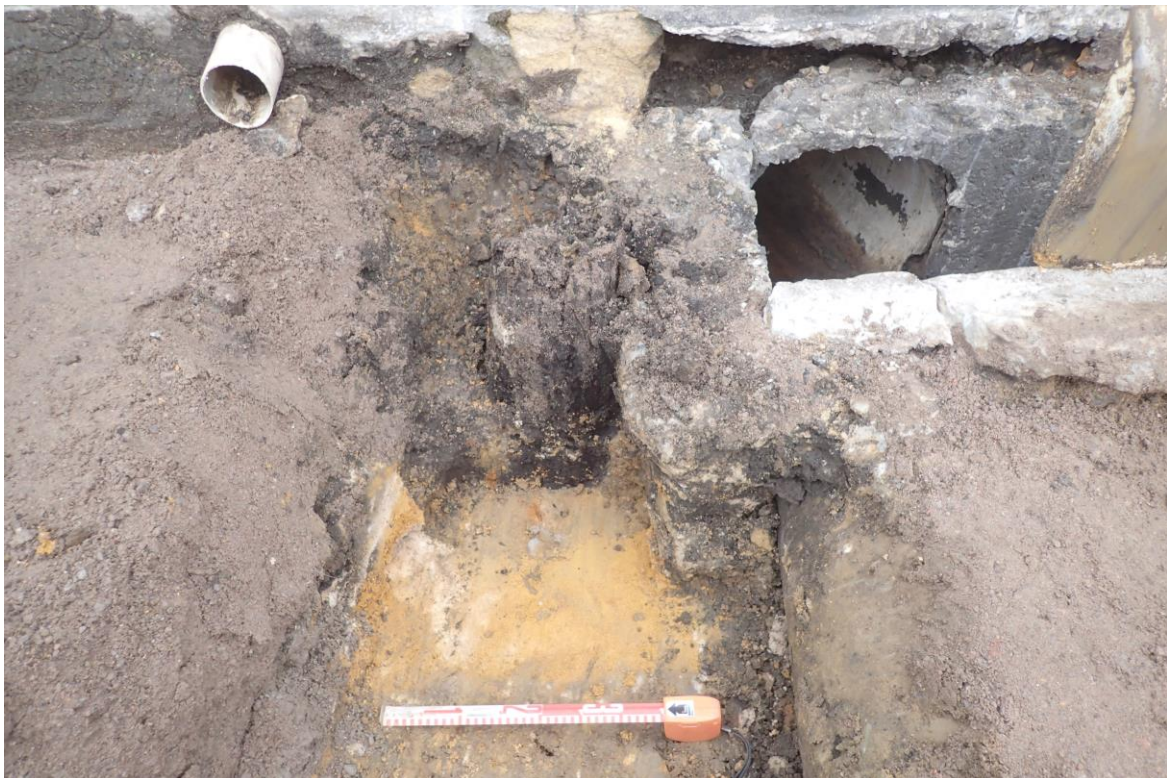
Figure 3.26: Detail of the remains of the wooden telegraph pole alongside the concrete drain with the plastic pipe.
