Orchard Hills Station Detailed Site Investigation

Sydney Metro Western Sydney Airport Station Boxes and Tunnelling Works

Project number	WSA-200-SBT
Document number	SMWSASBT-CPG-SWD-SW000-GE-RPT-040514
Revision date	26/09/2022
Revision	A.05

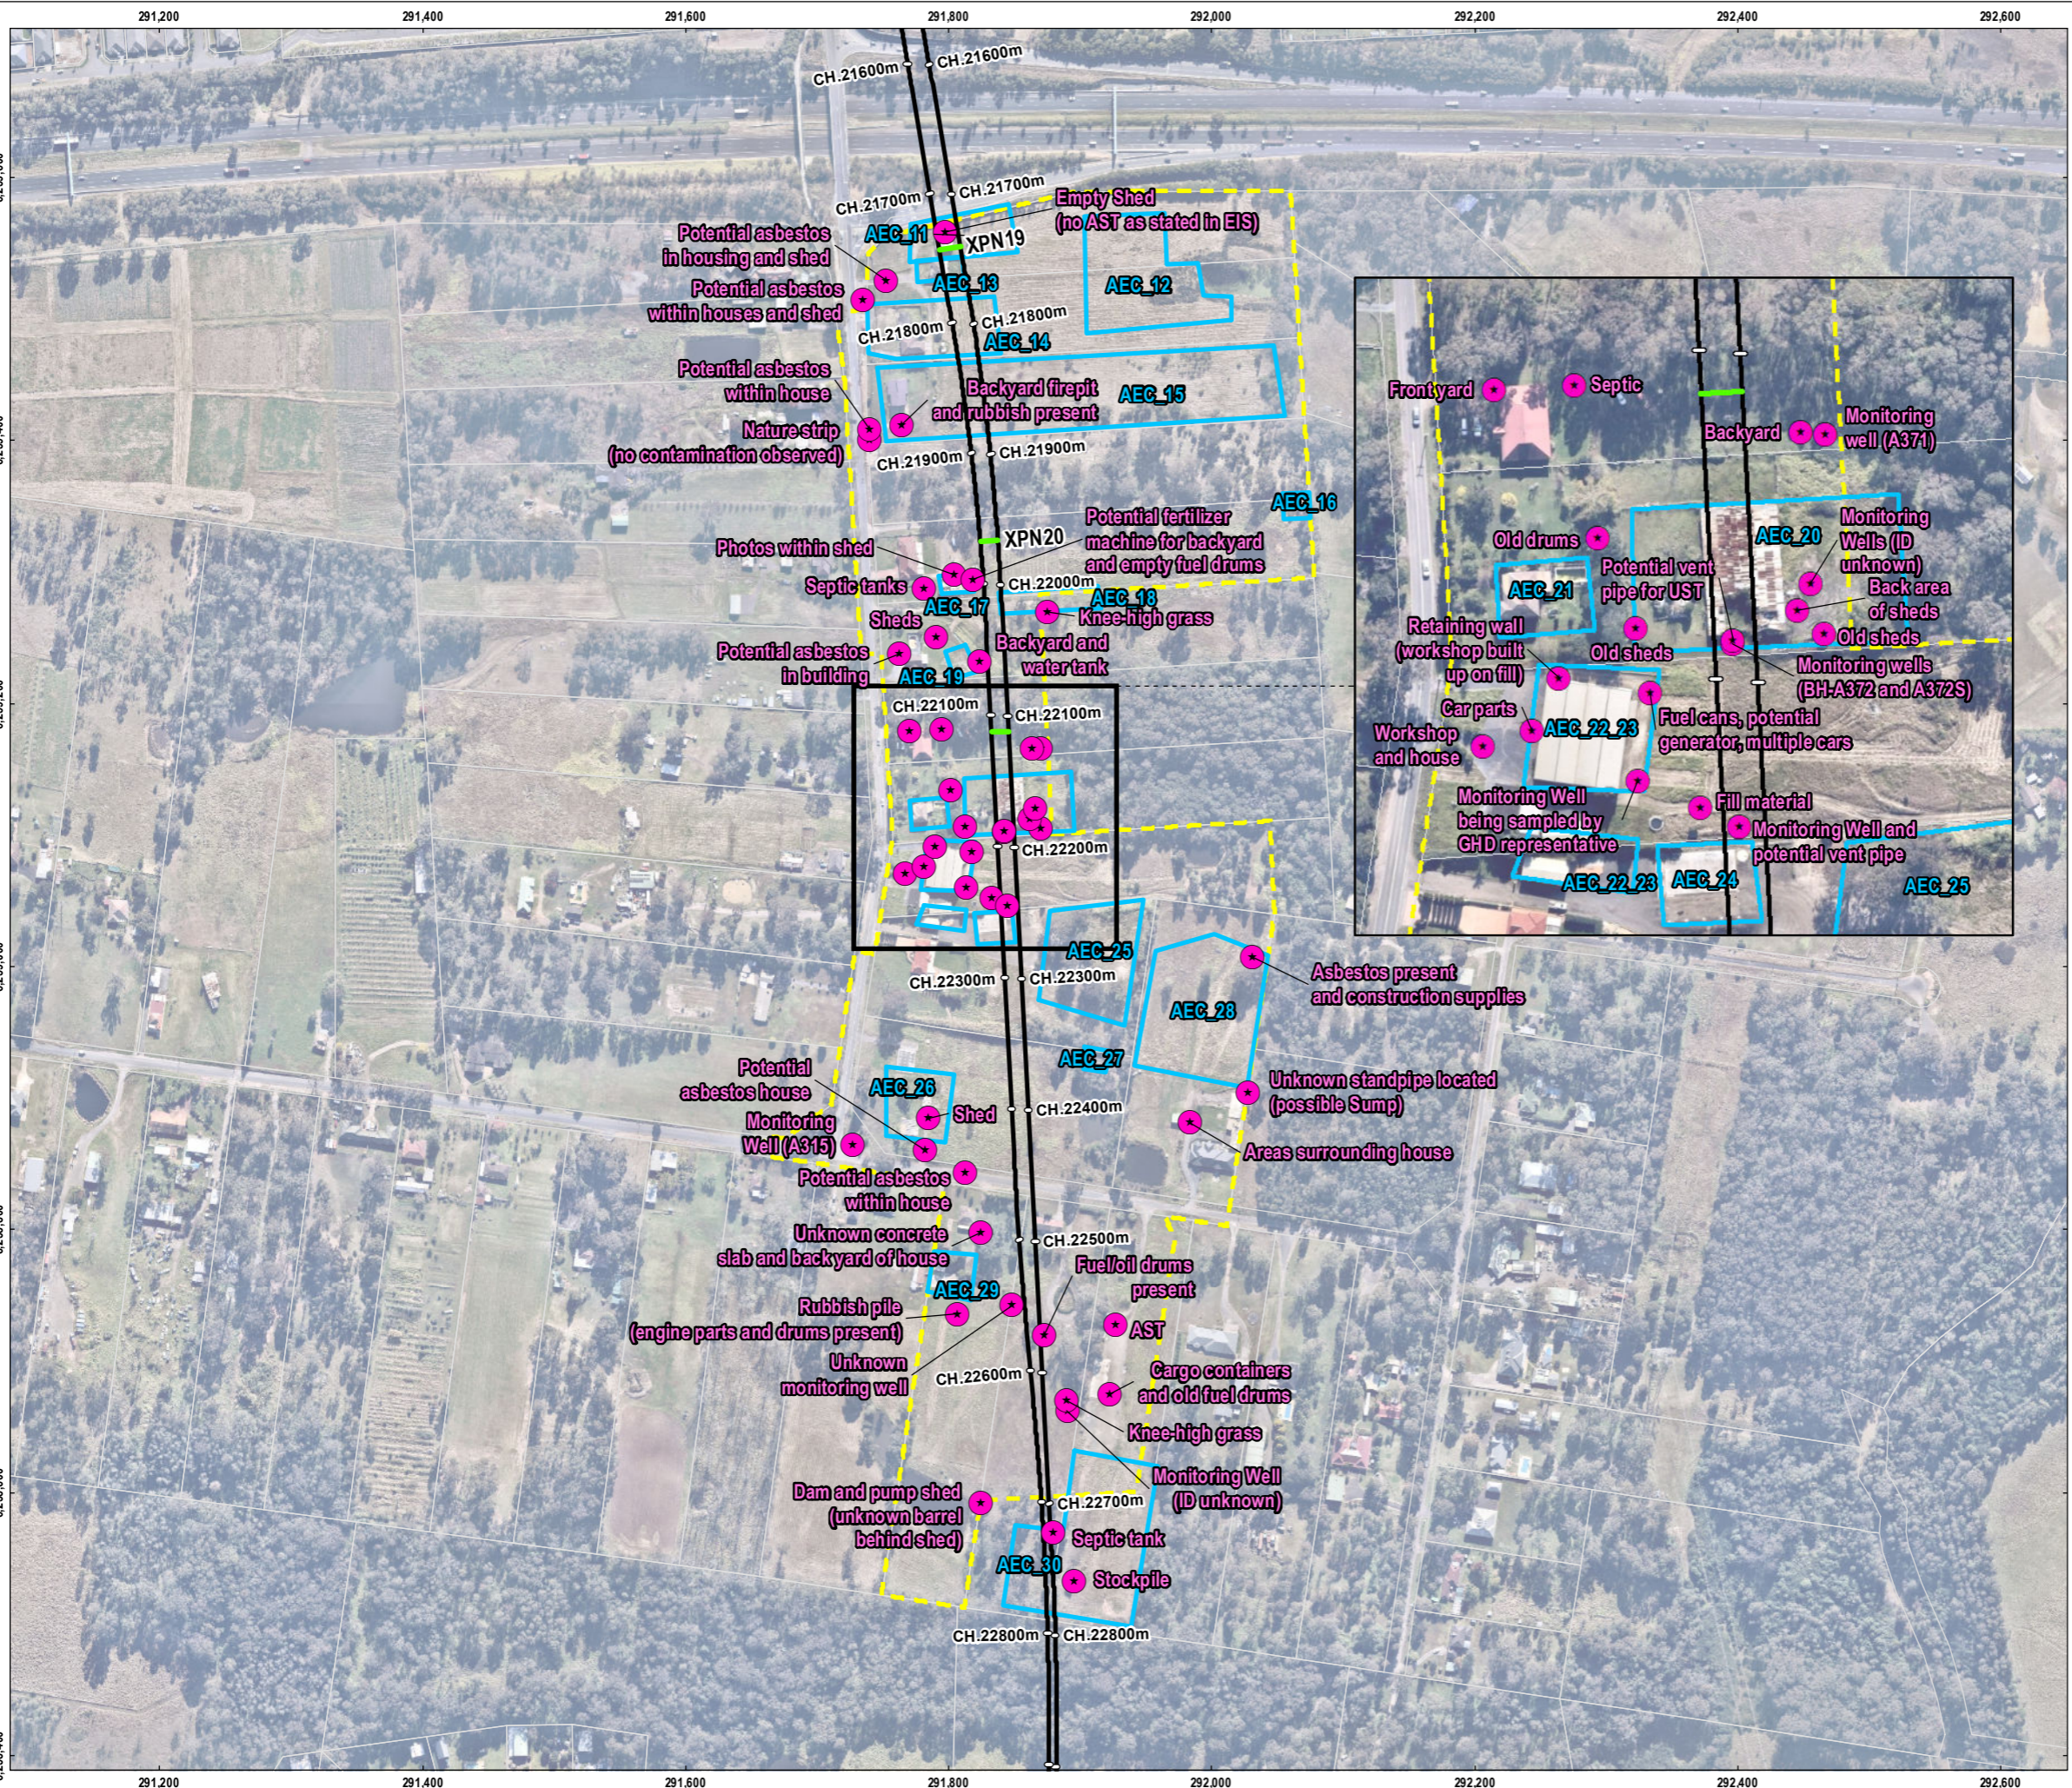
FIGURE 3
 Site Observations - Orchard Hills
 Station and Portal Dive Structure

- A concrete pad with a severed metal pipe protruding from it was noted on the southern side of the large shed at 94-98 Kent Road that could potentially be associated with bulk fuel storage and warrants further investigation.

- Several soil stockpiles were observed on the site. An investigation is required to establish the quality of the material in the stockpile and management requirements.

- An AST was identified at 22 - 26 Lansdowne Road. While the AST appeared to be in good condition, it was situated on the grass and was not mounted in a frame, or within bunding. The AST was located in close proximity to sheds and farming equipment however it was not clear whether the AST had been historically located in this area. Further investigation is warranted to assess whether contamination may have resulted from the AST.
