# Orchard Hills Section A Site Audit Report and Statement

Sydney Metro Western Sydney Airport Station Boxes and Tunnelling Works

<b>Project number</b>	WSA-200-SBT
<b>Document number</b>	SMWSASBT-CPG-OHE-SN150-EN-RPT-295264
<b>Revision date</b>	22/12/2023
<b>Revision</b>	1

**SITE AUDIT REPORT - ORCHARD HILLS STATION (STAGE 1), SYDNEY METRO WESTERN SYDNEY AIRPORT**

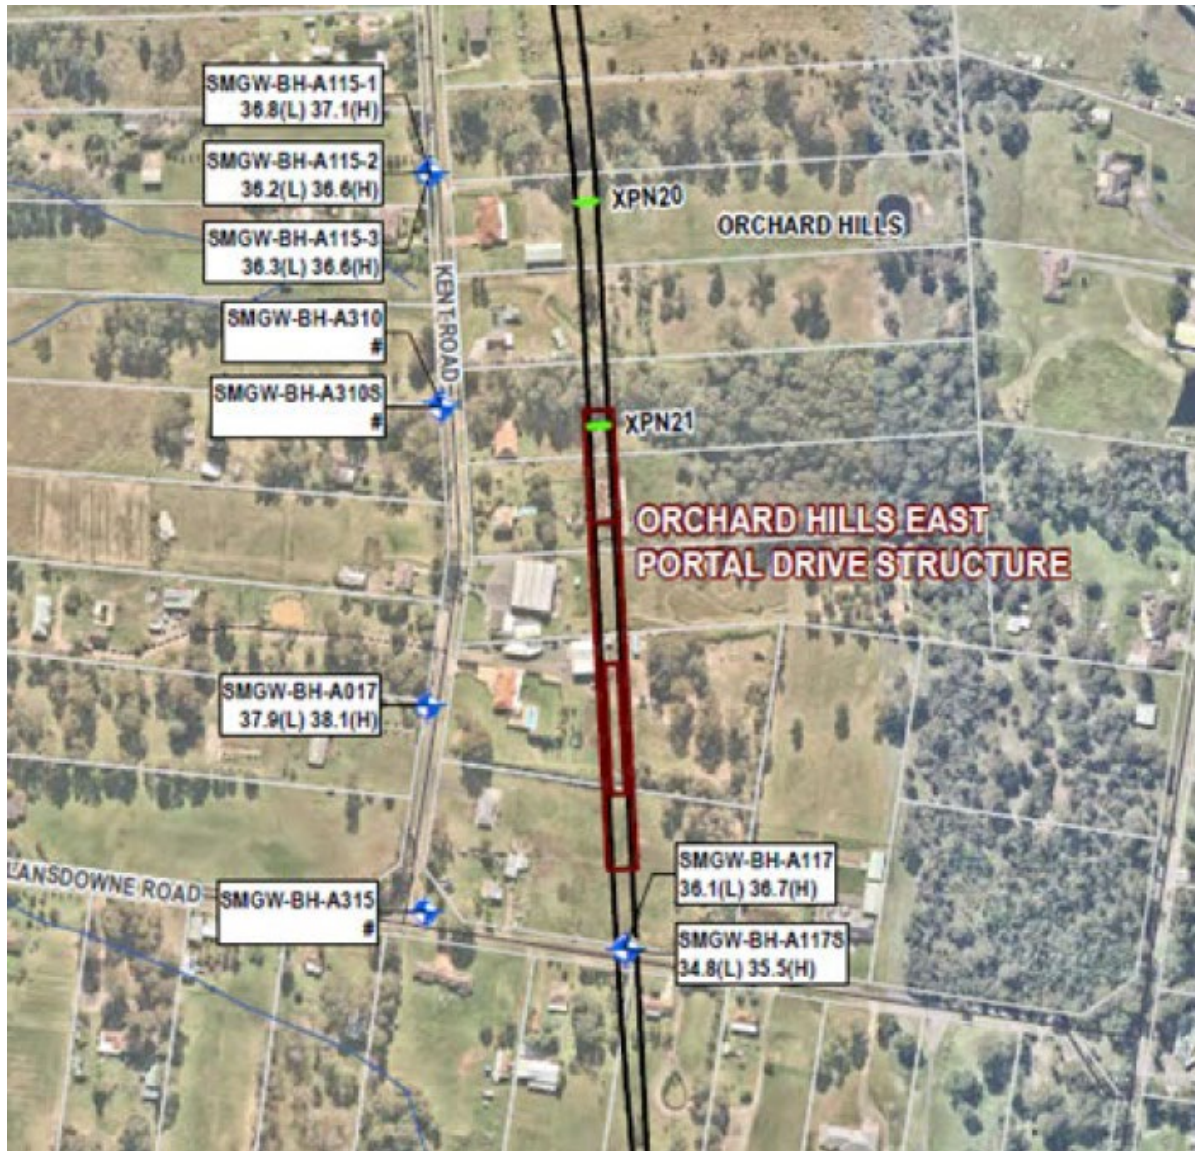
Figure 9.1: Locations of Historical Offsite Groundwater Monitoring Wells (Source: the SAQP)

- The laboratory detection limit adopted for PFOS was greater than the HEPA (2020) criterion for 99% (0.00023  $\mu\text{g/L}$ ) but below the criterion for 95% (0.13  $\mu\text{g/L}$ ) freshwater species protection. Historically, PFOS concentrations exceeding the HEPA (2020) criterion for 99% freshwater species protection (and below 95% freshwater species protection) were reported in the assumed upgradient offsite monitoring wells SMGW-BH-A310, SMGW-BH-A315 and SMGW-BH-A315S (**Figure 9.1**), indicating that it is likely that the site groundwater contains PFAS.

- In consideration of the monitoring results, the PFAS concentrations in site groundwater are anticipated to be low (above 99% but below 95% species protection criteria). Given the nearest surface water receptors (Blaxland Creek and South Creek) are not of high ecological conservation value, adopting the HEPA (2020) criterion for 99% freshwater species protection to assess PFAS concentrations in groundwater is likely to be conservative and the overall risk associated with PFAS in groundwater is expected to be low.

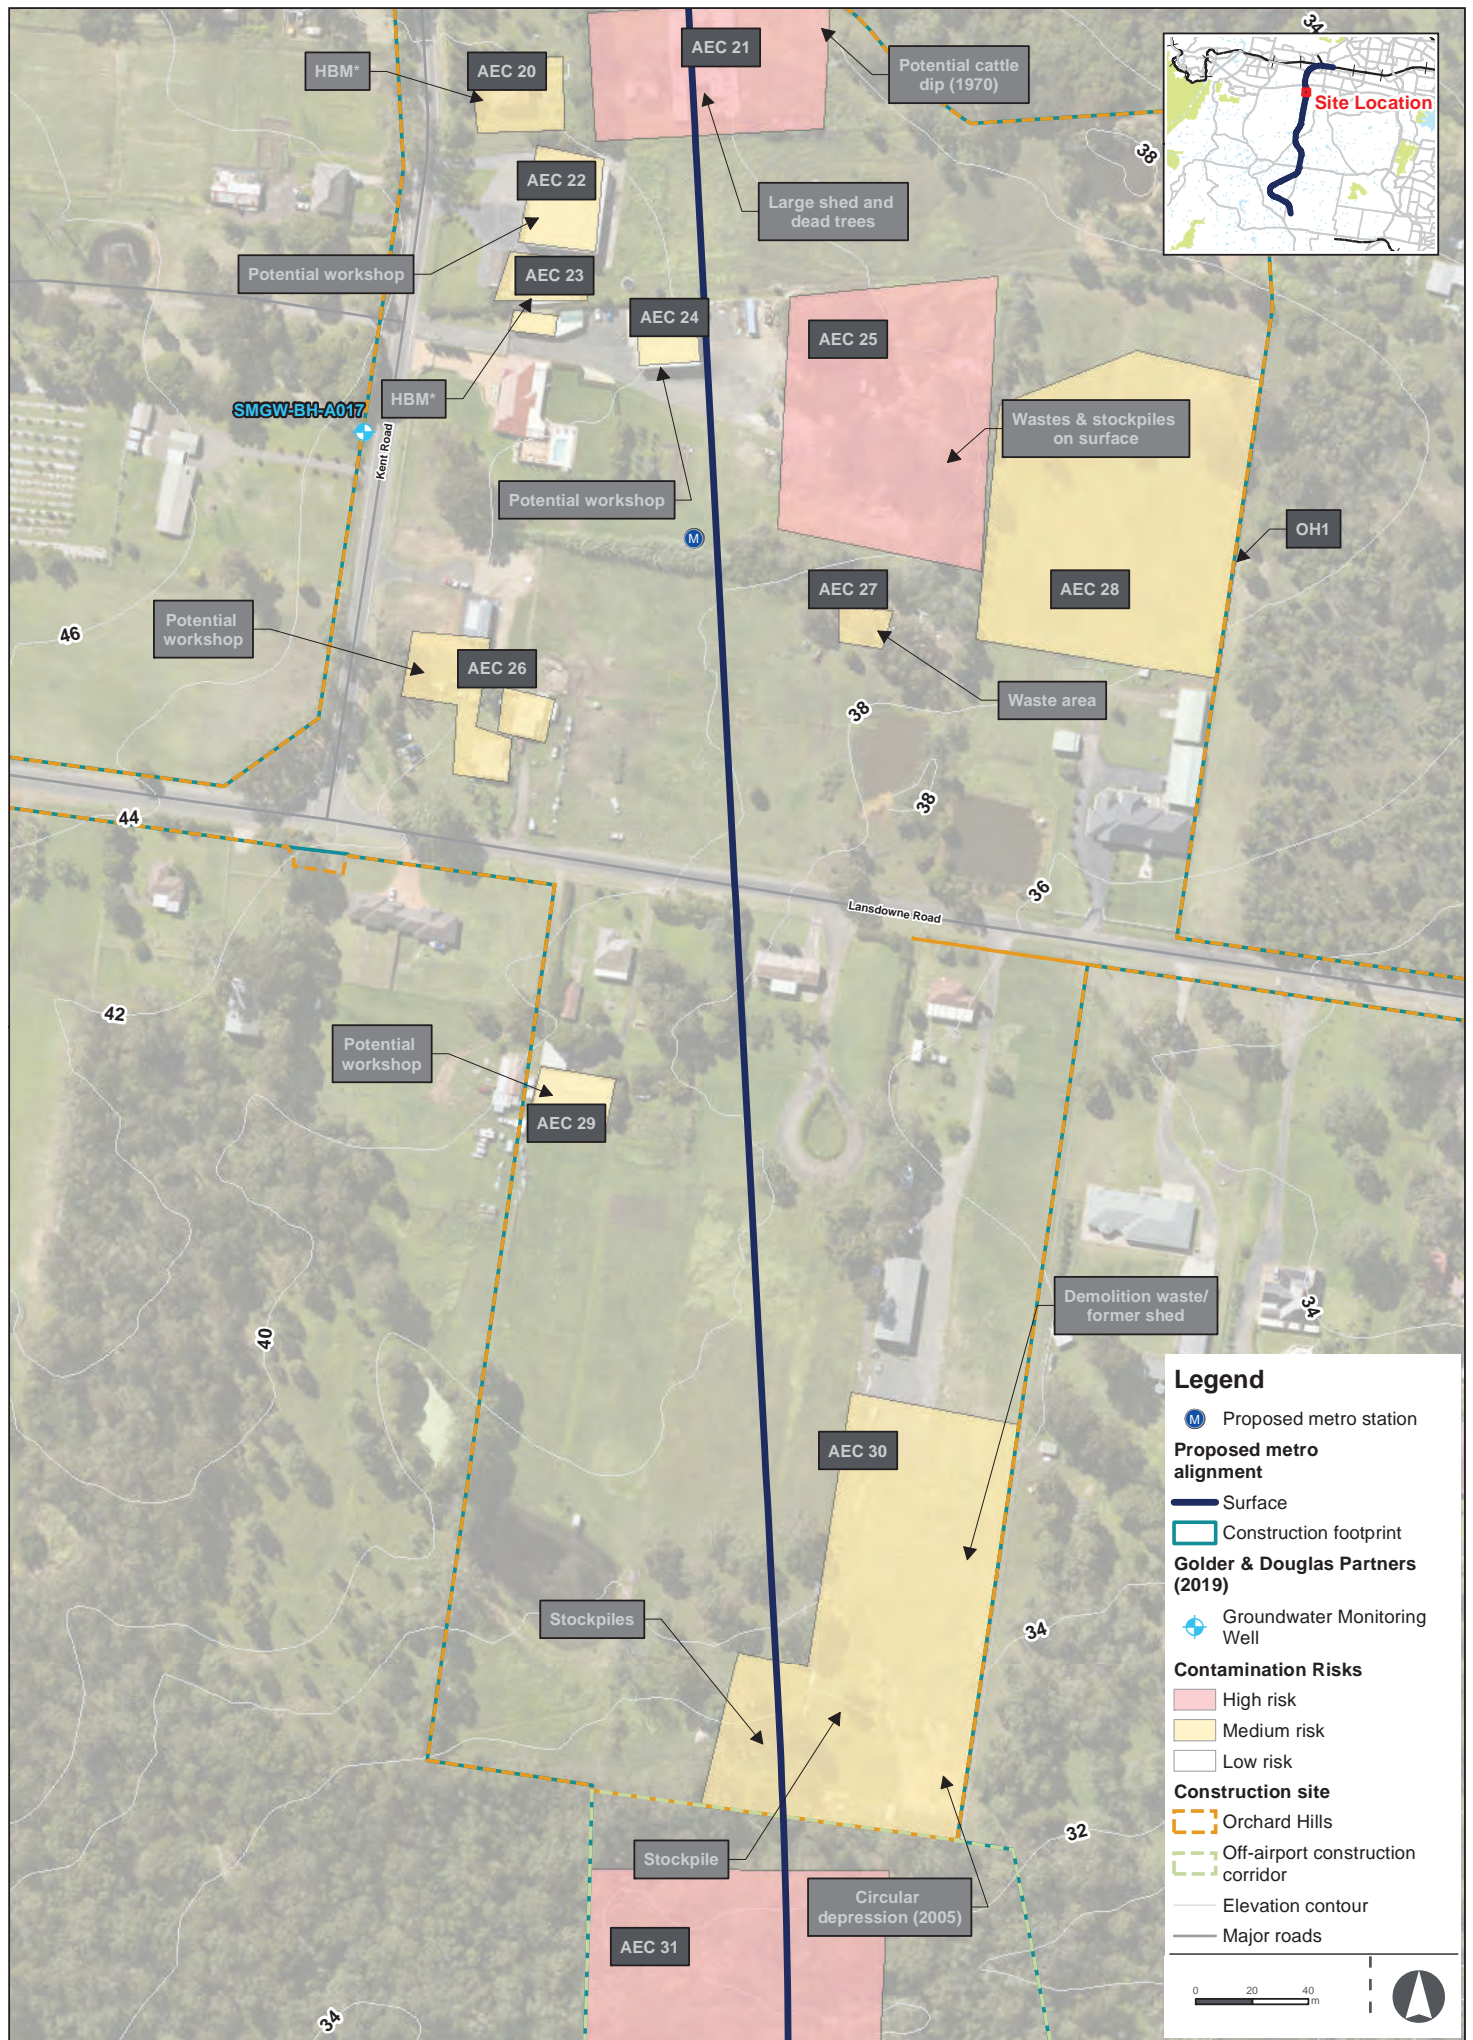
Attachment 3A: AECs Identified on the Stage 1 Site and in Surrounding Areas

Orchard Hills construction footprint contamination sources and risk ranking

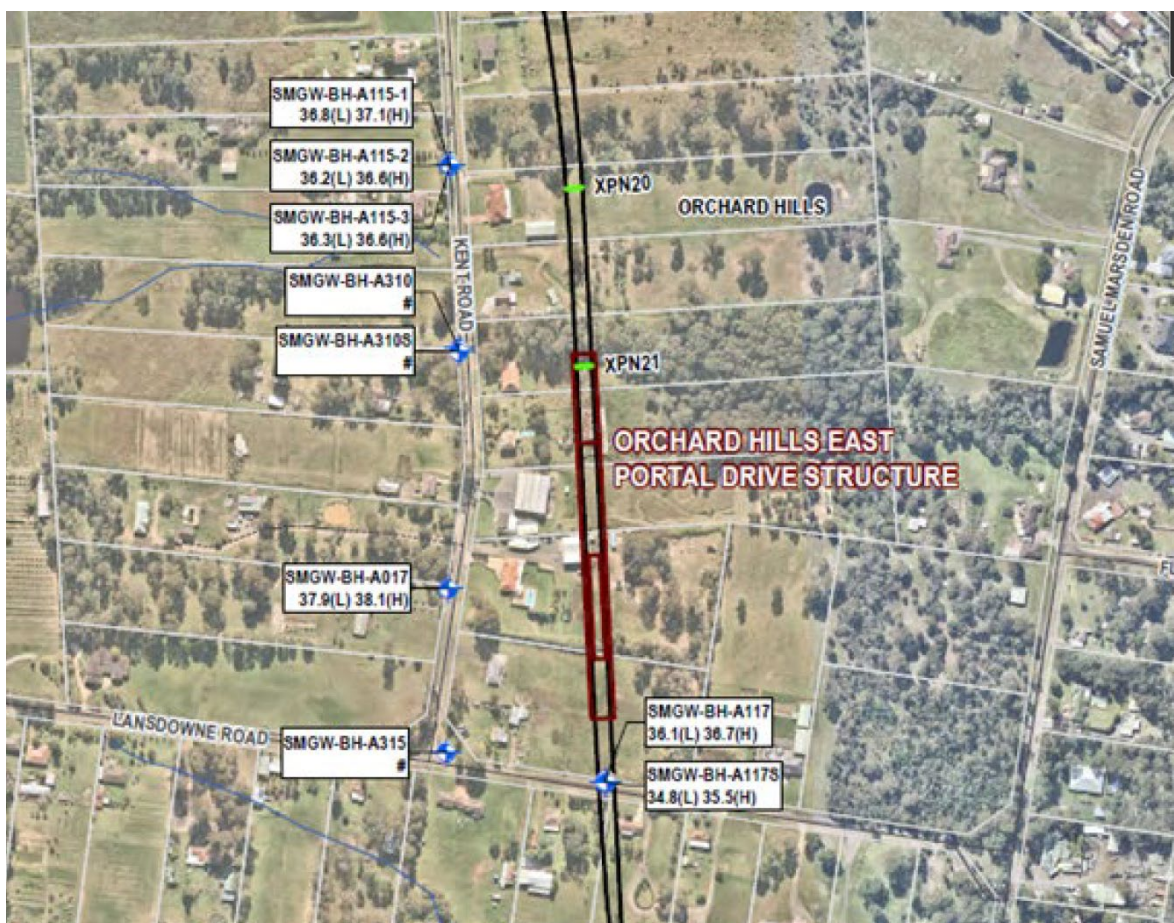
Figure 1: Locations of historical groundwater monitoring wells SMGW-BH-A310, SMGW-BH-A315/SMGW-BH-A315S (Source: the SAQP)

- Given the nearest surface water receptors (Blaxland Creek and South Creek) are not of high ecological conservation value, adopting the HEPA (2020) criterion for 99% freshwater species protection to assess PFAS concentrations in groundwater is likely to be conservative.

In summary, it is the opinion of the Auditor that the findings from the DSI Addendum were consistent with the historical monitoring data and indicated groundwater is unlikely to pose unacceptable risk to the environment. The proposed six-monthly groundwater monitoring, including monitoring of the newly installed wells SBT-GW-1043 and SBT-GW-1063, during construction will allow ongoing assessment of such risks.
