**SYDNEY METRO - WESTERN SYDNEY AIRPORT
STATION BOXES AND TUNNELLING WORKS**

Site Audit Report and Site Audit Statement – Bringelly Service Facility

Project number	WSA-200-SBT
Document number	SMWSASBT-CPG-AEC-SF400-EN-RPT-295462
Revision date	3 April 2025
Revision	1

TO-095-A4

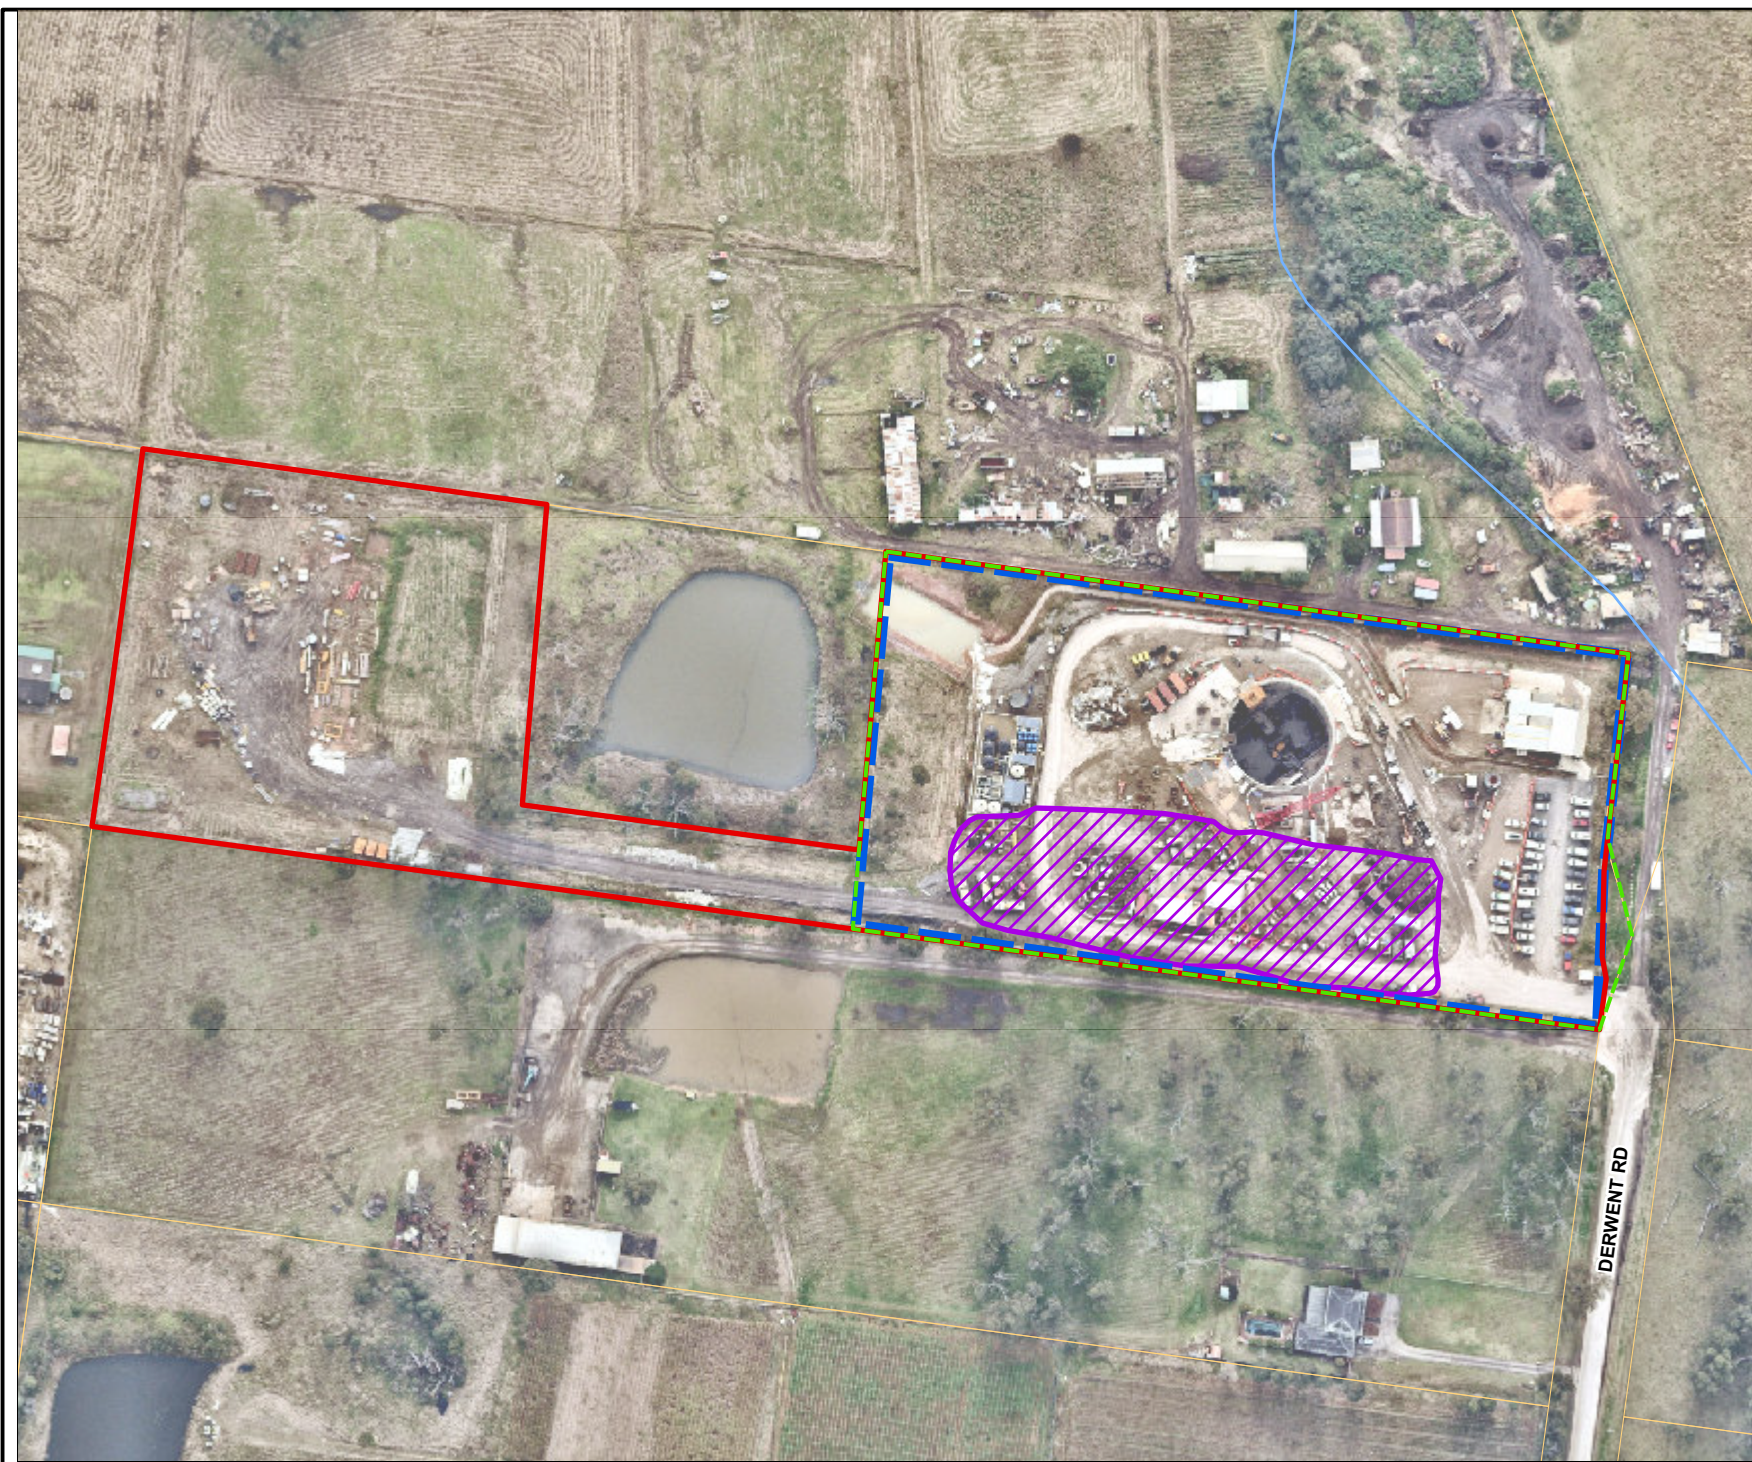
FIGURE 4

ASBESTOS SOURCE ZONE

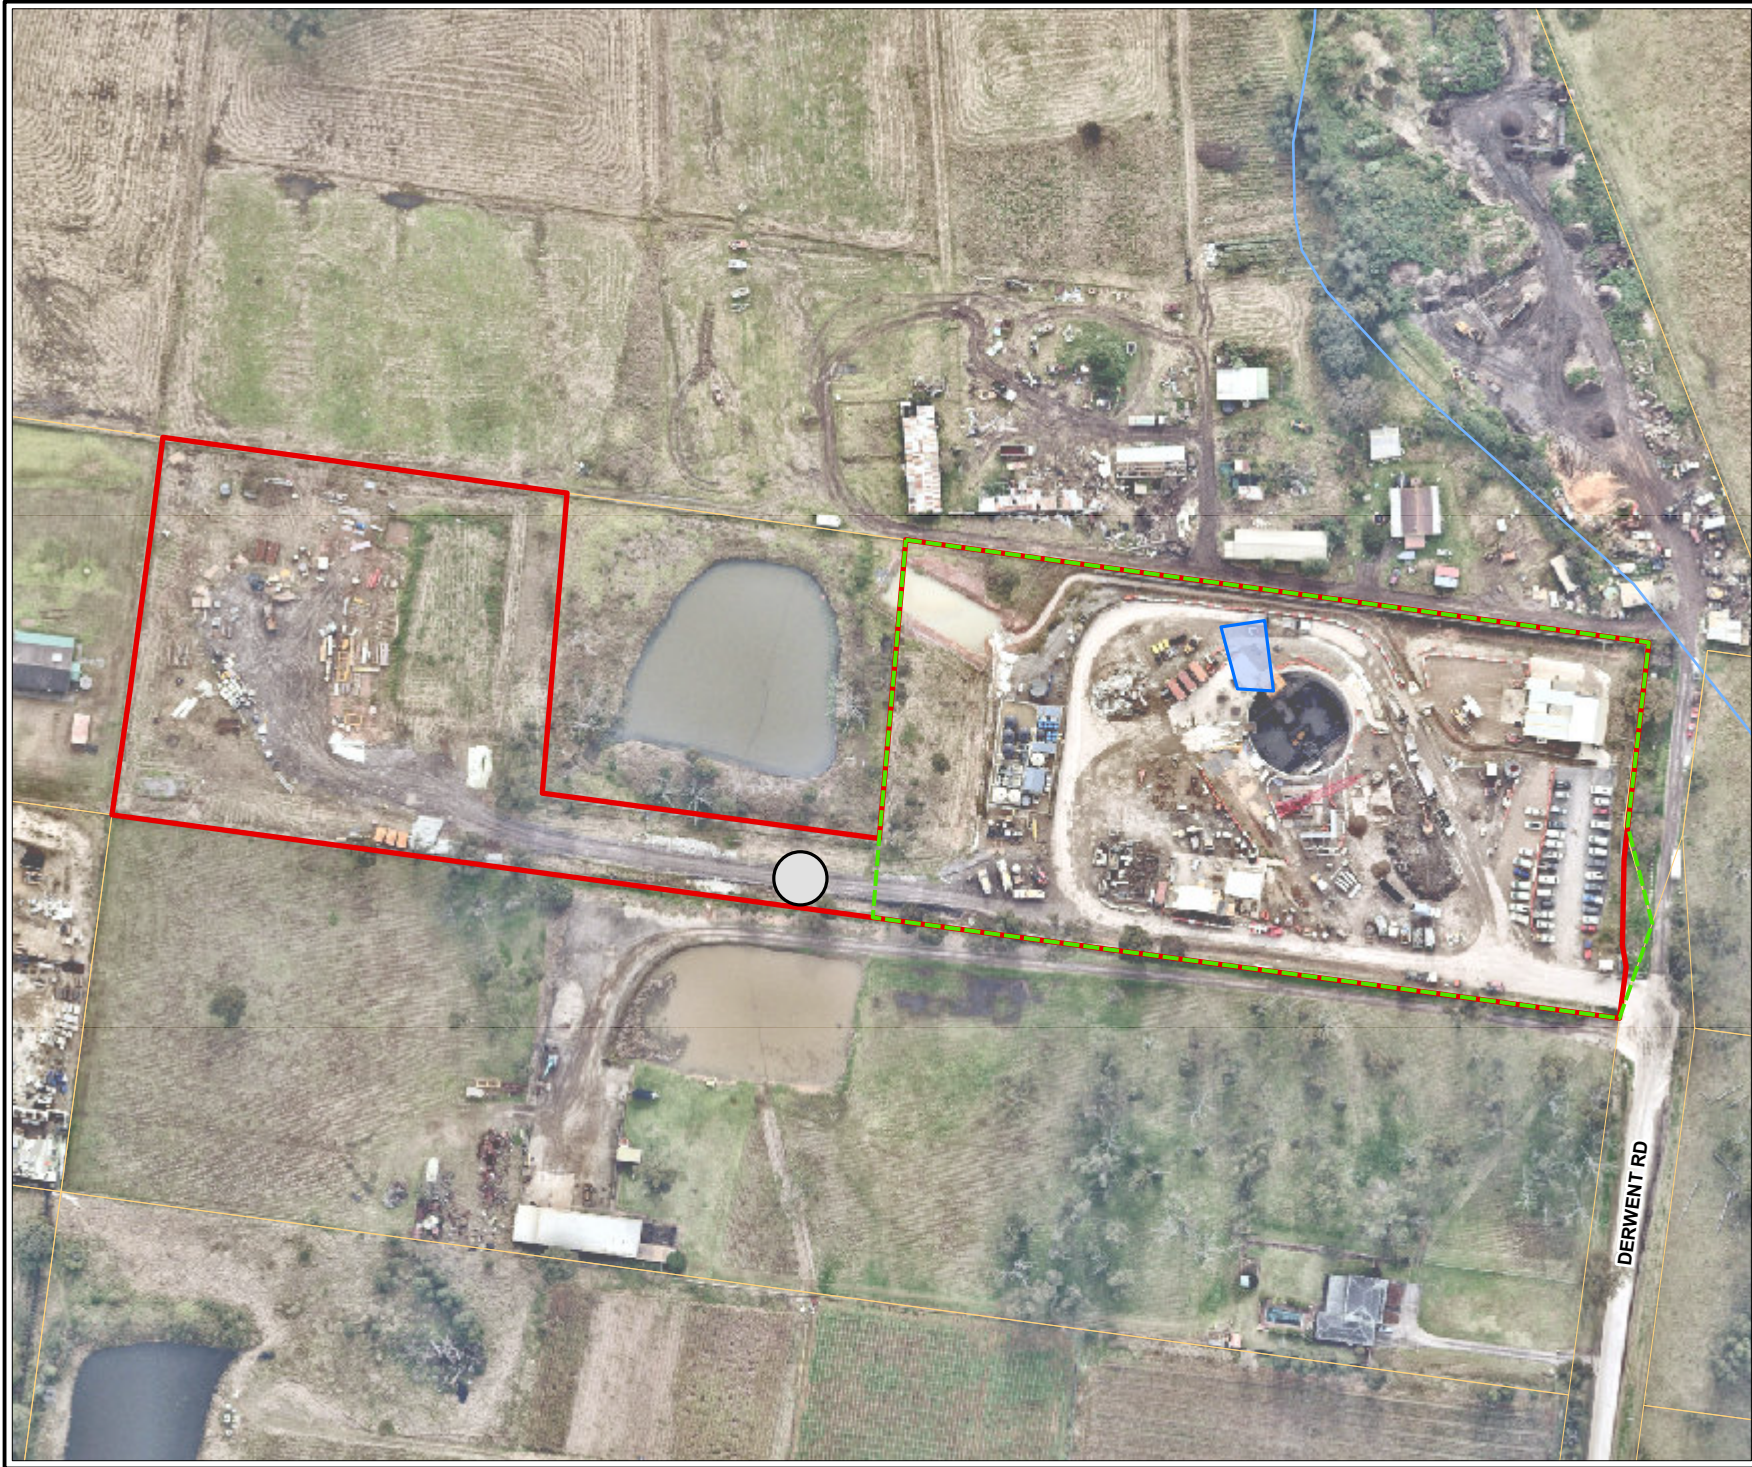
FIGURE 8

- 26 August 2022:** A redundant asbestos pipe was observed to have been mixed with spoil. Airsafe sampled the soil and the asbestos pipe for waste classification. The waste was subsequently removed by Mann Group from the site under an asbestos removal control plan prepared by Airsafe between 26 September 2022 and 29 September 2022. In accordance with Safework NSW Code of Practice 2022 *How to safely remove asbestos*, Auswide Operations notified SafeWork NSW of the asbestos removal works on 5 September 2022. Visual asbestos clearance inspections were subsequently completed by Airsafe on 29 September 2022 and again on 20 October 2022. As part of the clearance inspection on 29 September 2022, three soil samples were collected by Airsafe from the area where spoil was excavated and were tested for asbestos. No asbestos was detected in the sampled soils.

- 12 October 2022:** Three fragments of suspected ACM were detected on the ground surface at the haul road near the southern site boundary. As the fragments were less than 10 m² in size, they were removed on 12 October 2022 in accordance with a hazardous material removal control plan prepared by Mann Group as well as Safework NSW Code of Practice 2022 *How to safely remove asbestos*. The removed asbestos was disposed of offsite with the materials from the unexpected find on 26 August 2022.

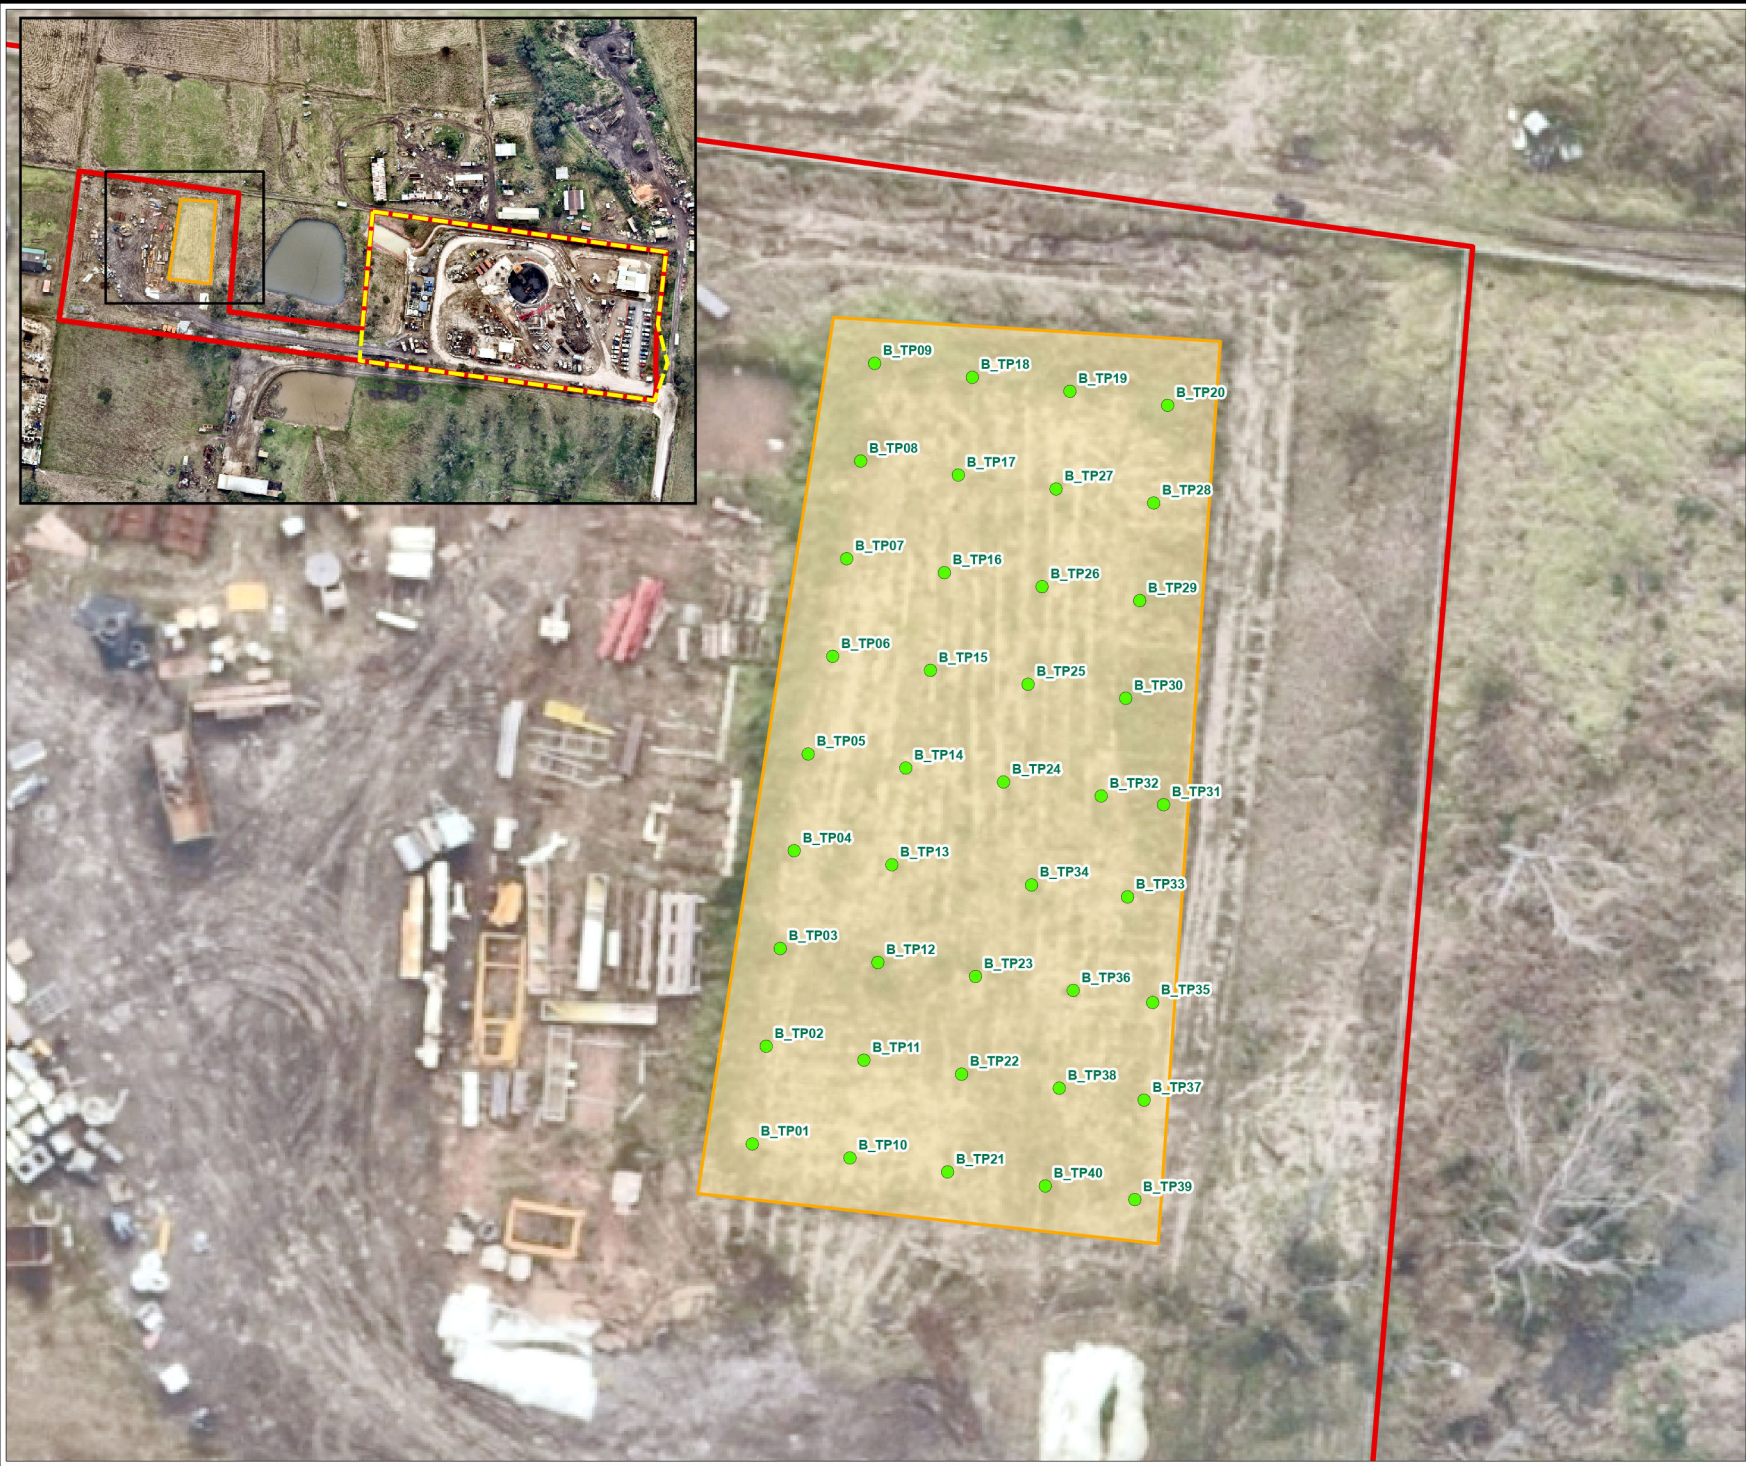
Attachment 8: Test Pit Sampling Locations, Asbestos Source Zone Stockpile

- No ACM was observed on the stockpile surface.
- One fragment of ACM (> 7 mm) was identified in test pit location B-TP24_1-1.5, with a calculated concentration of 0.005% w/w, which is below validation criterion of 0.05% w/w.

- One fragment of ACM (>7 mm) was identified in test pit location B-TP26_1-1.5 with a calculated concentration of 0.006% w/w, which is below the validation criterion of 0.05% w/w.
- The 500 mL asbestos samples reported detections of AF in B_TP05_1-1.5 at 0.000017% w/w, which is below the validation criterion of 0.001% w/w.
- An ACM fragment was observed at B-TP23 in material excavated from the test pit, but asbestos was not detected in either the 10 L bulk or 500 mL samples from this location.
