# TECHNICAL BULLETIN

TB-0176

## L90 Feeder Differential Protection Relays

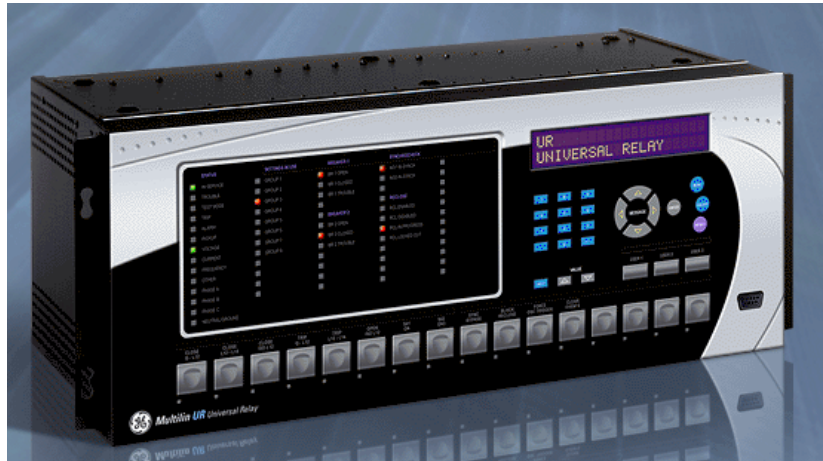
L90 Feeder differential protection relay

Two GE L90 feeder differential protection relays tripped upon restoration of DC supply causing a loss of two 132kV feeders.

These relays have been tested and a firmware issue identified which makes them prone to tripping the backup distance protection when either of the following two cases occurs.

The trip shows up as a Zone 1 trip on all three phases.

“After recovering from a channel failure, L90 devices must synchronise for the line differential element to return to normal operation. During this process, the voltage memory used by the distance element can be reset, which changes the polarisation voltage references, and then, can cause distance element operation.”

Testing has shown the likelihood of an unwanted trip is much more likely for a DC restoration than it is for a communications channel restoration.

This deficiency is possible in all of Endeavour Energy's L90 relays however it is only a problem if the backup distance protection is enabled.

- Avoid in-service restoration of DC supply without opening the trip link at both ends of the feeder.
- Avoid in-service restoration of communications channel without opening the trip link at both ends of the feeder.

A permanent fix for this issue is still being investigated and may include the upgrading of relay firmware during the next routine maintenance or disabling this functionality.
