# TECHNICAL BULLETIN

TB - 0195

## Frame leakage busbar protection – Operating principles and inadvertent trip avoidance

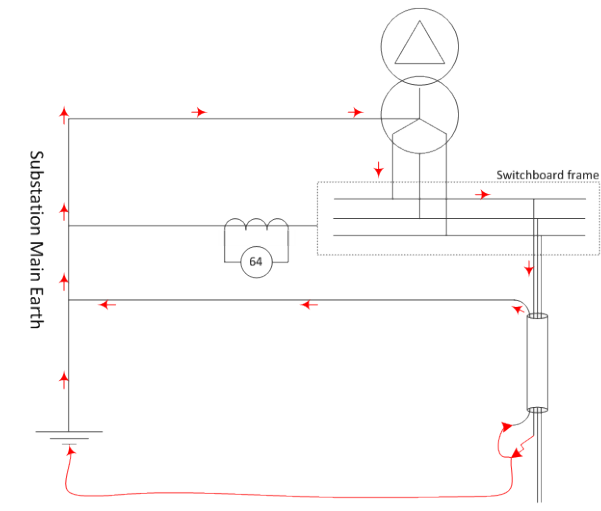
| Cable bonding in accordance with earthing design | Inadvertent cable screen bonding to switchboard frame |
|---|---|
| Correct connection of cable screen to substation earth. Return fault path <i>does not</i> include the frame leakage busbar protection scheme. | Inadvertent connection of cable screen to frame. Fault path includes the switchboard frame and may operate the busbar protection. |

All switchboard wiring shall be in accordance with approved substation, earthing and cable bonding designs. This includes any wiring for power cables, protection and control, or telecommunication purposes.

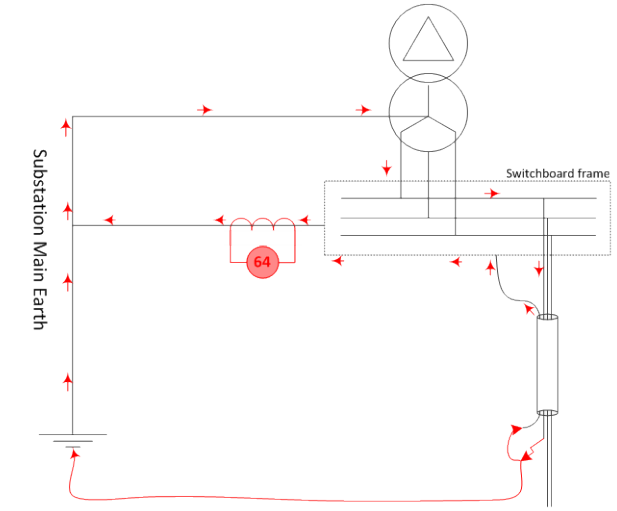
As a simple example, if a distribution cable screen is inadvertently bonded to the switchgear frame, part of the fault current will return through the switchgear frame, causing operation of the busbar scheme.

Earth connections to the frame of a switchboard protected by frame leakage should not be made unless part of an approved design.
