# Technical Bulletin

## TB 0213 – LV link pillar failures

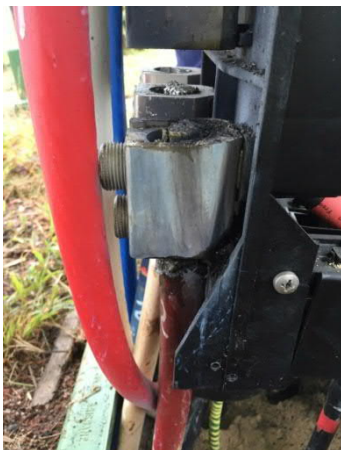
In two other cases, the securing screws were not tightened onto the conductor strands correctly. The screws were left protruding as shown in figures 1 and 2 below, instead of flush as shown in figure 4.

Figure 1: The failed “A” phase connection with top screw not sufficiently

When making the cable connections, the screws must be hand tightened with a torque wrench to 50Nm. A power tool is only permitted for this function if the tool has an adjustable torque setting which can be set to 50 Nm.

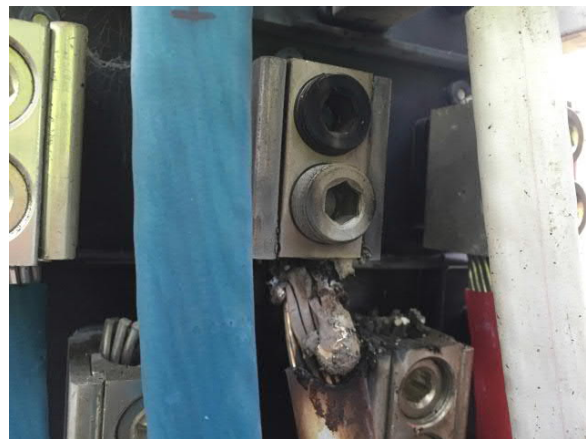
Figure 2: The failed “B” phase connection with the bottom screw not sufficiently tightened.

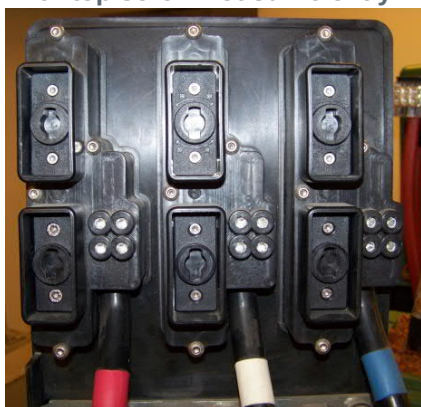
Figure 3: All links firmly locked into position during cable connection.

The installation instructions direct the installer to leave the links firmly locked in position (as shown in figure 3) while the securing screws are tightened. This will prevent the link housing twisting or distorting during tightening of the screws. After all cable connections are completed the required links may be removed according to the circuit design.

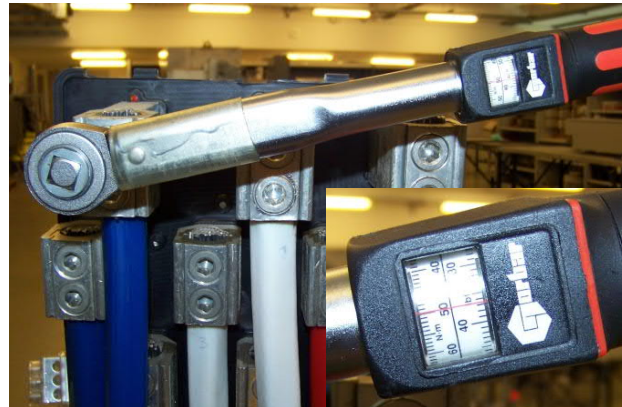
Figure 4: Torque wrench set at 50Nm used to tighten the connections. Note all screws finish flush with the housing when tightened correctly
