# Technical Bulletin

## TB 0338 – Motorised Safelink RMU Inspection Process

**Date:** 22/09/2023

To communicate the Inspection Process required on a specific batch of Motorised ABB Safelink RMUs.

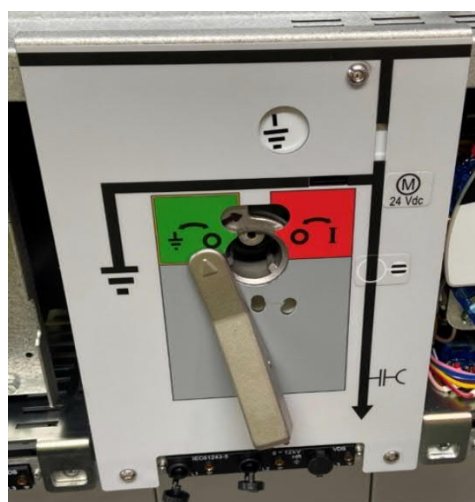
Figure 1.  
Selector switch in normal operation when applying/removing earth.

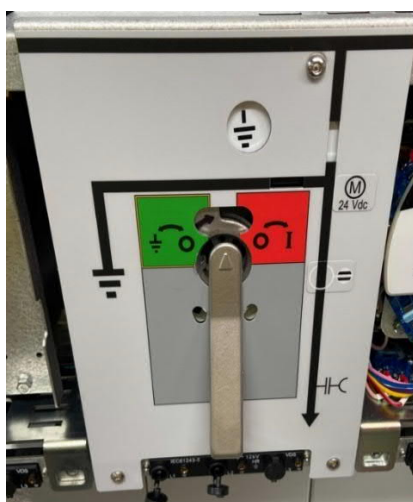
Figure 2.  
Selector switch returned to centre position, should not pass this point with the earth applied.

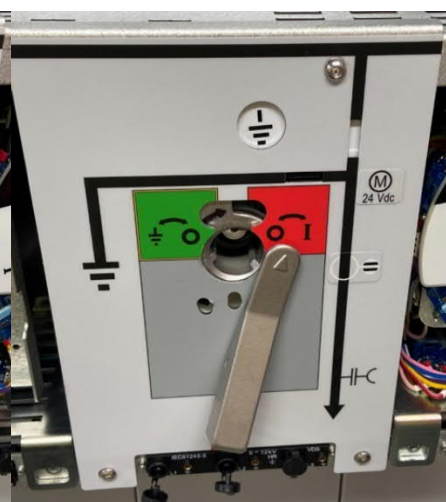
This fault allows the selector switch to be placed in the operating position when the cable is earthed and potentially switched from earth through to open position and through to the closed position in one movement.

- Check if the selector switch can be turned clockwise to allow the OTA or operating handle to be fitted (as per figure 3 below)
- If you can turn it clockwise, the motorised switch has the defect and shall be warning tagged accordingly.

Figure 3.  
Selector switch allowed to travel clockwise and lock in.  
**Defective mechanism.**

- a. it shall be warning tagged and remain in service
- b. a follow-up 'PM06 Replace Safelink Mechanism' work order needs to be raised against each switch that fails (WBS NDS-000088, X Hours, Materials ....)
- c. Notify EngDel with an email to mainsenquiry@endeavourenergy.com.au with RMU and switch details.
