# Technical Bulletin

## TB 0356 – Rectification of Loose Spring Charge Limit Switch – Reyrolle LMVP Series.

Date: 11/10/2024

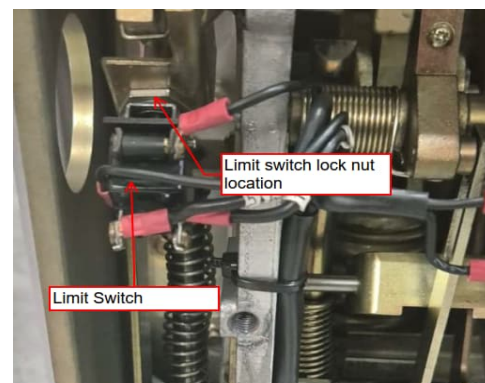
There has been an increase in the number of reported cases of the nut that secures the spring charge limit switch becoming loose in the mechanism of the Reyrolle LMVP series circuit breakers. This is usually picked up during minor overhaul activities and has also caused several functional failures.

The spring charge limit switch is used to disconnect the spring charge motor once the spring is fully charged. A loose limit switch may eventually result in damage to the motor and cause a malfunction in the trip/close operation of the circuit breaker.

Figure 1 Limit switch in operating mechanism.

Hardware securing the spring charge limit switches must be tightened as per OEM manuals after which they are to be secured with dual nuts. OEM manuals can be found through this link - [G:\Equipment Manual Library\South Manuals\switchgear](#).

It is a requirement that the securing hardware (nut) be checked for tightness during minor overhaul activities, and replaced, retightened and locked (as above) where necessary.
