Pre-K Center Field Report
17 Battery Place North
LLW # 093479

**2-26 Washington Street
New York, NY 10004**

Report Prepared by: [MDSerbaty Associates Architecture LLC](#)
SCA Design Manager: [Anthony Whaley](#)
Completion Date: [09/01/2015](#)

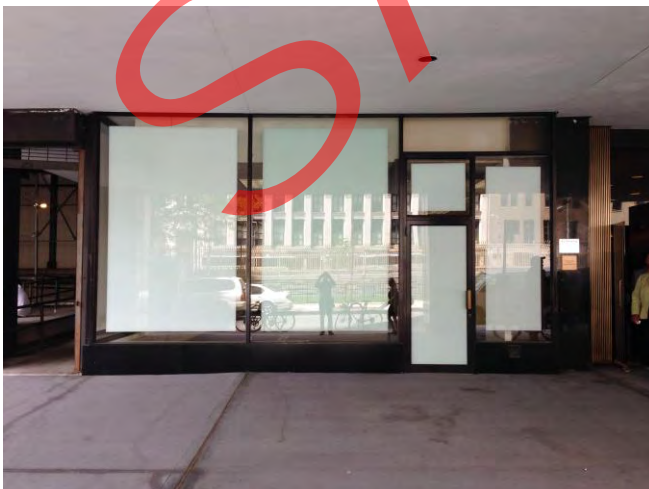
A.7: Southwest Entry Storefront (at Proposed Lobby)

- A. Existing arcade is in fair condition currently under construction. Various pieces of granite cladding are chipped or missing at column enclosures. Existing glass and aluminum storefront to the south at the proposed school lobby is in fair condition and has its own private entry door (though not code compliant) separate from revolving doors at main building lobby. There is an existing hose-bib adjacent to the door. The existing set of doors at the northeast end of the building provides direct access to a flight of stairs leading to the second floor roof level at the rear (Refer to Appendix Photo A8).

- A. Replace storefront door/ vestibule at south corner of building with new system for school lobby access. Provide school signage (Refer to Appendix Photo A.7).

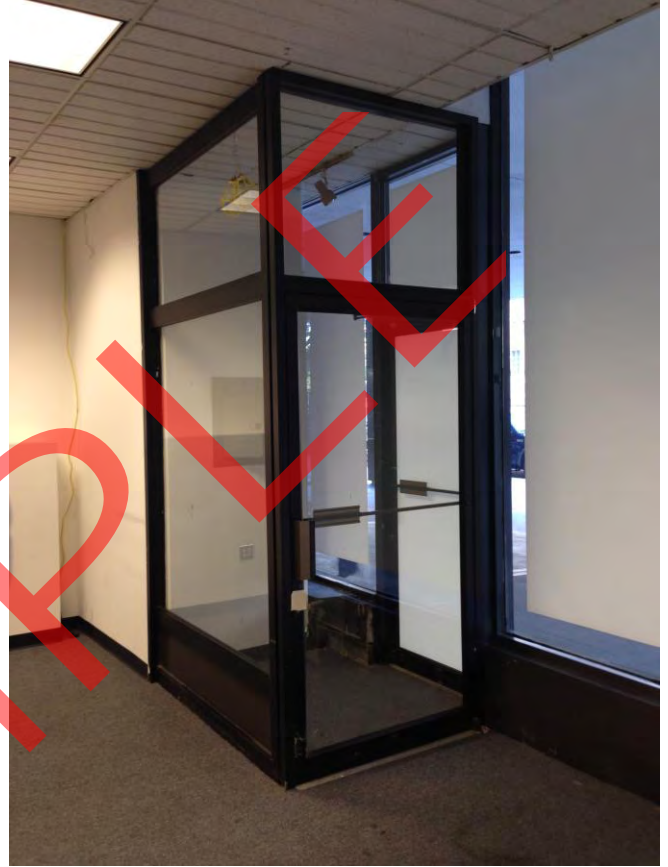
A.10: Vestibule at Proposed Lobby Entry
(Non-Code Compliant)

- A. Remove and replace flooring and fin tube radiators in the proposed lobby space.
- B. Remove and replace existing vestibule and entry doors to meet code and egress requirements.

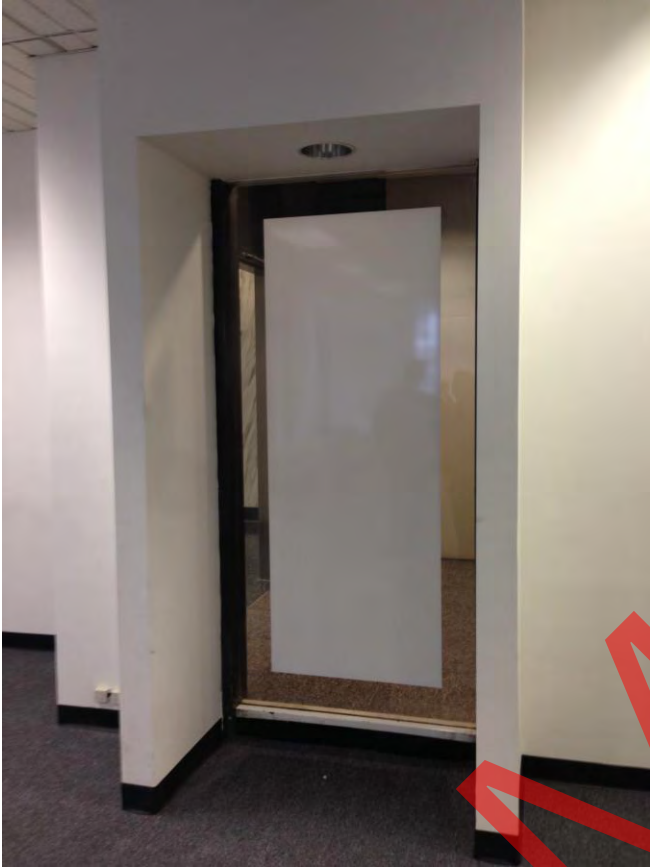
A.13: Display Case Build-out

- A. There is evidence of water damage in the proposed lobby space on the ground floor.
- B. Proposed lobby space contains two GWB build-outs with spot lights and display windows (Refer to Appendix Photos A.13, A.15).

- C. Repaint/repair walls and ceilings at the ground floor. Provide wall infill at glazed display openings.
- D. Provide security desk area near new school entrance on the ground floor and at the second floor by the elevators.

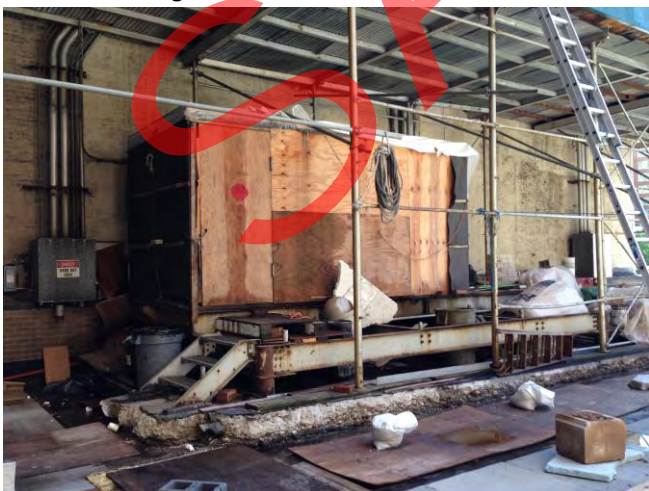
A.33: Storage Shed/Platform

- E. Existing outdoor stair is damaged and not up to Code Standards for egress. Segments of wrought iron guardrail are missing and either bent or broken. One entire run of handrail against the masonry wall is missing. Only the posts for the center handrail remain; the top rail is missing.
- F. Existing dunnage is in poor condition. The concrete slab below is damaged/spalling. A contractor's storage shed built on existing dunnage presents safety concerns in the presence of children (Refer to Appendix Photo A.33).

- A. Roofing and flashing shall be replaced. In areas where play equipment is to be installed, provide resilient safety surface. New roof drains may have to be installed.
- B. Provide 8'-0" safety fence to prevent children from climbing/falling over the parapet. Also provide fence at location of City Easement and around existing storage shed (Refer to SK-4).
- C. Remove existing damaged guardrail and handrails at outdoor stair. Provide new Code compliant guardrail and handrails at full length of stair.

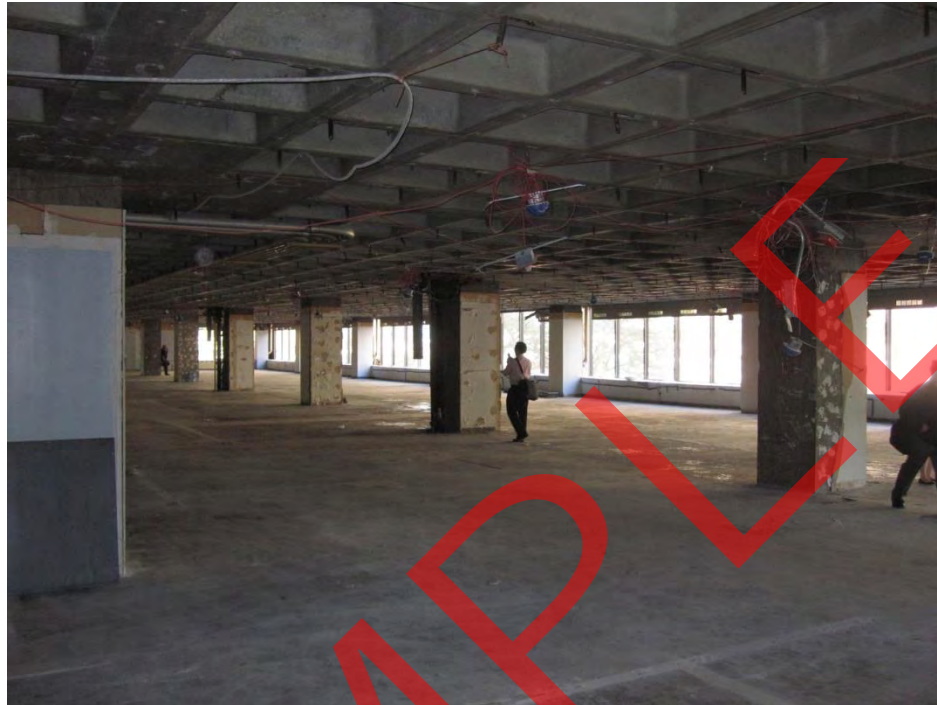
- C. The second floor space under consideration has been "guttled" as part of pre-lease preparation of the space. See Photo M-1. The space has a perimeter induction unit system which is built into metal cabinetry below the windows. The units are located at the building perimeter beneath the single pane windows that form the exterior skin of the building envelope. The induction unit system is supplied with both conditioned primary air and hot water/chilled water for heating and cooling, either is supplied from a two-pipe system depending on the heating or cooling seasonal conditions. See photos M-2 and M-3. The induction units have a condensate pan without a drain (occasional start up condensate is expected to re-evaporate). The chilled water loop that feeds induction system terminals is reportedly kept near 55° F supply temperature.

Photo M-1: Second floor space for pre-lease preparation

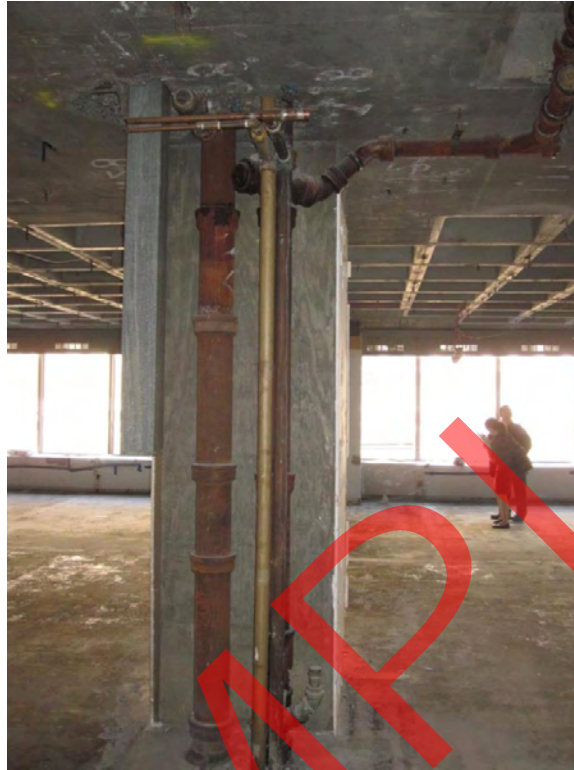
- A. There were 3 wet stack locations observed within the 2nd floor space under consideration. See photos P-1 and P-2. It appeared at each of these locations, which were adjacent to the main building columns. A 4" cast iron sanitary drain existed alongside a 1.5" copper hot water and cold water domestic water riser.
- B. Part of 2nd floor space under consideration is built above a street level open air arcade. See photo P-3. Our assumption to support the Pre-K bathrooms which are proposed to be located above the arcade will be to utilize the space below the 2nd floor above the arcade, where there is approximately 36" of interstitial space. If we cannot use this space to tie into the 3 existing wet stack locations, it could adversely affect the proposed plumbing design.
- C. Existing men's and women's toilet rooms located in the building interior core of this 2nd floor

Photo P-1: Wet stack in 2nd floor

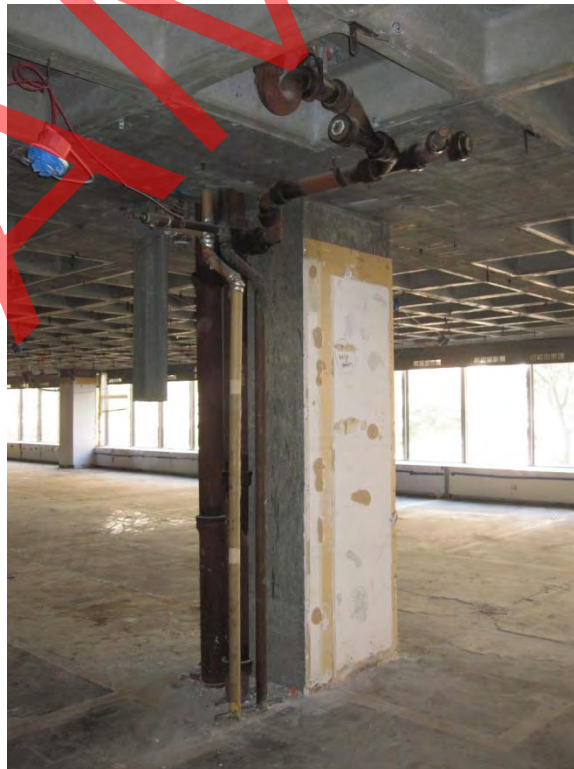
Photo P-2: Wet stack in 2nd floor

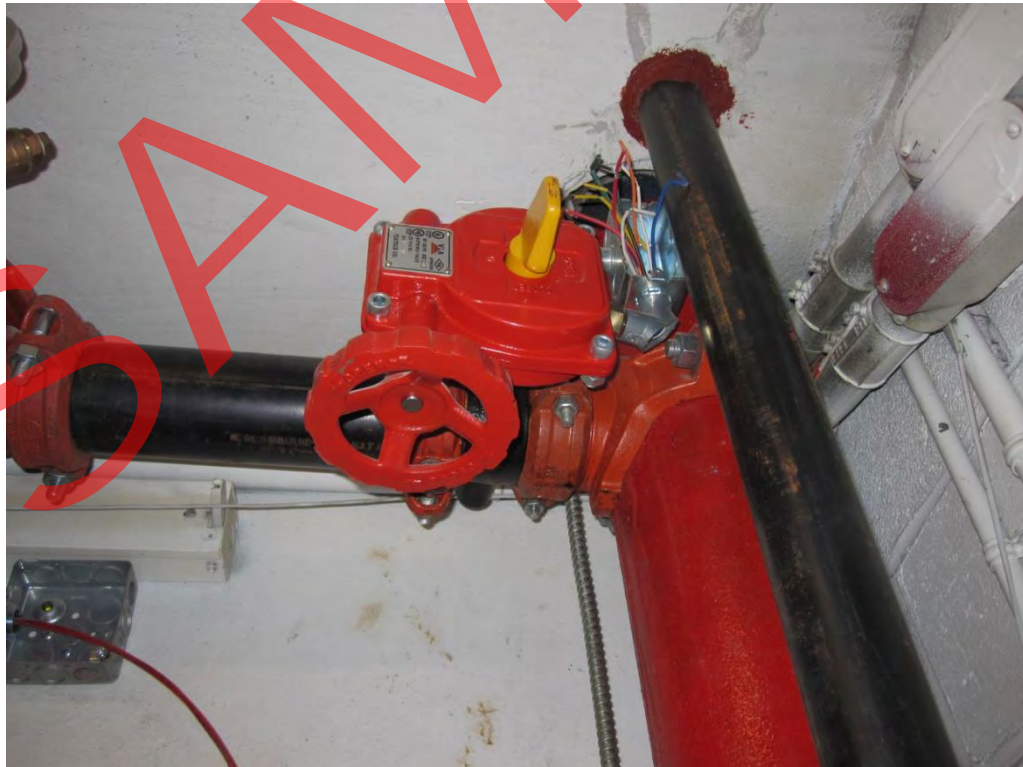
Photo PF-3: Incomplete installations of tamper switch wiring and alarm wiring

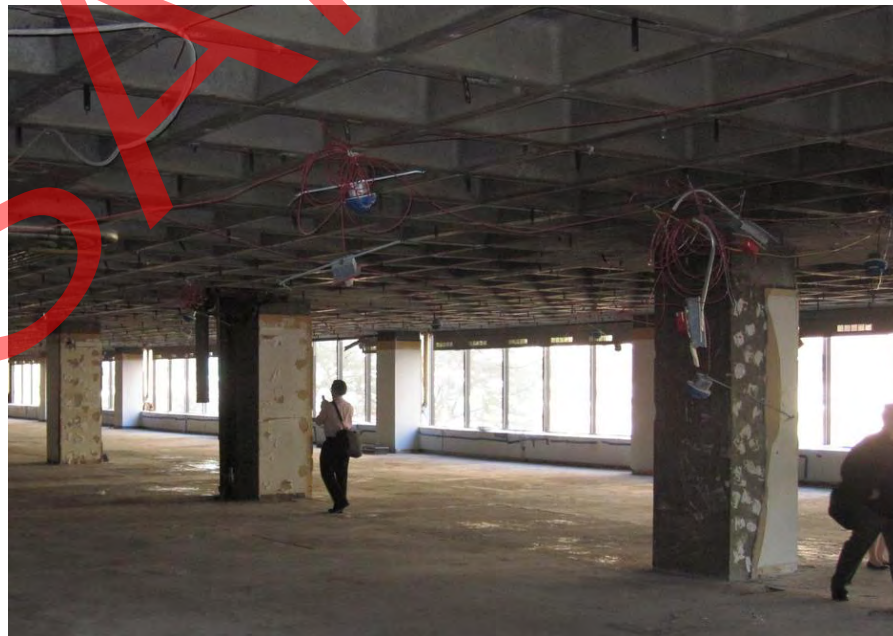
- A. The fire alarm system for the building still exists. The alarms are temporarily suspended mid-air from the demolished suspended ceilings and walls on the 2nd floor. This includes both suspended ceiling smoke detectors, mounted horn and strobe alarms, and pulls stations. See photo FA-1. It would appear that the system would be considered non-operational since smoke detectors are duct taped over and wiring and conduits are loosely suspended.

Photo FA-1: Temporarily suspended fire alarm system in 2nd floor ceiling
