2013 Operational Reliability Assessment of the Longhorn Pipeline System

Susan Rose, Harvey Haines, Carolyn Kolovich, Adam Steiner,
Benjamin Wright, and Dennis Johnston
March 31, 2015

MAGELLAN PIPELINE COMPANY

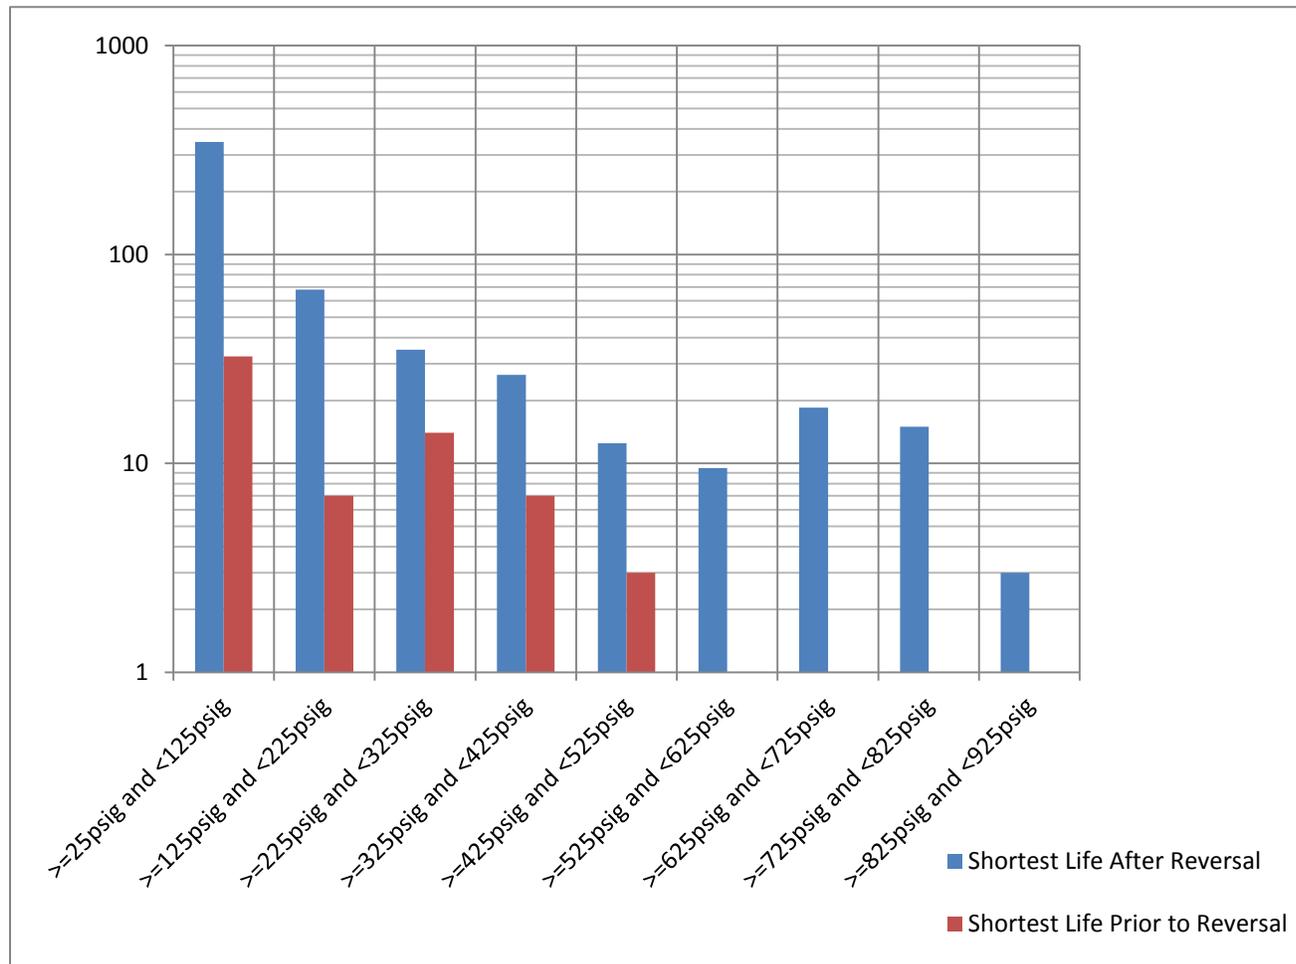
Figure 2. Histogram of Pressure Cycle Frequency and Magnitude Prior to and After Line Reversal

The fatigue lives for the Crane to East Houston segment of pipeline have changed due to altered line operation since November 2013. To illustrate the reduction in calculated time to failure of the case locations, a histogram was created showing the pressure cycle frequency and

magnitude for the locations with the shortest remaining lives in this ORA and in the 2012 ORA. The November to December 2013 data and 2012 a random 2-month period in early 2012 were compared. The results are shown in Figure 3.

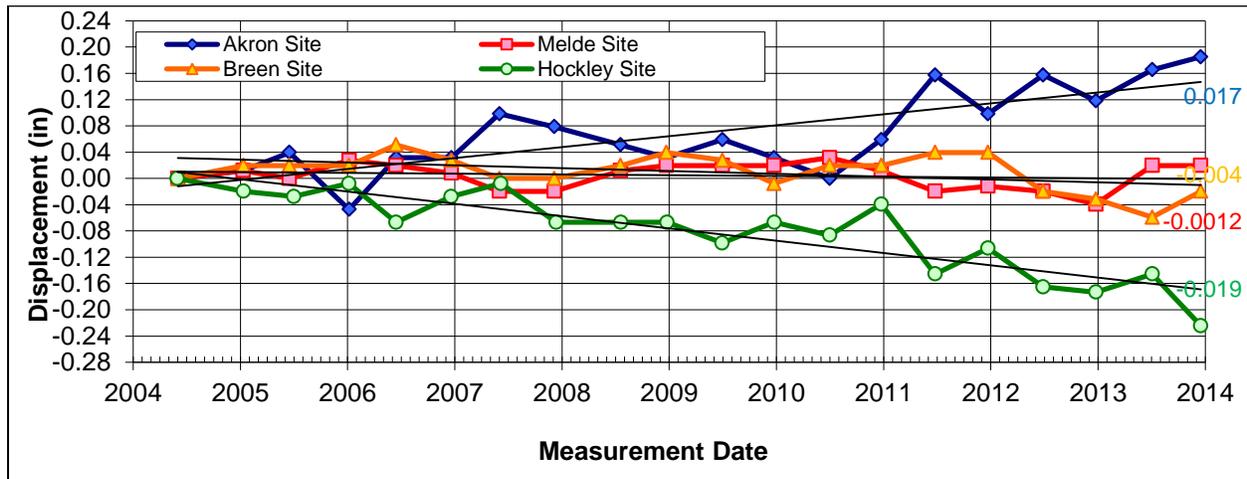
Figure 3. Fault Displacement over 9-Year Period

Monitoring stations across four faults were installed in March 2004 in accordance with section 6.2 of the ORAPM. Baseline readings were taken in late May and early June 2004. Nineteen subsequent displacement readings have been taken at approximately 6-month intervals. A plot of the displacements over time is shown in Figure 3 below. Faults move in one direction only, so the up and down variability is an indication of the uncertainty of the measurement. With 10 years of data we attempted to measure the actual fault movement over time by calculating best fit trend lines. The trend lines show no measureable movement on the Melde and Breen faults, with only slight movement of 0.017 in/yr (0.43 mm/yr) over 9½ years for the Akron fault and - 0.019 in/yr (-0.48 mm/yr) over 9½ years for the Hockley fault.

For this year’s analysis with 10 years of data, we used the calculated movement from the best fit trend lines and compared these estimates of fault growth to the Kiefner stress analysis described in the 2005 ORA Annual Report. Table 7 shows the amount of movement at each fault that can occur before it exceeds the stress levels allowed by ASME B31.4. The differences in allowable fault displacements are caused in large part by differences in the angle of the fault movement. The calculated rate of displacement has accelerated and reduced the number of years to reach the allowed displacement from the amount reported in the first half of 2013 Report (Table 6). This decrease is not alarming but does warrant watching, especially for the Hockley fault.

Hockley fault monitoring is recommended every 5 years even though the estimated time to failure for the fault is 34 years. Because the accuracy of the fault movement measurements appears to be 0.4 – 0.8 inch (1 - 2 mm), several measurements are needed over time to obtain a trend. The other three faults have reinspection times of 250+ years. Such long times to reach a displacement that could result in failure would normally not warrant any monitoring. However, according to the U.S. Geological Survey, September 2005⁵ there are documented cases of fault movement reinitiating, so monitoring every five years for these 3 faults is also appropriate.

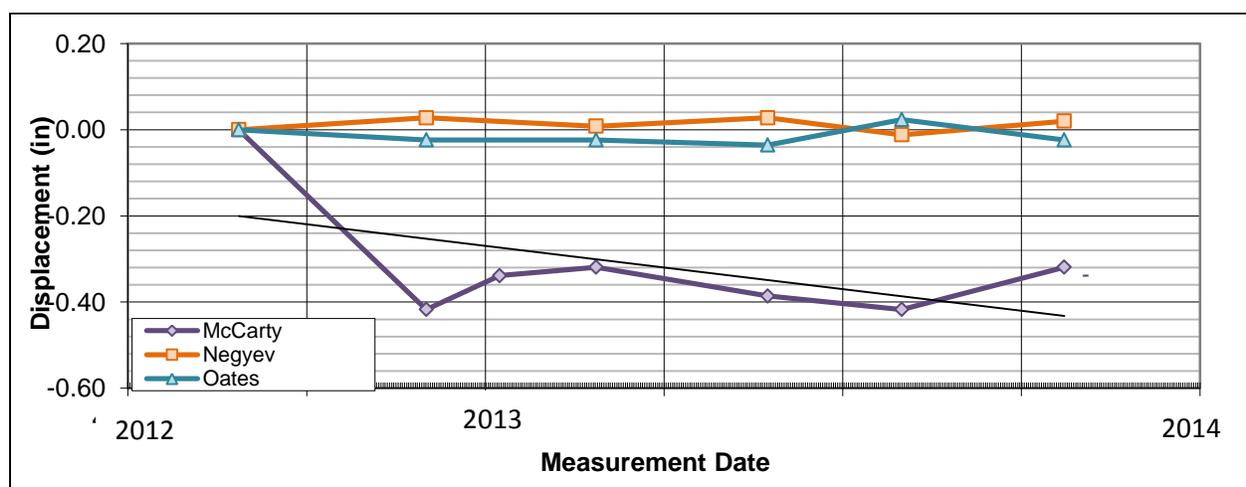
Figure 4. Fault Displacement over 1-Year Period for McCarty, Negyev and Oates

Three additional faults have been instrumented for the new lateral connecting the East Houston Terminal and existing Longhorn pipeline. Baseline readings have been taken for the McCarty, Negyev, and Oates faults in September 2012. There are five readings performed after the baseline readings in approximately one year. The trend line for Negyev and Oates show no movements. McCarty shows 0.183 in/yr (4.65 mm/yr) movement (Figure 4).

Trend lines established for McCarty, Negyev and Oates in Table 7 show the time to a significant displacement for pipeline to be under stress similar to the Melde and Akron faults. Calculations resulted a very long time to reach critical displacement for Negyev and Oates. McCarty may require more readings. Although this is suspect as it appears the baseline reading contains a significant error of almost 1/2-inch. If the point was eliminated the rate would be close to zero. Rather than delete this point because it is suspicious it was chosen to leave it in the analysis, because it will become less influential in the least squares curve fit as more data is collected over time and there is no immediate threat from the McCarty fault even with this suspect data.

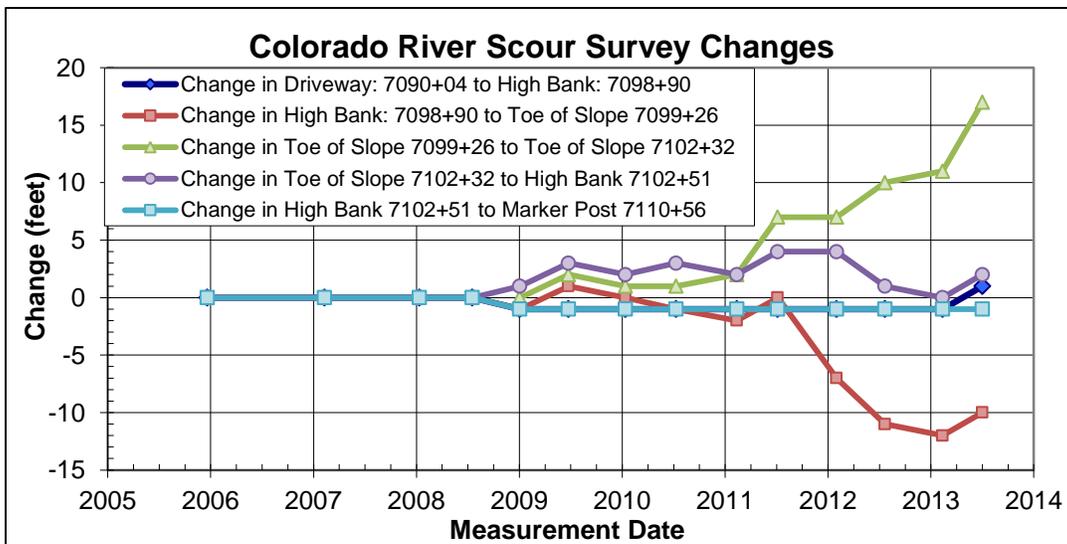
Figure 5. Changes in the Scour Survey of the Colorado River over 7 Years

These changes in the distance from the High Bank to the Toes of Pin Oak Creek and the distance between the Toes and the distance from the West High Bank to the Toe of the Colorado River warrant a more accurate survey of the depth of burial of the pipeline in the river bed between the Toes of the two bodies of water to determine how much depth of cover loss is acceptable.
