2021 Operational Reliability Assessment of the Longhorn Pipeline System

Final Report

Magellan Pipeline Company

March 30, 2023

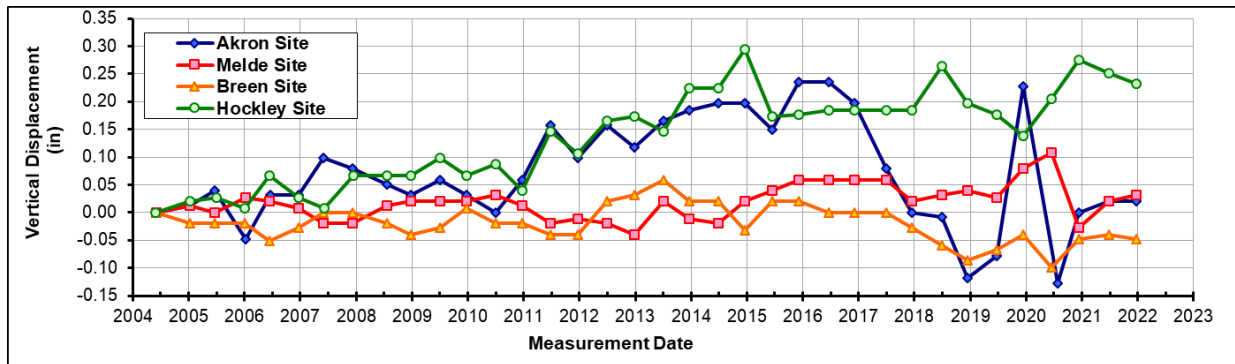
Figure 9. Fault Displacement over 17.5-Year Monitoring Period at Akron, Melde, Breen, and Hockley Faults

and early June 2004. Thirty-five subsequent displacement readings¹⁸ have been taken at approximately 6-month intervals. Figure 9 shows a plot of the vertical displacements over time.

Since 2017, the benchmark recordings have shown Akron fault's multiple backward and rebound movements. Based on the 2021 readings, this fault experienced a relatively small amount of movement oscillating near its baseline displacement.

Data collected at Melde and Breen faults since the benchmarks were installed in 2004 shows slow progressive movement, as verified by the 34th and 35th resurveys¹⁹ in 2021. For the Hockley fault, the recent resurveys indicate movement above the average historical rate suggesting continuous monitoring is required.

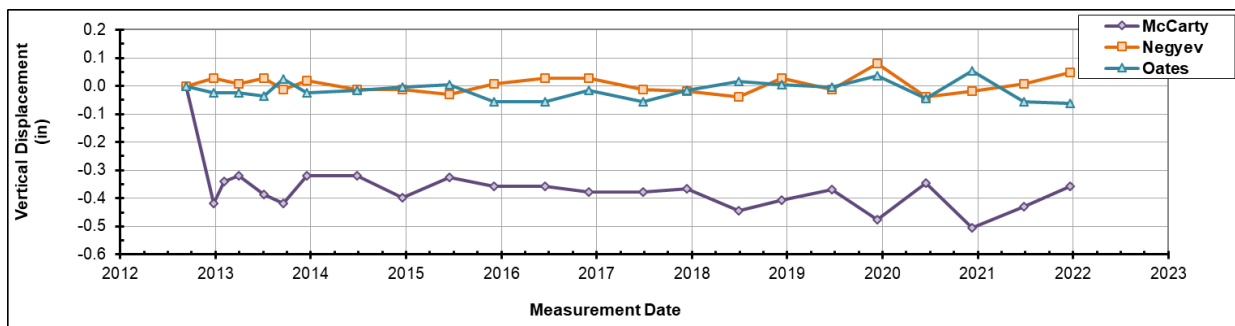
Figure 10. Fault Displacement over 9.5-Year Monitoring Period at McCarty, Negyev, and Oates Faults

In 2012, three additional faults were instrumented for the lines constructed to connect the existing Longhorn line to East Houston. These are the McCarty fault near Station 35+80, Negyev Fault near Station 140+00, and Oates Fault near Station 147+00. Baseline readings were taken for the McCarty, Negyev, and Oates faults in September 2012. After the baseline readings, there have been 21 readings taken between December 2012 and December 2021, as shown in Figure 10.
