# ARBORICULTURAL DEVELOPMENT IMPACT ASSESSMENT REPORT

Sydney Metro City and SouthWest Line Wide – Dulwich Hill NSW

REVISION B 3rd of August 2021

Prepared for Systems Connect

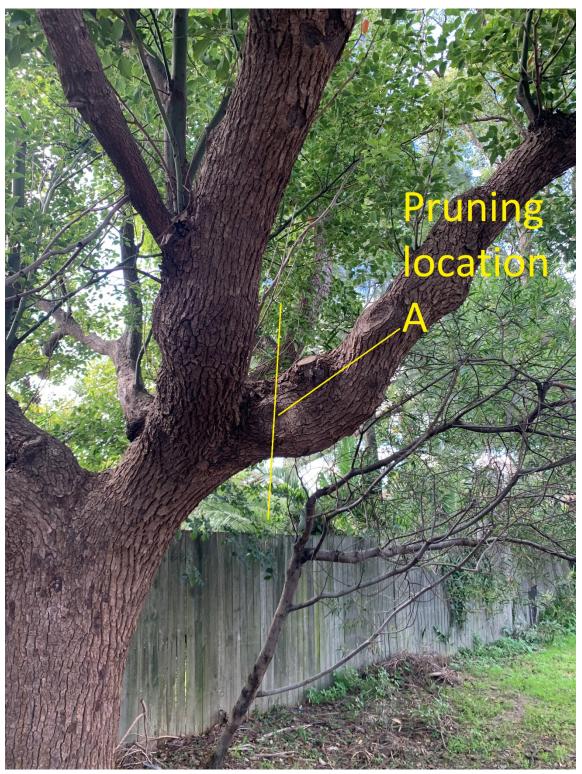
Figure 1 - Pruning Location A

Pruning Location A is a second order branch with a diameter at the pruning location of approximately 300mm. This branch extends in a southwesterly direction. This branch is to be pruned at the secondary branch junction at the branch collar at the location shown in figure 2.

Selective pruning is required to provide canopy clearance for construction transport access. One second order branch is required to be removed as shown in Figures 1. All pruning is to be carried out under the supervision of the Site Arborist (AQF Level 5) by an arborist with qualifications of AQF Level 3 or higher. All pruning is to be in accordance with *AS4373-2007 Pruning of Amenity Trees*.

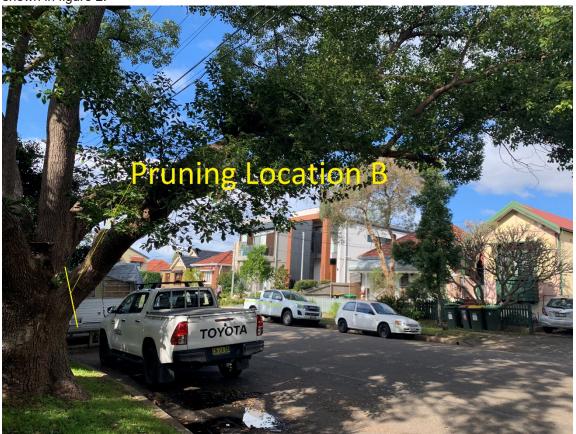
Figure 2 - Pruning Location B

Pruning Location B is a first order branch with a diameter at the pruning location of approximately 300mm. This branch extends in a southwesterly direction. This branch is to be pruned at the primary branch junction at the branch collar at the location shown in figure 2.

Selective pruning is required to provide canopy clearance for construction transport access. One first order branch is required to be removed at Pruning Location B as shown in Figure 2 and one third order branch is required to be removed at Pruning Location C as shown in Figure X. All pruning is to be carried out under the supervision of the Site Arborist (AQF Level 5) by an arborist with qualifications of AQF Level 3 or higher. All pruning is to be in accordance with AS4373-2007 Pruning of Amenity Trees.

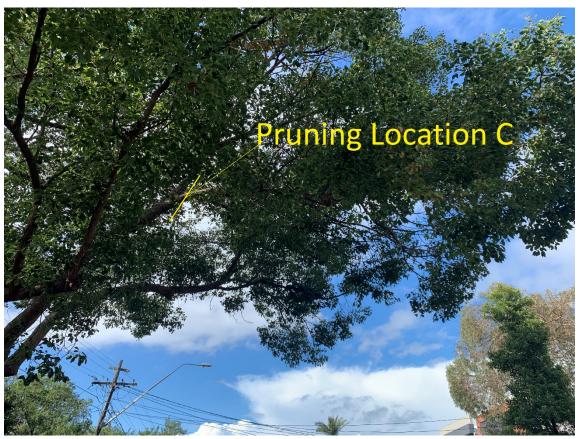
Figure 3 - Pruning Location C

Pruning Location C is a third order branch with a diameter at the pruning location of approximately 100mm. This branch extends in a southwesterly direction. This branch is to be pruned at the primary branch junction at the branch collar at the location shown in figure 3.
