# Distribution Overhead Defect Handbook

**Document No. MMI 0002**

**Amendment No. 3**

30/04/25

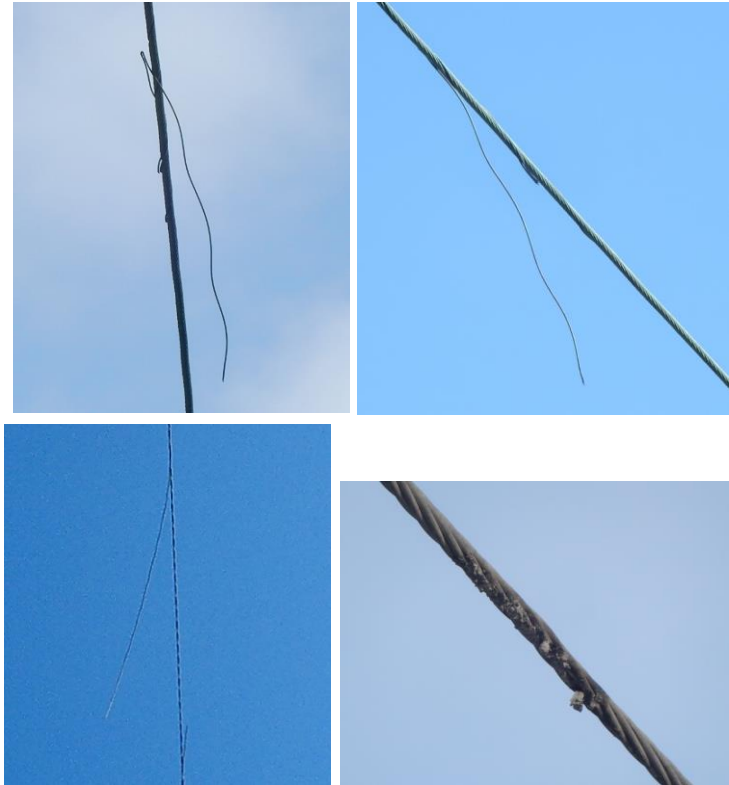
| Defect Description | Defect Photo | Task Details |
|---|---|---|
| <u>Conductor - Broken or Damaged</u> | | <u>Priority</u><br><b>SAP Priority 2</b><br>Immediate/48 hrs |
| <b>Indicators:</b> <ul style="list-style-type: none"><li>- Strand(s) of the conductor of have broken.</li><li>- Physical separation of the conductor.</li></ul> | | <u>Bushfire Defect</u><br>Yes |

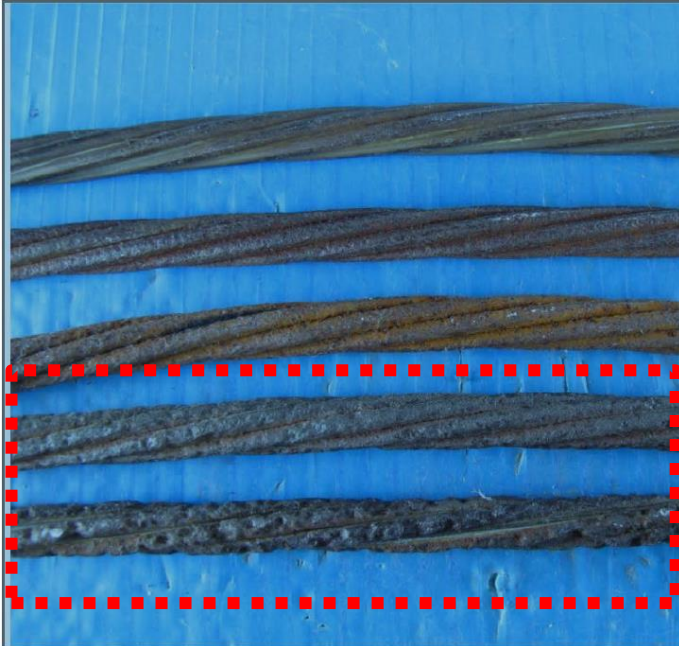
| Defect Description | Defect Photo | Task Details |
|---|---|---|
| <u>Conductor - Major Rust / Corrosion</u> | | <u>Priority</u><br>SAP Priority 6<br>1 Month |
| <b>Indicators:</b> <ul style="list-style-type: none"><li>- Conductor deterioration, showing signs of pitting and rust.</li><li>- Previously considered a Category 4 or 5.</li></ul> | | <u>Bushfire Defect</u><br>Yes |

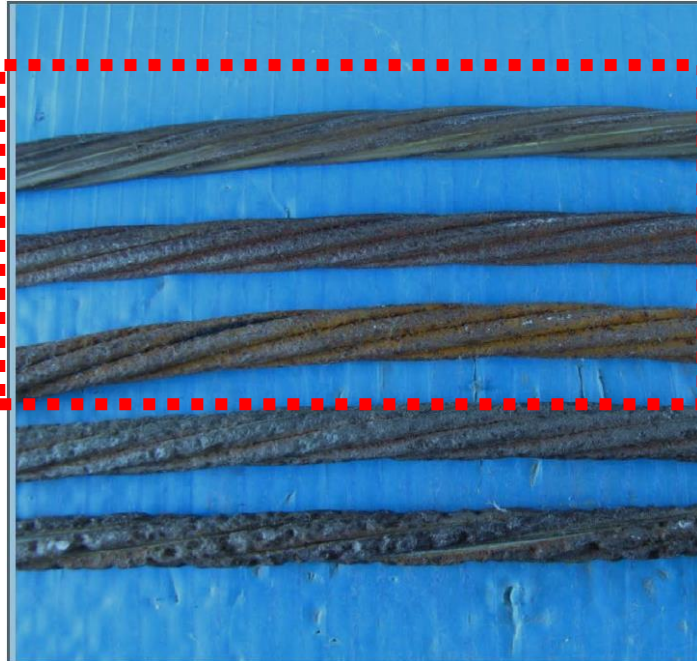
| Defect Description | Defect Photo | Task Details |
|---|---|---|
| <u>Conductor - Minor Rust / Corrosion</u> | | <u>Priority</u><br>No Defect |
| <b>Indicators:</b><br><br>- Conductor showing slight signs of deterioration: whereby there is surface rust on the conductor.<br><br>- Previously considered a Category1-3. | | <u>Bushfire Defect</u><br>No |

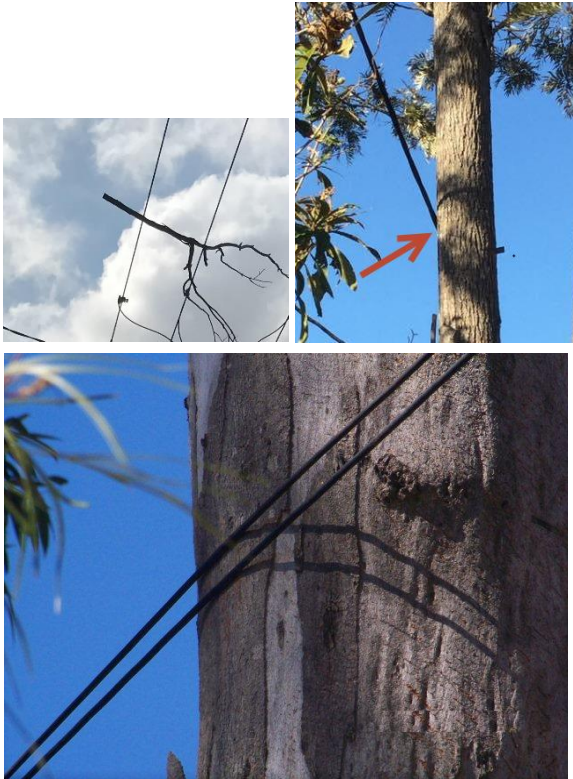
| Defect Description | Defect Photo | Task Details |
|---|---|---|
| <b><u>Mains - Vegetation Clearance Breached</u></b> | | <b><u>Priority</u></b><br>Refer to MMI 0013 |
| <b>Indicators:</b> <ul style="list-style-type: none"><li>- Bare conductors that are in contact with vegetation;</li><li>- Covered conductors that are touching heavy branches that are likely to cause insulation damage to the conductor;</li><li>- Branches laying across bare mains;</li><li>- Branches applying downward pressure to services creating over-tension.</li></ul> | | <b><u>Bushfire Defect</u></b><br>Refer to MMI 0013 |

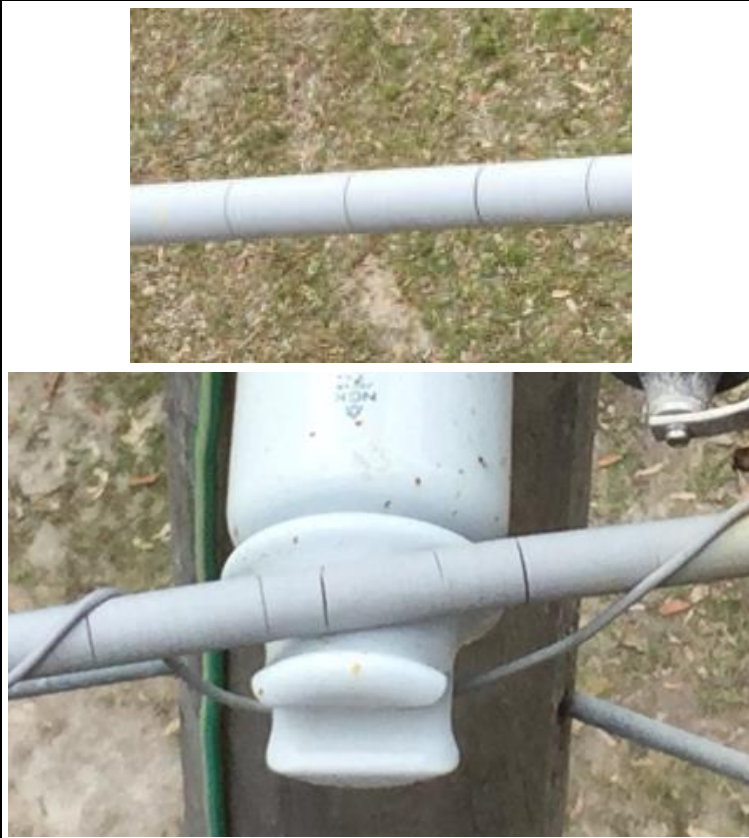
| Defect Description | Defect Photo | Task Details |
|---|---|---|
| <u>CCT - Insulation Damaged</u> | | <u>Priority</u><br>No Defect |
| <b>Indicators:</b><br><br>- Cracking of the insulation on CCT conductors. | | <u>Bushfire Defect</u><br>No |

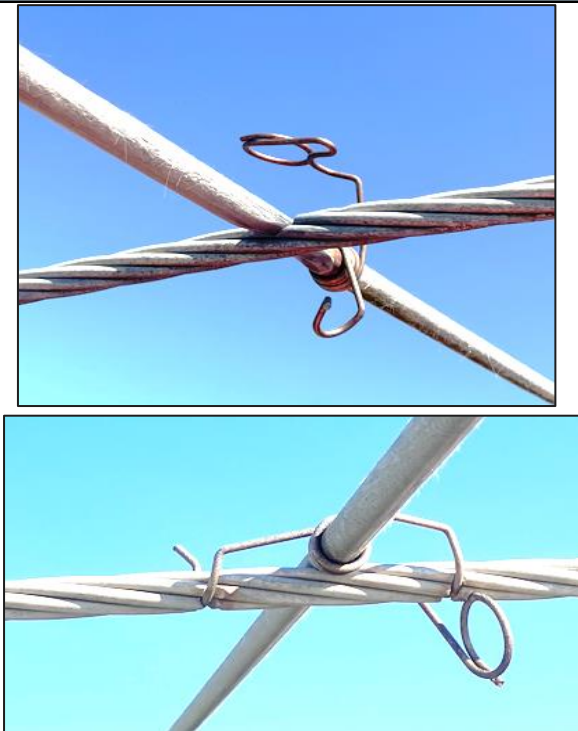
| Defect Description | Defect Photo | Task Details |
|---|---|---|
| <u>Spreader – Damaged Conductor</u> | | <u>Priority</u><br>SAP Priority 2<br>Immediate/48 hrs |
| <p><b>Indicators:</b></p> <ul style="list-style-type: none"><li>- Spreader has caused damage to the conductor.</li><li>- Spreader clips have caused damage to the conductor.</li></ul> | | <u>Bushfire Defect</u><br>Yes |

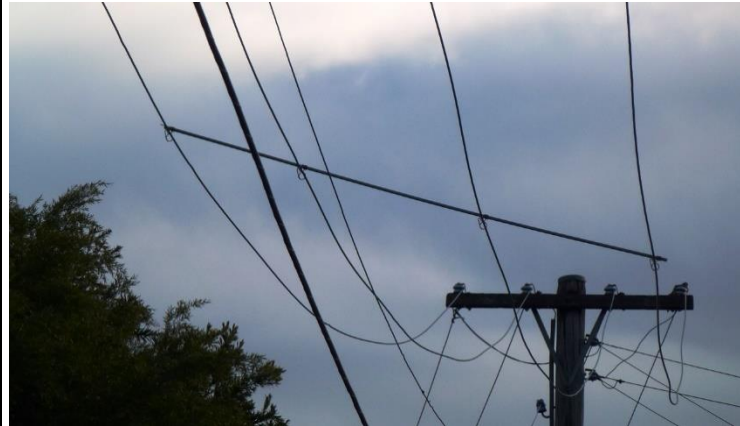
| Defect Description | Defect Photo | Task Details |
|---|---|---|
| <u>Spreader - Out of Alignment</u> | | <u>Priority</u><br>No Defect |
| <p><b>Indicators:</b></p> <ul style="list-style-type: none"><li>- Spreader is not flat across all phases.</li><li>- Spreader is sitting diagonally.</li></ul> | | <u>Bushfire Defect</u><br>No Defect |

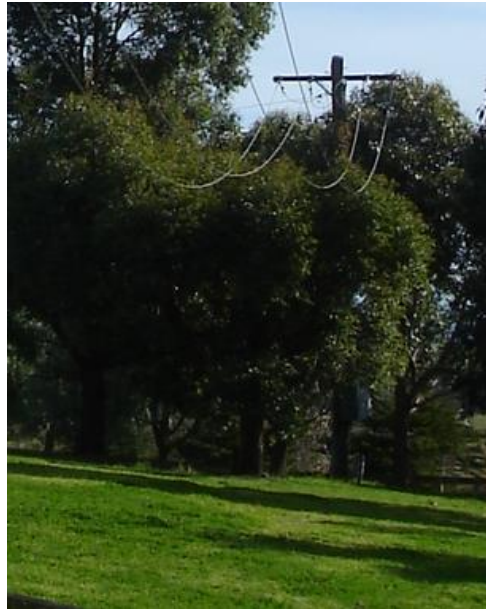
| Defect Description | Defect Photo | Task Details |
|---|---|---|
| <b><u>Spreader - Missing</u></b> | | <b><u>Priority</u></b><br><b>SAP Priority 9</b><br>Observation |
| <b>Indicators:</b><br><br>- Where a spreader should exist, and it doesn't. Refer to MDI 0031 for spreader requirements. | | <b><u>Bushfire Defect</u></b><br><br>No |

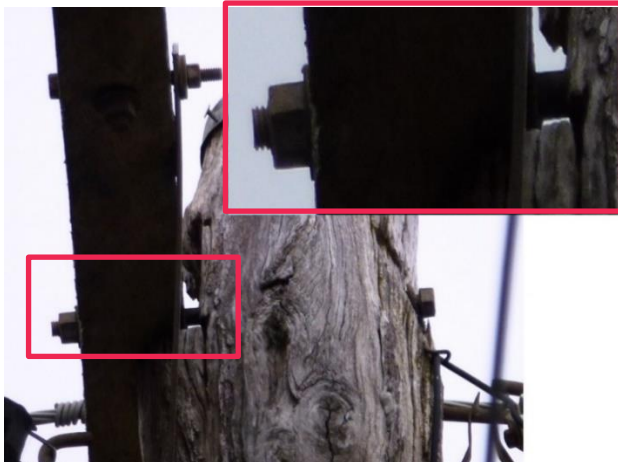
| Defect Description | Defect Photo | Task Details |
|---|---|---|
| <u>Crossarm - Loose</u> | | <u>Priority</u><br>SAP Priority 8<br>12 Months |
| <b>Indicators:</b> <ul style="list-style-type: none"><li>- Gap between crossarm and pole, with daylight able to be seen.</li><li>- Nut still on kingbolt</li></ul> | | <u>Bushfire Defect</u><br>No |

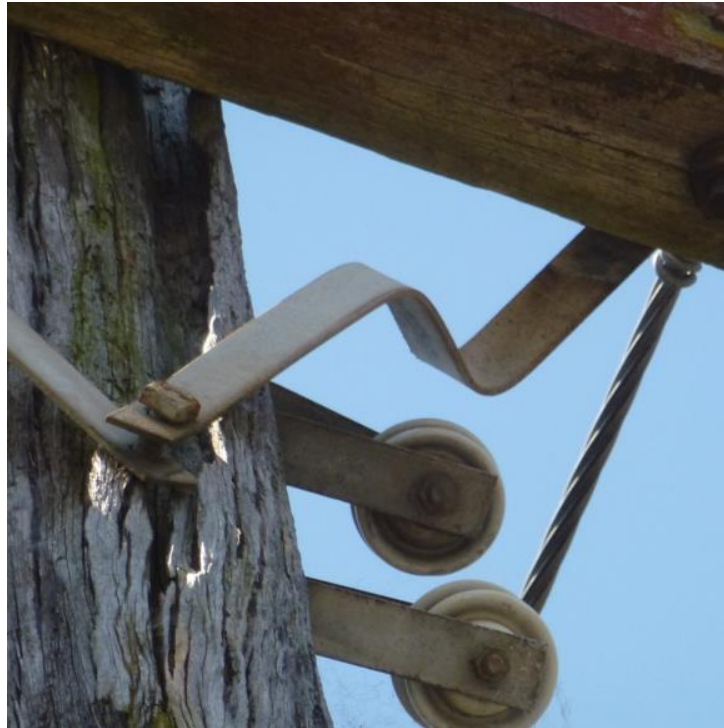
| Defect Description | Defect Photo | Task Details |
|---|---|---|
| <u>Crossarm Braces – Buckled, Damaged or Missing</u> | | <u>Priority</u><br>SAP Priority 7<br>6 Months |
| <p><b>Indicators:</b></p> <ul style="list-style-type: none"><li>- Crossarm braces are significantly buckled/damaged, warped.</li><li>- Minor damage to braces not a defect</li></ul> <p>NOTE: One missing brace on a two-brace construction is <u>not</u> considered a defect.</p> | | <u>Bushfire Defect</u><br>No |

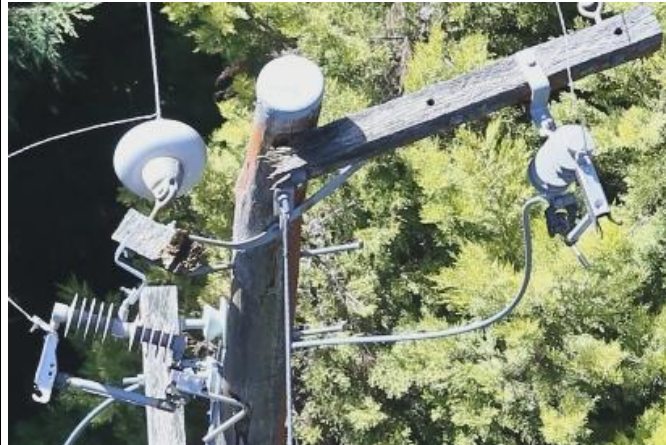
| Defect Description | Defect Photo | Task Details |
|---|---|---|
| <u>Crossarm – Failed or Broken</u> | | <u>Priority</u><br>SAP Priority 2<br>Immediate |
| <b>Indicators:</b> <ul style="list-style-type: none"><li>- Crossarm has failed.</li><li>- Crossarm completely separated or cracked through.</li><li>- Crossarm fallen or hanging.</li></ul> | | <u>Bushfire Defect</u><br>Yes |

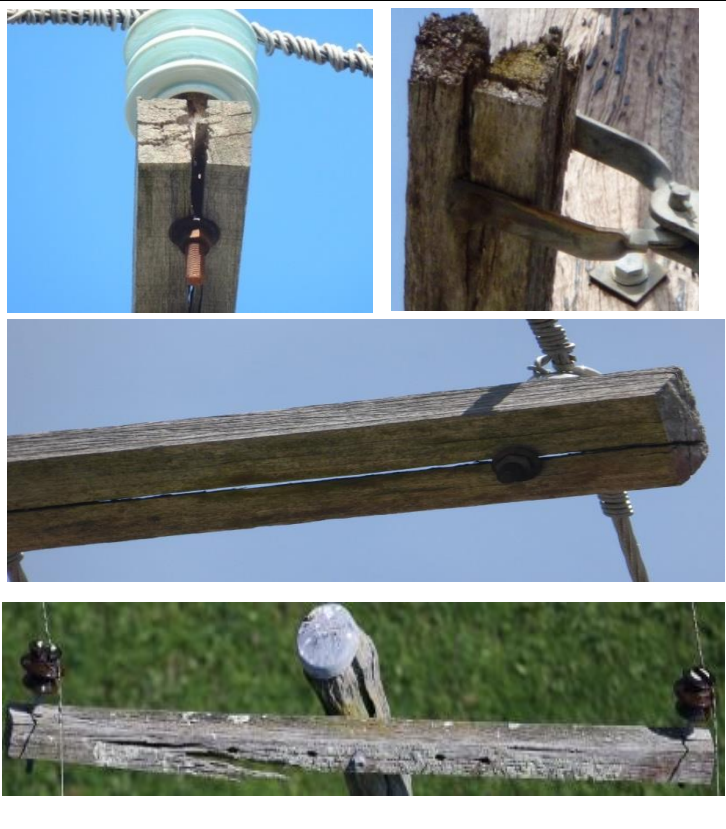
| <p><b><u>Crossarm - Splitting (Major)</u></b></p> | | <p><b><u>Priority</u></b><br/> <b>SAP Priority 2</b><br/> Immediate/1 Week</p> |
| <p><b>Indicators:</b></p> <ul style="list-style-type: none"> <li>- Split/s extend through entire cross-section.</li> <li>- Separation of timber (daylight can clearly be seen).</li> <li>- Hardware slipping/moving due to split, at imminent risk of falling out.</li> <li>- Crossarm failure is imminent.</li> </ul> | | <p><b><u>Bushfire Defect</u></b><br/> Yes</p> <p><b><u>Standard Job</u></b></p> <ul style="list-style-type: none"> <li>- Replace LV Crossarm (1LVARM)</li> <li>- Replace HV Crossarm (1HVARM)</li> <li>- Replace Transmission Crossarm (1TRARM)</li> <li>- Replace Service Crossarm (1SEARM)</li> </ul> <p><b><u>Component</u></b></p> <ul style="list-style-type: none"> <li>- Crossarm (CR)</li> </ul> <p><b><u>Failure Type</u></b></p> <ul style="list-style-type: none"> <li>- Reduction in mechanical strength (MS)</li> </ul> <p><b><u>Cause</u></b></p> <ul style="list-style-type: none"> <li>- Splitting (major) (S4)</li> </ul> |

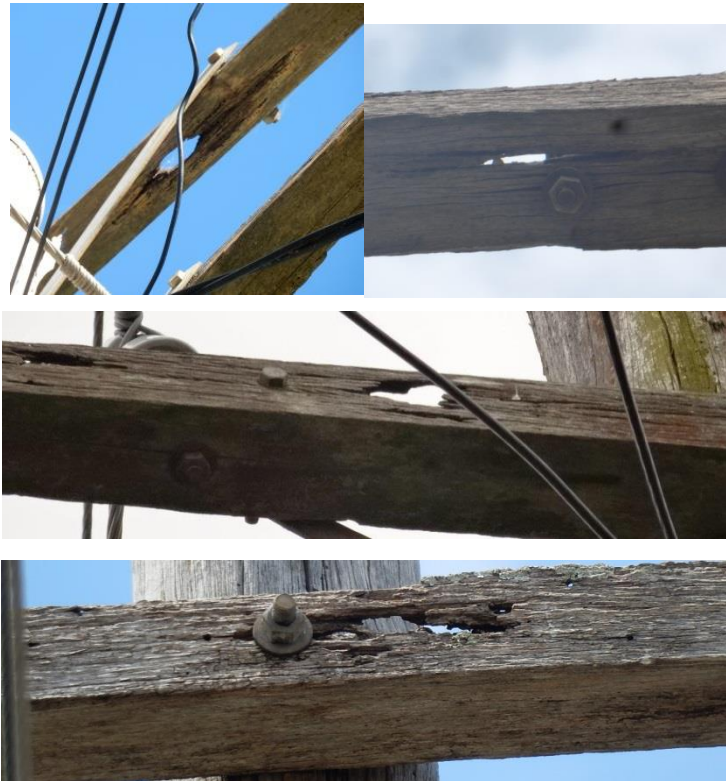
| Defect Description | Defect Photo | Task Details |
|---|---|---|
| <p><b><u>Crossarm - Deterioration (Major)</u></b></p> | | <p><b><u>Priority</u></b><br/><b>SAP Priority 2</b><br/>Immediate/1 Week</p> |
| <p><b>Indicators:</b></p> <ul style="list-style-type: none"><li>- Significant decay/burn <math>\geq 30\%</math> loss of cross-sectional area with holes that can be seen through.</li><li>- Large proportion of timber missing.</li><li>- Daylight can be seen through the crossarm.</li><li>- Hardware at imminent risk of falling out.</li><li>- Crossarm failure is imminent.</li></ul> | | <p><b><u>Bushfire Defect</u></b><br/>Yes</p> |

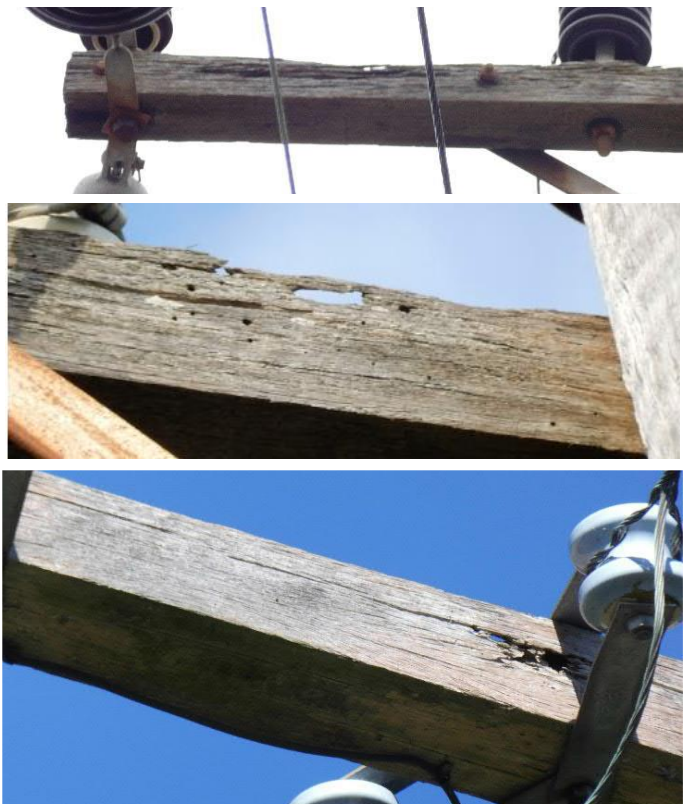
| Defect Description | Defect Photo | Task Details |
|---|---|---|
| <p><u>Crossarm - Deterioration (Moderate)</u></p> | | <p><u>Priority</u><br/>SAP Priority 7<br/>6 Months</p> |
| <p><b>Indicators:</b></p> <ul style="list-style-type: none"><li>- Crossarm has deterioration (or burnt) and loss of cross-sectional area of &gt; 20% and &lt;30%.</li><li>- Significant deterioration but <u>no</u> obvious holes in which daylight can be seen through the crossarm.</li><li>- Hardware <u>not</u> at risk of falling out.</li></ul> | | <p><u>Bushfire Defect</u><br/>Yes</p> |

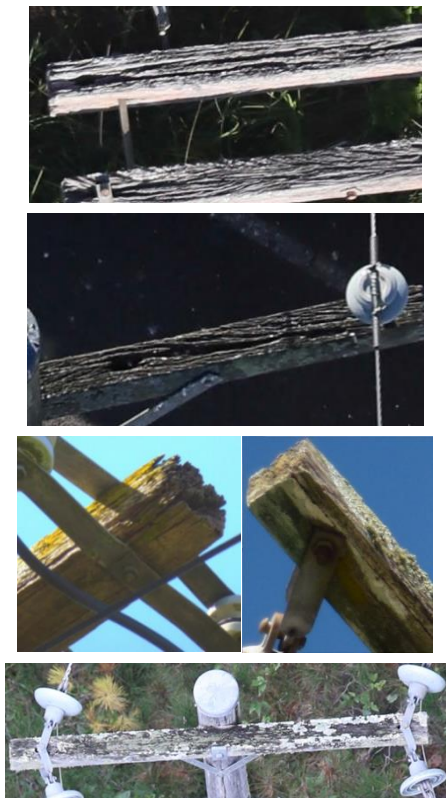
| Defect Description | Defect Photo | Task Details |
|---|---|---|
| <u>Crossarm - Deterioration (Minor)</u> | | <u>Priority</u><br>No Defect |
| <b>Indicators:</b> <ul style="list-style-type: none"><li>- Crossarm has deterioration but loss of cross-sectional area of &lt; 20%.</li><li>- Insignificant deterioration.</li><li>- Confined to ends of crossarm.</li><li>- Surface timber only.</li><li>- Unused drill holes for hardware.</li><li>- Lichen / moss present.</li></ul> | | <u>Bushfire Defect</u><br>No |

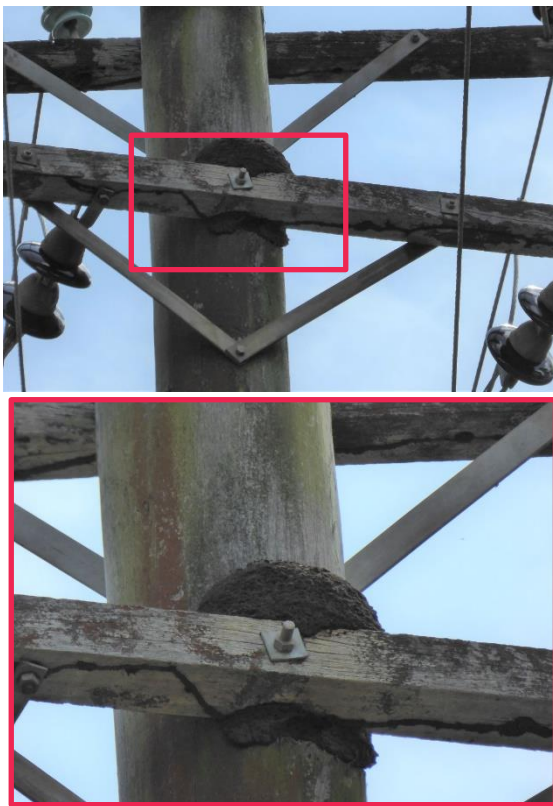
| Defect Description | Defect Photo | Task Details |
|---|---|---|
| <u>Crossarm - Termite Infestation</u> | | <u>Priority</u><br><b>SAP Priority 6</b><br>1 Month |
| <b>Indicators:</b> <ul style="list-style-type: none"><li>- Signs of termite mound/s (nest) on crossarm.</li><li>- Signs of termite galleries (mud tubes) on crossarm.</li></ul> | | <u>Bushfire Defect</u><br>Yes |

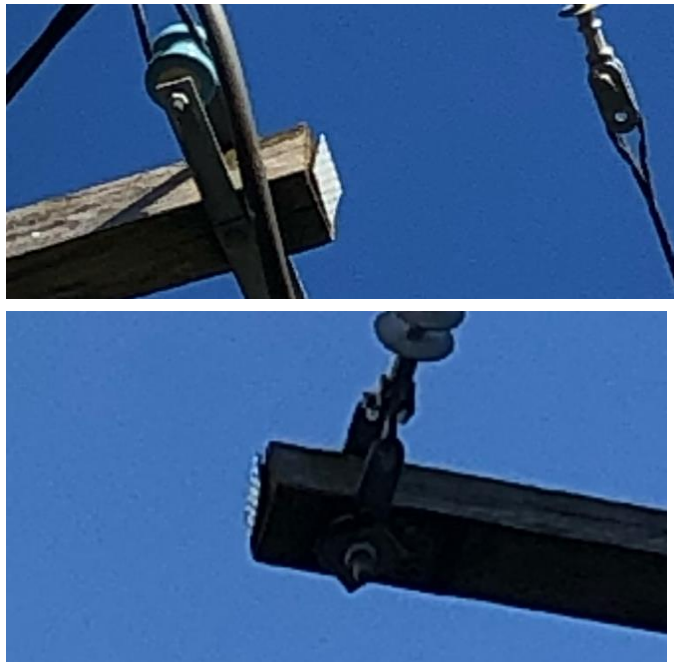
| Defect Description | Defect Photo | Task Details |
|---|---|---|
| <u>Crossarm – Gang Nail (Nail Plate) Loose</u> | | <u>Priority</u><br>SAP Priority 9<br>Observation |
| <b>Indicators:</b> <ul style="list-style-type: none"><li>- Gang nail not flush with crossarm surface</li><li>- Gang nail appears to be loose and is likely to fall out</li></ul> | | <u>Bushfire Defect</u><br>No |

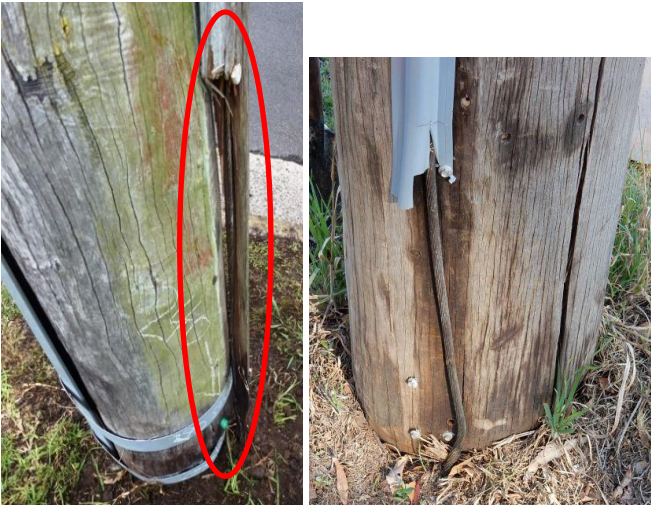
| Defect Description | Defect Photo | Task Details |
|---|---|---|
| <u>Earth Batten - Damaged, Broken or Missing</u> | | <u>Priority</u><br>SAP Priority 9<br>Observation |
| <p><b>Indicators:</b></p> <p>- Earth batten showing signs of mechanical damage <u>AND</u> contact with earth wire is possible.</p> <p><b>Note:</b> General damage to the earth batten alone is not considered a defect.</p> | | <u>Bushfire Defect</u><br>No |

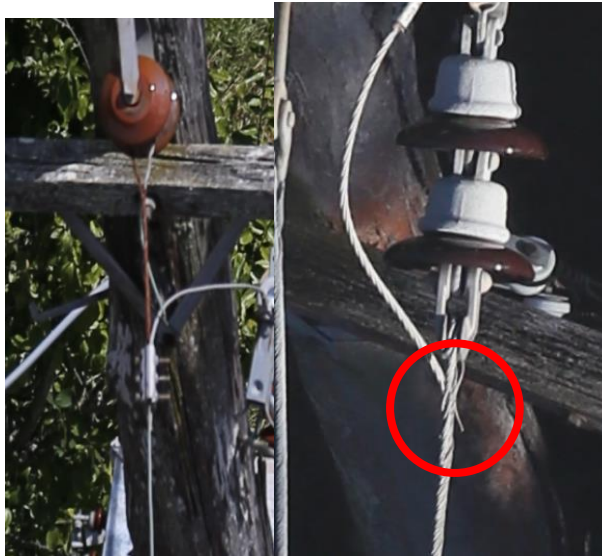
| Defect Description | Defect Photo | Task Details |
|---|---|---|
| <u>Dead-End – Damaged</u> | | <u>Priority</u><br>SAP Priority 6<br>1 Month |
| <b>Indicators:</b> <ul style="list-style-type: none"><li>- Dead end showing signs of mechanical damage.</li><li>- Loose strands.</li><li>- Heavy rust (ie, rust that extends the entire length of the dead-end).</li></ul> | | <u>Bushfire Defect</u><br>Yes |

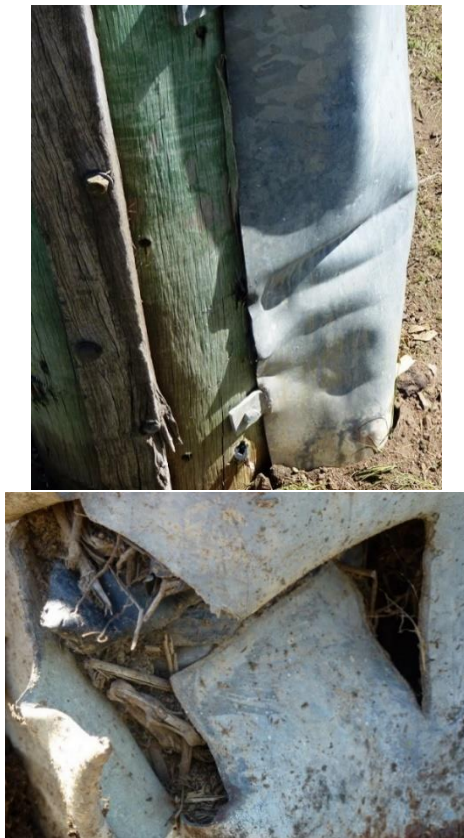
| Defect Description | Defect Photo | Task Details |
|---|---|---|
| <b><u>Cable Guard - Moderate Damage, Broken or Missing</u></b> | | <b><u>Priority</u></b><br><b>SAP Priority 7</b><br>6 Months |
| <b>Indicators:</b> <ul style="list-style-type: none"><li>- Cable guard having dents which are more than a 5cms in depth.</li><li>- Cable can be seen through cable guard.</li><li>- Cable guard not present.</li></ul> | | <b><u>Bushfire Defect</u></b><br>No |

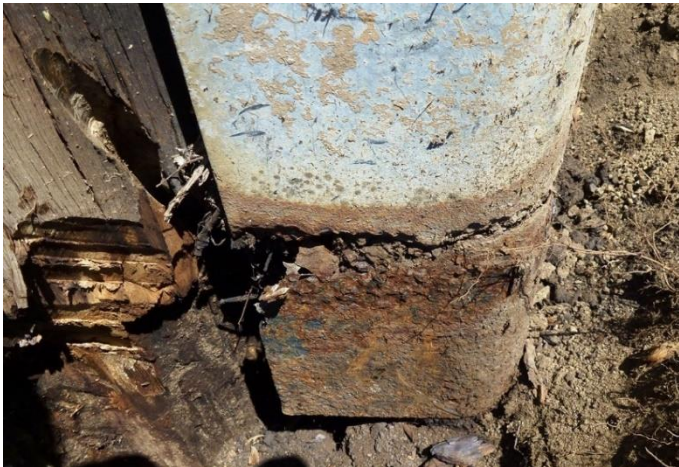
| Defect Description | Defect Photo | Task Details |
|---|---|---|
| <u>Cable Guard - Rusted</u> | | <u>Priority</u><br>SAP Priority 9<br>Observation |
| <b>Indicators:</b> <ul style="list-style-type: none"><li>- Cable guard has separation and/or showing large holes in the metal.</li><li>- Surface rust does not constitute a defect.</li></ul> | | <u>Bushfire Defect</u><br>No |

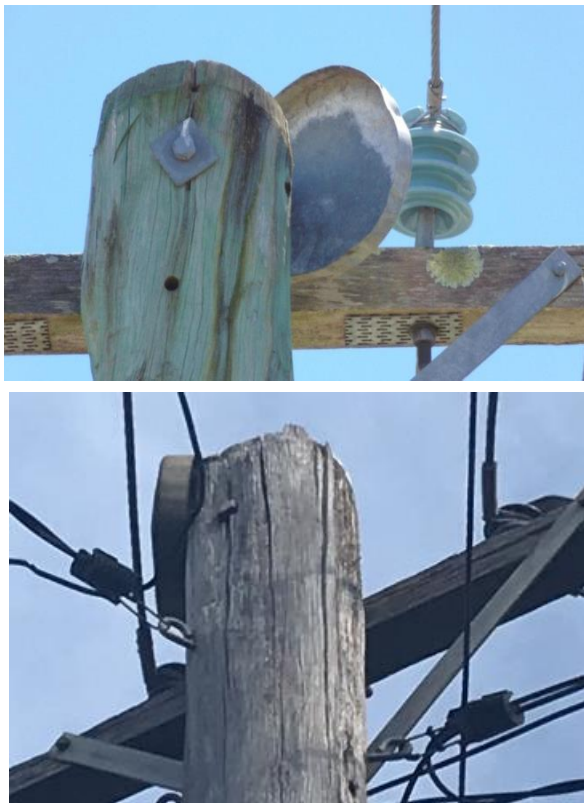
| Defect Description | Defect Photo | Task Details |
|---|---|---|
| <p><b><u>Pole Cap – Loose / Hanging<br/>AND Compromising Clearances</u></b></p> | | <p><b><u>Priority</u></b></p> |
| <p><b>Indicators:</b></p> <ul style="list-style-type: none"><li>- Pole cap is loose / hanging, and</li><li>- Pole cap is <u>in contact</u> with <u>bare</u> conductor/s, or</li><li>- Pole cap is <u>compromising clearances</u> to <u>bare</u> conductor/s.</li></ul> | | <p><b><u>In Contact – SAP 2</u></b> (Immediate/48)</p> <p><b><u>Compromising Clearance – SAP 7</u></b> (3 Months)</p> <p><b><u>Bushfire Defect</u></b><br/>Yes</p> <p><b><u>Standard Job</u></b><br/>- Hanging Pole Cap (1PCAPH)</p> <p><b><u>Component</u></b><br/>- Pole Cap (PC)</p> <p><b><u>Failure Type</u></b><br/>- Compromising clearances (CL)</p> <p><b><u>Cause</u></b><br/>- Installation Error (IE) / Deterioration (DG)</p> |

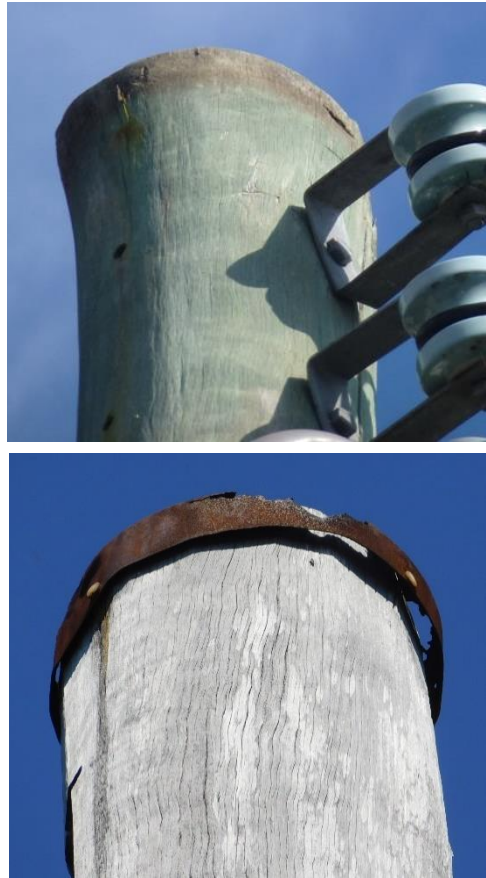
| Defect Description | Defect Photo | Task Details |
|---|---|---|
| <p><b><u>Pole Cap - Missing or Damaged</u></b></p> | | <p><b><u>Priority</u></b><br/><b>SAP Priority 9</b><br/>Observation</p> |
| <p><b>Indicators:</b></p> <ul style="list-style-type: none"><li>- Pole cap is missing / not present.</li><li>- Pole cap is damaged or corroded such that there are holes present and/or it is no longer preventing water entry into pole top.</li></ul> | | <p><b><u>Bushfire Defect</u></b><br/>No</p> |

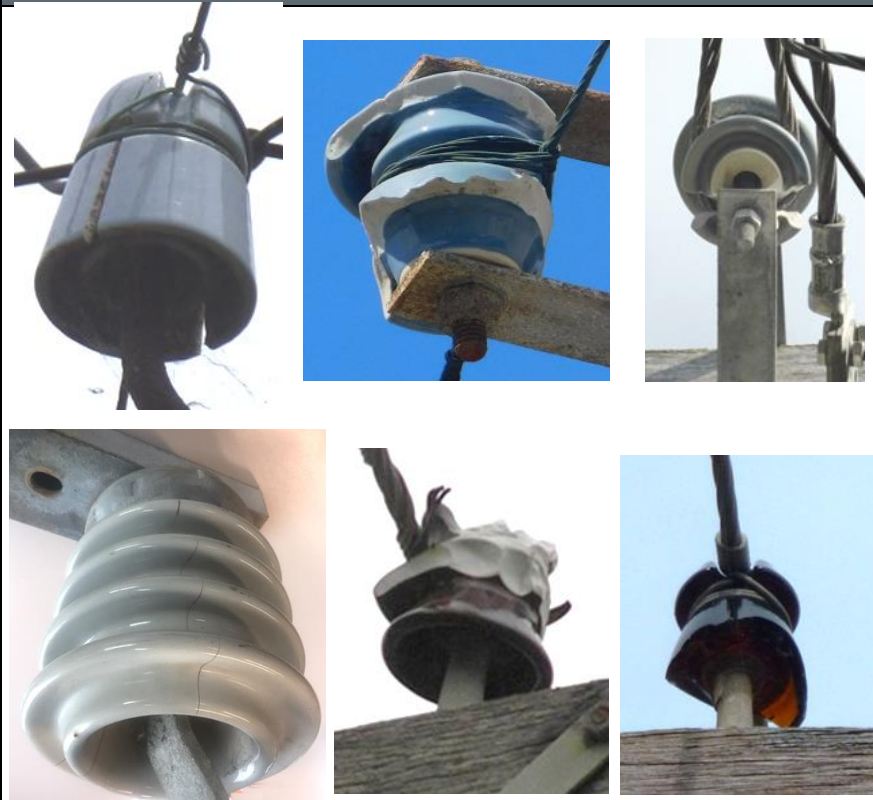
| Defect Description | Defect Photo | | | Task Details |
|---|---|---|--|---|
| <u>Porcelain Insulator – Major Damage</u> | | <u>Priority</u> | | |
| | | Trans./HV – SAP 6 (1 Month) | | |

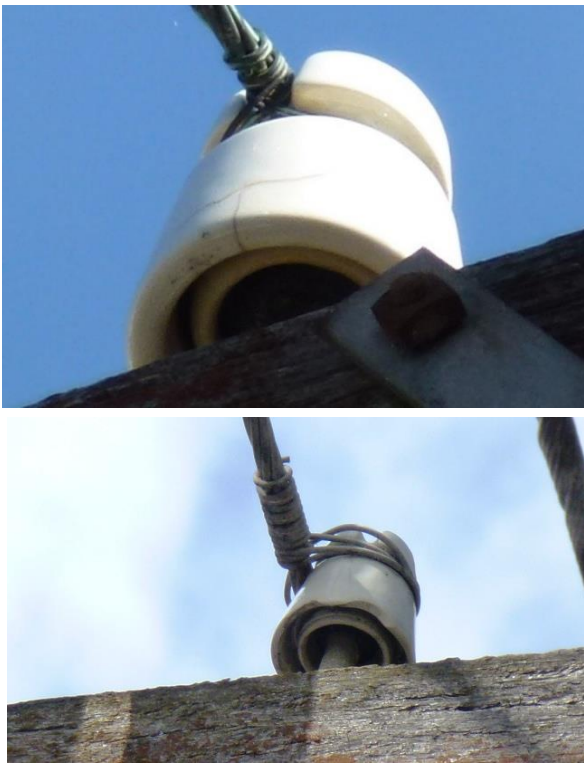
| Defect Description | Defect Photo | Task Details |
|---|---|---|
| <p><b><u>Porcelain Insulator – Minor Damage</u></b></p> <p><b>Indicators:</b></p> <ul style="list-style-type: none"><li>- Minor cracks / damage.</li><li>- Chips to the insulator in areas not under strain</li><li>- Chips that are only &lt;2cm in width.</li><li>- Minor hairline cracks (only extend part way through insulator).</li></ul> | | <p><b><u>Priority</u></b><br/>No Defect</p> |
| | | <p><b><u>Bushfire Defect</u></b><br/>No</p> |

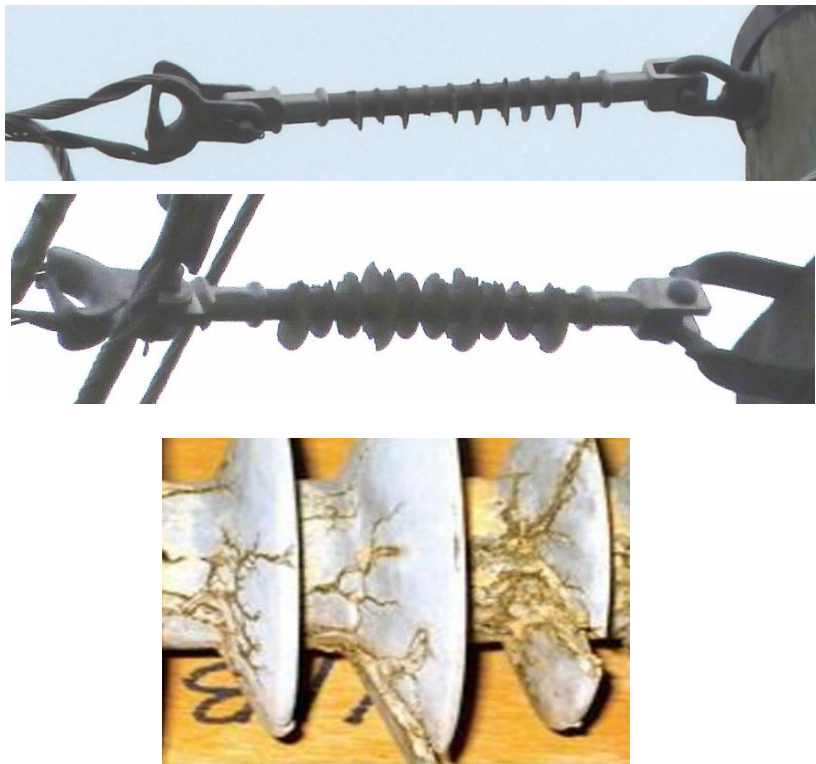
| Defect Description | Defect Photo | Task Details |
|---|---|---|
| <p><b><u>Polymer Insulator – Major Damage</u></b></p> | | <p><b><u>Priority</u></b></p> <p><b>SAP Priority 2</b></p> <p>Immediate/48 hrs</p> |
| <p><b>Indicators:</b></p> <ul style="list-style-type: none"><li>- All (or almost all) sheds missing / significantly reduced.</li><li>- Fibreglass rod is exposed.</li><li>- Electrical tracking (carbon treeing).</li></ul> | | <p><b><u>Bushfire Defect</u></b></p> <p><b>Yes</b></p> |

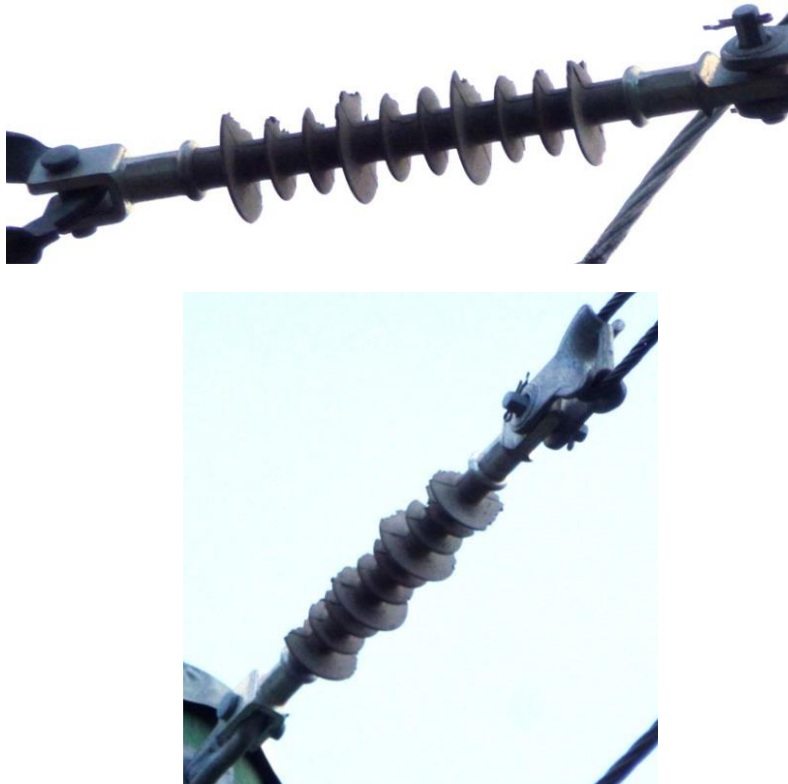
| Defect Description | Defect Photo | Task Details |
|---|---|---|
| <p><b><u>Polymer Insulator – Moderate Damage</u></b></p> | | <p><b><u>Priority</u></b><br/><b>SAP Priority 7</b><br/>6 Months</p> |
| <p><b>Indicators:</b></p> <ul style="list-style-type: none"><li>- 20% or more of sheds missing / significantly reduced.<br/><i>(but less than major category above)</i></li></ul> | | <p><b><u>Bushfire Defect</u></b><br/>Yes</p> |

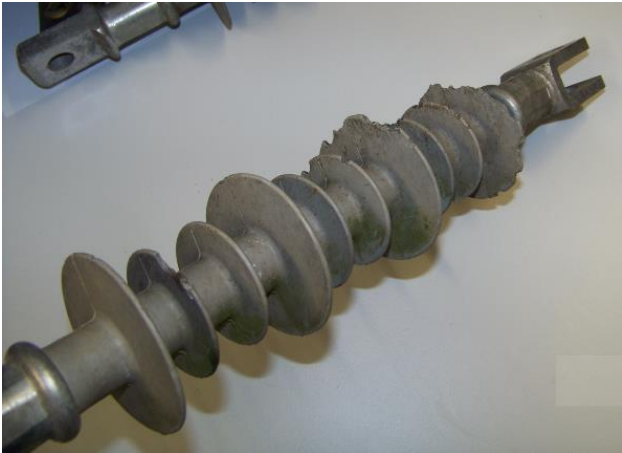
| Defect Description | Defect Photo | Task Details |
|---|---|---|
| <u>Polymer Insulator – Minor Damage</u> | | <u>Priority</u><br>No Defect |
| <b>Indicators:</b> <ul style="list-style-type: none"><li>- Minor shed damage (&lt;20% reduction).</li><li>- Majority of sheds still intact.</li><li>- Presence of mould, fungus or insect activity.</li></ul> | | <u>Bushfire Defect</u><br>No |

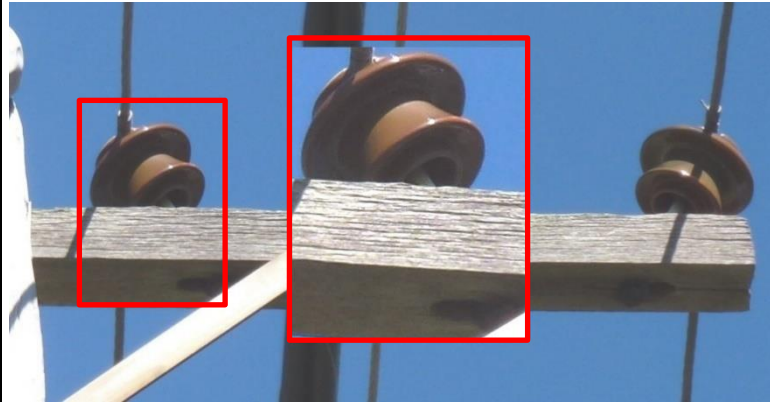
| Defect Description | Defect Photo | Task Details |
|---|---|---|
| <p><u><b>Insulator - Leaning (Major)</b></u><br/><u><b>Caused by Crossarm Degradation</b></u></p> <p><b>Indicators:</b></p> <ul style="list-style-type: none"><li>- Major lean (&gt;45°);</li><li>- Significant elongation of pin hole; AND</li><li>- Conductor clearance is compromised.</li></ul> | | <p><u><b>Priority</b></u><br/><b>SAP Priority 7</b><br/>6 Months</p> |
| | | <p><u><b>Bushfire Defect</b></u><br/>Yes</p> |

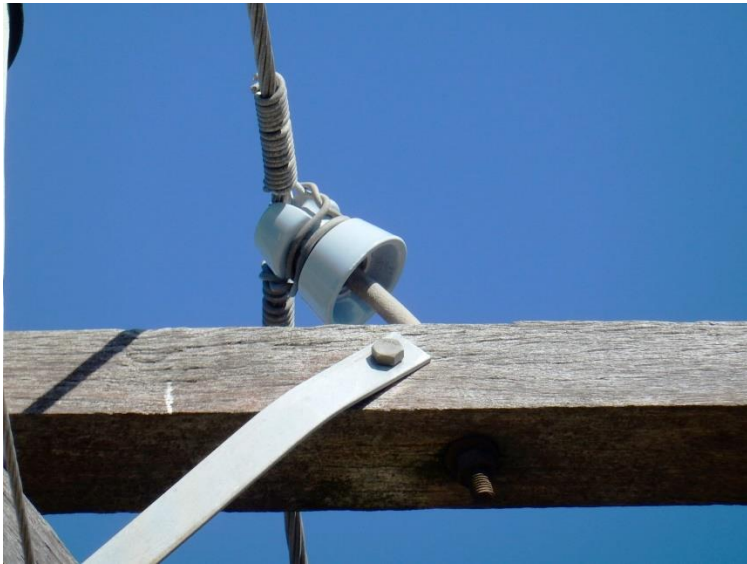
| Defect Description | Defect Photo | Task Details |
|---|---|---|
| <p><u><b>Insulator - Leaning (Major)</b></u><br/><u><b>Caused by Overloading</b></u></p> <p><b>Indicators:</b></p> <ul style="list-style-type: none"><li>- Major lean (&gt;45°); and</li><li>- Insulator has bent pin; and</li><li>- Conductor clearance is compromised.</li></ul> | | <p><u><b>Priority</b></u><br/><b>SAP Priority 7</b><br/>6 Months</p> |
| | | <p><u><b>Bushfire Defect</b></u><br/><b>Yes</b></p> |

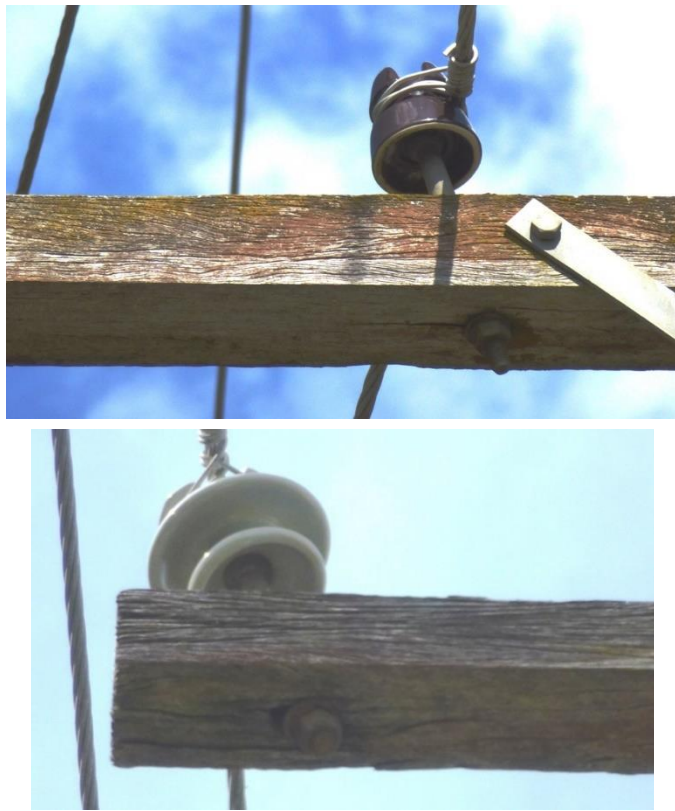
| Defect Description | Defect Photo | Task Details |
|---|---|---|
| <div><u>Insulator - Leaning (Minor)</u></div> <div><div>Indicators:</div><ul style="list-style-type: none"><li>- A lean of the insulator of less than 45 degrees from vertical.</li><li>- Minor elongation of pin hole.</li><li>- Conductor clearances to other phases is <u>not</u> compromised.</li></ul></div> | | <div><u>Priority</u></div> <div>No Defect</div> |
| | | <div><u>Bushfire Defect</u></div> <div>No</div> |

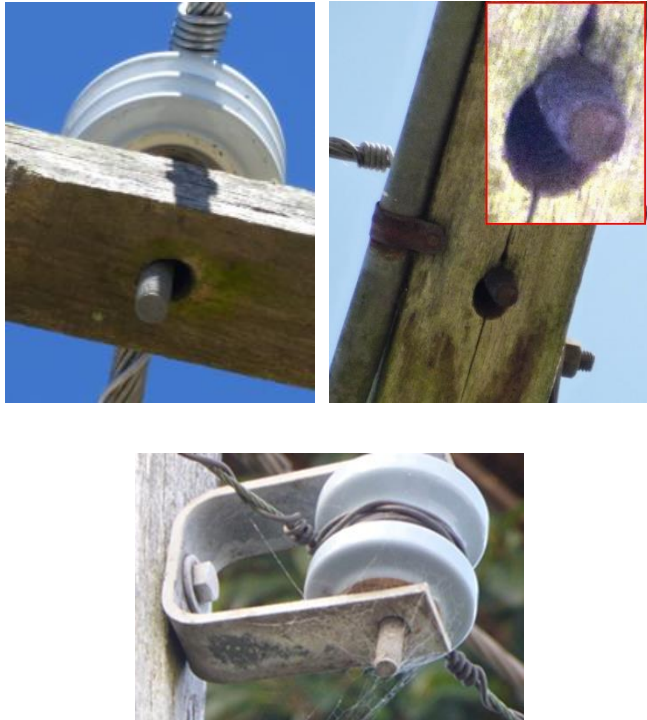
| Defect Description | Defect Photo | Task Details |
|---|---|---|
| <p><b><u>Insulator - Nut Missing</u></b><br/><b><u>(Pin / Intermediate)</u></b></p> | | <p><b><u>Priority</u></b><br/><b>SAP Priority 7</b><br/>6 Months</p> |
| <p><b>Indicators:</b></p> <ul style="list-style-type: none"><li>- Nut missing / non-existent.</li><li>- Only applies to pin / intermediate constructions.</li></ul> | | <p><b><u>Bushfire Defect</u></b><br/>No</p> |

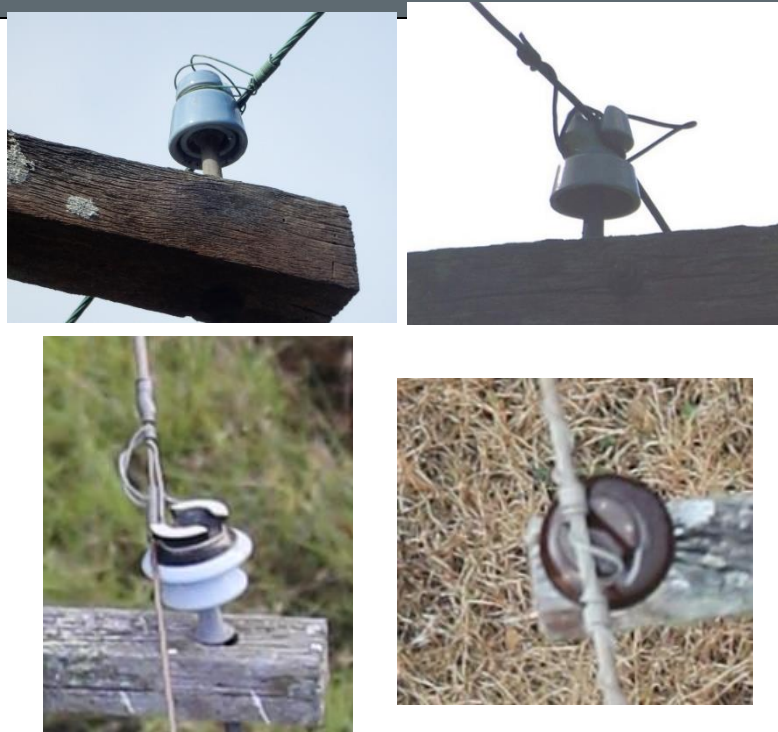
| Defect Description | Defect Photo | Task Details |
|---|---|---|
| <p><u>Tie Wire - Loose</u></p> | | <p><u>Priority</u><br/>SAP Priority 7<br/>6 Months</p> |
| <p><b>Indicators:</b></p> <ul style="list-style-type: none"><li>- Conductor is still attached to insulator, but tie wire is loose.</li><li>- Daylight can be seen between the tie wire and the conductor.</li></ul> | | <p><u>Bushfire Defect</u><br/>Yes</p> |

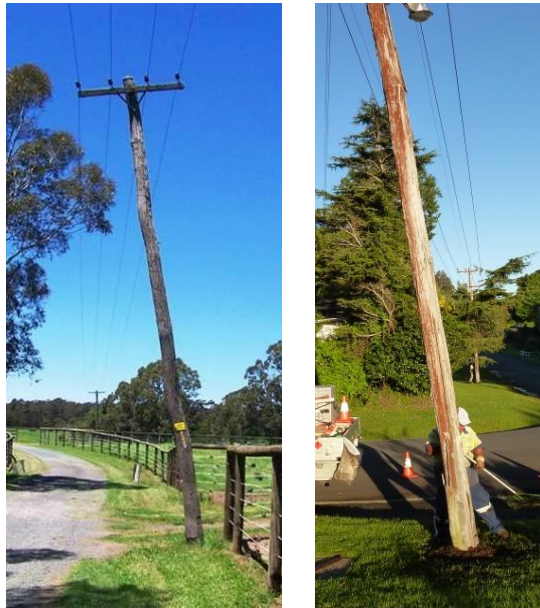
| Defect Description | Defect Photo | Task Details |
|---|---|---|
| <p><b><u>Pole – Leaning (Major)</u></b></p> | | <p><b><u>Priority</u></b></p> <p><b>SAP Priority 7</b></p> <p>3 Months</p> |

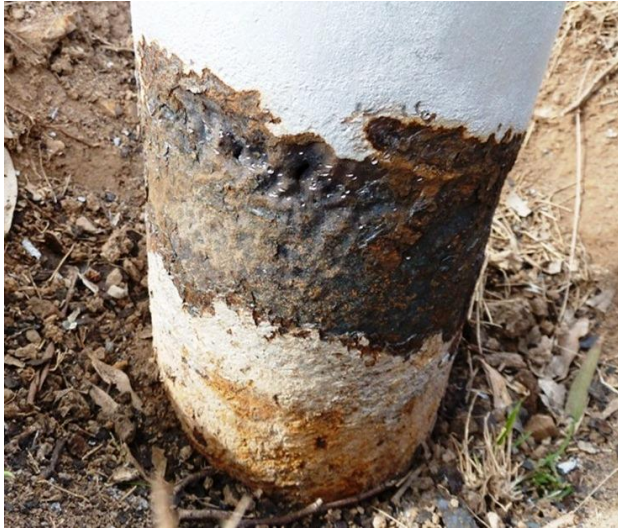
| Defect Description | Defect Photo | Task Details |
|---|---|---|
| <u>Steel Pole - Corrosion (Minor)</u> | | <u>Priority</u><br>SAP Priority 7<br>6 Months |

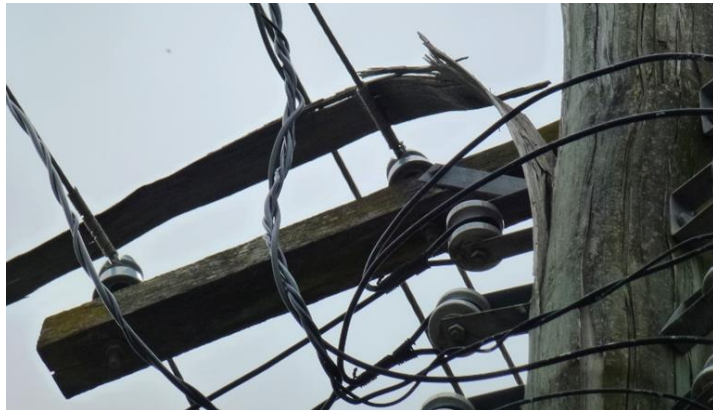
| Defect Description | Defect Photo | Task Details |
|---|---|---|
| <u>Sapwood – In Contact with Conductor/s</u> | | <u>Priority</u><br><b>SAP Priority 2</b><br>Immediate/48 hrs |

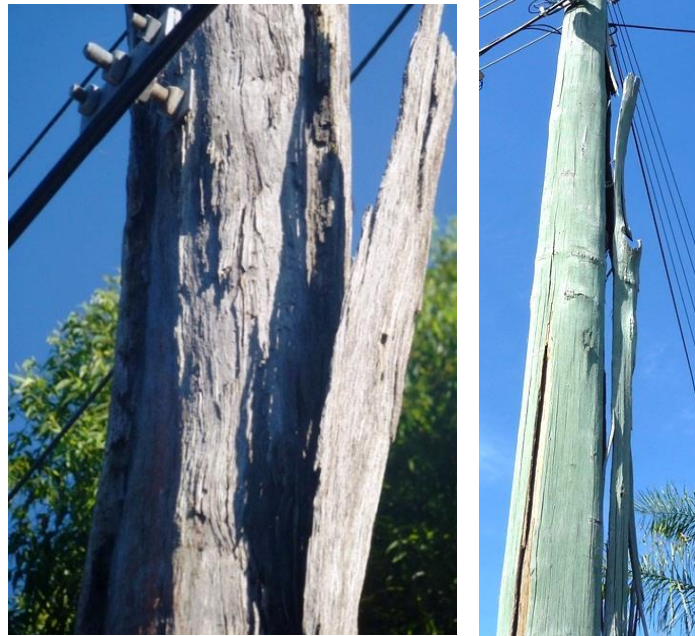
| Defect Description | Defect Photo | Task Details |
|---|---|---|
| <p><u>Sapwood – Loose but NOT Compromising Clearances</u></p> | | <p><u>Priority</u><br/>No Defect</p> |

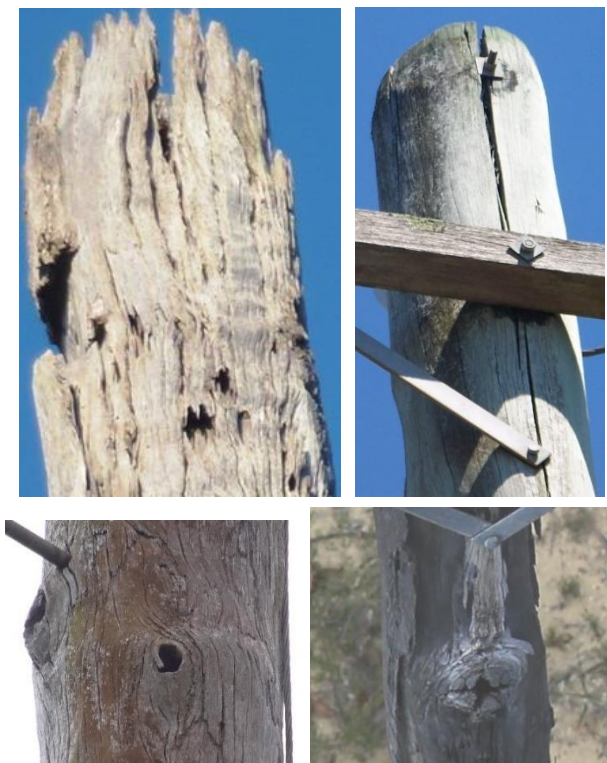
| Defect Description | Defect Photo | Task Details |
|---|---|---|
| <p><b><u>Mid Pole / Pole Top - Deterioration</u></b></p> | | <p><b><u>Priority</u></b><br/><b>SAP Priority 7</b><br/>6 Months</p> |

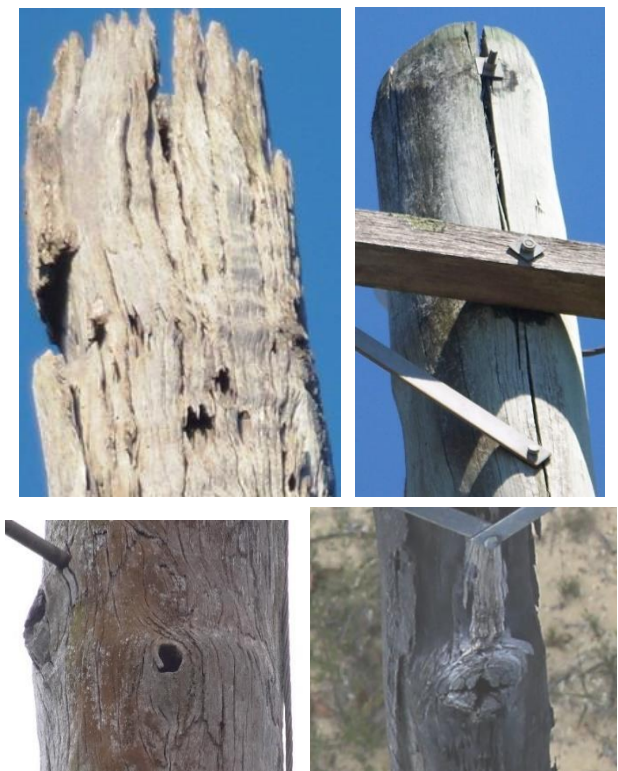
| Defect Description | Defect Photo | Task Details |
|---|---|---|
| <p><b><u>Pole Top - Condemning</u></b></p> | | <p><b><u>Priority</u></b><br/><b>SAP Priority 7</b><br/>6 Months</p> |

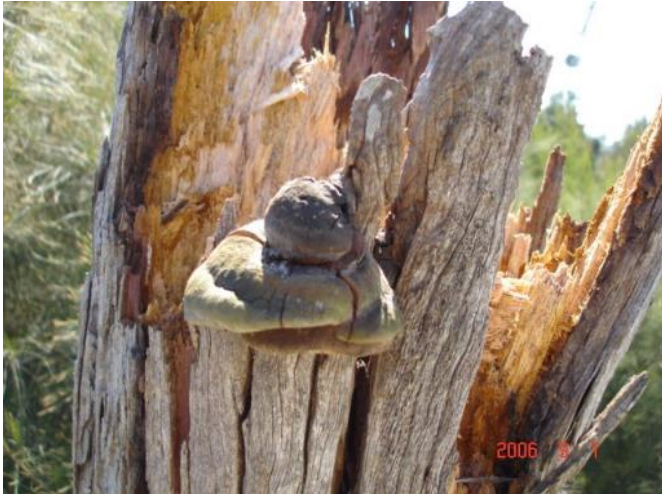
| Defect Description | Defect Photo | Task Details |
|---|---|---|
| <b><u>Fruiting Bodies Present - Demonstrating Internal Rot is Present</u></b> | | <b><u>Priority</u></b><br><b>SAP Priority 6</b><br>1 Month |
| <b>Indicators:</b><br><br>- Presence of fruiting bodies are found. | | <b><u>Bushfire Defect</u></b><br>Yes |

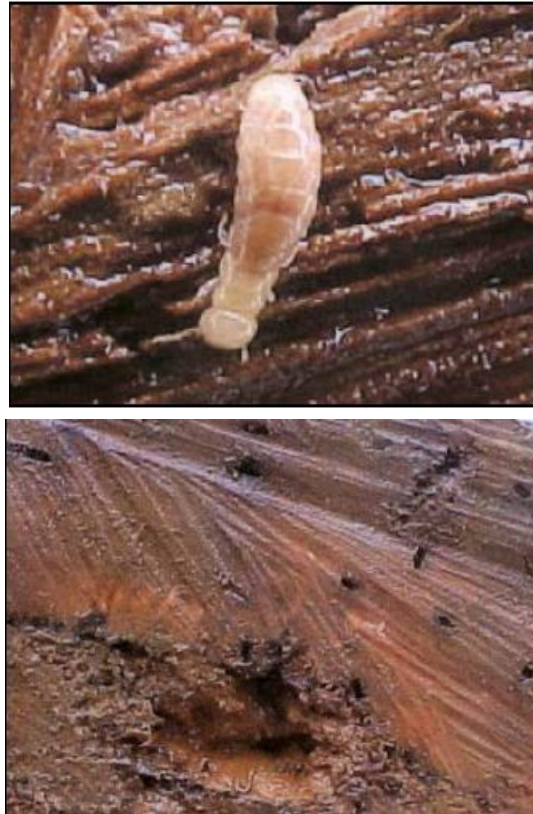
| Defect Description | Defect Photo | Task Details |
|---|---|---|
| <p><b><u>Termites - Glyptotermes</u></b></p> | | <p><b><u>Priority</u></b></p> <p>Dependent upon pole condition following inspection. Refer to MMI0001 and Pole Serviceability Flowchart.</p> |
