# Distribution Overhead Defect Handbook

**Document No. MMI 0002**

**Amendment No. 3**

30/04/25

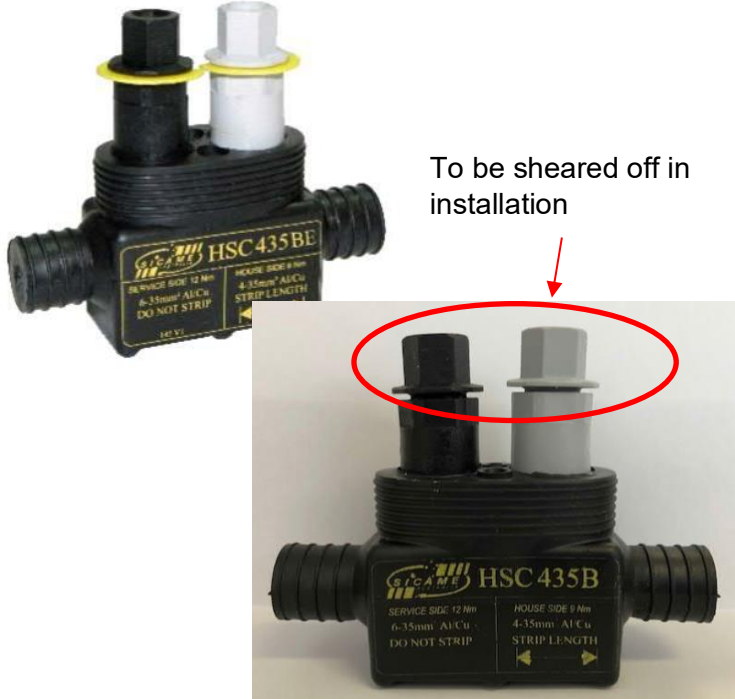
| Defect Description | Defect Photo | Task Details |
|---|---|---|
| <p><b><u>HSC/IPC – Major Damage, Loose or Not Secure</u></b></p> | <p>To be sheared off in installation</p> | <p><b><u>Priority</u></b><br/> <b>SAP Priority 2</b><br/> Immediate/48 hrs</p> |

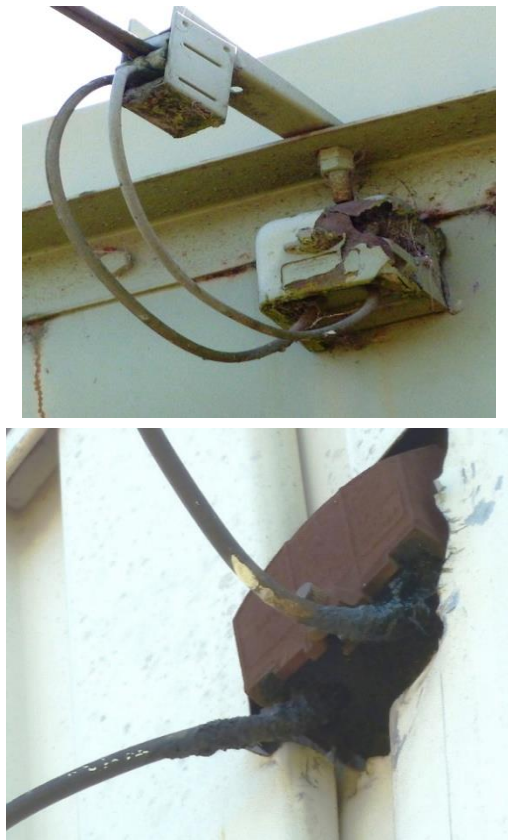
| Defect Description | Defect Photo | Task Details |
|---|---|---|
| <b><u>Mains Connection Box (MCB) – Damaged or Burnt</u></b> | | <b><u>Priority</u></b><br>Report to customer immediately |

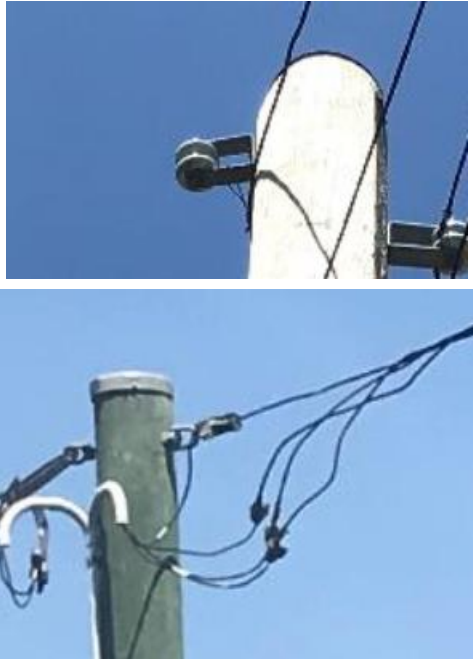
| Defect Description | Defect Photo | Task Details |
|---|---|---|
| <p><b><u>Service Mains - Not Secure to Insulator / Equipment</u></b></p> | | <p><b><u>Priority</u></b><br/>SAP Priority 6<br/>1 Month</p> |

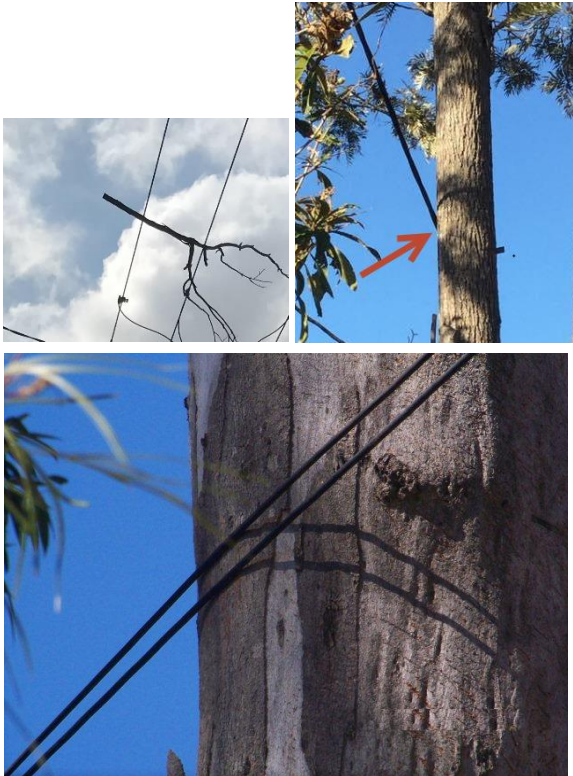
| Defect Description | Defect Photo | Task Details |
|---|---|---|
| <b><u>Services - Vegetation Clearance Breached</u></b> | | <b><u>Priority</u></b><br>Refer to MMI 0013 |

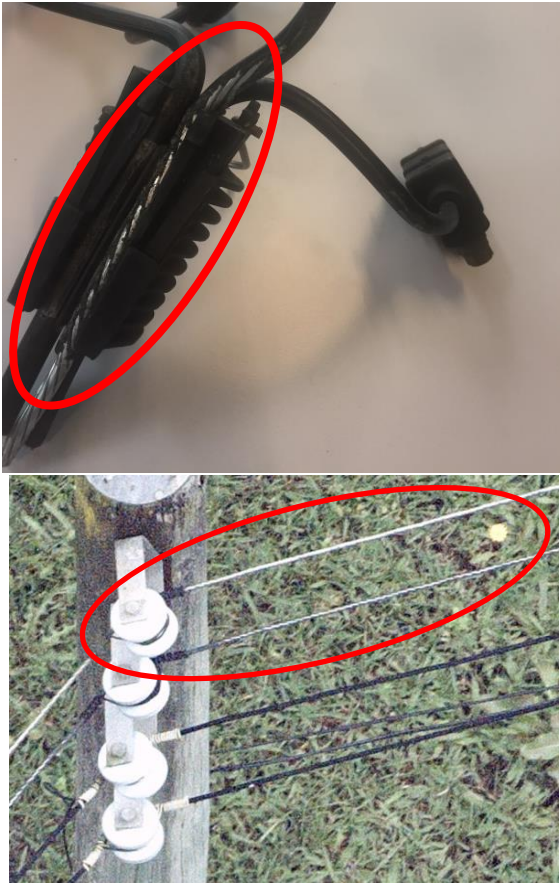
| Defect Description | Defect Photo | Task Details |
|---|---|---|
| <p><u>Service Wire – Major Damage</u></p> | | <p><u>Priority</u><br/>SAP Priority 6<br/>1 Month</p> |

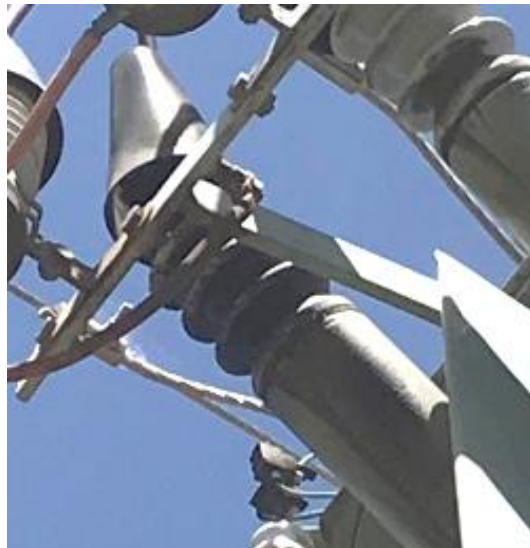
| Defect Description | Defect Photo | Task Details |
|---|---|---|
| <u>HV / LV Bushing - Broken</u> | | <u>Priority</u><br>As per insulator defects. |

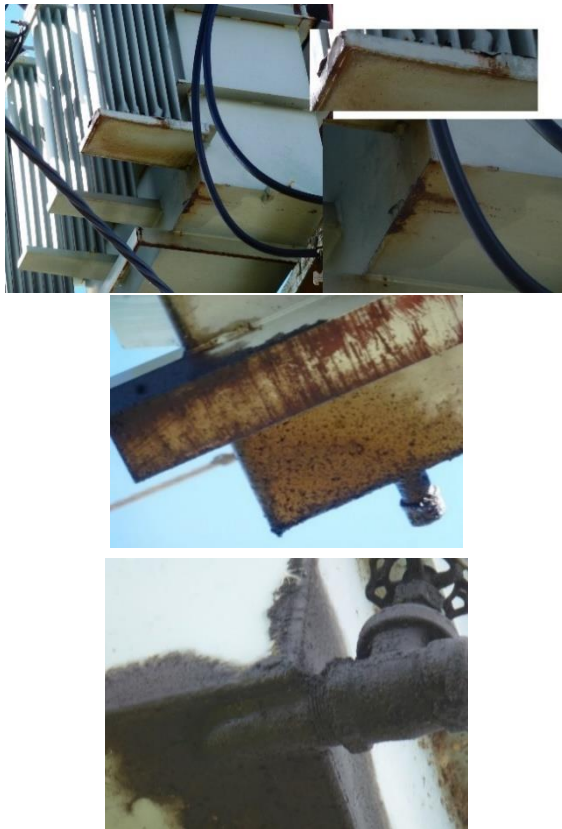
| Defect Description | Defect Photo | Task Details |
|---|---|---|
| <u>Transformer Tank – Leaking Oil</u> | | <u>Priority</u><br>SAP Priority 7<br>6 Months |

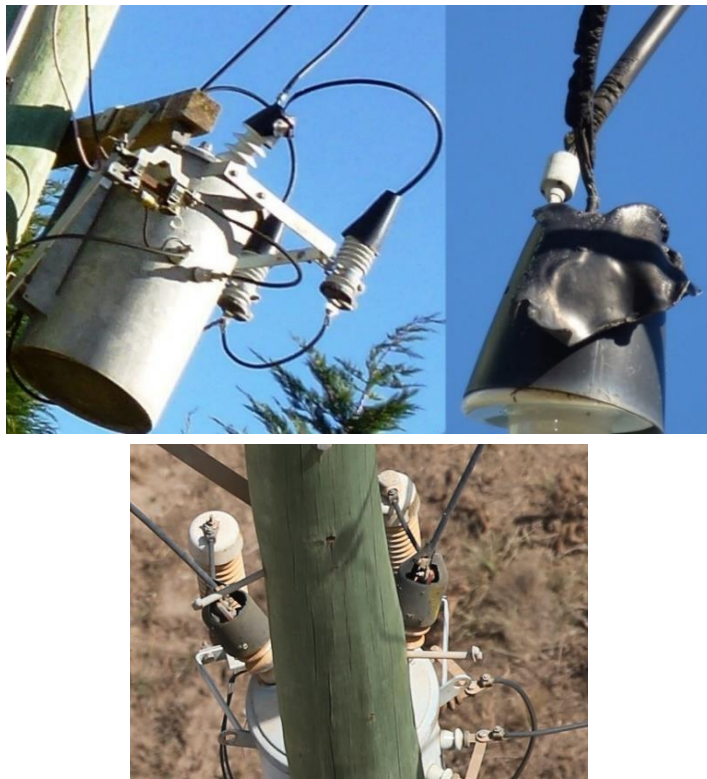
| Defect Description | Defect Photo | Task Details |
|---|---|---|
| <p><b><u>Shroud (Possum Guard) – Burned or Melted</u></b></p> | | <p><b><u>Priority</u></b></p> <p><b>SAP Priority 7</b></p> <p>6 Months</p> |

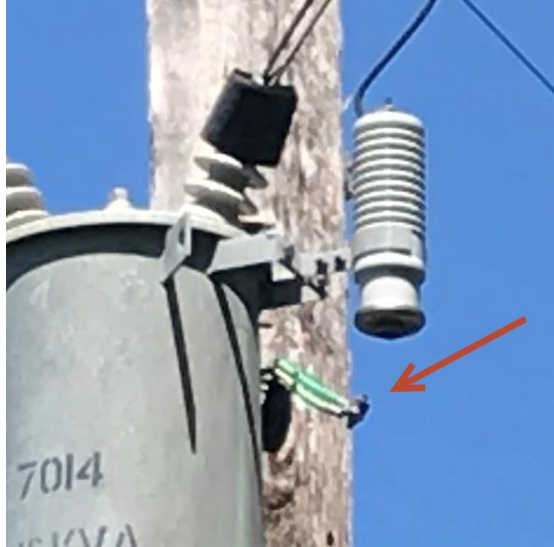
| Defect Description | Defect Photo | Task Details |
|---|---|---|
| <u>Surge Diverter - Earth Connection Missing</u> | | <u>Priority</u><br>SAP Priority 7<br>3 Months |

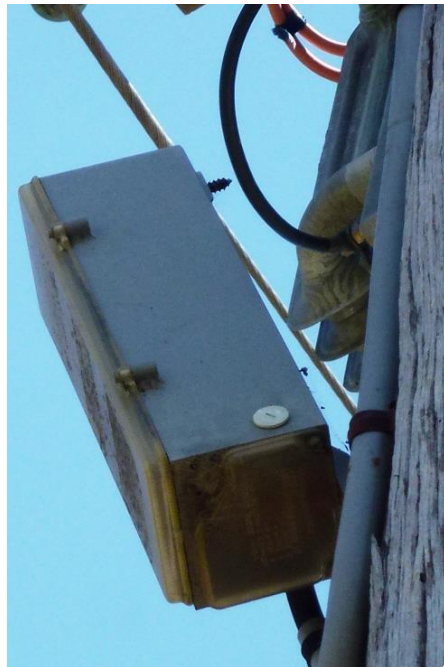
| Defect Description | Defect Photo | Task Details |
|---|---|---|
| <u>MDI Housing - Not Secured</u> | | <u>Priority</u><br>SAP Priority 9<br>Observation |

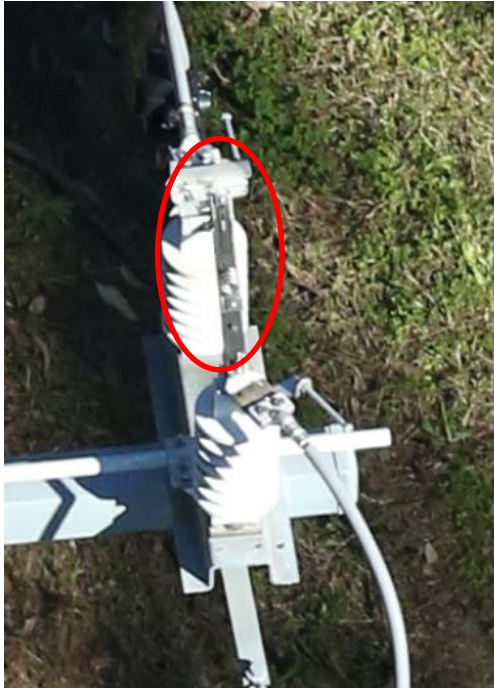
| Defect Description | Defect Photo | Task Details |
|---|---|---|
| <u>Arcing Horn - Broken or Missing</u> | | <u>Priority</u><br>SAP Priority 7<br>3 Months |

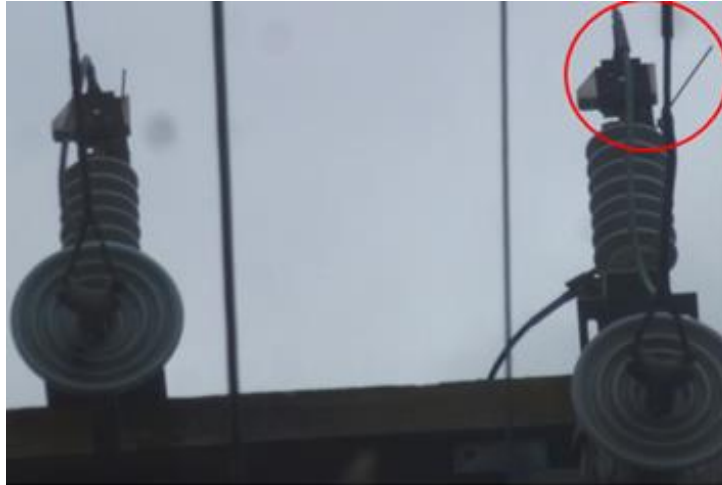
| Defect Description | Defect Photo | Task Details |
|---|---|---|
| <u>Arcing Horn - Out of Alignment</u> | | <u>Priority</u><br>SAP Priority 7<br>3 Months |

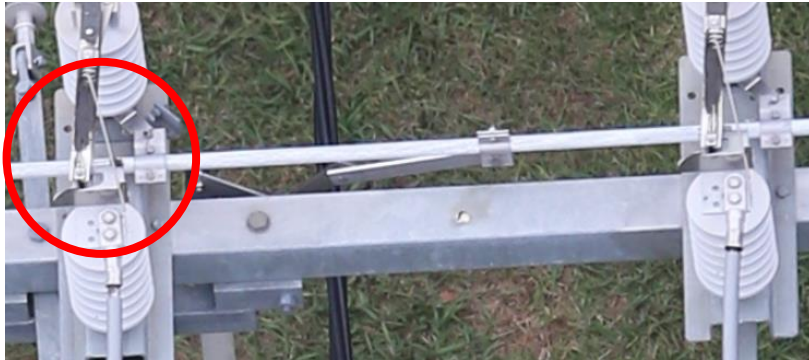
| Defect Description | Defect Photo | Task Details |
|---|---|---|
| <u>Main Contact (Blade) – Out of Alignment or Not Fully Closed</u> | | <u>Priority</u> |

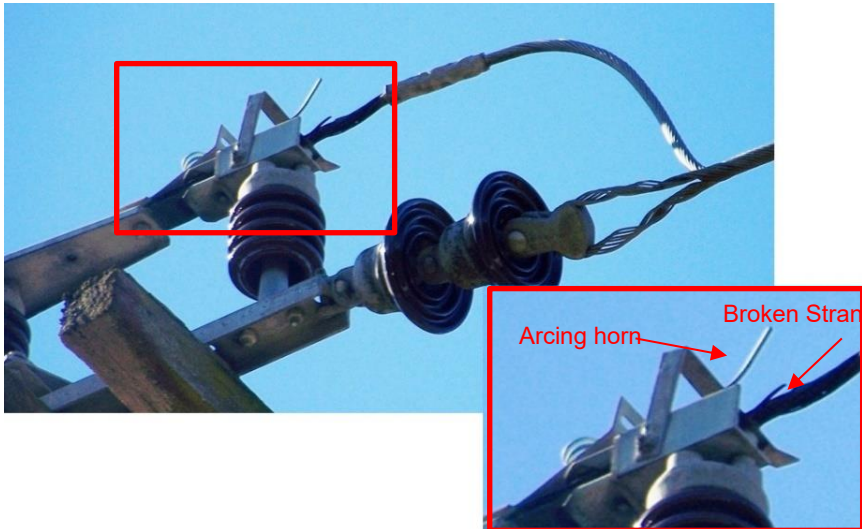
| Defect Description | Defect Photo | Task Details |
|---|---|---|
| <u>ABS Bond - Damaged</u> | | <u>Priority</u><br>SAP Priority 7<br>6 Months |

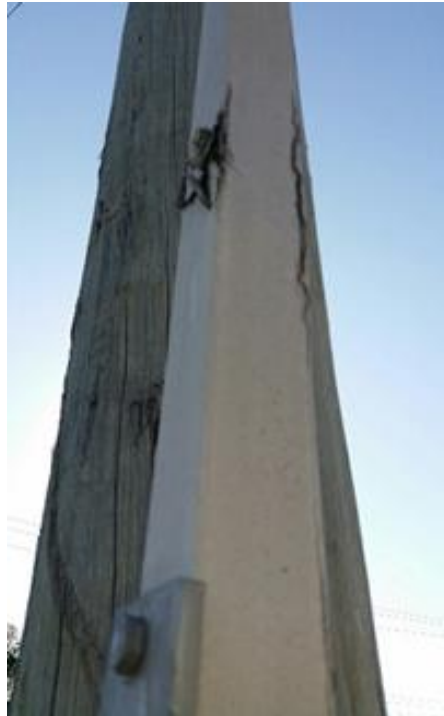
| Defect Description | Defect Photo | Task Details |
|---|---|---|
| <u>Down Rods - Broken, Warped or Damaged</u> | | <b><u>Priority</u></b><br><b>SAP Priority 7</b><br>3 Months |

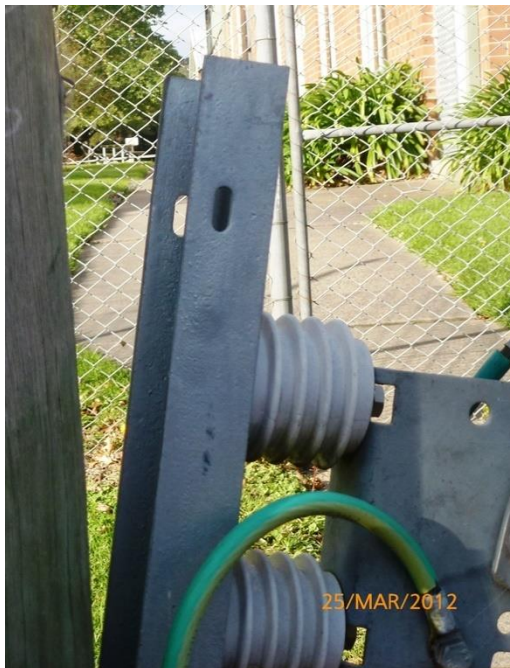
| Defect Description | Defect Photo | Task Details |
|---|---|---|
| <u>Operating Handle – Broken or Damaged</u> | | <u>Priority</u><br>SAP Priority 7<br>3 Months |

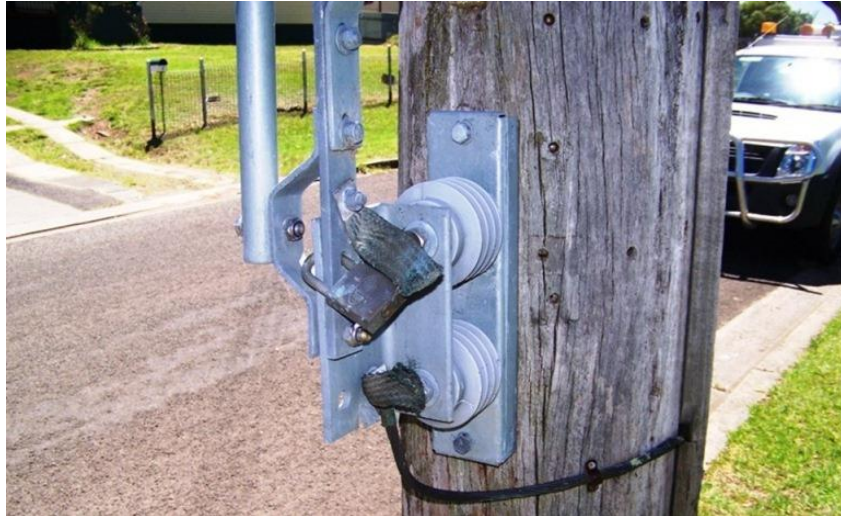
| Defect Description | Defect Photo | Task Details |
|---|---|---|
| <u>Operating Handle – Un-earthed</u> | | <u>Priority</u><br>SAP Priority 7<br>3 Months |

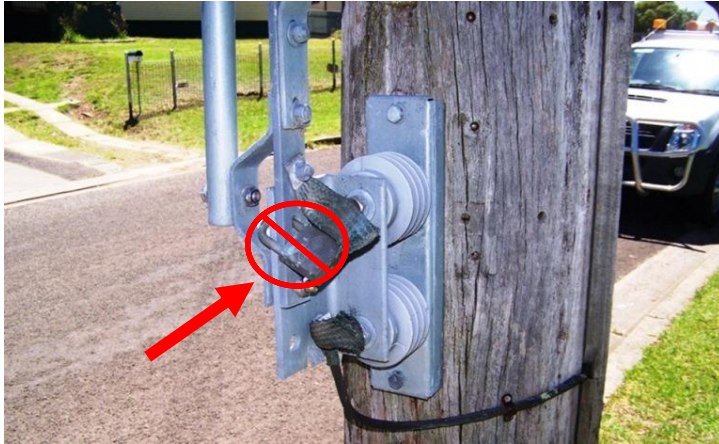
| Defect Description | Defect Photo | Task Details |
|---|---|---|
| <u>ABS Lock Device - Damaged or Missing</u> | | <u>Priority</u><br><b>SAP Priority 2</b><br>Immediate/48 hrs |

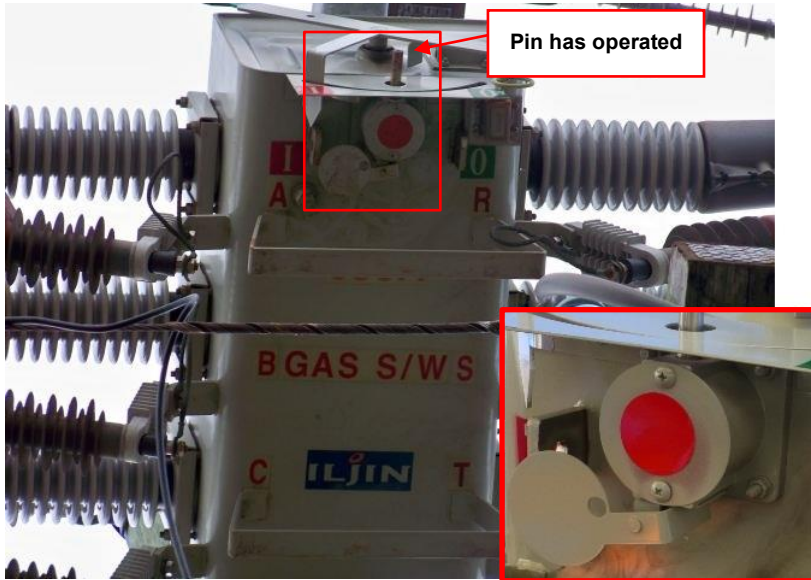
| <p><b><u>LBS Indicator – Low Gas</u></b></p> | | <p><b><u>Priority</u></b><br/><b>SAP Priority 7</b><br/>3 Months</p> |

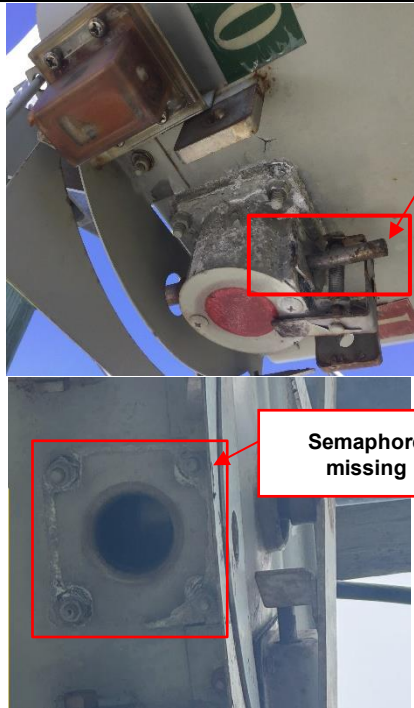
| <b><u>LBS Indicator Semaphore – Rusted or Missing</u></b> | | <b><u>Priority</u></b><br><b>SAP Priority 7</b><br>3 Months |

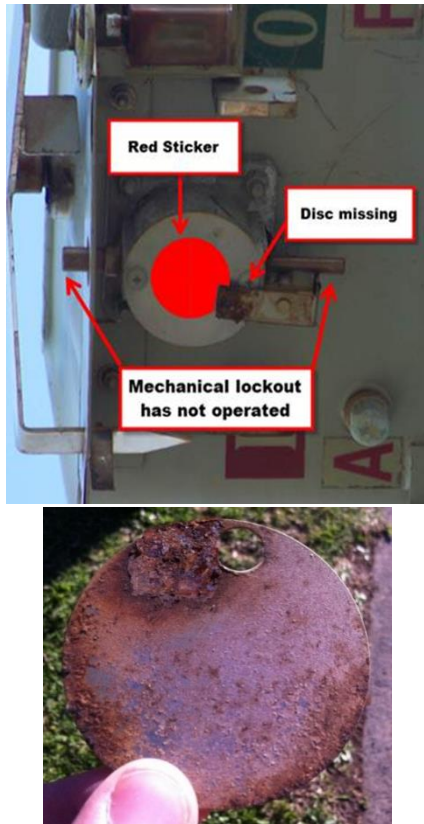
| Defect Description | Defect Photo | Task Details |
|---|---|---|
| <p><u>LBS Indicator Cover Plate - Rusted or Missing</u></p> | | <p><u>Priority</u><br/>SAP Priority 7<br/>6 Months</p> |

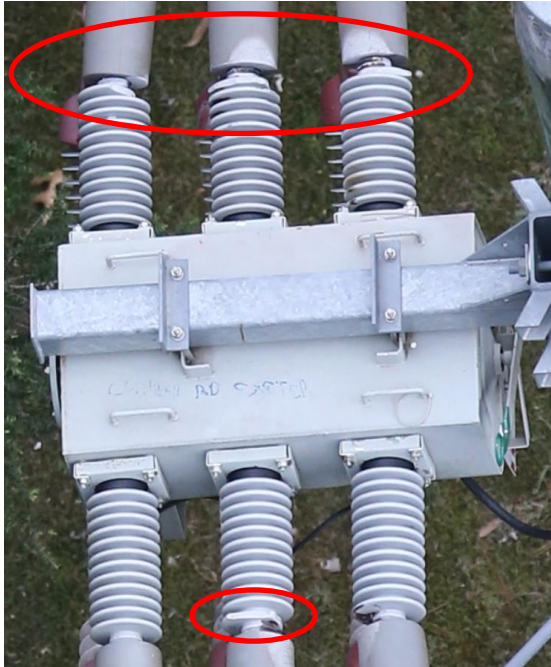
| Defect Description | Defect Photo | Task Details |
|---|---|---|
| <p><u>LBS Bushings - Damaged, Cracked or Chipped</u></p> | | <p><u>Priority</u><br/>SAP Priority 7<br/>3 Months</p> |

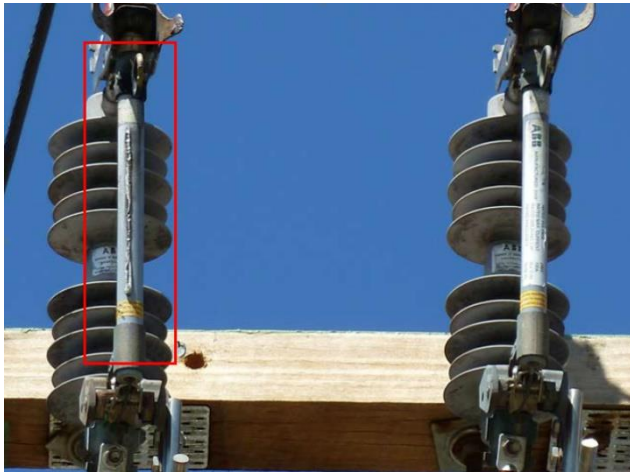
| Defect Description | Defect Photo | Task Details |
|---|---|---|
| <b><u>DOF Carrier - Damaged or Blown Fuse Link</u></b> | | <b><u>Priority</u></b><br><b>SAP Priority 7</b><br>6 Months |

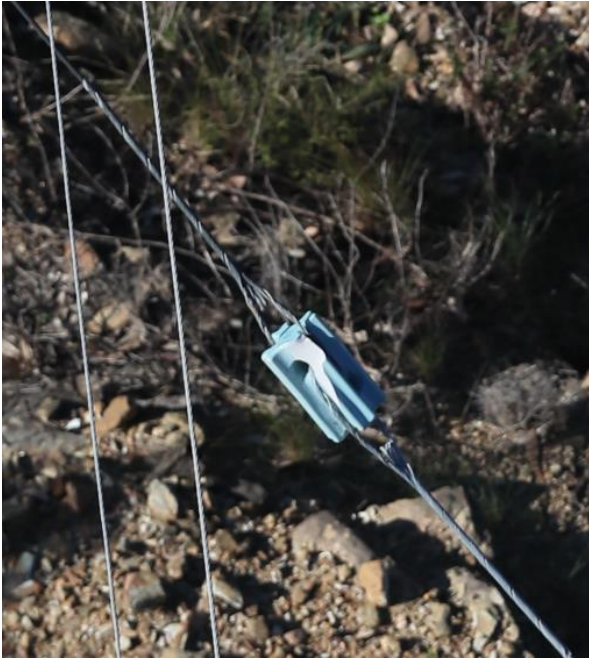
| Defect Description | Defect Photo | Task Details |
|---|---|---|
| <u>Stay Insulator – Damaged or Broken</u> | | <u>Priority</u><br>SAP Priority 7<br>6 Months |

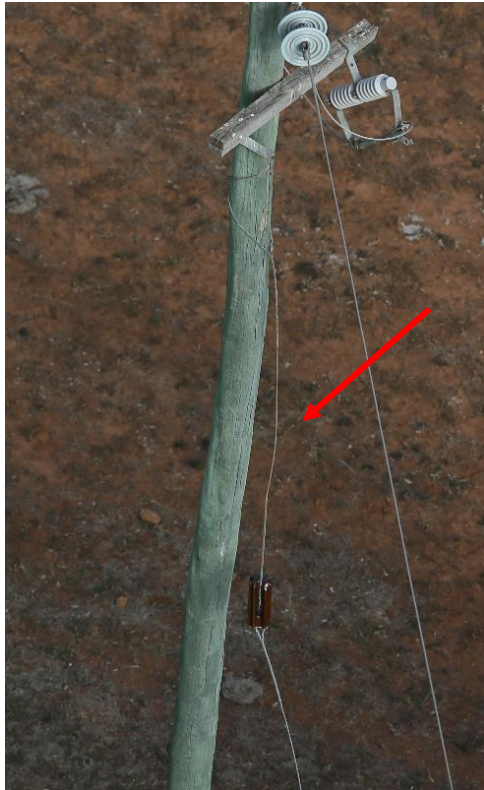
| Defect Description | Defect Photo | Task Details |
|---|---|---|
| <u>Stay Wire - Broken or Damaged</u> | | <u>Priority</u><br><b>SAP Priority 2</b><br>Immediate/48 hrs |

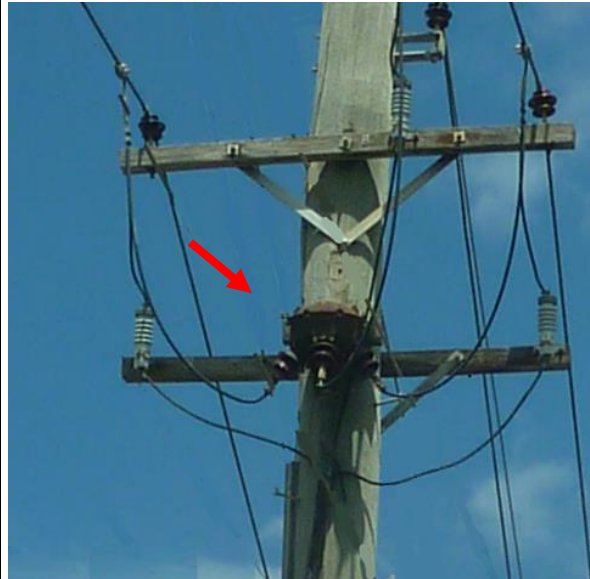
| Defect Description | Defect Photo | Task Details |
|---|---|---|
| <u>UGOH Pot head - Installed</u> | | <u>Priority</u><br>SAP Priority 8<br>12 Months |
