ENVIRONMENTAL MONITORING REPORT, AUGUST 2021

PARRAMATTA LIGHT RAIL INFRASTRUCTURE WORKS

30 August 2021

Parramatta
Connect

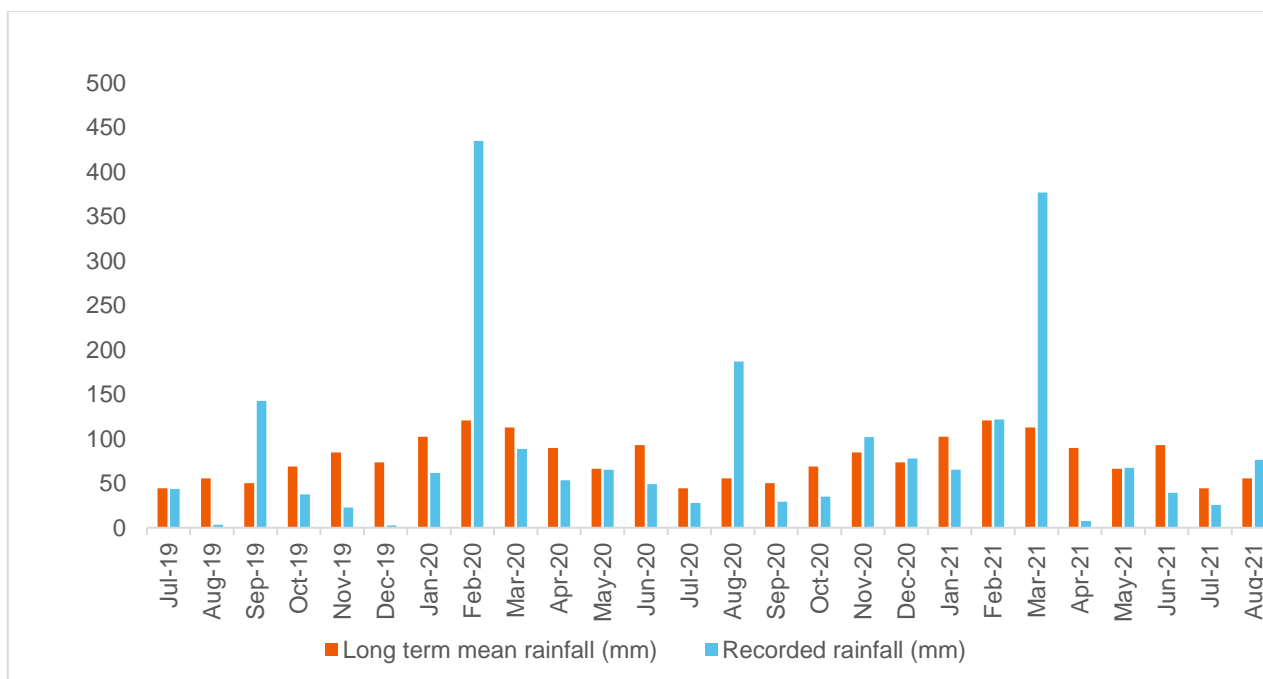
Figure 3-1 Monthly rainfall comparison

The total rainfall recorded during the reporting period was 76.4 mm with three days exceeding one millimetre of rain. Two events exceeded the 85th percentile (33.1mm).

A summary of the weather observations and weather events during the reporting period of relevance to the Soil and Water Management Sub-plan and Air Quality Management Sub-Plan Trigger Action Response Plans (TARPs) are summarised in **Table 7-2**. A comparison between long term monthly means and recorded values can be found in **Figure 3-2**.
