ENVIRONMENTAL MONITORING REPORT, FEBRUARY 2022

PARRAMATTA LIGHT RAIL INFRASTRUCTURE WORKS

28 February 2022

Project number	N81080
Document number	PLR1INF-CPBD-ALL-EN-RPT-0000033
Revision date	3 March 2022
Revision	1

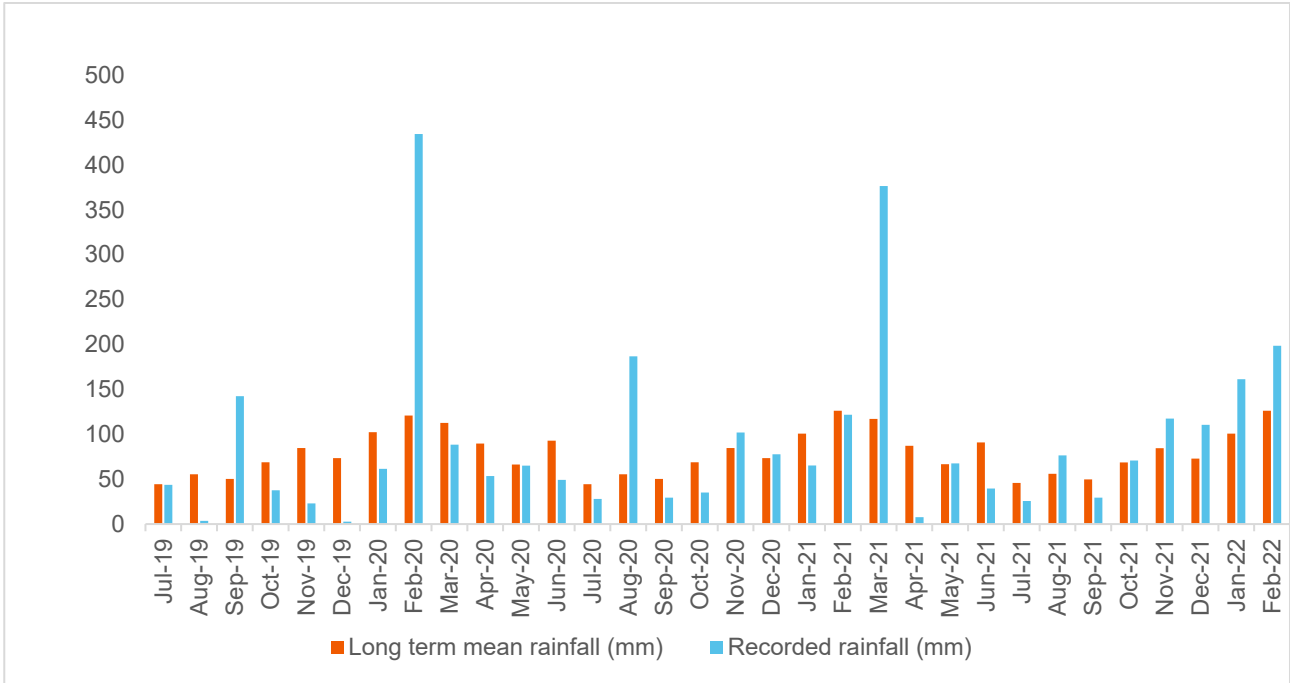
Figure 3-1 Monthly rainfall comparison

The total rainfall recorded during the reporting period was 198.6 mm with 14 days exceeding one millimetre of rain. One rain event exceeded the 85th percentile (33.1mm).

A summary of the weather observations and weather events during the reporting period of relevance to the Soil and Water Management Sub-plan and Air Quality Management Sub-Plan Trigger Action Response Plans (TARPs) are summarised in **Table 7-2**. A comparison between long term monthly means and recorded values can be found in **Figure 3-2**.
