ENVIRONMENTAL MONITORING REPORT, JUNE 2022

PARRAMATTA LIGHT RAIL INFRASTRUCTURE WORKS

4 July 2022

Parramatta
Connect

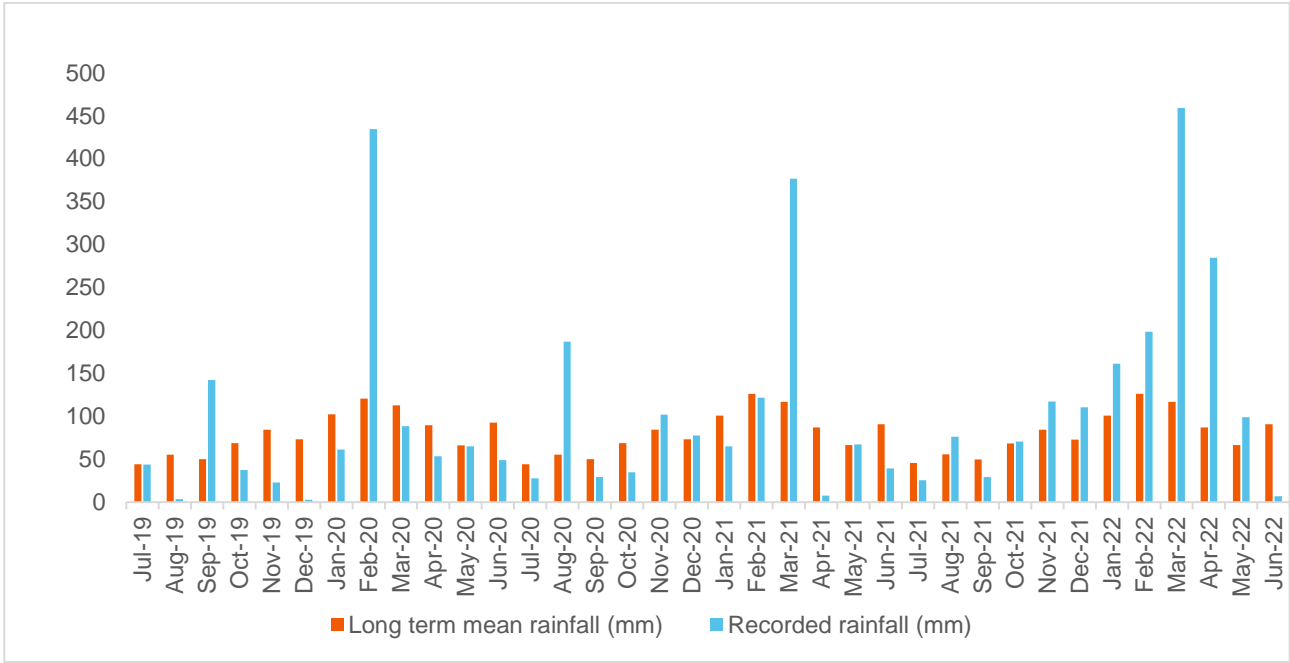
Figure 3-1 Monthly rainfall comparison

A summary of the weather observations and weather events during the reporting period of relevance to the Soil and Water Management Sub-plan and Air Quality Management Sub-plan Trigger Action Response Plans (TARPs) are summarised in **Table 7-2**. A comparison between long term monthly means and recorded values can be found in **Figure 3-2**.
