# ENVIRONMENTAL MONITORING REPORT, MARCH 2021

## PARRAMATTA LIGHT RAIL INFRASTRUCTURE WORKS

9 April 2021

<b>Project number</b>	<b>N81080</b>
<b>Document number</b>	PLR1INF-CPBD-ALL-EN-RPT-0000022
<b>Revision date</b>	9 April 2021
<b>Revision</b>	2

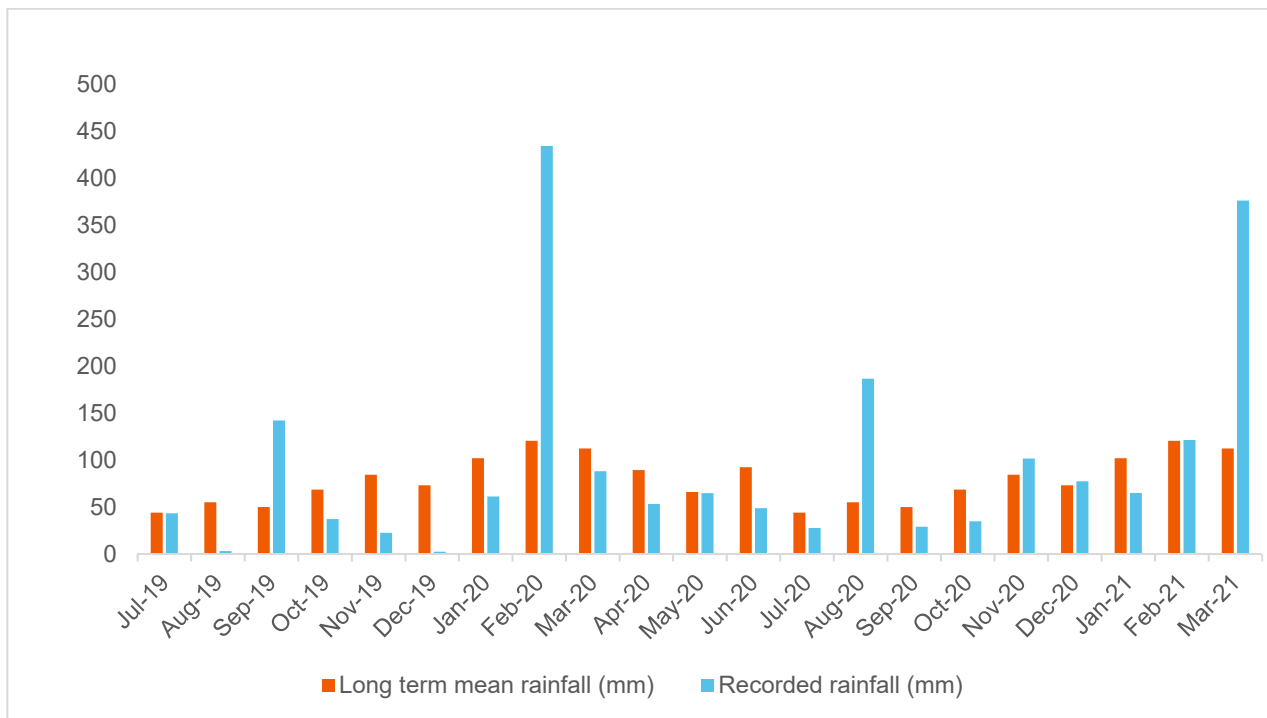
**Figure 3-1 Monthly rainfall comparison**

The total rainfall recorded during the reporting period was 376.6 mm with 14 days exceeding one millimetre of rain. Five rain events exceeded both the 80<sup>th</sup> percentile (25.8mm) and the 85<sup>th</sup> percentile (33.1mm).

A summary of the weather observations and weather events during the reporting period of relevance to the Soil and Water Management Sub-plan and Air Quality Management Sub-Plan Trigger Action Response Plans (TARPs) are summarised in **Table 7-2**. A comparison between long term monthly means and recorded values can be found in **Figure 3-2**.
