ENVIRONMENTAL MONITORING REPORT, MARCH 2022

PARRAMATTA LIGHT RAIL INFRASTRUCTURE WORKS

11 April 2022

Project number	N81080
Document number	PLR1INF-CPBD-ALL-EN-RPT-0000034
Revision date	11 April 2022
Revision	2

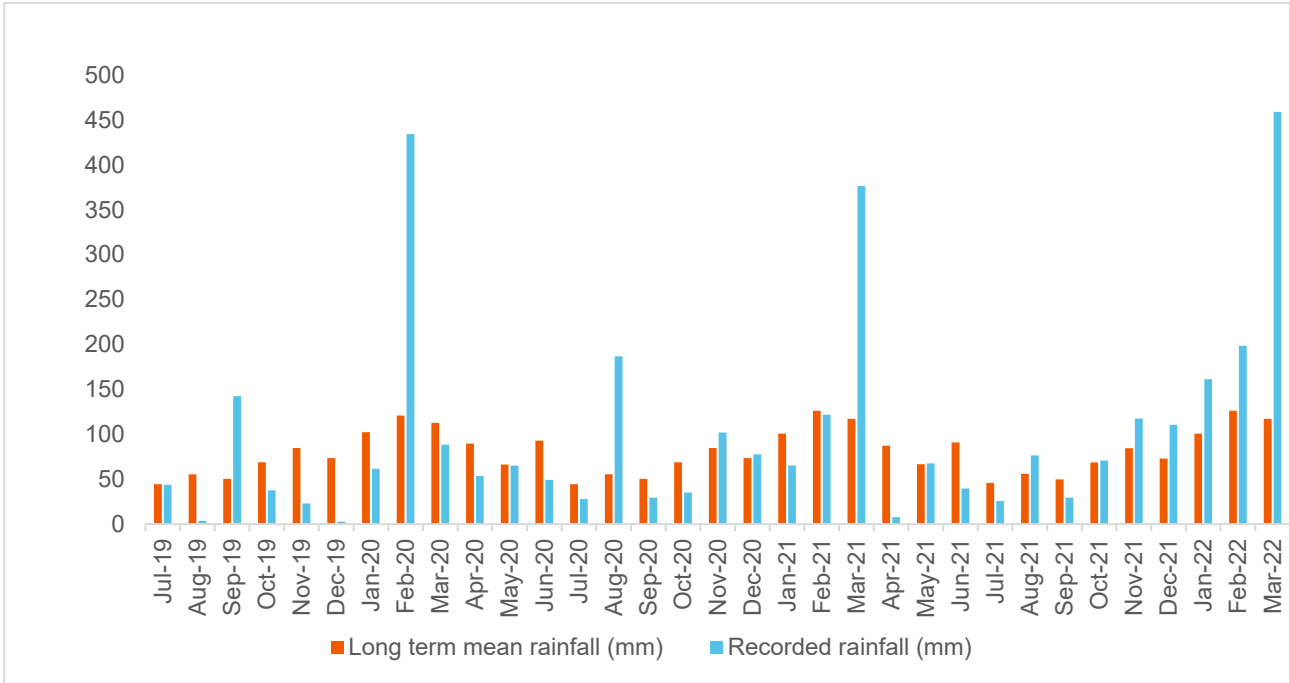
Figure 3-1 Monthly rainfall comparison

A summary of the weather observations and weather events during the reporting period of relevance to the Soil and Water Management Sub-plan and Air Quality Management Sub-Plan Trigger Action Response Plans (TARPs) are summarised in **Table 7-2**. A comparison between long term monthly means and recorded values can be found in **Figure 3-2**.
