# ENVIRONMENTAL MONITORING REPORT, OCTOBER 2021

## PARRAMATTA LIGHT RAIL INFRASTRUCTURE WORKS

5 November 2021

<b>Project number</b>	<b>N81080</b>
<b>Document number</b>	PLR1INF-CPBD-ALL-EN-RPT-0000029
<b>Revision date</b>	5 November 2021
<b>Revision</b>	1

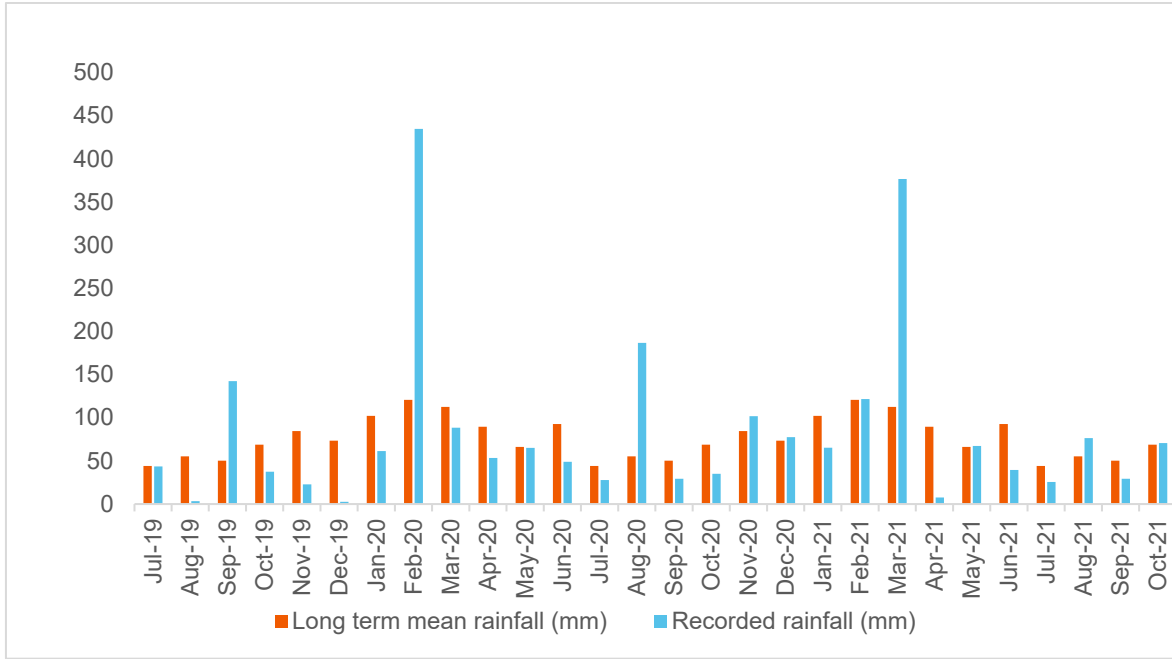
**Figure 3-1 Monthly rainfall comparison**

The total rainfall recorded during the reporting period was 70.6 mm with 11 days exceeding one millimetre of rain. No events exceeded the 80<sup>th</sup> percentile (25.8mm).

A summary of the weather observations and weather events during the reporting period of relevance to the Soil and Water Management Sub-plan and Air Quality Management Sub-Plan Trigger Action Response Plans (TARPs) are summarised in **Table 7-2**. A comparison between long term monthly means and recorded values can be found in **Figure 3-2**.
