Construction Monitoring Report September 2020 – February 2021

Sydney Metro City & Southwest – Line-wide Works

Contract Number:	C600
Systems Connect Number	N21063
Document number:	SMCSWLWC-SYC-CSW-EM-REP-007401
Revision date:	21/06/2021
Revision:	1

Sydney Metro Line Wide Works - BPS Campsie Anzac Street Vibration Monitoring Results

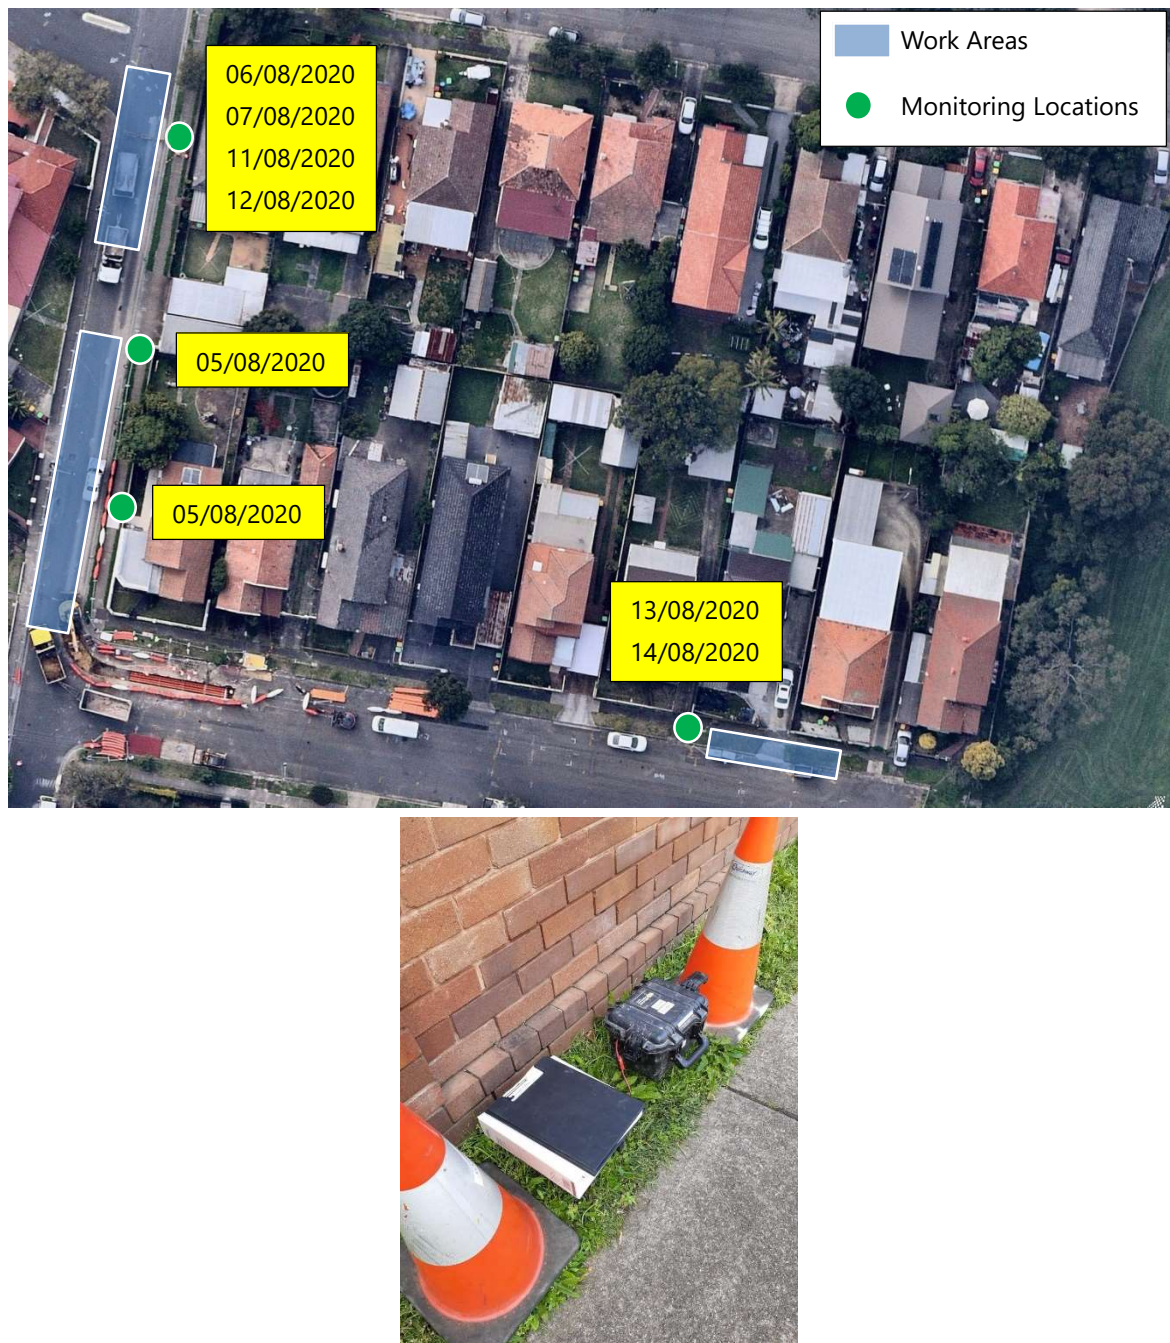
Figure 1 - Monitoring location during BPS works

Attended vibration monitoring was undertaken on the 5th, 6th, 7th, 11th, 12th, 13th and 14th of August 2020 at Anzac Street, Canterbury. Vibration monitoring was conducted with a Sigicom INFRA C12 vibration monitor (s/n 66890) with SMS alerts set up in accordance with the vibration monitoring plan.

Note: Top: aerial photo of monitoring locations and work areas; Bottom: site photo of monitoring location

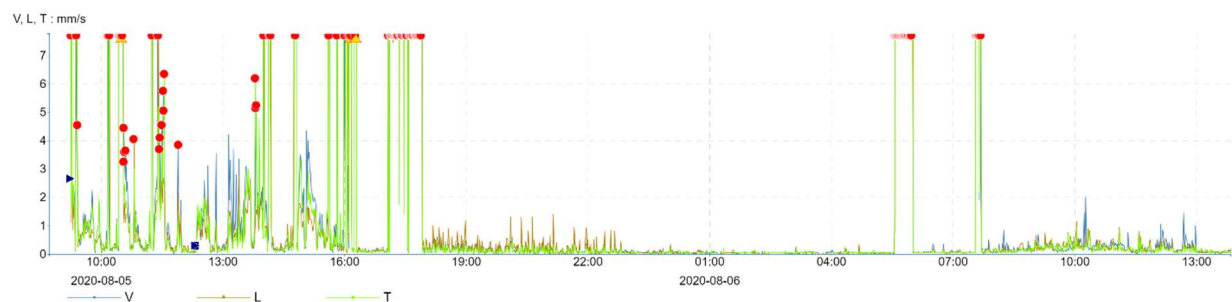
Figure 2 - Monitoring results on the 5th and 6th of August during Anzac Street BPS construction works

Note: Red dot ● indicates SMS alert sent based on trigger set at 7.5 mm/s

The red dots in the figures above represent exceedance of the trigger levels for SMS alerts. All incidents were promptly investigated. It was found that all were not related to the construction activities (e.g. someone nudging the monitor by mistake, a surveyor dropping books near the monitor by mistake or removing/ installing the monitor at the beginning or end of the shift without turning the monitor off).

Therefore, results of the vibration monitoring indicated that vibration generated by construction activities was below the relevant vibration criteria that was established in the *Campsie CVMP*.

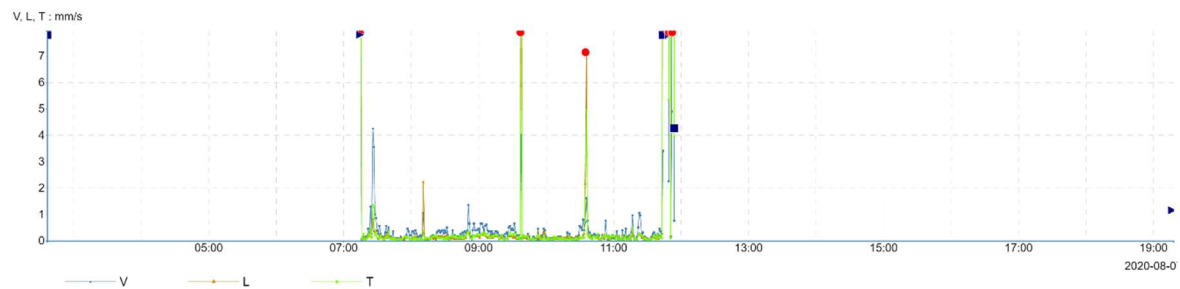
Figure 3 - Monitoring results on the 7th of August during Anzac Street BPS construction works

Note: Red dot ● indicates SMS alert sent based on trigger set at 7.5 mm/s

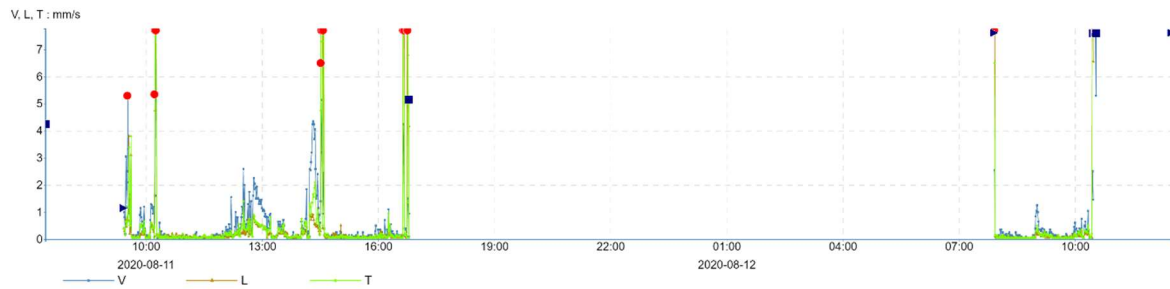
Figure 4 - Monitoring results on the 11th and 12th of August during Anzac Street construction works

Note: Red dot ● indicates SMS alert sent based on trigger set at 7.5 mm/s

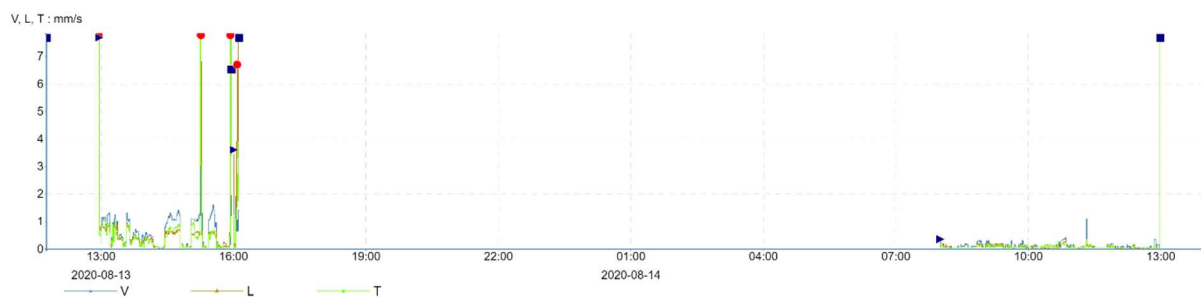
Figure 5 - Monitoring results on the 13th and 14th of August during Anzac Street construction works

Note: Red dot ● indicates SMS alert sent based on trigger set at 7.5 mm/s

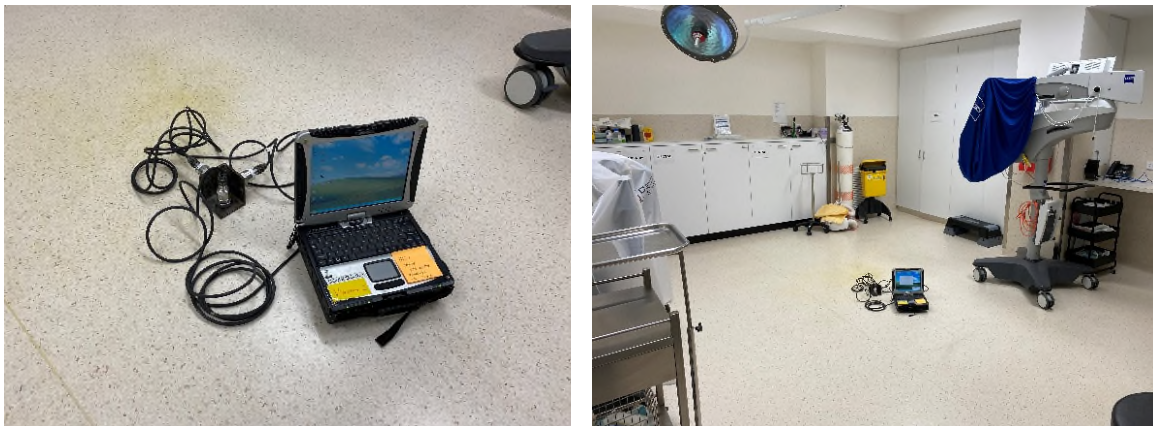
**Figure 2: Instrumentation set up – Day surgery theatre, 22 Clarke Street, Crows Nest**
