# Construction Monitoring Report September 2023 – February 2024

## Sydney Metro City & Southwest – Line-wide Works

Contract Number:	C600
Systems Connect Number:	N21063
Document number:	SMCSWLWC-SYC-CSW-EM-REP-023196
Revision date:	9/05/2024
Revision:	2

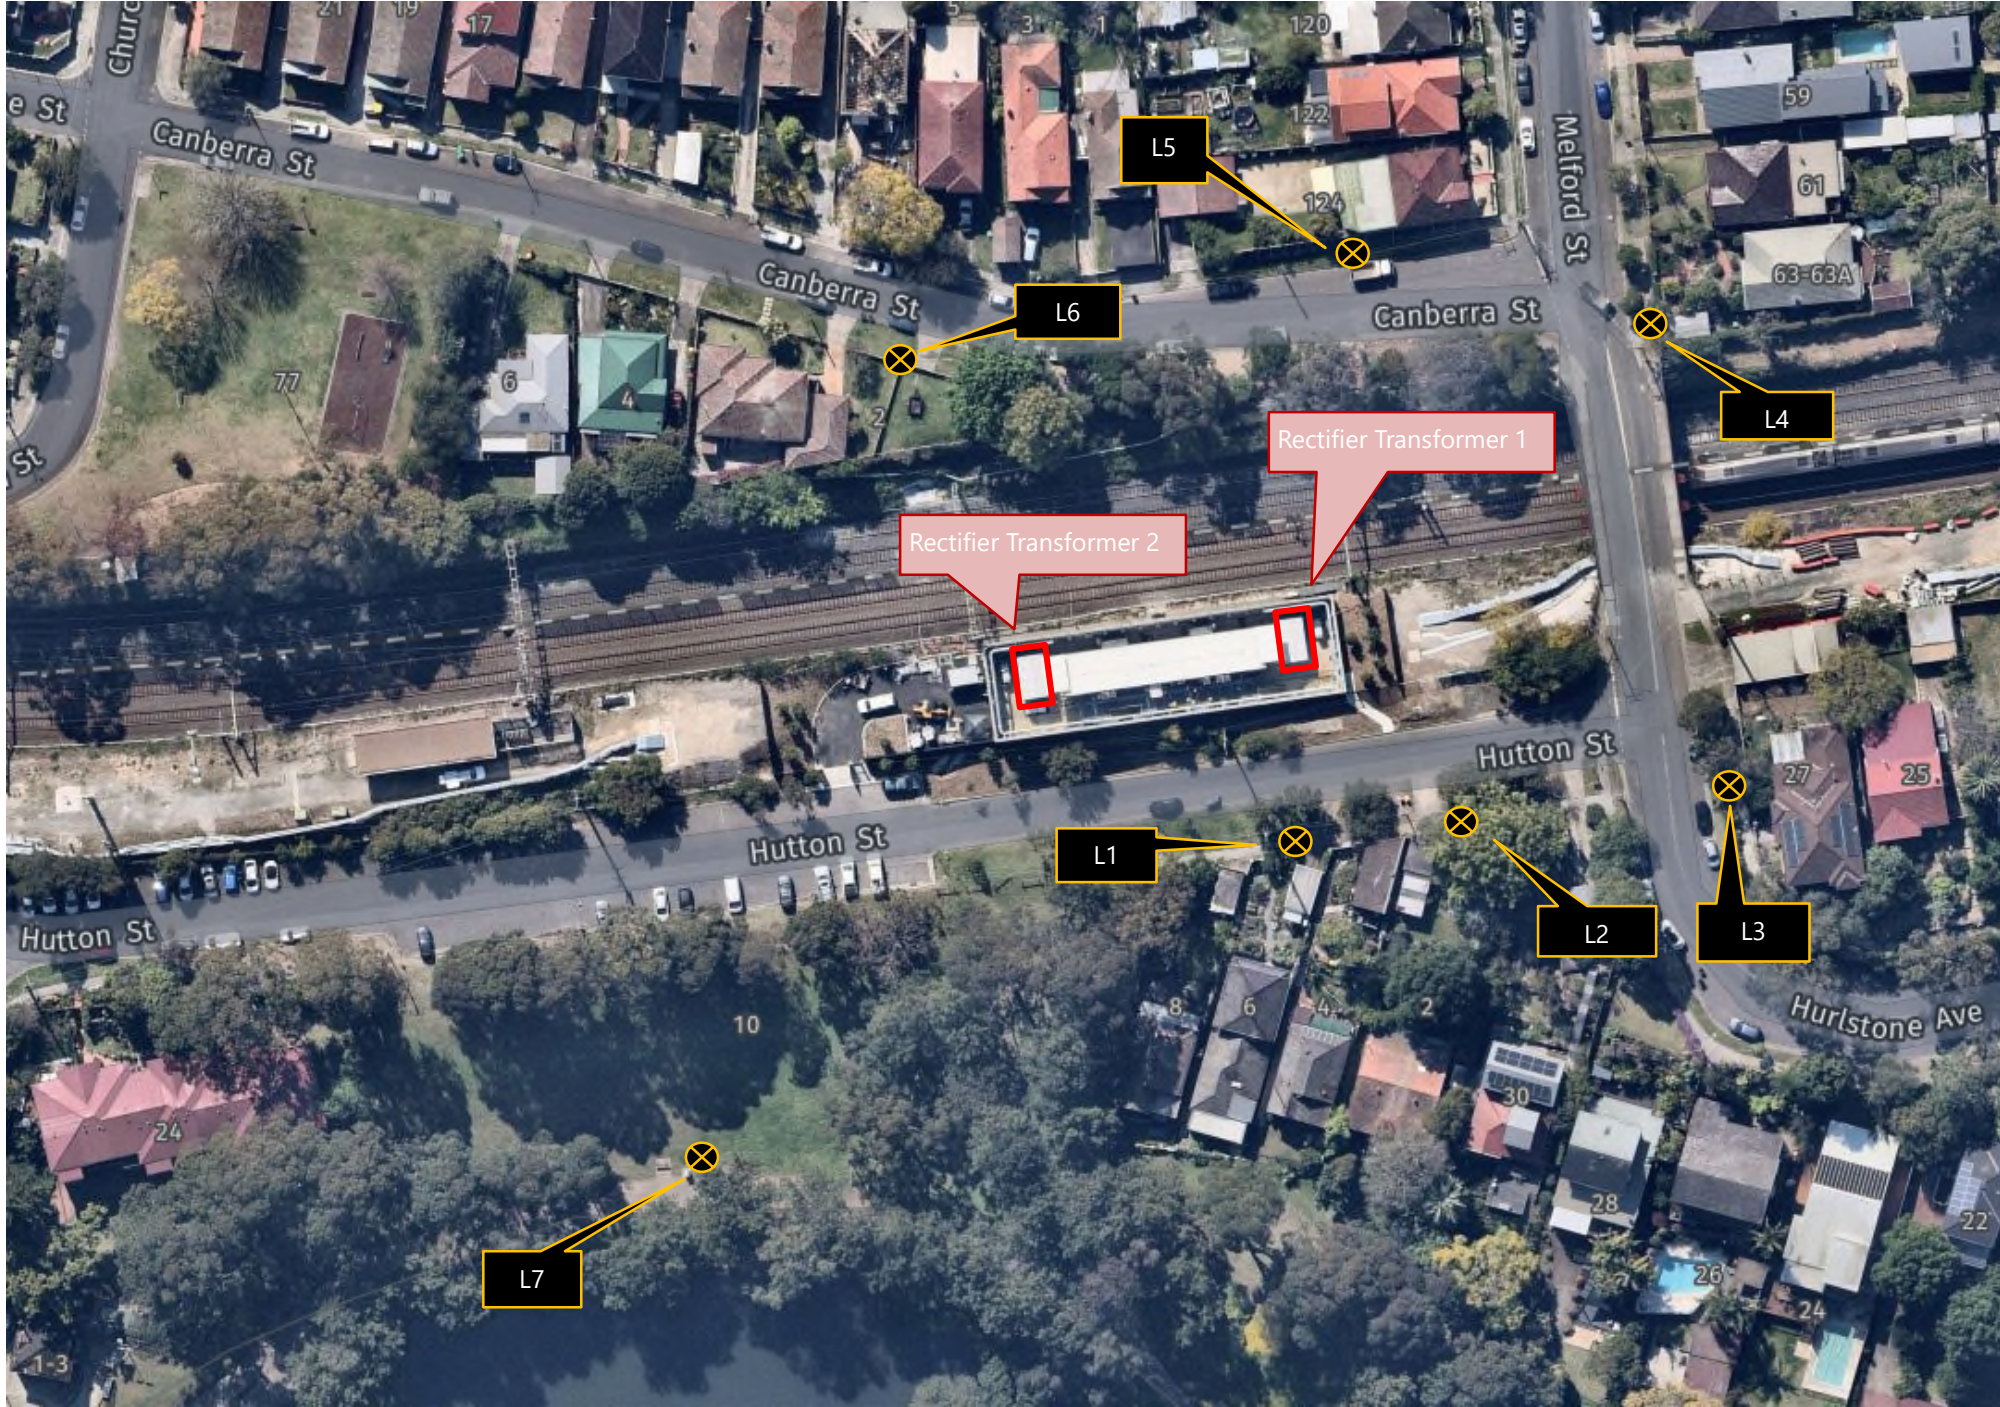
Figure 1: TCR noise monitoring locations

L7	Boat Harbour	Passive recreation area to the south-west of the Canterbury Substation. The monitoring was conducted in a free-field location on the footpath that runs along the banks of Cooks River.

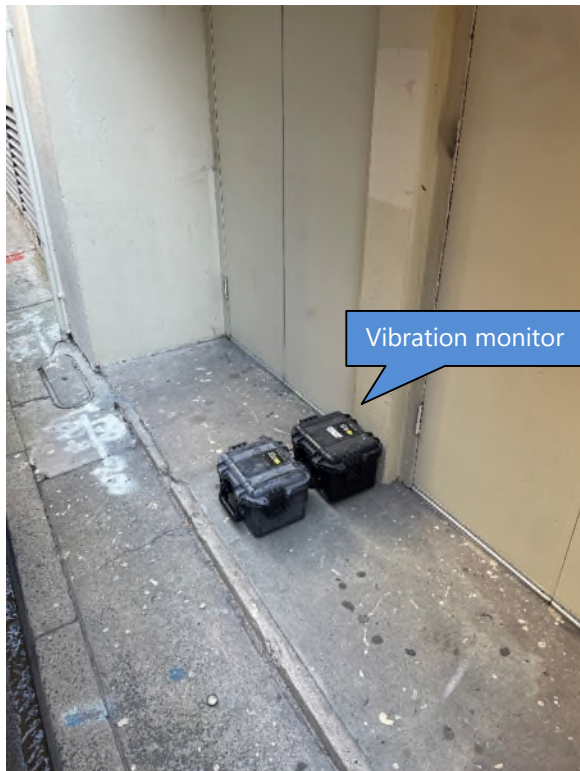
Figure 2.2: Instrumentation set up

The triaxial transducers used in the measurements have current calibration certificates.

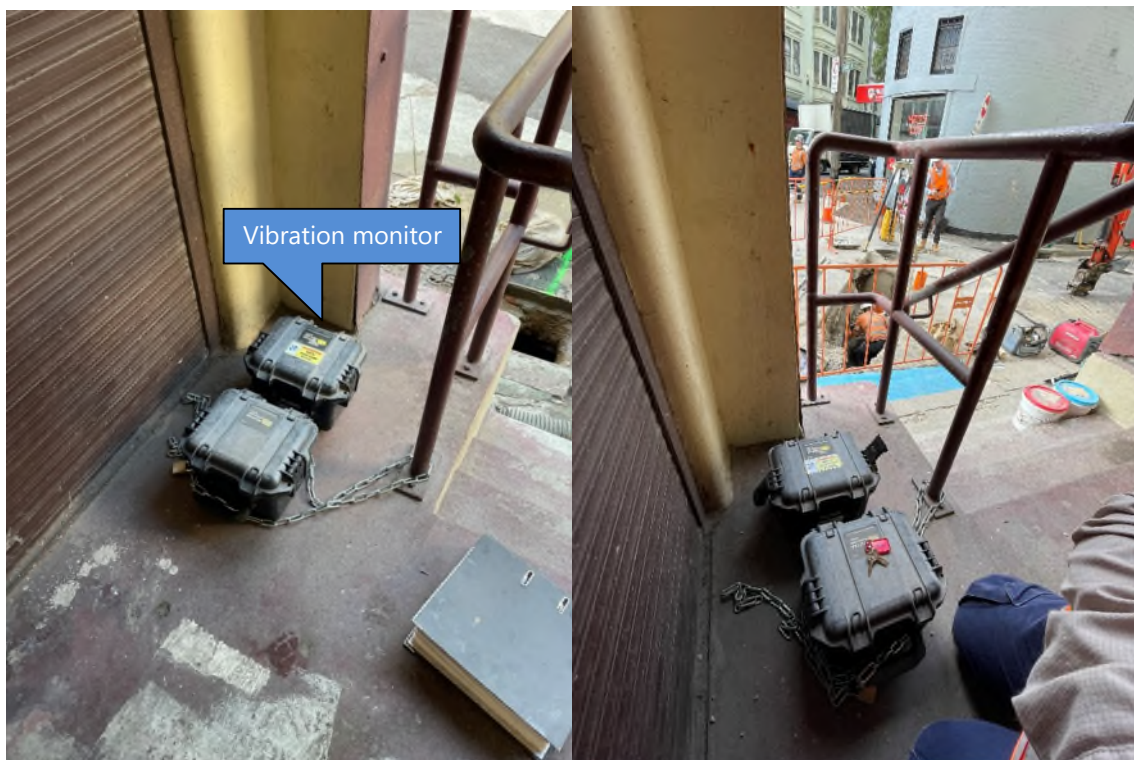
Figure 2.2: Instrumentation set up

The triaxial transducers used in the measurements have current calibration certificates.

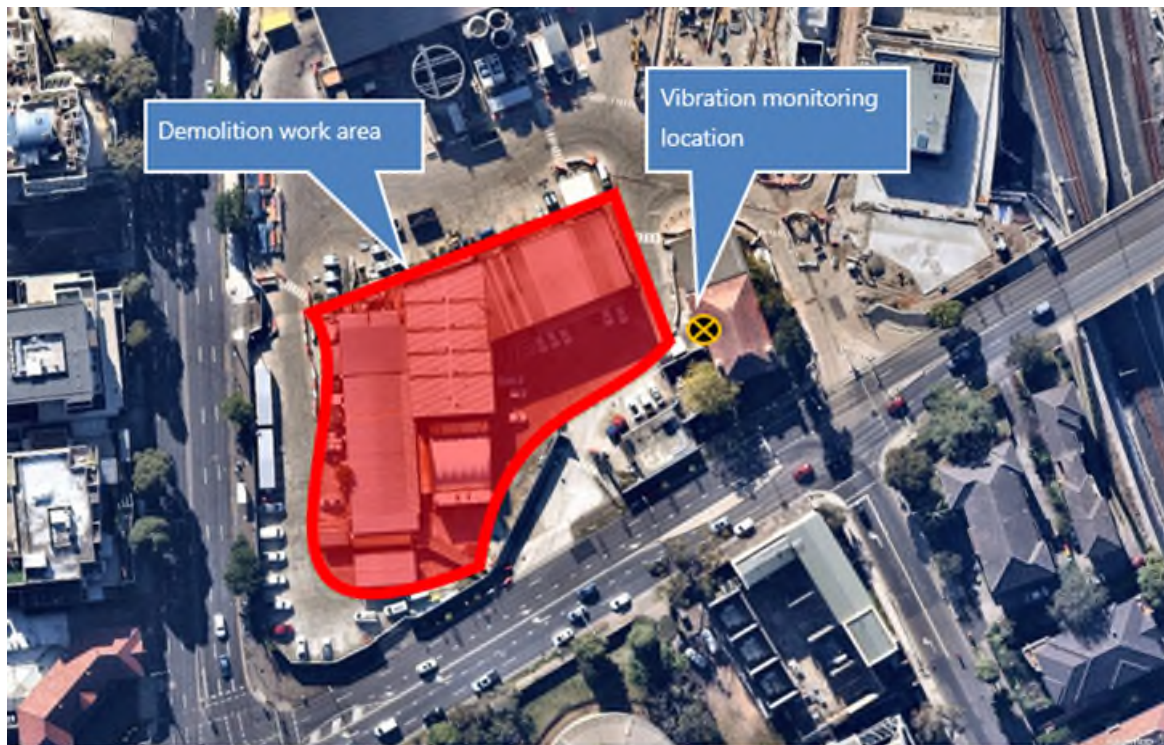
Figure 2.1: Vibration monitoring location

Measurement ID	Assessment Point	Date and time	Measured plant	Monitoring type	Approx. distance to measured plant
M1	Mowbray Road House, Chatswood	07:15am 25.09.2023 – 11:31am 04.10.2023	24t & 35t excavator (with grapple, crusher and ripper boot attachments), dump truck, skid steer, EWP and delivery trucks	Vibration	10-75m

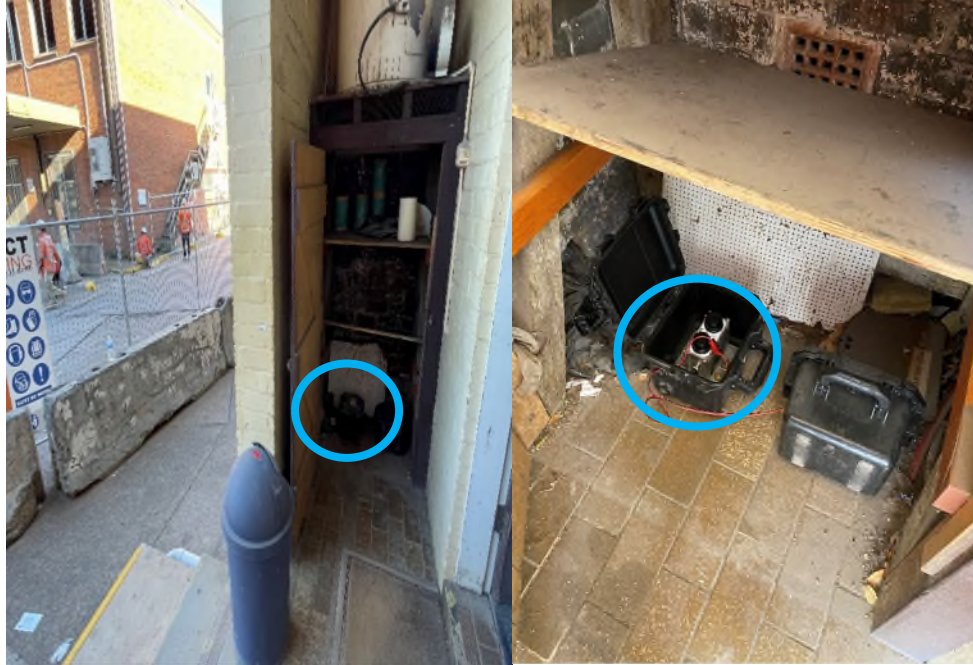
### A.1      Vibration monitor setup

The vibration monitor was installed as close as possible to the foundation of Mowbray Road House. For monitoring on hard surfaces, in accordance with AS 2775-2004<sup>1</sup>, the surface was brushed to displace any loose dirt and the monitor was attached to the surface using double sided adhesive tape. The vibration monitoring setup is shown in APPENDIX A.
