Report on
Detailed Site Investigation (Contamination)

Surface & Civil Alignment Works (SCAW) Package for
Sydney Metro - Western Sydney Airport (SMWSA)
Area of Environmental Concern (AEC) 30, 22-26
Lansdowne Road, Orchard Hills

Project 204814.01
May 2023

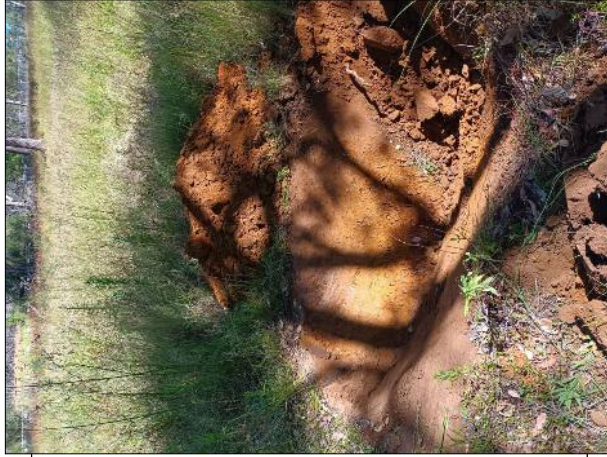
0.80m	EXCAVATION AEC30TP01 TERMINATED AT 0.80 m Target depth					
				1.0

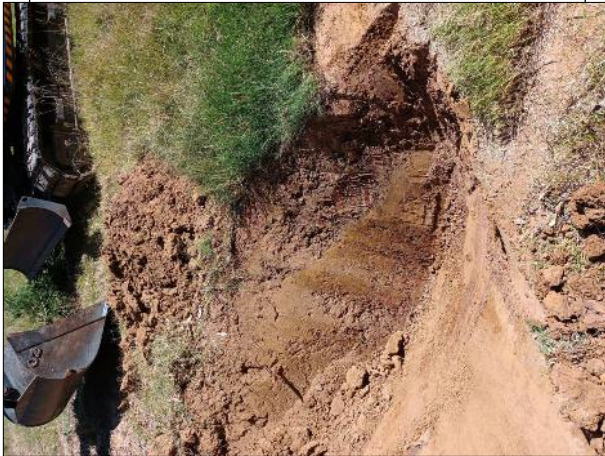
1.20m ES 1.30m	1.0		CI-CH		w<PL	St to VSt		1.20: HP =210 kPa 1.20: PID<5
							1.30m			EXCAVATION AEC30TP03 TERMINATED AT 1.30 m Target depth

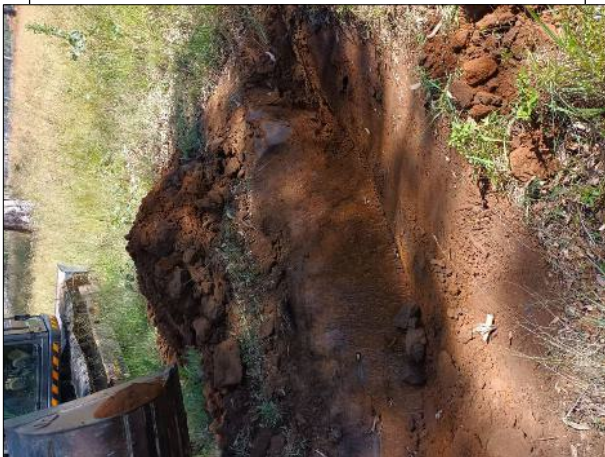
0.5		CI-CH				
				1.0			EXCAVATION AEC30TP04 TERMINATED AT 0.90 m Target depth			
				1.5

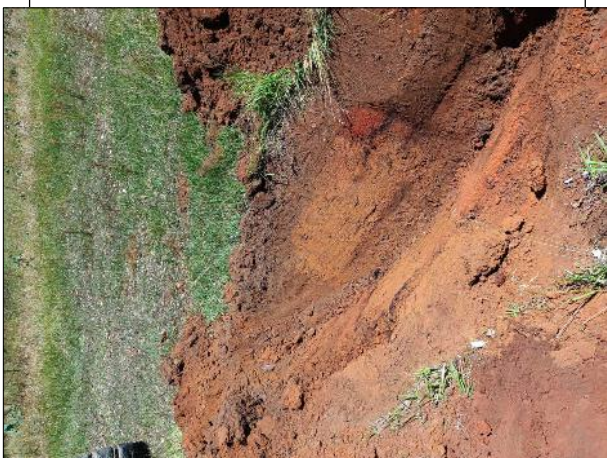
0.60m ES 0.70m	0.5						w<PL	St to VSt	X	0.60: HP =210 kPa 0.60: PID<5
					1.0			EXCAVATION AEC30TP05 TERMINATED AT 0.80 m Target depth

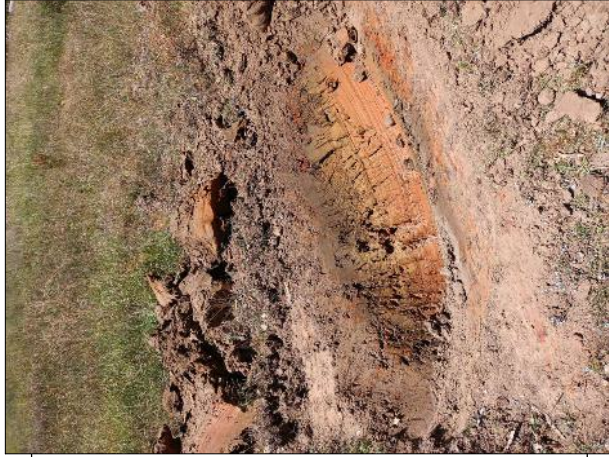
0.80m			EXCAVATION AEC30TP08 TERMINATED AT 0.80 m Target depth				
				1.0

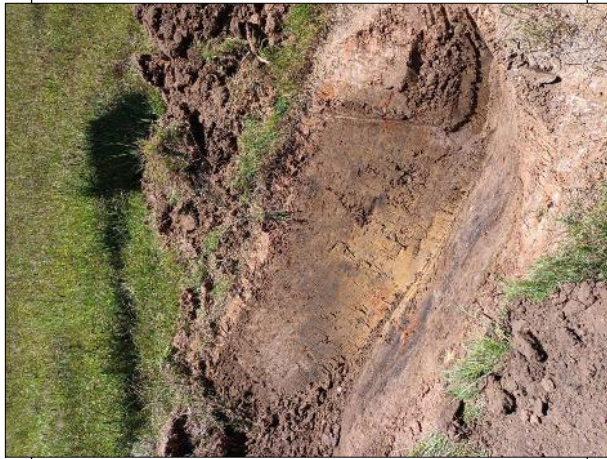
1.00m ES 1.10m	1.0			EXCAVATION AEC30TP09 TERMINATED AT 1.10 m Target depth			X	1.00: HP =240 kPa 1.00: PID<5					
				1.5

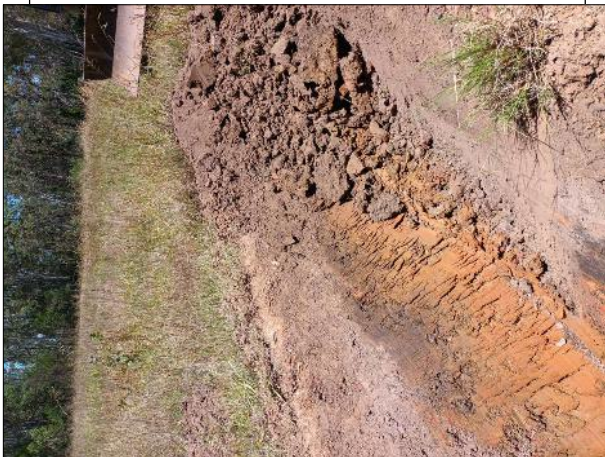
CI-CH	Silty CLAY: medium to high plasticity, red-brown, trace fine to medium ironstone gravel	w<PL	St to VSt	X			
				0.90m ES 1.00m	0.90m			EXCAVATION AEC30TP11 TERMINATED AT 0.90 m Target depth			X

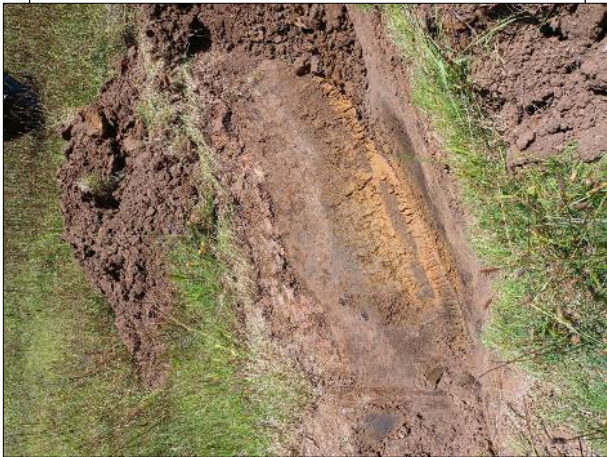
1.10m ES	1.0		CI-CH				X	1.00: HP =230 kPa 1.00: PID<5
											EXCAVATION AEC30TP14 TERMINATED AT 1.10 m Target depth				
								1.5

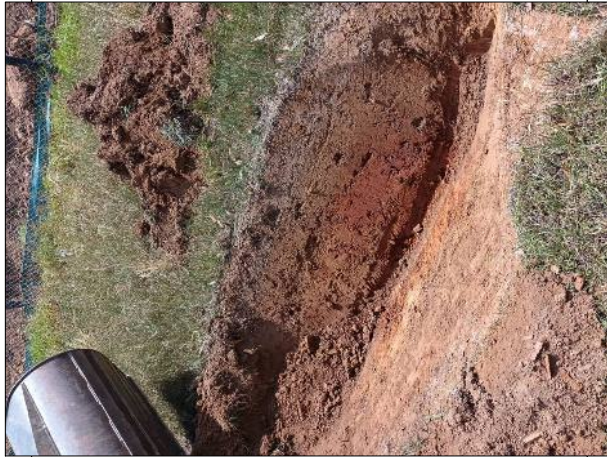
0.80m ES 0.90m	0.5		CI-CH	At 0.7m: grading to dark red-brown			✗	0.80: HP ≈180 kPa 0.80: PID<5
							1.0			EXCAVATION AEC30TP21 TERMINATED AT 1.00 m Target depth

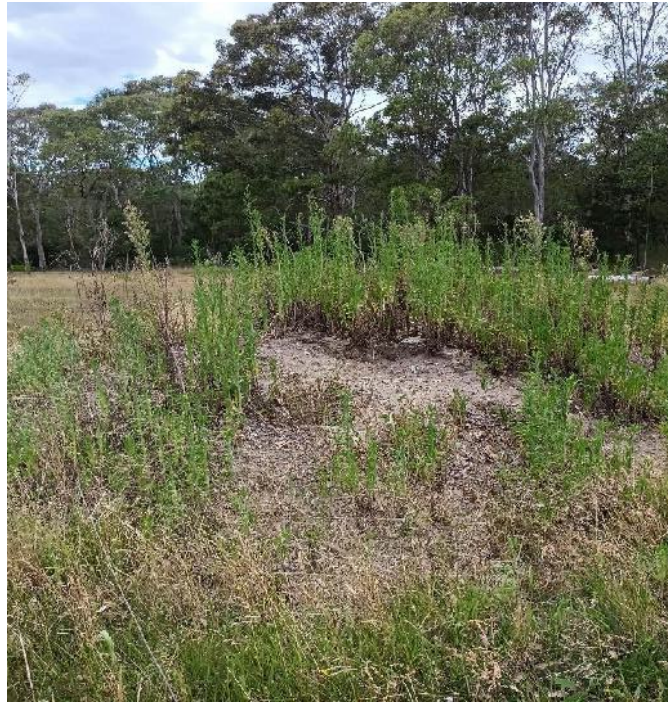
Photograph 1 - Stockpile AEC30SP1 (15 December 2022)

On 15 December 2022, two stockpiles (AEC30SP1 and AEC30SP2) were identified at the locations shown in Drawing AEC30-1, Appendix A. AEC30SP1 was observed to be approximately 11.25 m³ and AECSP2 was observed to be approximately 2.25 m³. Each stockpile was observed to comprise grey sand with rootlets and gravel (i.e., similar material). Stockpile sampling was undertaken on 15 December 2022 and 17 January 2023. On 17 January 2023, stockpile AECSP2 was observed to be covered in tiles which had been placed over the stockpile. DP has not been provided any additional

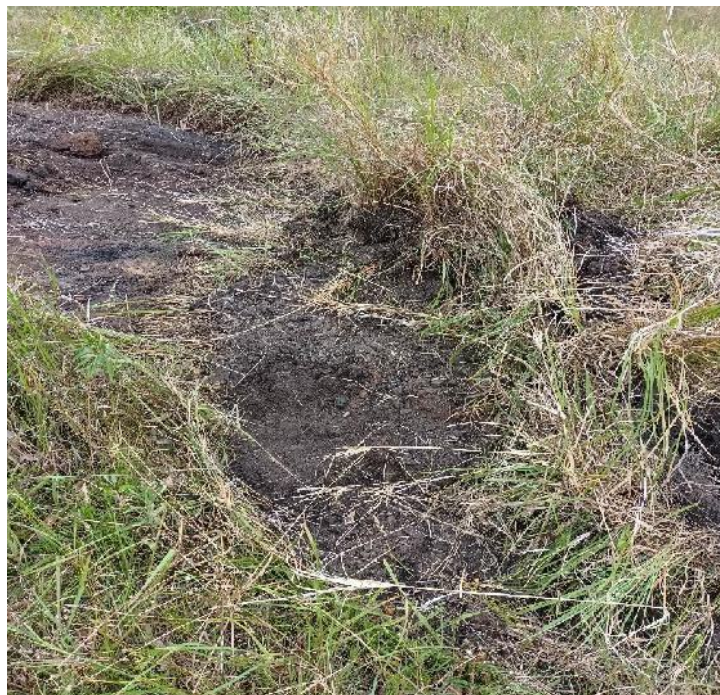
Photograph 2 - Stockpile AEC30SP2 (15 December 2022)

Exceedances of EIL were noted in stockpile sample AEC30SP2 for arsenic (300 mg/kg) exceeding the EIL of 100 mg/kg and copper (370 mg/kg) exceeding the EIL of 190 mg/kg.

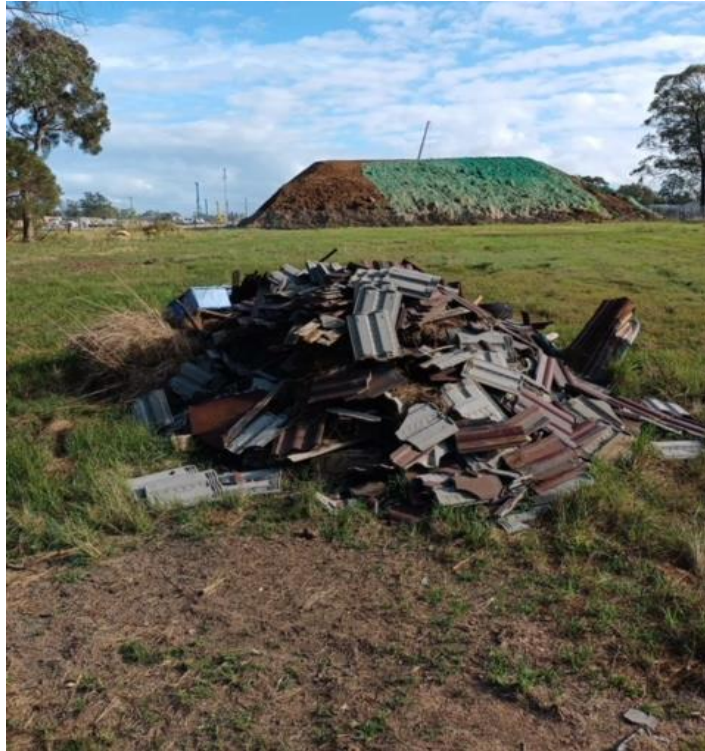
Photograph 3 - Stockpile AEC30SP2 (17 January 2023)

information about where the tiles came from or who placed them on the stockpiles. No potential asbestos-containing material was observed. Photographs of stockpiles on both dates are provided in Appendix J.

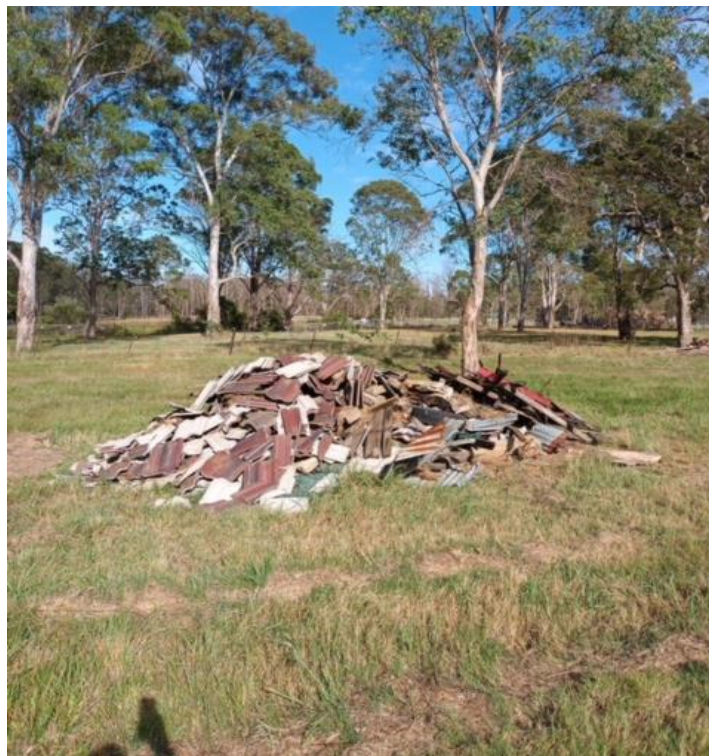
Photograph 4 - Stockpile AEC30SP2 (17 January 2023)
