Report on
Detailed Site Investigation (Contamination)

Surface & Civil Alignment Works (SCAW) Package for
Sydney Metro - Western Sydney Airport (SMWSA)
Area of Environmental Concern (AEC) 34,
43B Luddenham Road, Orchard Hills

Project 204814.01
June 2023

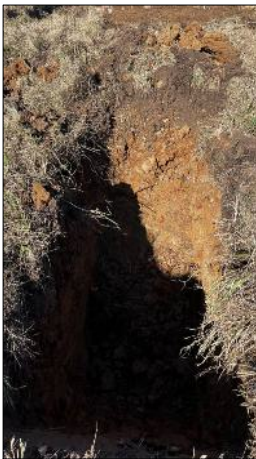
1.20m ES 1.30m		0.5		CI-CH	At 0.8m: pale grey and red-orange	w<PL	St		RESIDUAL SOIL	
						1.0								0.50: PID=1.2
						1.5		CL-CI	Silty CLAY: low to medium plasticity, pale grey and yellow, with extremely weathered sandstone	w<PL	VSt		1.20: PID=2.5

1.70m			EXCAVATION AEC34TP01 TERMINATED AT 1.70 m Target depth				
							2.0

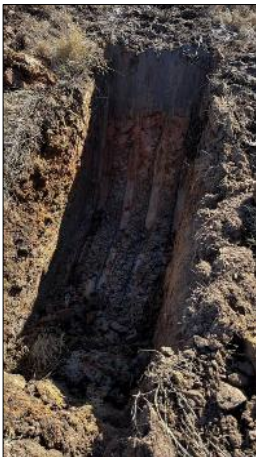
0.50m ES 0.60m	0.5		CH		w<PL	St	300	0.50: PID=2.5
														400	
							1.20m ES 1.30m	1.0		CL-CI	Silty CLAY: low to medium plasticity, pale grey, orange and yellow, with extremely weathered ironstone and rootlets	w<PL	VSt		1.20: PID=1.6

1.5			EXCAVATION AEC34TP02 TERMINATED AT 1.50 m Target depth

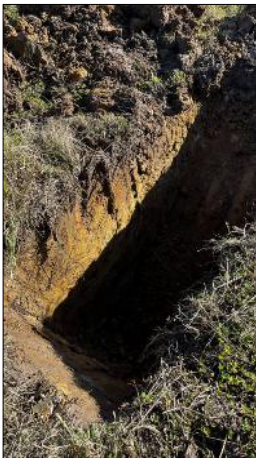
1.60m ES 1.70m	1.5		CL	At 1.4m: pale grey, yellow and red-orange, extremely weathered ironstone gravel	w<PL	St - VSt		1.60: PID=0.9		
					2.0			EXCAVATION AEC34TP03 TERMINATED AT 2.00 m Target depth

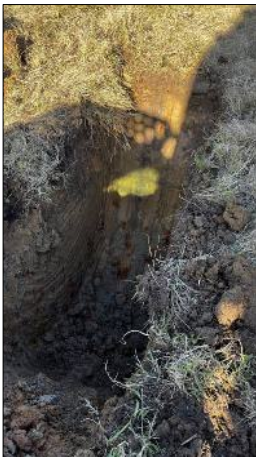
0.90m				0.0-0.1 depth	
					Not Observed					Silty CLAY: medium to high plasticity, pale grey, orange and yellow, with extremely weathered ironstone gravel				RESIDUAL SOIL

1.10m	1.0		CI-CH		w<PL	VSt		0.50: PID=1.8	
						ES 1.20m								1.10: PID=1.1	
							1.5			1.50m					
										EXCAVATION AEC34TP06 TERMINATED AT 1.50 m Target depth
