Report on
Detailed Site Investigation (Contamination)

Surface & Civil Alignment Works (SCAW) Package for
Sydney Metro - Western Sydney Airport (SMWSA)
Area of Environmental Concern (AEC) 40,
Luddenham Road, Orchard Hills

Project 204814.01
June 2023

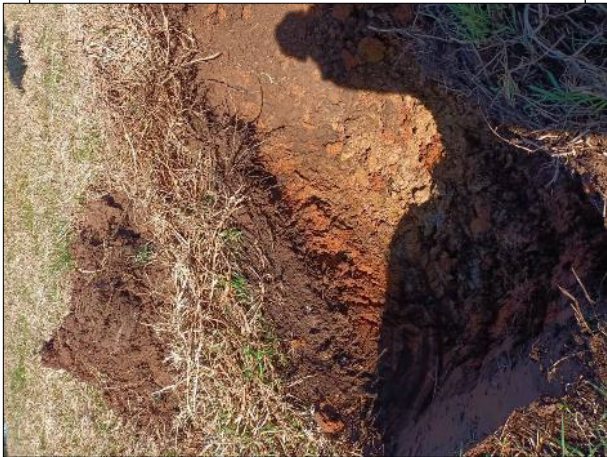
0.20m Silty CLAY: medium to high plasticity, red-brown, trace fine to medium ironstone gravel		w-PL	VSt					
							0.70m Silty CLAY: high plasticity, pale brown, trace fine to medium siltstone gravel		w-PL	VSt

1.10m EXCAVATION AEC40TP01 TERMINATED AT 1.10 m Target depth								
					1.5

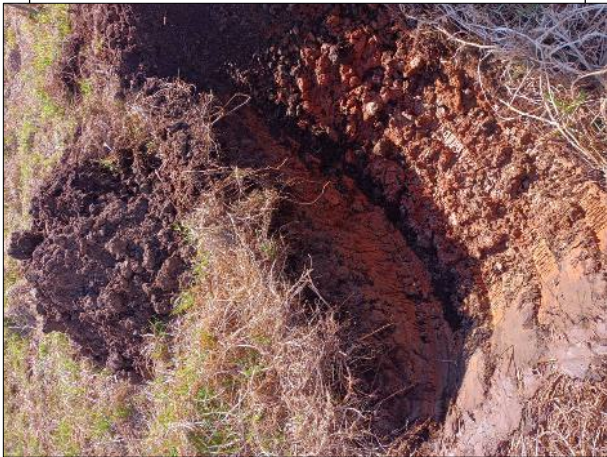
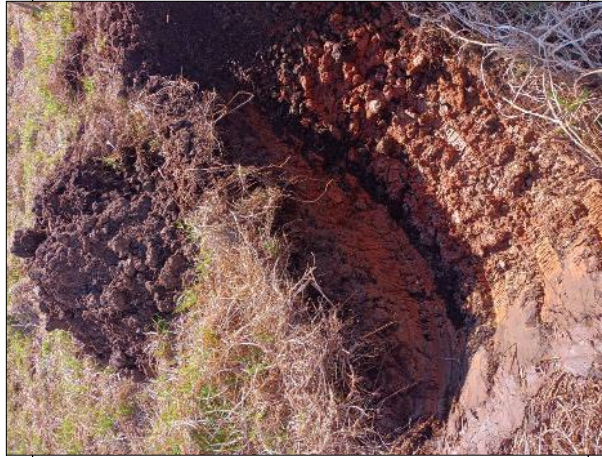
0.80m ES 0.90m	0.5	<div></div>	CI-CH	0.50m	Silty CLAY: medium to high plasticity, pale grey, trace fine to coarse siltstone gravel	w-PL	St to VSt	X	0.80: HP =210 kPa 0.80: PID <1

1.0			1.10m					
									EXCAVATION AEC40TP06 TERMINATED AT 1.10 m Target depth

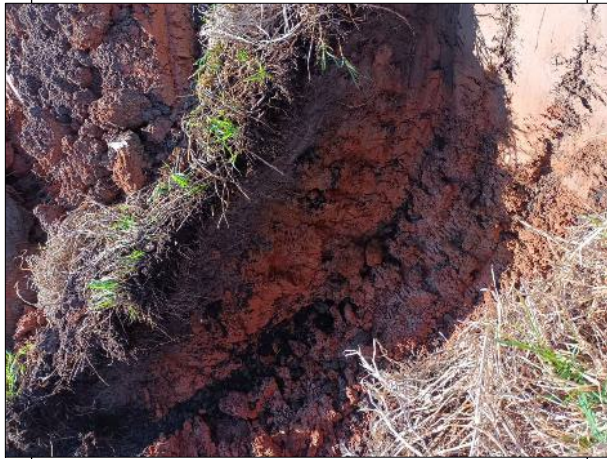
DRILLING				MATERIAL						
VE PENETRATION	SUPPORT	GROUND WATER LEVELS	SAMPLES & FIELD TESTS	DEPTH (m)	GRAPHIC LOG	CLASSIFICATION SYMBOL	MATERIAL DESCRIPTION Soil Type, Colour, Plasticity or Particle Characteristic Secondary and Minor Components	MOISTURE CONDITION CONSISTENCY RELATIVE DENSITY	HAND PENETRO- METER	STRUCTURE & Other Observations
			ES 0.10m	0.0			FILL: sandy SILT: medium to high plasticity, dark brown, fine to medium sand, trace rootlets	w-PL		FILL 0.00: PID <1
			0.40m ES 0.50m	0.5			Silty CLAY: medium to high plasticity, red-brown mottled grey, trace fine to medium ironstone gravel	w-PL	St to VSt	RESIDUAL SOIL 0.40: HP =210 kPa 0.40: PID <1
			0.90m ES 1.00m	1.0			EXCAVATION AEC40TP07 TERMINATED AT 1.10 m Target depth			0.90: HP =210 kPa 0.90: PID <1
				1.5

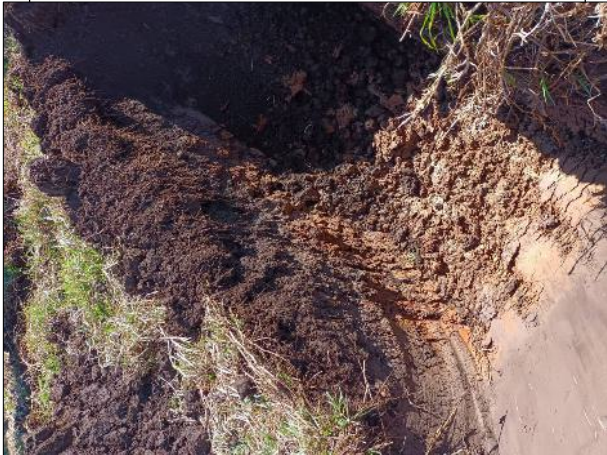
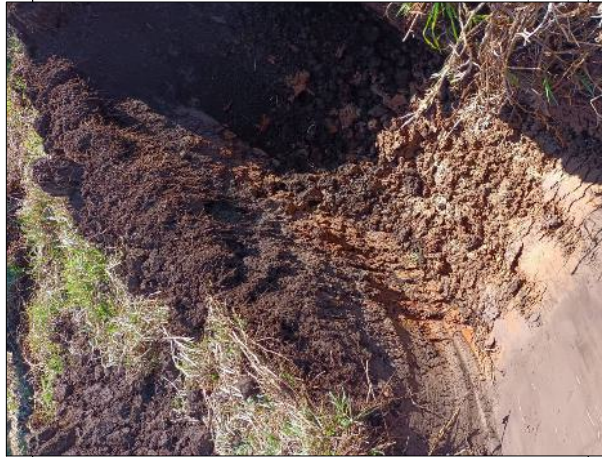
0.80m ES 0.90m	0.5		CI-CH					w-PL	St to VSt		✗	0.80: HP =180 kPa 0.80: PID <1			
					1.0			1.00m	EXCAVATION AEC40TP08 TERMINATED AT 1.00 m Target depth

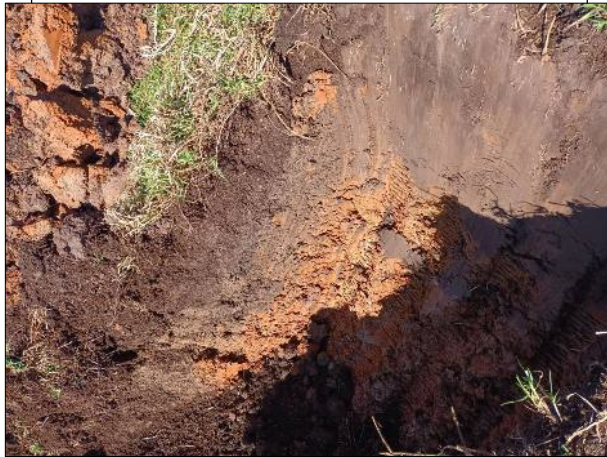
0.50m ES 0.60m	0.5			Silty CLAY: medium to high plasticity, red-brown, trace fine to medium ironstone gravel	w-PL	VSt	X	RESIDUAL SOIL 0.50: HP =210 kPa 0.50: PID <1

1.00m ES 1.10m	1.0						X	1.00: HP =270 kPa 1.00: PID <1		
							1.20m			EXCAVATION AEC40TP11 TERMINATED AT 1.20 m Target depth						
							1.5

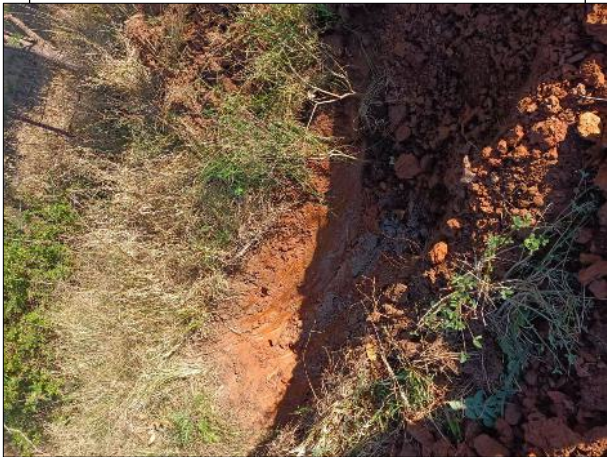
0.80m ES 0.90m	0.70m		CH	Silty: high plasticity, pale grey mottled red-brown, trace fine to medium ironstone gravel	w<PL	H			X	0.80: HP =430 kPa 0.80: PID <5

1.10m			EXCAVATION AEC40TP12 TERMINATED AT 1.10 m Target depth							
					1.5

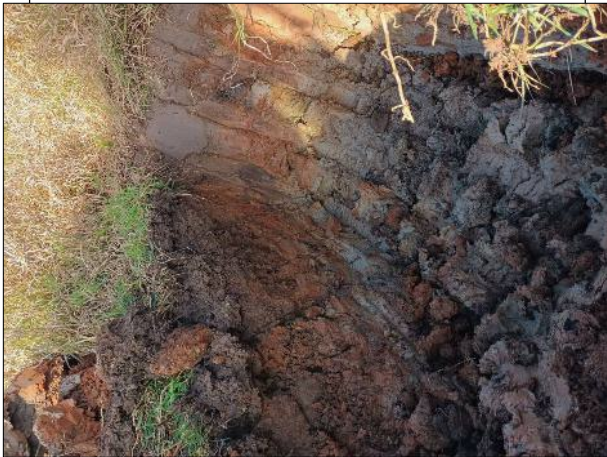
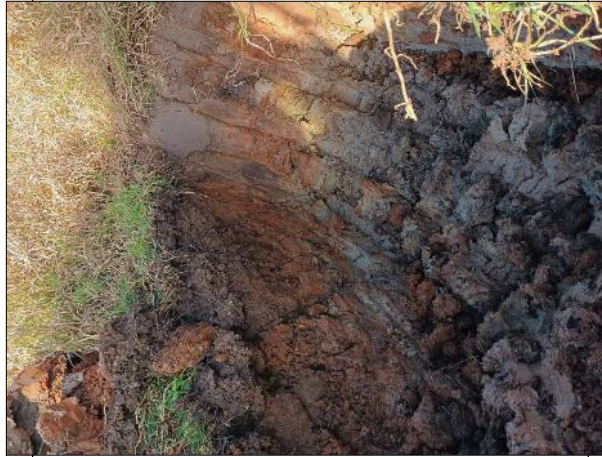
0.30m ES 0.40m		<div></div>	CI-CH	0.20m	Silty CLAY: medium to high plasticity, red-brown, trace fine to medium ironstone gravel	w-PL	St			RESIDUAL SOIL 0.30: HP =170 kPa 0.30: PID <5

0.80m ES-0 0.90m		<div></div>	CH	0.70m	Silty CLAY: high plasticity, pale grey mottled red-brown, trace fine to medium ironstone gravel	w-PL	St			
											1.0		1.10m	EXCAVATION AEC40TP13 TERMINATED AT 1.10 m Target depth	
									<div>

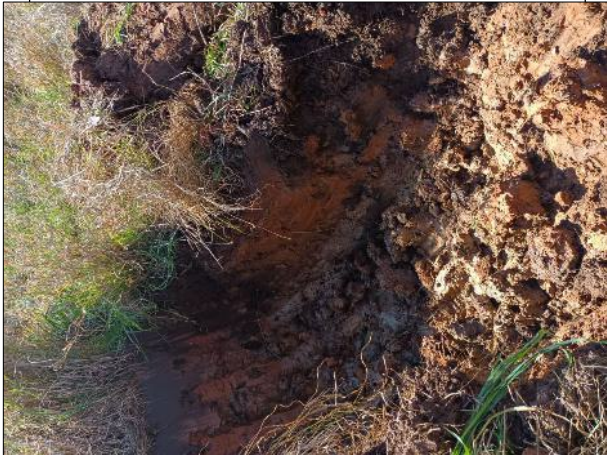
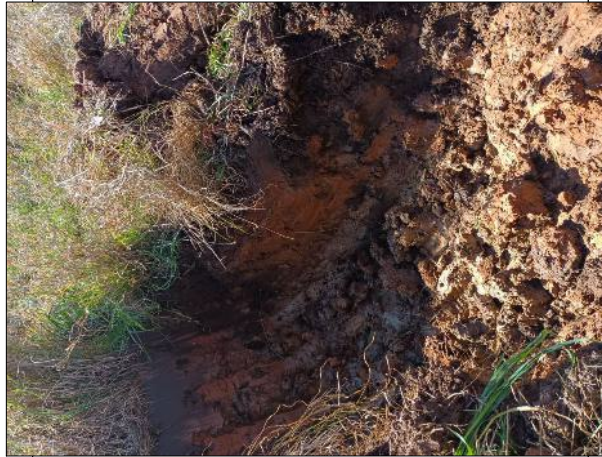
0.80m ES 0.90m	0.5		CI-CH								
					0.70m			Silty CLAY: high plasticity, pale grey mottled red-brown, trace fine to medium ironstone gravel	w-PL	St	X	0.80: HP =170 kPa 0.80: PID <5

1.00m		CH	EXCAVATION AEC40TP14 TERMINATED AT 1.00 m Target depth							
					1.0

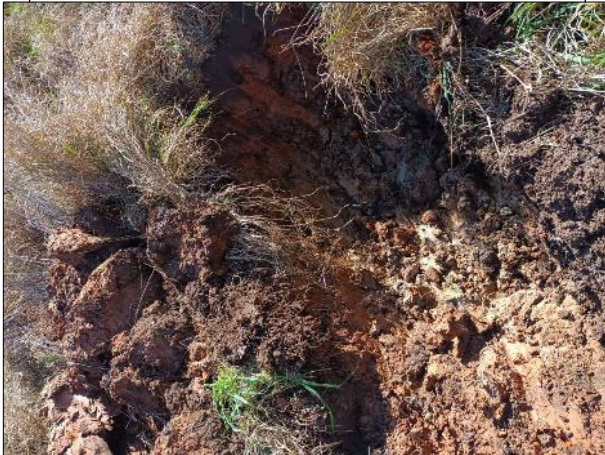
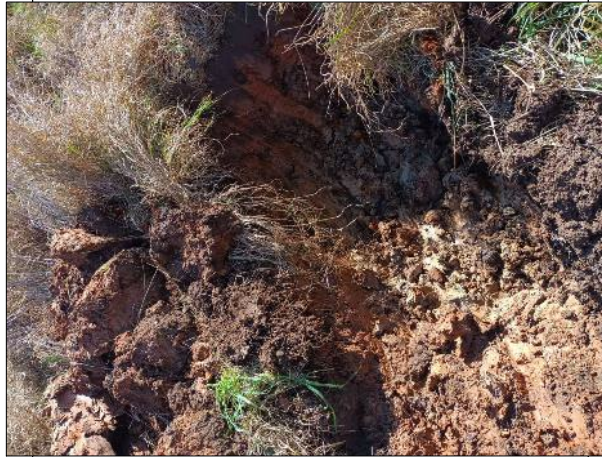
Free groundwater was observed at AEC40TP15 at a depth of 0.7 m. No free groundwater was observed in the other test pits.

0.80m ES 0.90m	0.60m		CH	Silty CLAY: high plasticity, pale grey mottled red-brown, trace fine to medium ironstone gravel	w-PL	St		✗		0.80: HP =180 kPa 0.80: PID <5

1.00m			EXCAVATION AEC40TP15 TERMINATED AT 1.00 m Target depth								
					1.0

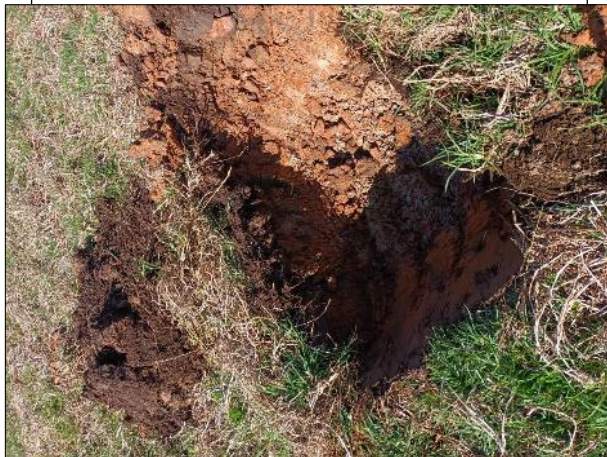
DRILLING				MATERIAL												
VE PENETRATION	SUPPORT	GROUND WATER LEVELS	SAMPLES & FIELD TESTS	DEPTH (m)	GRAPHIC LOG	CLASSIFICATION SYMBOL	MATERIAL DESCRIPTION Soil Type, Colour, Plasticity or Particle Characteristic Secondary and Minor Components	MOISTURE CONDITION	CONSISTENCY RELATIVE DENSITY	HAND PENETRO- METER	STRUCTURE & Other Observations					
			ES 0.10m	0.0			FILL: sandy SILT: medium to high plasticity, dark brown, fine to medium sand, trace rootlets	w-PL			FILL 0.00: PID <5					
			ES 0.30m ES 0.40m	0.30 0.40		CI-CH	Silty CLAY: medium to high plasticity, red-brown, trace fine to medium ironstone gravel	w-PL	St to VSt	X	RESIDUAL SOIL 0.30: HP =190 kPa 0.30: PID <5					
			ES 0.80m ES 0.90m	0.80 0.90		CH	Silty CLAY: high plasticity, pale grey mottled red-brown, trace fine to medium ironstone gravel	w-PL	St	X	0.80: HP =170 kPa 0.80: PID <5

1.0			EXCAVATION AEC40TP16 TERMINATED AT 0.90 m Target depth									
				1.5

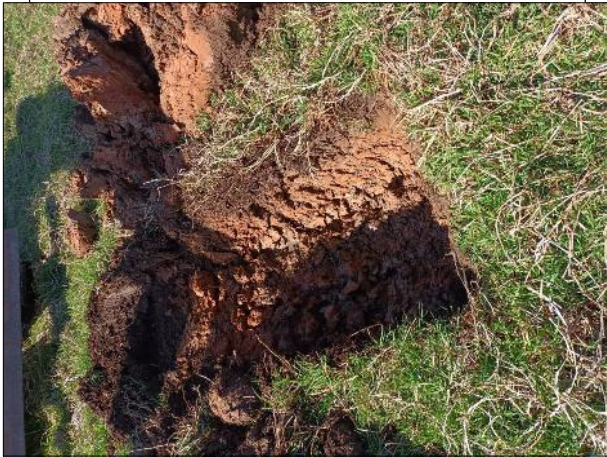
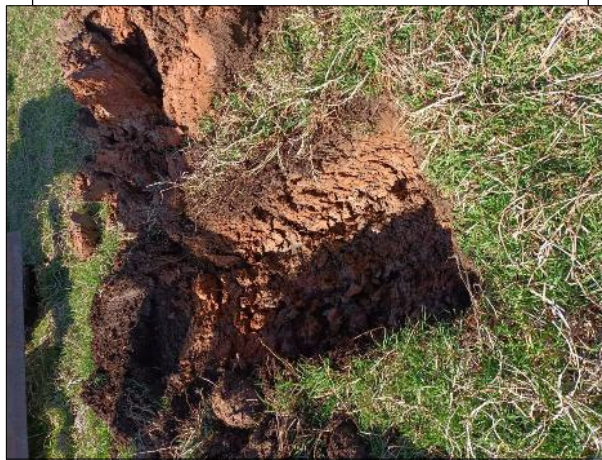
0.20m								
				ES 0.30m								
				0.70m		<div></div>	CH	Silty CLAY: medium to high plasticity, red-brown, trace fine to medium ironstone gravel	w-PL	St to VSt	<div></div>	0.70: HP =170 kPa 0.70: PID <5
				ES 0.80m								
<div></div>					1.0			EXCAVATION AEC40TP18 TERMINATED AT 0.90 m Target depth

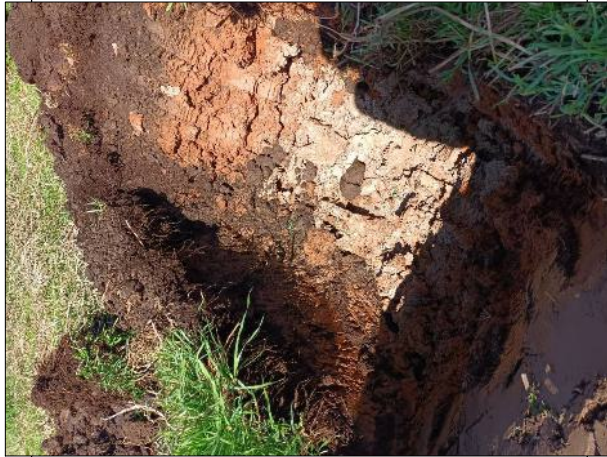
DRILLING				MATERIAL							
VE PENETRATION	SUPPORT	GROUND WATER LEVELS	SAMPLES & FIELD TESTS	DEPTH (m)	GRAPHIC LOG	CLASSIFICATION SYMBOL	MATERIAL DESCRIPTION Soil Type, Colour, Plasticity or Particle Characteristic Secondary and Minor Components	MOISTURE CONDITION	CONSISTENCY RELATIVE DENSITY	HAND PENETRO- METER	STRUCTURE & Other Observations
			ES 0.10m	0.0			FILL: sandy SILT: medium to high plasticity, dark brown, fine to meium sand, trace rootlets	w-PL			FILL 0.00: PID <5
			ES 0.30m ES 0.40m	0.20m 0.5		CI-CH	Silty CLAY: medium to high plasticity, red-brown, trace fine to medium ironstone gravel	w-PL	St to VSt	✗	RESIDUAL SOIL 0.30: HP =200 kPa 0.30: PID <5
			ES 0.80m ES 0.90m	0.70m 1.0		CH	Silty CLAY: high plasticity, pale grey mottled red-brown, trace fine to medium ironstone gravel	w-PL	St to VSt	✗	0.80: HP =180 kPa 0.80: PID <5

1.0	EXCAVATION AEC40TP19 TERMINATED AT 1.00 m Target depth						
				1.5

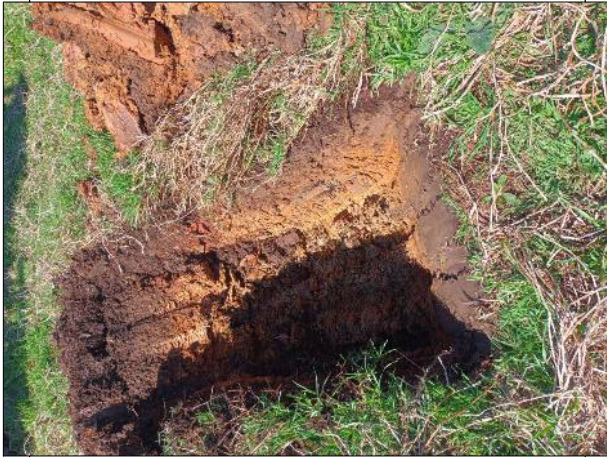
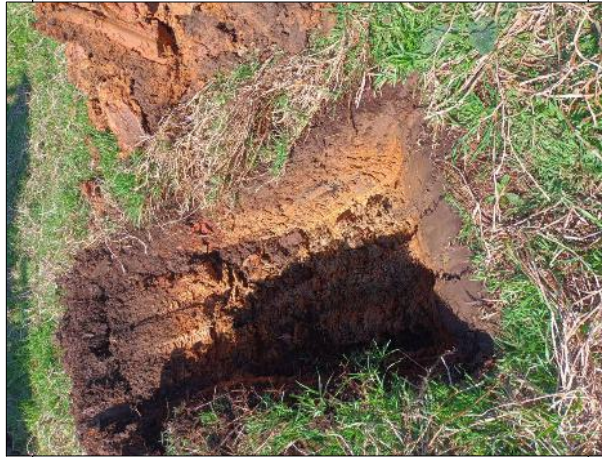
0.80m ES 0.90m	0.80m	CI-CH		Silty CLAY: high plasticity, pale grey mottled red-brown, trace fine to medium ironstone gravel		w-PL	St	×	0.80: HP =160 kPa 0.80: PID <5

1.00m	CH		EXCAVATION AEC40TP20 TERMINATED AT 1.00 m Target depth							
					1.5

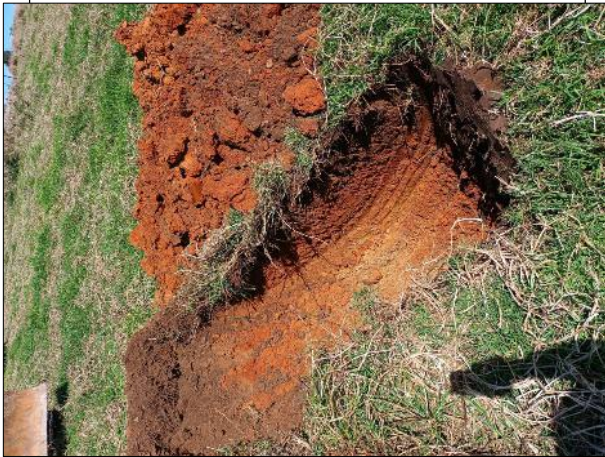
0.30m ES 0.40m	0.5			Silty CLAY: medium to high plasticity, red-brown, trace fine to medium ironstone gravel			X	RESIDUAL SOIL 0.30: HP =170 kPa 0.30: PID <5
			Not Observed	0.80m ES 0.90m	1.0		CI-CH		w-PL	St	X	0.80: HP =120 kPa 0.80: PID <5

1.20m			EXCAVATION AEC40TP22 TERMINATED AT 1.20 m Target depth				
					1.5

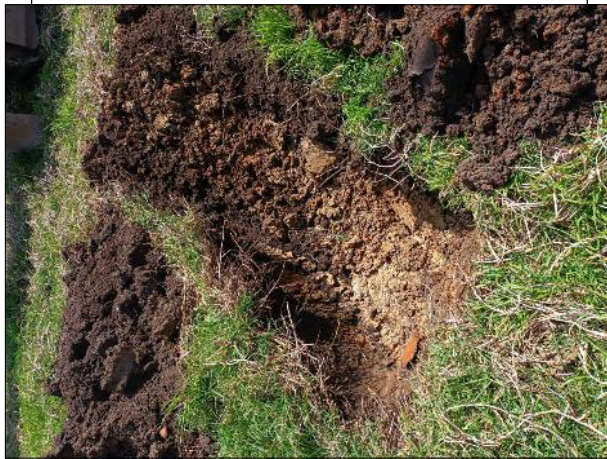
0.5		CH	Silty CLAY: high plasticity, pale grey mottled red-brown, trace fine to medium ironstone gravel		St						
			0.70m												
			ES 0.80m					w-PL			0.70: HP =170 kPa 0.70: PID <5

1.0			EXCAVATION AEC40TP23 TERMINATED AT 0.90 m Target depth								
				1.5

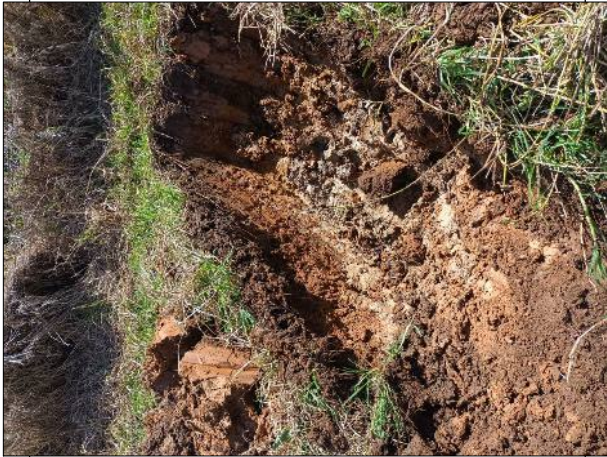
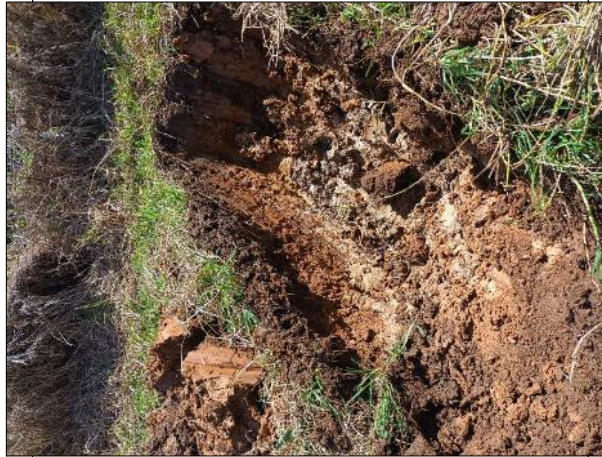
0.30m ES 0.40m				Silty CLAY: medium to high plasticity, red-brown, trace fine to medium ironstone gravel										
0.5m				CI-CH										
0.70m				Silty CLAY: high plasticity, pale grey mottled red-brown, trace fine to medium ironstone gravel

0.80m ES 0.90m				CH										
1.00m				EXCAVATION AEC40TP24 TERMINATED AT 1.00 m Target depth										
1.5m

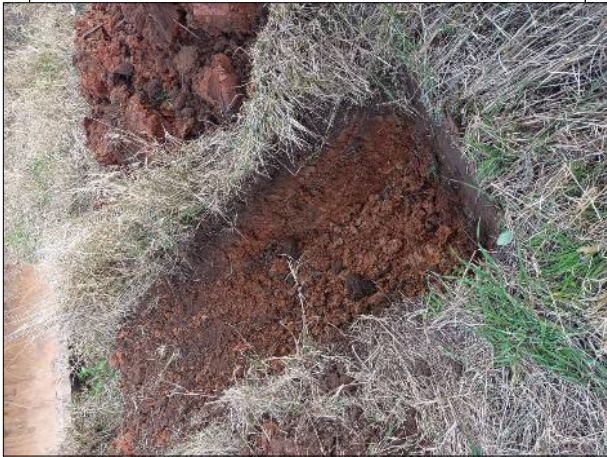
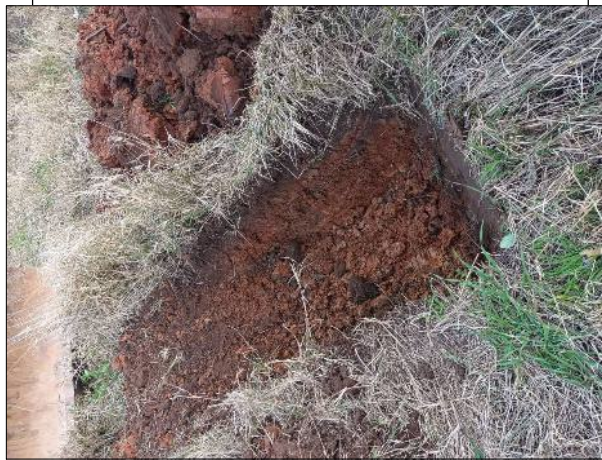
0.20m			0.20m			Silty CLAY: medium to high plasticity, red-brown, trace fine to medium ironstone gravel				X		
		0.30m												
		ES			0.5		CI-CH			w-PL	St

0.40m												
				0.80m								X		
				ES										
				0.90m				EXCAVATION AEC40TP25 TERMINATED AT 0.90 m Target depth						
					1.0

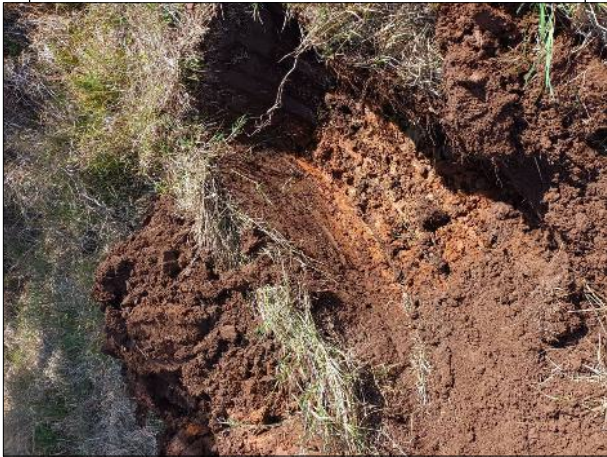
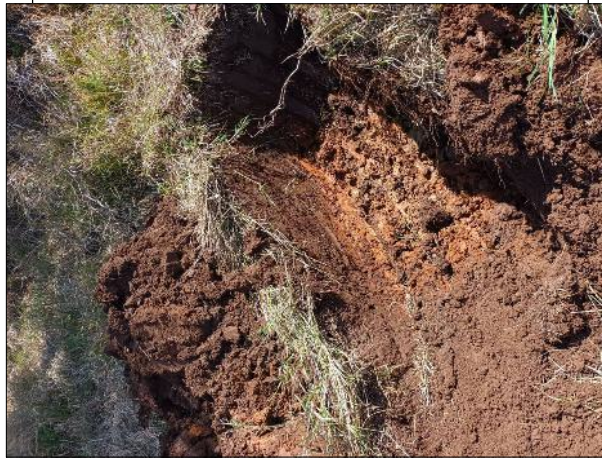
0.80m ES 0.90m	0.5		CI-CH	At 0.7m: pale brown	w-PL	St					
					0.90m			EXCAVATION AEC40TP26 TERMINATED AT 0.90 m Target depth			✕	0.80: HP =150 kPa 0.80: PID <5
