Report on
Detailed Site Investigation (Contamination)

Surface & Civil Alignment Works (SCAW) Package for
Sydney Metro - Western Sydney Airport (SMWSA)
Area of Environmental Concern (AEC) 43,
1793 Elizabeth Drive, Badgerys Creek

Project 204814.01
November 2022

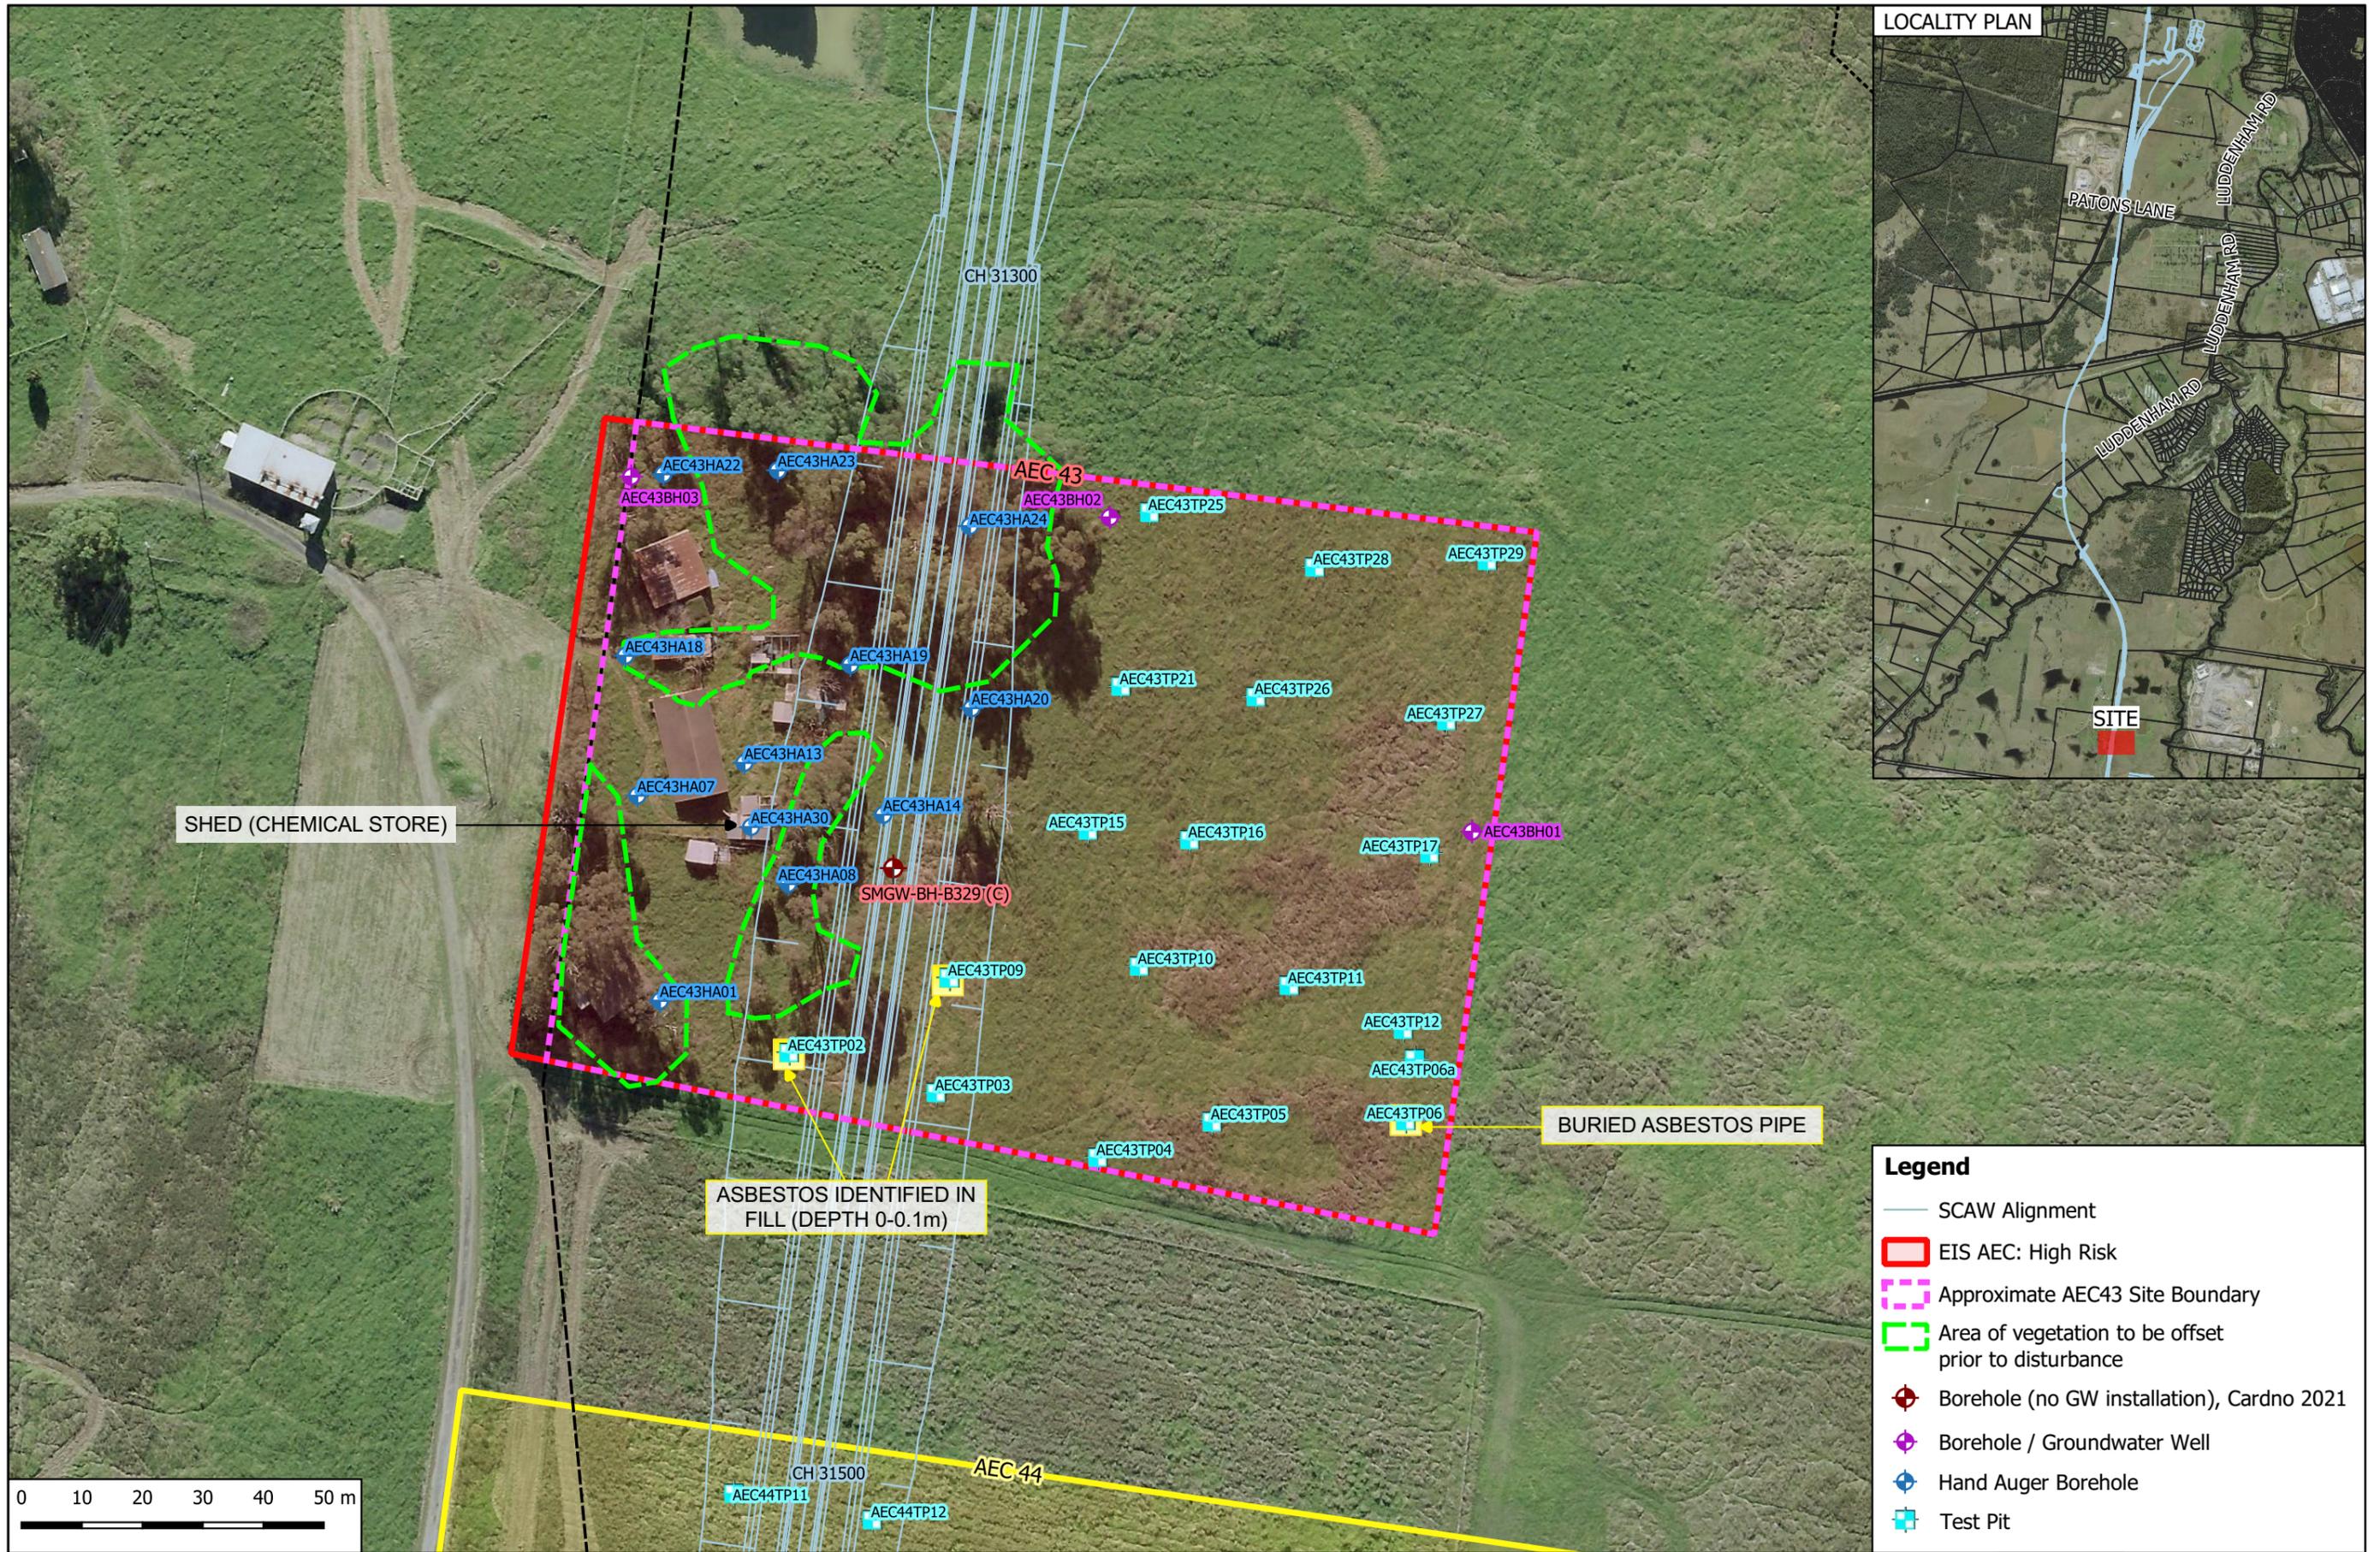
PROJECT No:	204814.01
DRAWING No:	AEC43-01
REVISION:	Rev 0

Technical Paper 8: Contamination, prepared as part of Sydney Metro - Western Sydney Airport, Environmental Impact Statement (EIS), documents areas of environmental concern identified for the Sydney Metro - Western Sydney Airport project. The objective of the DSI is to assess the suitability of the part of AEC 43 that will be disturbed by SCAW activities (the site) and to determine whether further investigation and / or management is required. The site is shown on Drawing AEC43-01, Appendix A.

Cardno, *Contamination Assessment Report, Sydney Metro Western Sydney Airport*, 1 September 2021 (80021888-CDO-CAR-RPT-004-RevE) (Cardno, 2021) includes data for one soil sampling location (SMGW-BH-B329) at the site. Borehole SMGW-BH-B329 was drilled on 25 to 26 March 2021. Silty clay fill to a depth of 0.2 m was found to be underlain by clay to 1.8 m, then silty clay to 2.71 m, and sandy clay to 3.07 m. Soil was underlain by sandstone, mudstone and siltstone to a depth of 15.18 m. The borehole log is provided in Appendix C. The location of SMGW-BH-B329 is shown on Drawing AEC43-01, Appendix A.

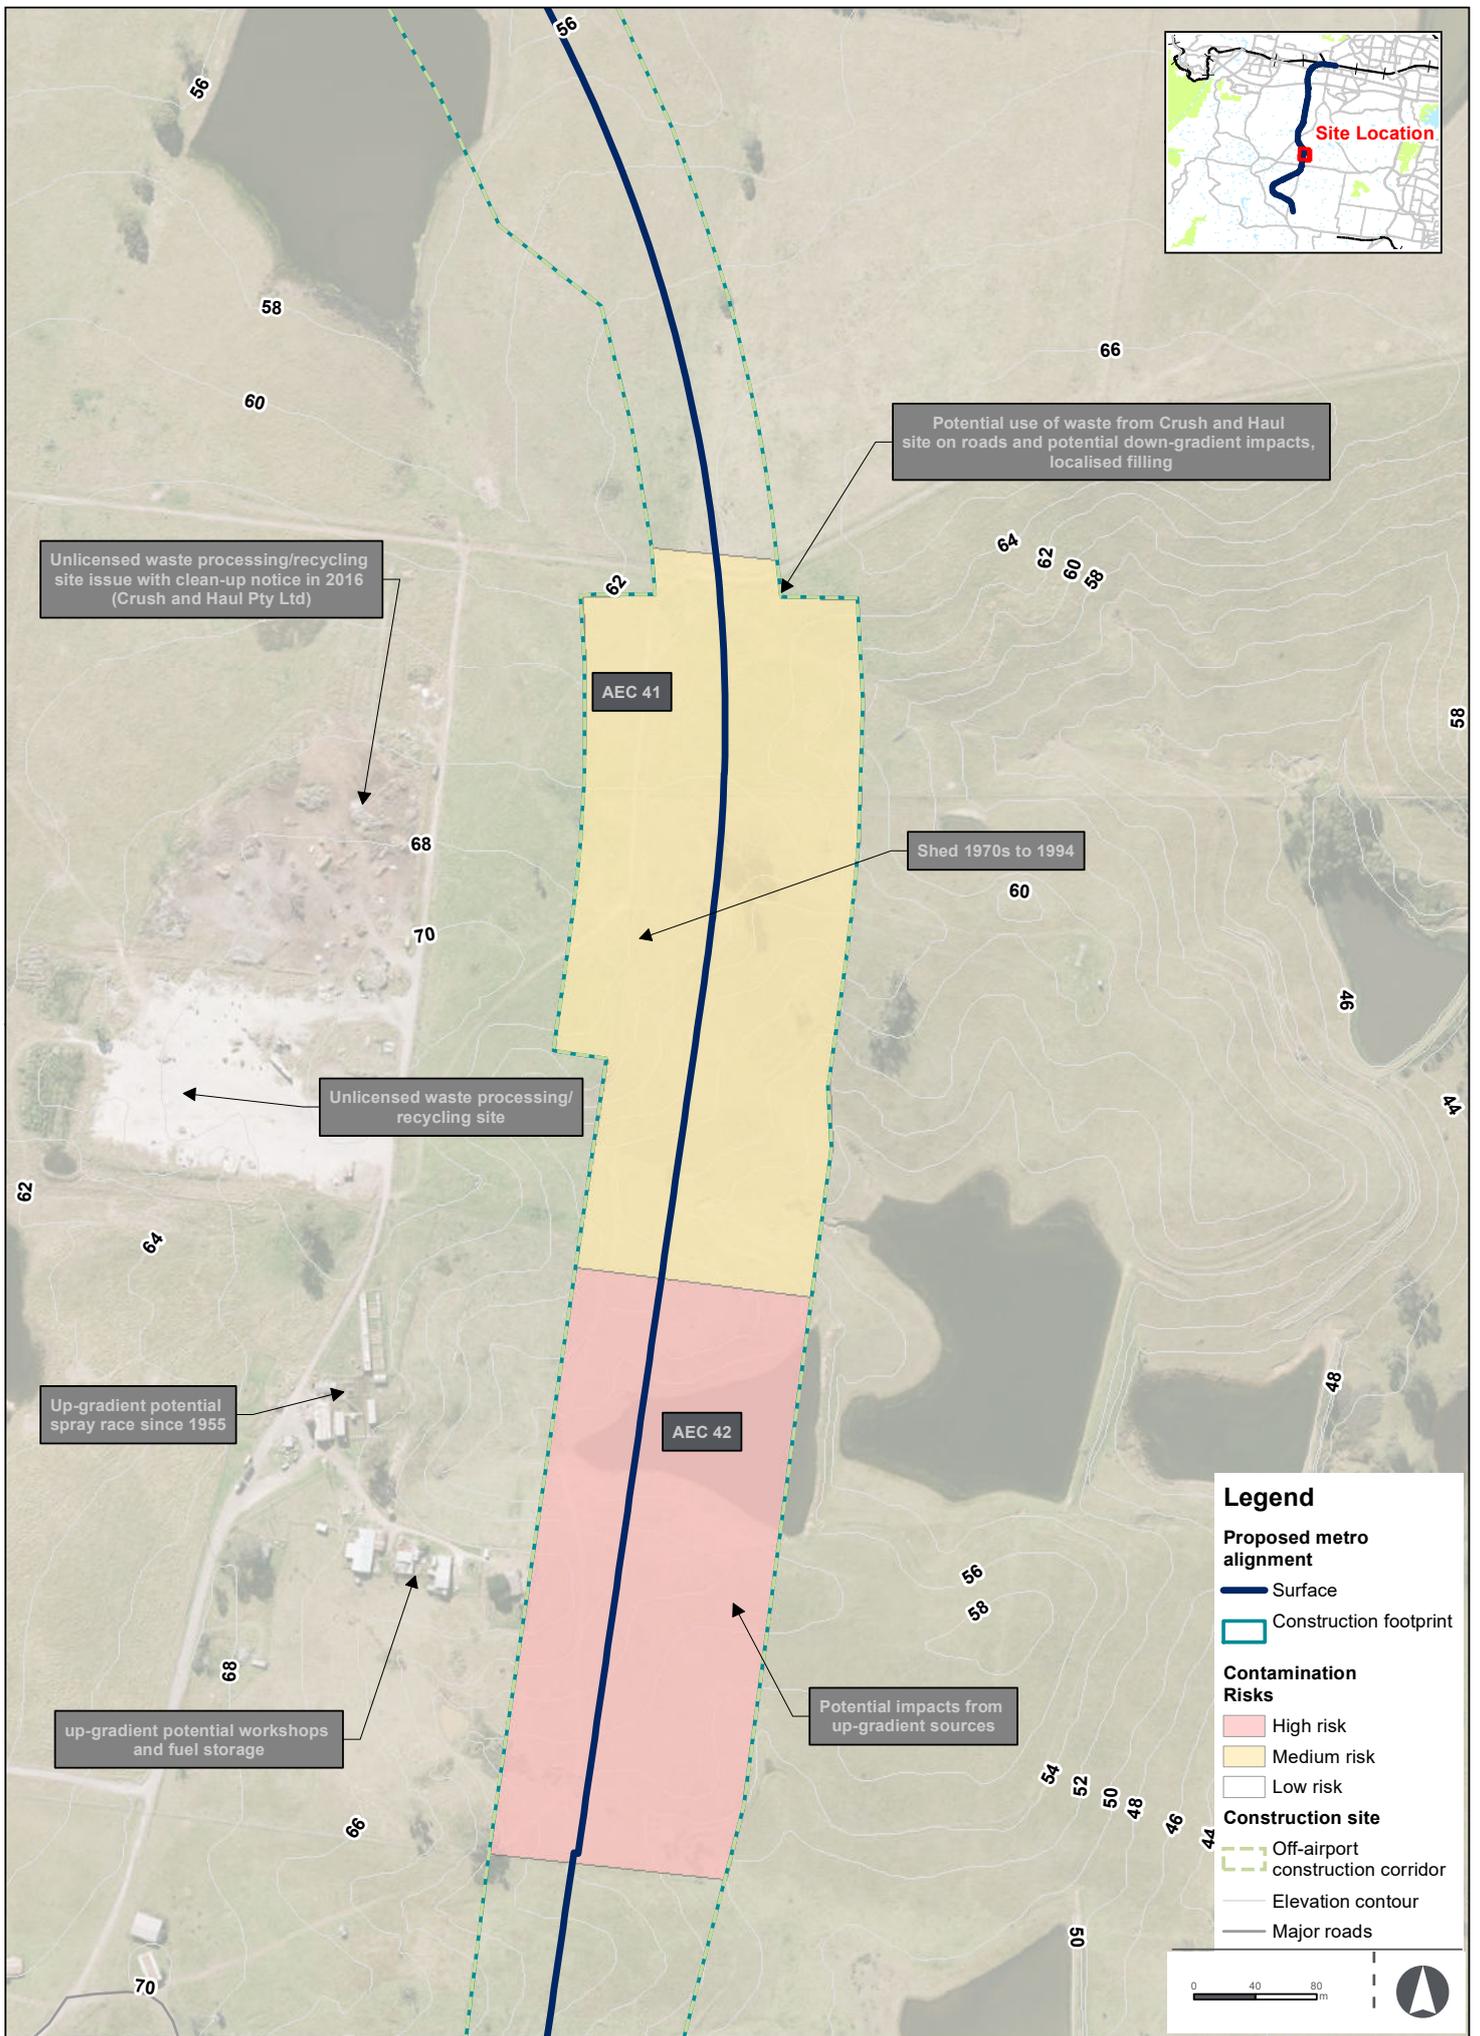
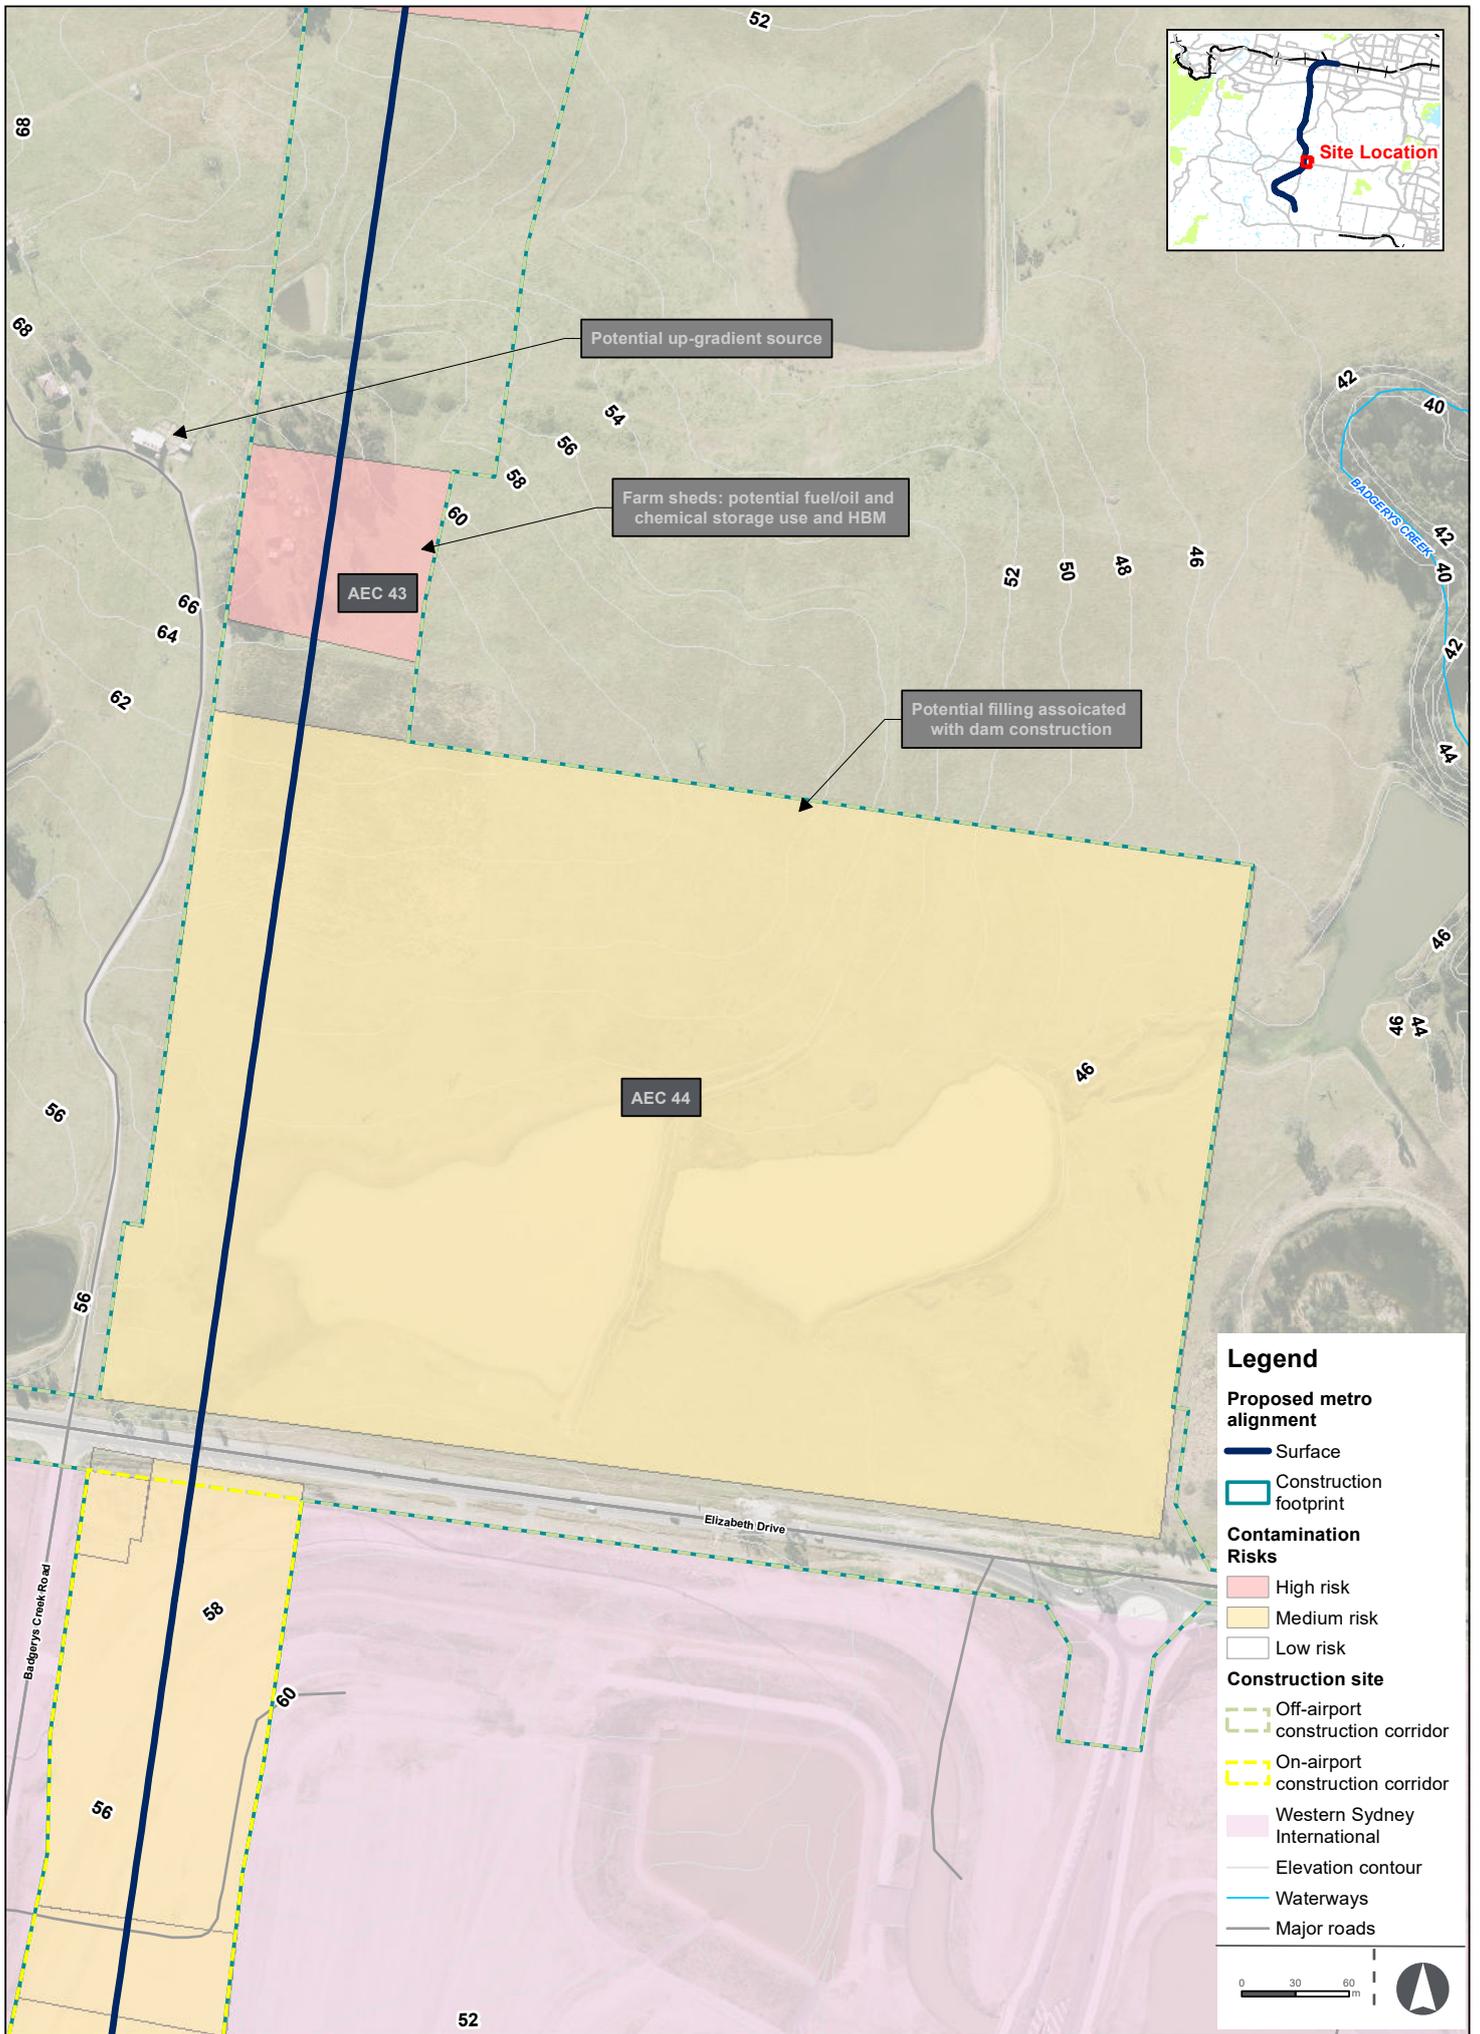
Off-airport construction corridor in Badgerys Creek contamination sources and risk ranking

*HBM - Potential hazardous building materials
Indicative only, subject to design development

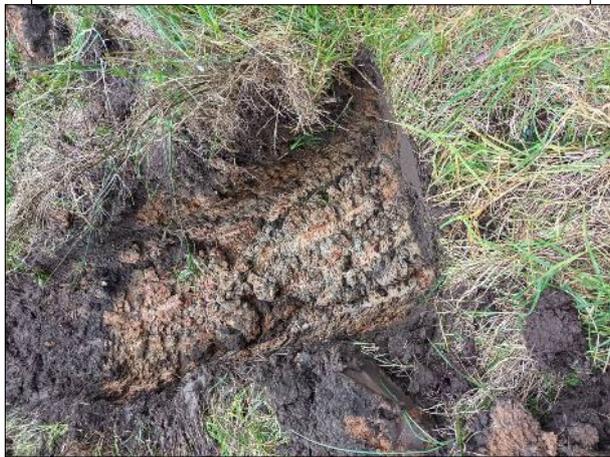
1.0			EXCAVATION AEC43TP02 TERMINATED AT 0.90 m Target depth

DRILLING				MATERIAL							
VE PENETRATION	SUPPORT	GROUND WATER LEVELS	SAMPLES & FIELD TESTS	DEPTH (m)	GRAPHIC LOG	CLASSIFICATION SYMBOL	MATERIAL DESCRIPTION Soil Type, Colour, Plasticity or Particle Characteristic Secondary and Minor Components	MOISTURE CONDITION	CONSISTENCY RELATIVE DENSITY	HAND PENETROMETER	STRUCTURE & Other Observations
E F H			ES 0.10m	0.0	[Cross-hatch symbol]		FILL: sandy SILT: medium to high plasticity, dark brown, fine to medium sand, trace rootlets	w-PL		X	FILL 0.00: PID <1
			ES 0.30m ES 0.40m	0.30 0.40	[Vertical lines symbol]	CH	Silty CLAY: high plasticity, red-brown mottled grey, trace fine to medium gravel, trace fine to medium siltstone gravel	w-PL	St to VSt	X	RESIDUAL SOIL 0.30: HP =140 kPa 0.30: PID <1
			ES 0.80m ES 0.90m	0.80 0.90			At 0.6m: grey mottled red-brown			X	0.80: HP =200 kPa 0.80: PID <1

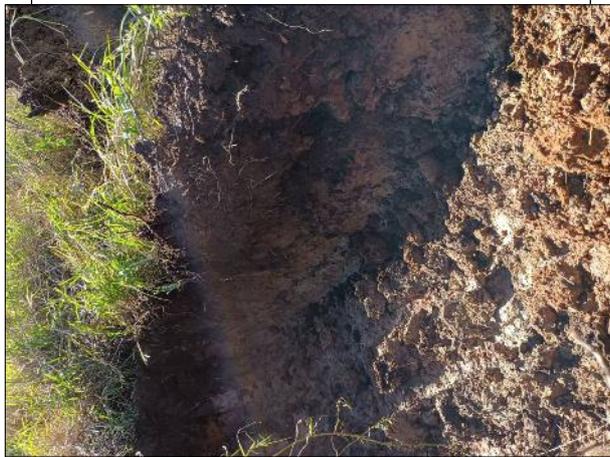
DRILLING				MATERIAL								
VE PENETRATION	SUPPORT	GROUND WATER LEVELS	SAMPLES & FIELD TESTS	DEPTH (m)	GRAPHIC LOG	CLASSIFICATION SYMBOL	MATERIAL DESCRIPTION Soil Type, Colour, Plasticity or Particle Characteristic Secondary and Minor Components	MOISTURE CONDITION	CONSISTENCY RELATIVE DENSITY	HAND PENETROMETER 100 200 300 400	STRUCTURE & Other Observations	
E F H			ES 0.10m	0.0	[Cross-hatch pattern]		FILL: sandy SILT: medium to high plasticity, dark brown, fine to medium sand, trace rootlets	w-PL		X	FILL 0.00: PID <1	
			ES 0.30m ES 0.40m	0.30 0.40	[Vertical lines]	CH	Silty CLAY: high plasticity, grey mottled orange-brown, trace fine to medium ironstone gravel	w-PL	VSt	X	RESIDUAL SOIL 0.30: HP =230 kPa 0.30: PID <1	
			ES 0.80m ES 0.90m	0.80 0.90			EXCAVATION AEC43TP03 TERMINATED AT 0.90 m Target depth			X	0.80: HP =270 kPa 0.80: PID <1

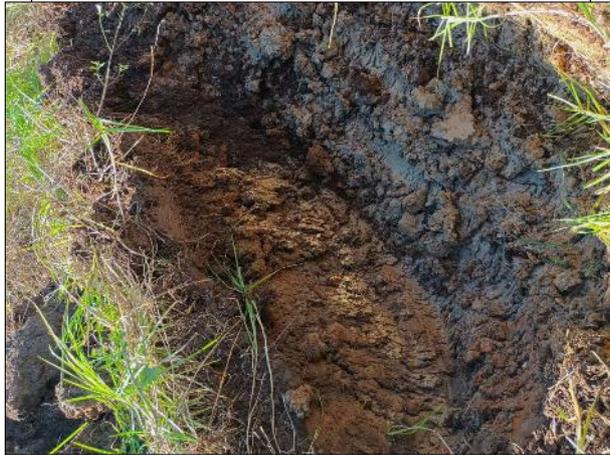
1.0			EXCAVATION AEC43TP04 TERMINATED AT 1.00 m Target depth				
							1.5

DRILLING				MATERIAL										
VE	E	F	H	SUPPORT	GROUND WATER LEVELS	SAMPLES & FIELD TESTS	DEPTH (m)	GRAPHIC LOG	CLASSIFICATION SYMBOL	MATERIAL DESCRIPTION Soil Type, Colour, Plasticity or Particle Characteristic Secondary and Minor Components	MOISTURE CONDITION	CONSISTENCY RELATIVE DENSITY	HAND PENETROMETER	STRUCTURE & Other Observations
X						ES 0.10m	0.0	[Cross-hatch symbol]		FILL: sandy SILT: medium to high plasticity, dark brown, fine to medium sand, trace rootlets	w-PL			FILL 0.00: PID <1
					Not Observed	ES 0.30m ES 0.40m	0.30 0.40	[Vertical lines symbol]	CH	Silty CLAY: high plasticity, red-brown, trace fine to medium ironstone gravel	w-PL	St to VSt	X	Field Replicate BD4/20220817 taken at 0.0-0.1m depth RESIDUAL SOIL 0.30: HP =200 kPa 0.30: PID <1
						ES 0.80m ES 0.90m	0.80 0.90			At 0.8m: grey mottled red-brown			X	0.80: HP =170 kPa 0.80: PID <1

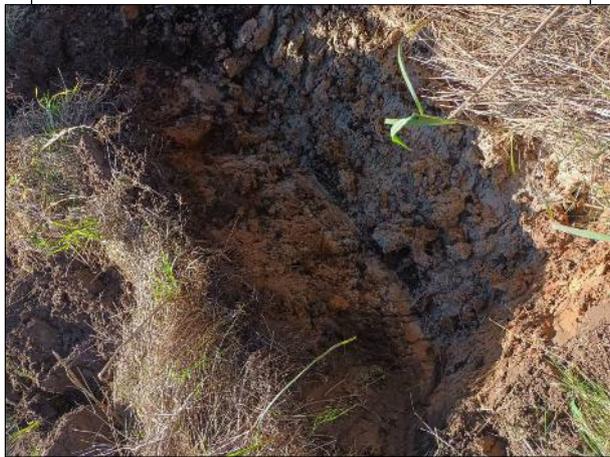
0.70m									
				ES 0.80m									
					1.0			EXCAVATION AEC43TP05 TERMINATED AT 0.90 m Target depth					
					1.5

DRILLING				MATERIAL									
VE PENETRATION	E F H	SUPPORT	GROUND WATER LEVELS	SAMPLES & FIELD TESTS	DEPTH (m)	GRAPHIC LOG	CLASSIFICATION SYMBOL	MATERIAL DESCRIPTION Soil Type, Colour, Plasticity or Particle Characteristic Secondary and Minor Components	MOISTURE CONDITION	CONSISTENCY	RELATIVE DENSITY	HAND PENETROMETER	STRUCTURE & Other Observations
				ES 0.10m	0.0	XXXX	0.10m	FILL: sandy CLAY: medium to high plasticity, dark brown, fine to medium sand, trace rootlets	w-PL			X	FILL 0.00: PID <1
				ES 0.20m				Silty CLAY: high plasticity, orange-brown, trace fine to medium ironstone gravel				X	RESIDUAL SOIL 0.20: HP =180 kPa 0.20: PID <1
				ES 0.30m				At 0.4m: grey mottled orange-brown	w-PL	St		X	0.70: HP =170 kPa 0.70: PID <1

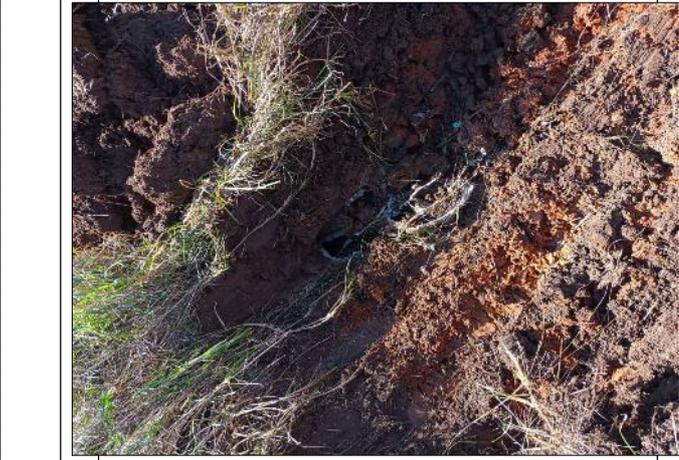
A buried fibre-cement pipe (observed to potentially contain asbestos) was encountered at a depth of approximately 0.3 m below ground level at AEC43TP06. The pipe was observed to run in an (approximate) north to south direction. A section of fibre-cement pipe, approximately 0.3 m long, was also observed to be buried at a shallow depth (approximately 0.1 m) next to the pipeline.

0.40m	FILL: sandy SILT: medium to high plasticity, dark brown, fine to medium sand, trace rootlets	w-PL		FILL 0.00: PID <1 0.30: Pipe sample PACM1 taken at 0.3m depth
				0.5	EXCAVATION AEC43TP06 TERMINATED AT 0.40 m Services present - pipe presumed to contain asbestos					
				1.0

Given the presence of asbestos contamination, it is considered that remediation is required to render the site suitable for the proposed development. A Remediation Action Plan (RAP) should be prepared for remediation of the site. Prior to demolition, a hazardous materials building survey should be undertaken for structures that will be demolished at the site (if not undertaken already).

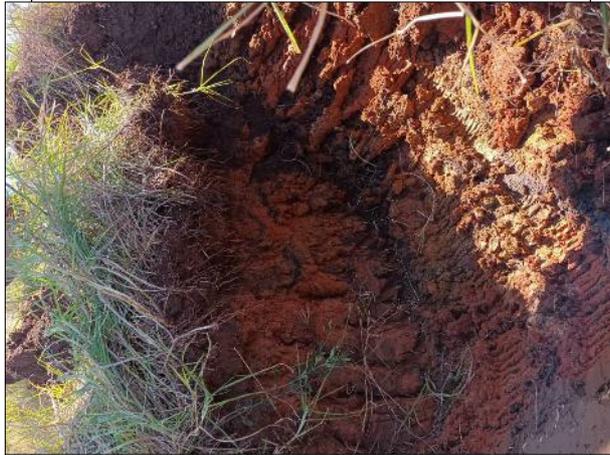
DRILLING				MATERIAL												
VE PENETRATION	E EXISTING EXCAVATION	F FIRMNESS	H HARDNESS	SUPPORT	GROUND WATER LEVELS	SAMPLES & FIELD TESTS	DEPTH (m)	GRAPHIC LOG	CLASSIFICATION SYMBOL	MATERIAL DESCRIPTION Soil Type, Colour, Plasticity or Particle Characteristic Secondary and Minor Components	MOISTURE CONDITION	CONSISTENCY RELATIVE DENSITY	HAND PENETROMETER	STRUCTURE & Other Observations		
						ES 0.10m	0.0	[Cross-hatch pattern]		FILL: sandy SILT: medium to high plasticity, dark brown, fine to medium sand, trace rootlets	w-PL			FILL 0.00: PID <1		
					Not Observed	ES 0.40m ES 0.50m	0.5	[Vertical lines pattern]	CH	Silty CLAY: high plasticity, red-brown, trace fine ironstone gravel	w-PL	St to VSt	X	RESIDUAL SOIL 0.40: HP =200 kPa 0.40: PID <1		
						ES 0.90m ES 1.00m	1.0			EXCAVATION AEC43TP06a TERMINATED AT 1.00 m Target depth			X	0.90: HP =210 kPa 0.90: PID <1

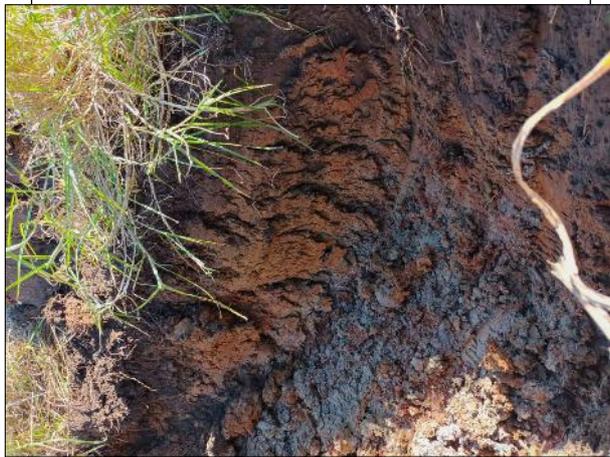
1.0			EXCAVATION AEC43TP10 TERMINATED AT 0.90 m Target depth					
				1.5

DRILLING				MATERIAL								
VE PENETRATION	SUPPORT	GROUND WATER LEVELS	SAMPLES & FIELD TESTS	DEPTH (m)	GRAPHIC LOG	CLASSIFICATION SYMBOL	MATERIAL DESCRIPTION Soil Type, Colour, Plasticity or Particle Characteristic Secondary and Minor Components	MOISTURE CONDITION	CONSISTENCY RELATIVE DENSITY	HAND PENETROMETER	STRUCTURE & Other Observations	
E F H			ES 0.10m	0.0	[Cross-hatch symbol]	0.20m	FILL: sandy SILT: medium to high plasticity, dark brown, fine to medium sand, trace rootlets	w-PL		X	FILL 0.00: PID <1	
			ES 0.30m ES 0.40m	0.5	[Vertical lines symbol]	CH	Silty CLAY: high plasticity, red-brown, trace fine to medium ironstone gravel	w-PL	St to VSt	X	RESIDUAL SOIL 0.30: HP =190 kPa 0.30: PID <1	
			ES 0.80m ES 0.90m	0.90m			At 0.8m: grey mottled red-brown			X	0.80: HP =220 kPa 0.80: PID <1

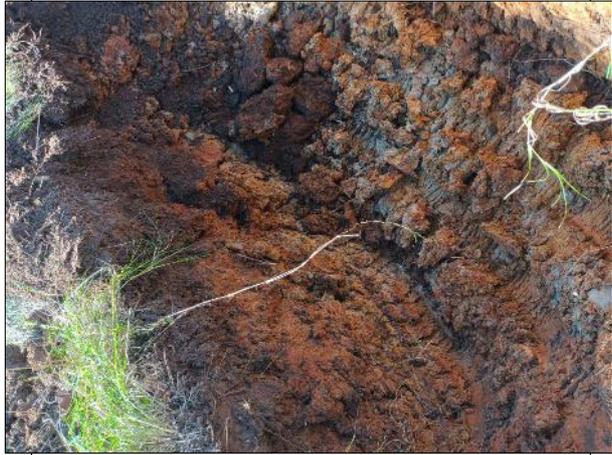
1.20			EXCAVATION AEC43TP11 TERMINATED AT 1.20 m Target depth				
				1.5

DRILLING				MATERIAL							
VE PENETRATION	SUPPORT	GROUND WATER LEVELS	SAMPLES & FIELD TESTS	DEPTH (m)	GRAPHIC LOG	CLASSIFICATION SYMBOL	MATERIAL DESCRIPTION Soil Type, Colour, Plasticity or Particle Characteristic Secondary and Minor Components	MOISTURE CONDITION	CONSISTENCY RELATIVE DENSITY	HAND PENETROMETER	STRUCTURE & Other Observations
E F H			ES 0.10m	0.0	[Cross-hatch symbol]		FILL: sandy SILT: medium to high plasticity, dark brown, fine to medium sand, trace rootlets	w-PL			FILL 0.00: PID <1
			ES 0.30m ES 0.40m	0.30 0.40	[Vertical lines symbol]		Silty CLAY: high plasticity, red-brown, trace fine to medium ironstone gravel			X	RESIDUAL SOIL 0.30: HP =200 kPa 0.30: PID <1
		Not Observed	ES 0.80m ES 0.90m	0.5 0.80 0.90	[Vertical lines symbol]	CH	At 0.8m: grey mottled red-brown	w-PL	St to VSt	X	0.80: HP =200 kPa 0.80: PID <1

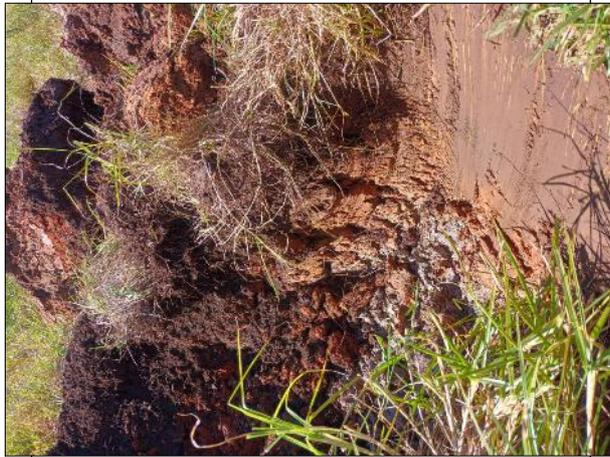
0.60m					
					0.80m					
					0.90m					
					1.0	EXCAVATION AEC43TP12 TERMINATED AT 1.10 m Target depth				
					1.5

0.40m					
					0.5	Silty CLAY: high plasticity, grey mottled red-brown, trace fine to medium ironstone gravel, trace fine to medium siltstone gravel	w-PL	St to VSt	X	0.80: HP =200 kPa 0.80: PID <1

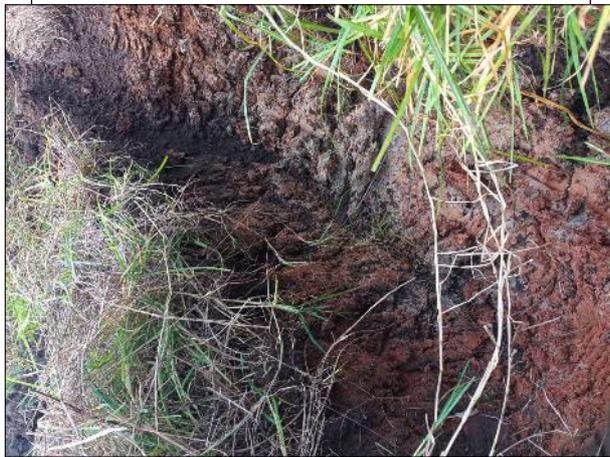
1.0		EXCAVATION AEC43TP15 TERMINATED AT 0.90 m Target depth

DRILLING				MATERIAL				
VE PENETRATION	SUPPORT	SAMPLES & FIELD TESTS	DEPTH (m)	GRAPHIC LOG	MATERIAL DESCRIPTION Soil Type, Colour, Plasticity or Particle Characteristic Secondary and Minor Components	MOISTURE CONDITION	CONSISTENCY RELATIVE DENSITY	STRUCTURE & Other Observations
E F H		ES 0.10m	0.0	X	FILL: sandy SILT: medium to high plasticity, dark brown, fine to medium sand, trace rootlets	w-PL		FILL 0.00: PID <1
	Not Observed	ES 0.30m ES 0.40m	0.30 0.40	CH	Silty CLAY: medium to high plasticity, red-brown, trace fine to medium ironstone gravel	w-PL	X	RESIDUAL SOIL 0.30: HP =170 kPa 0.30: PID <1 Field Replicate BD1/20220818 taken at 0.3-0.4m depth
		ES 0.80m ES 0.90m	0.5 0.70 0.90	CH	Silty CLAY: high plasticity, grey mottled red-brown, trace fine to medium ironstone gravel, trace fine to medium siltstone gravel	w-PL	X	0.80: HP =220 kPa 0.80: PID <1

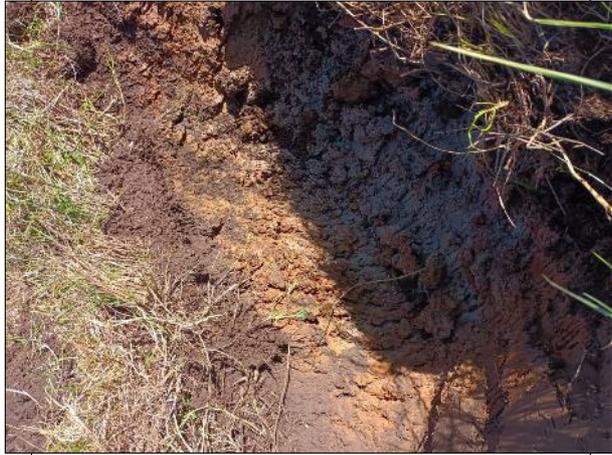
1.0		CH					X								
					1.20			EXCAVATION AEC43TP16 TERMINATED AT 1.20 m Target depth												
					1.5

0.80m ES 0.90m	0.80 0.90		CH	Silty CLAY: high plasticity, grey mottled red-brown, trace fine to medium ironstone gravel	w-PL	VSt		X	0.80: HP =240 kPa 0.80: PID <1 0.90: HP =240 kPa

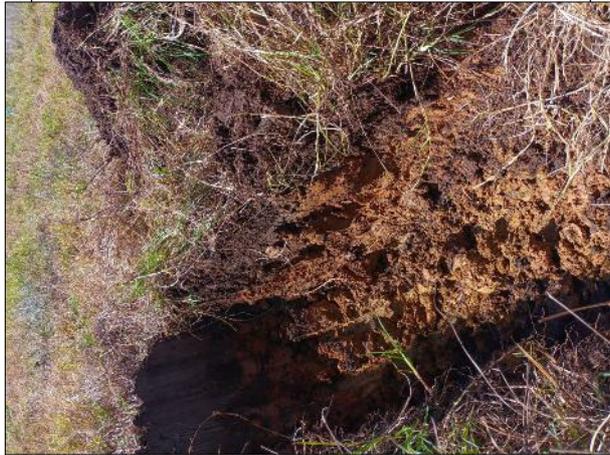
1.0			EXCAVATION AEC43TP17 TERMINATED AT 1.00 m Target depth				
							1.5

DRILLING				MATERIAL										
VE PENETRATION	E EXISTING EXCAVATION	BH BACKHOE BUCKET	B BULLDOZER BLADE	R RIPPER	SUPPORT	SAMPLES & FIELD TESTS	DEPTH (m)	GRAPHIC LOG	CLASSIFICATION SYMBOL	MATERIAL DESCRIPTION Soil Type, Colour, Plasticity or Particle Characteristic Secondary and Minor Components	MOISTURE CONDITION	CONSISTENCY RELATIVE DENSITY	HAND PENETROMETER	STRUCTURE & Other Observations
					Not Observed	ES 0.10m	0.0	[Cross-hatch symbol]		FILL: sandy SILT: medium to high plasticity, dark brown, fine to medium sand, trace rootlets	w-PL			FILL 0.00: PID <1
						ES 0.30m ES 0.40m	0.30 0.40	[Vertical lines symbol]		Silty CLAY: high plasticity, red-brown, trace fine to medium ironstone gravel	w-PL	St to VSt	X	RESIDUAL SOIL 0.30: HP =200 kPa 0.30: PID <1
						ES 0.80m ES 0.90m	0.80 0.90	[Vertical lines symbol]	CH				X	0.80: HP =180 kPa 0.80: PID <1

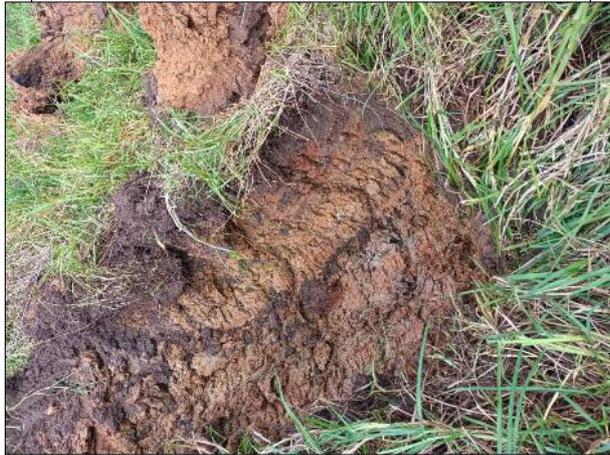
1.0			EXCAVATION AEC43TP21 TERMINATED AT 1.00 m Target depth				
							1.5

DRILLING				MATERIAL										
VE PENETRATION	E EXISTING EXCAVATION	BH BACKHOE BUCKET	B BULLDOZER BLADE	R RIPPER	SUPPORT	SAMPLES & FIELD TESTS	DEPTH (m)	GRAPHIC LOG	CLASSIFICATION SYMBOL	MATERIAL DESCRIPTION Soil Type, Colour, Plasticity or Particle Characteristic Secondary and Minor Components	MOISTURE CONDITION	CONSISTENCY RELATIVE DENSITY	HAND PENETROMETER	STRUCTURE & Other Observations
					Not Observed	ES 0.10m	0.0	[Cross-hatch symbol]	0.20m	FILL: sandy SILT: medium to high plasticity, dark brown, fine to medium sand, trace rootlets	w-PL		X	FILL 0.00: PID <1
						ES 0.30m ES 0.40m	0.30 0.40	[Vertical lines symbol]	CH	Silty CLAY: high plasticity, orange-brown, trace fine to medium ironstone gravel, trace fine to medium siltstone gravel	w-PL	St	X	RESIDUAL SOIL 0.30: HP =150 kPa 0.30: PID <1
						ES 0.80m ES 0.90m	0.80 0.90	[Vertical lines symbol]		At 0.7m: grey mottled orange-brown			X	0.80: HP =190 kPa 0.80: PID <1

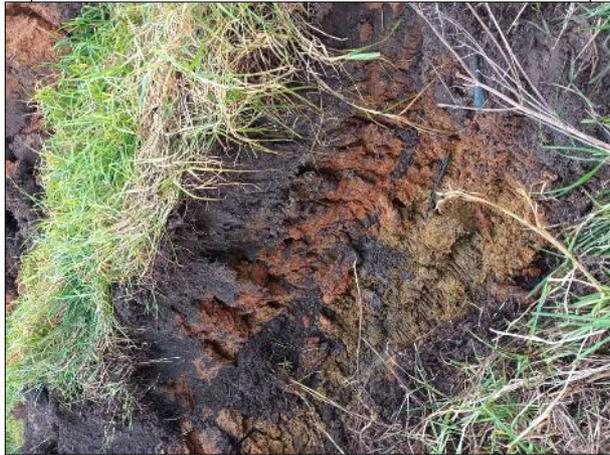
1.0			EXCAVATION AEC43TP25 TERMINATED AT 1.00 m Target depth				
							1.5

DRILLING				MATERIAL										
VE	E	F	H	SUPPORT	GROUND WATER LEVELS	SAMPLES & FIELD TESTS	DEPTH (m)	GRAPHIC LOG	CLASSIFICATION SYMBOL	MATERIAL DESCRIPTION Soil Type, Colour, Plasticity or Particle Characteristic Secondary and Minor Components	MOISTURE CONDITION	CONSISTENCY RELATIVE DENSITY	HAND PENETROMETER	STRUCTURE & Other Observations
X						ES 0.10m	0.0	[Cross-hatch pattern]		FILL: sandy SILT: medium to high plasticity, dark brown, fine to medium sand, trace rootlets, hose	w-PL			FILL 0.00: PID <1
					Not Observed	ES 0.30m ES 0.40m	0.30 0.40	[Vertical lines]	CH	Silty CLAY: high plasticity, orange-brown, trace fine to medium ironstone gravel		St	X	RESIDUAL SOIL 0.30: HP =140 kPa 0.30: PID <1
						ES 0.80m ES 0.90m	0.80 0.90			At 0.7m: orange-brown mottled grey			X	0.80: HP =180 kPa 0.80: PID <1

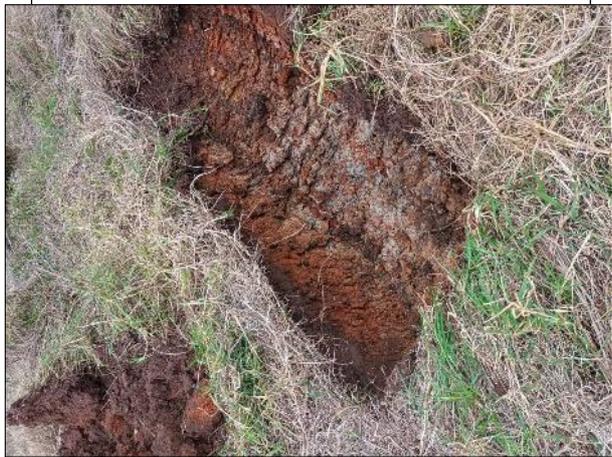
DRILLING				MATERIAL								
VE PENETRATION	E F H	SUPPORT	GROUND WATER LEVELS	SAMPLES & FIELD TESTS	DEPTH (m)	GRAPHIC LOG	CLASSIFICATION SYMBOL	MATERIAL DESCRIPTION Soil Type, Colour, Plasticity or Particle Characteristic Secondary and Minor Components	MOISTURE CONDITION	CONSISTENCY RELATIVE DENSITY	HAND PENETROMETER	STRUCTURE & Other Observations
[Pattern]				ES 0.10m	0.0	[Pattern]		FILL: sandy SILT: medium to high plasticity, dark brown, fine to medium sand, trace rootlets	w-PL			FILL 0.00: PID <5
				ES 0.30m	0.30	[Pattern]		Silty CLAY: high plasticity, red-brown, trace fine to medium ironstone gravel	w-PL	St to VSt	X	Field Replicate BD6/20220902 taken at 0.0-0.1m depth
				ES 0.40m	0.40	[Pattern]	CH				X	RESIDUAL SOIL 0.30: HP =180 kPa 0.30: PID <5
				ES 0.80m	0.80	[Pattern]		EXCAVATION AEC43TP27 TERMINATED AT 0.90 m Target depth			X	0.80: HP =200 kPa 0.80: PID <5
				ES 0.90m	0.90	[Pattern]					X

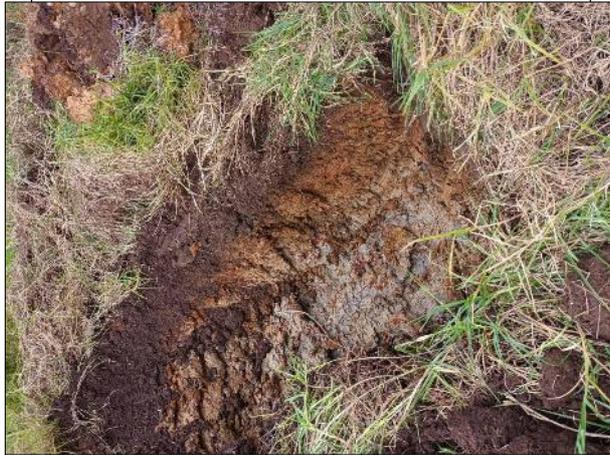
1.0			EXCAVATION AEC43TP28 TERMINATED AT 1.00 m Target depth				
					1.5

DRILLING				MATERIAL								
VE PENETRATION	E F H	SUPPORT	GROUND WATER LEVELS	SAMPLES & FIELD TESTS	DEPTH (m)	GRAPHIC LOG	CLASSIFICATION SYMBOL	MATERIAL DESCRIPTION Soil Type, Colour, Plasticity or Particle Characteristic Secondary and Minor Components	MOISTURE CONDITION	CONSISTENCY RELATIVE DENSITY	HAND PENETROMETER	STRUCTURE & Other Observations
				ES 0.10m	0.0			FILL: sandy SILT: medium to high plasticity, dark brown, fine to medium sand, trace rootlets	w-PL			FILL 0.00: PID <5
				ES 0.30m ES 0.40m	0.30 0.40			Silty CLAY: high plasticity, orange-brown, trace fine to medium ironstone gravel	w-PL	St to VSt	X	RESIDUAL SOIL 0.30: HP =180 kPa 0.30: PID <5
				ES 0.80m ES 0.90m	0.80 0.90		CH	At 0.7m: orange-brown mottled grey			X	0.80: HP =190 kPa 0.80: PID <5

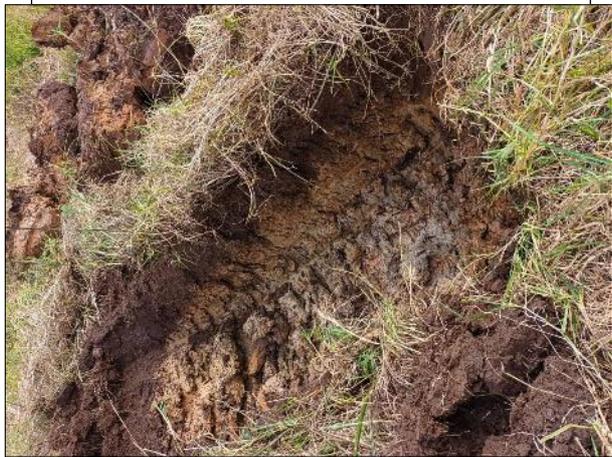
DRILLING				MATERIAL								
VE PENETRATION	E F H	SUPPORT	GROUND WATER LEVELS	SAMPLES & FIELD TESTS	DEPTH (m)	GRAPHIC LOG	CLASSIFICATION SYMBOL	MATERIAL DESCRIPTION Soil Type, Colour, Plasticity or Particle Characteristic Secondary and Minor Components	MOISTURE CONDITION	CONSISTENCY RELATIVE DENSITY	HAND PENETROMETER	STRUCTURE & Other Observations
				ES 0.10m	0.0	[Cross-hatch symbol]	0.20m	FILL: sandy SILT: medium to high plasticity, dark brown, fine to medium sand, trace rootlets	w-PL		X	FILL 0.00: PID <5
				ES 0.30m ES 0.40m	0.30 0.40	[Vertical lines symbol]	CH	Silty CLAY: high plasticity, pale orange-brown, trace fine to medium ironstone gravel	w-PL	St	X	RESIDUAL SOIL 0.30: HP =180 kPa 0.30: PID <5
				ES 0.80m ES 0.90m	0.80 0.90		0.90m	EXCAVATION AEC43TP29 TERMINATED AT 0.90 m Target depth			X	0.80: HP =180 kPa 0.80: PID <5

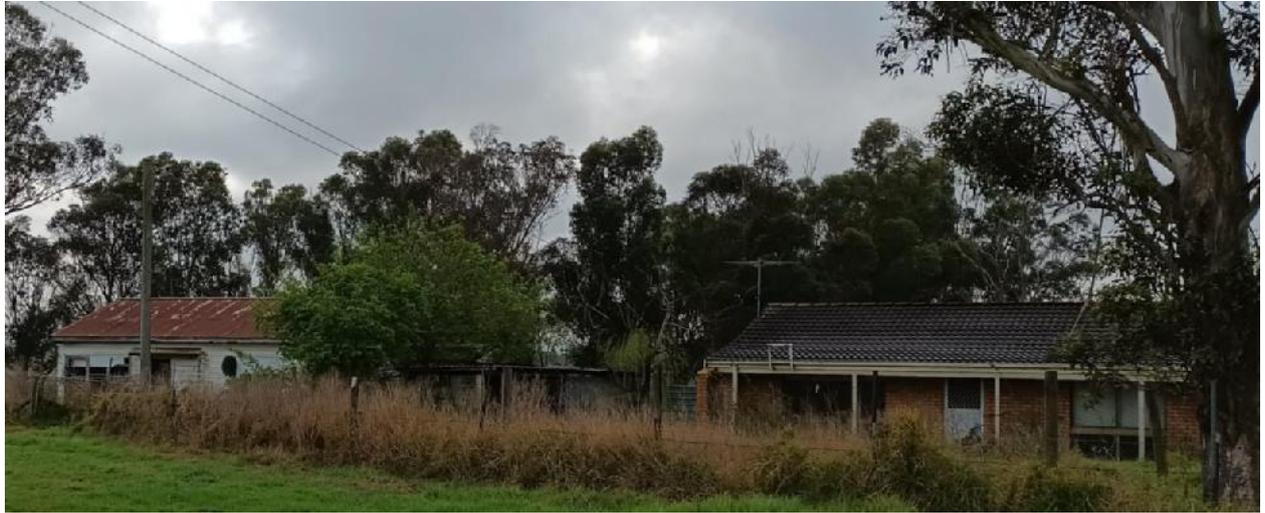
Photograph 1 - Site buildings

Buildings on the site will be demolished for the SCAW project. It is understood that, under European and Other Heritage Construction Environmental Management Plan for the SMWSA project, buildings at the site are not to be damaged until approval has been received. At the time of field work for this DSI, approval had not yet been received.

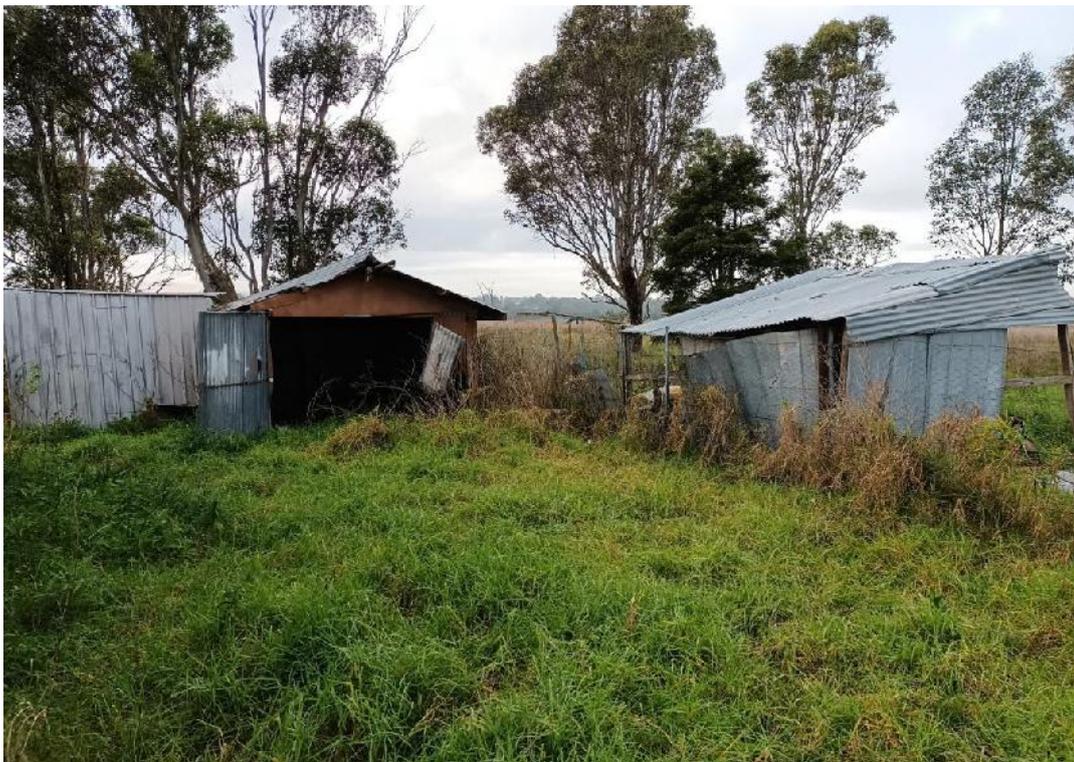
Photograph 2 - Site structures

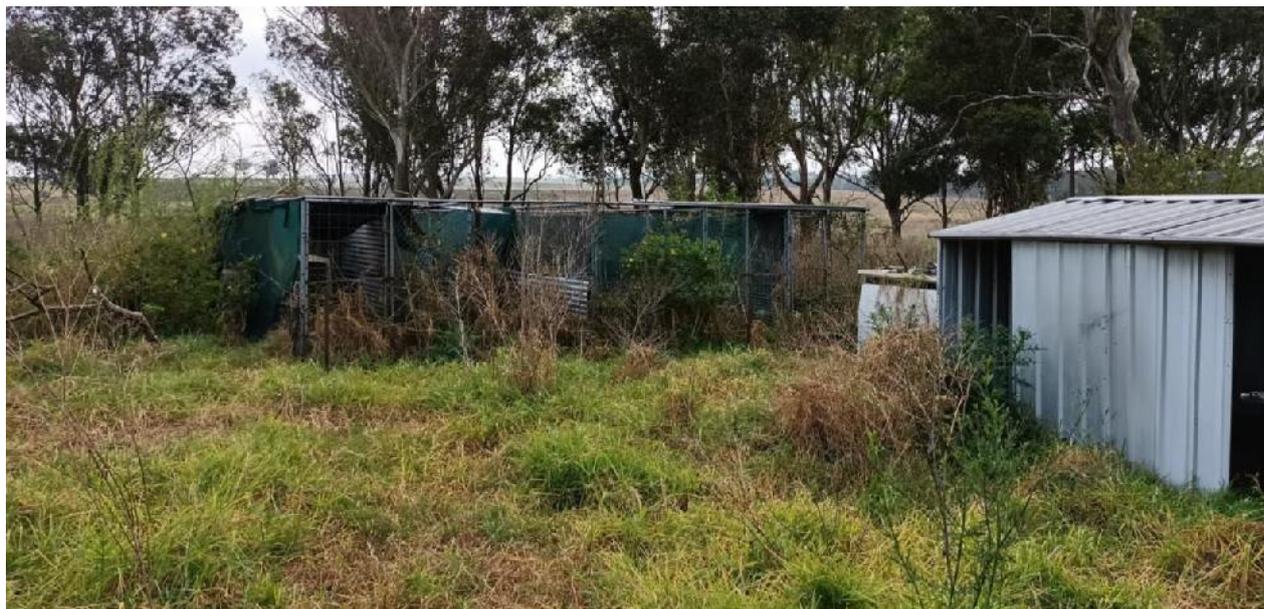
Photograph 3 - Site structures

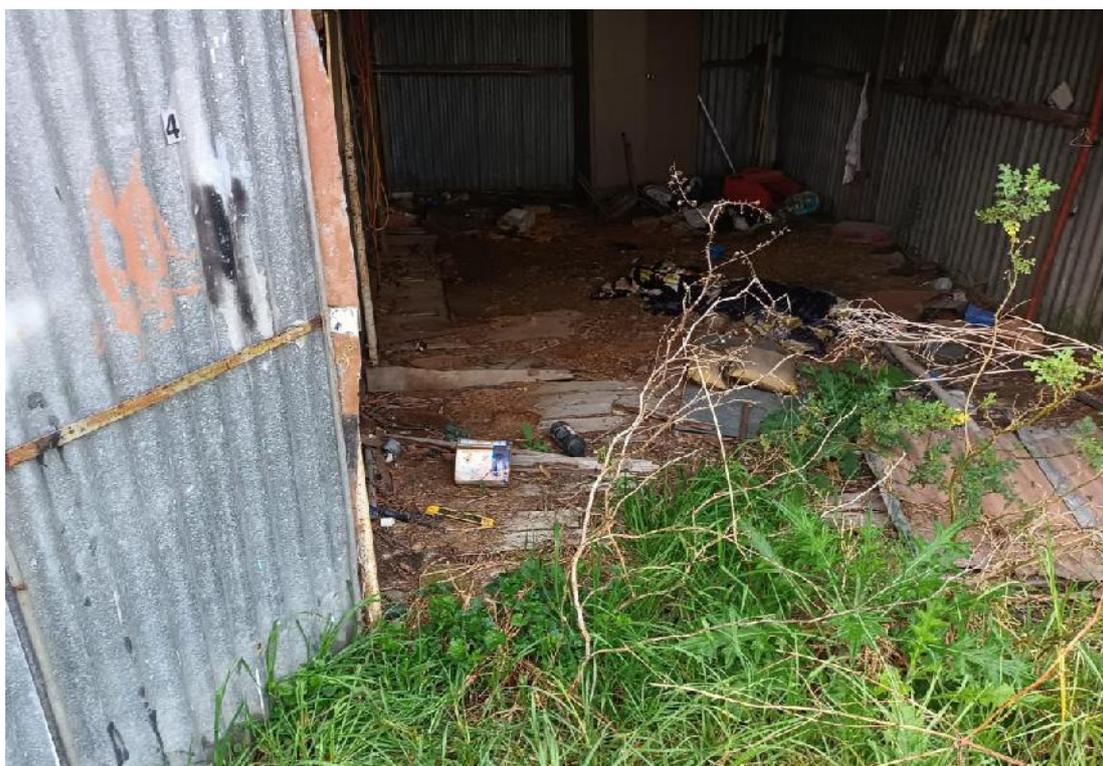
The land at the site has residences with sheds and animal shelters. The eastern part of the site was used for paddocks. One shed was observed to have a small number of empty paint cans and other small empty old chemical containers on the ground surface. The majority of the ground surface was covered in grass.

Photograph 4 - Shed with paint tins and chemical bottles

Prior to demolition, a hazardous materials building survey should be undertaken for structures that will be demolished at the site (if not undertaken already).
