Remediation Action Plan

Surface & Civil Alignment Works (SCAW) Package for
Sydney Metro - Western Sydney Airport (SMWSA)
Area of Environmental Concern (AEC) 35,
Luddenham Road, Orchard Hills

Prepared for
CPB Contractors Pty Limited & United Infrastructure
Pty Limited Joint Venture (CPBUI JV)

Project 204814.01
March 2023

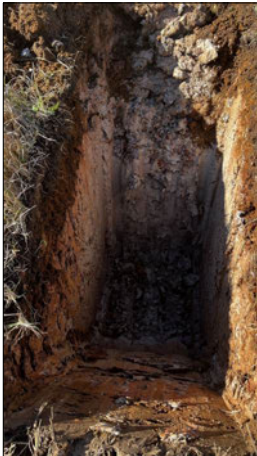
0.5						400	RESIDUAL SOIL
							0.80m								
							ES 0.90m	1.0							0.80: PID<1
							1.50m	1.5		CI-CH		w<PL			1.50: PID<1
							ES 1.60m								
											At 1.8m: extremely weathered ironstone gravel

2.10m	2.0							2.10: PID<1
							ES 2.20m								
								2.5							
								2.50			EXCAVATION AEC35TP02 TERMINATED AT 2.50 m Target depth

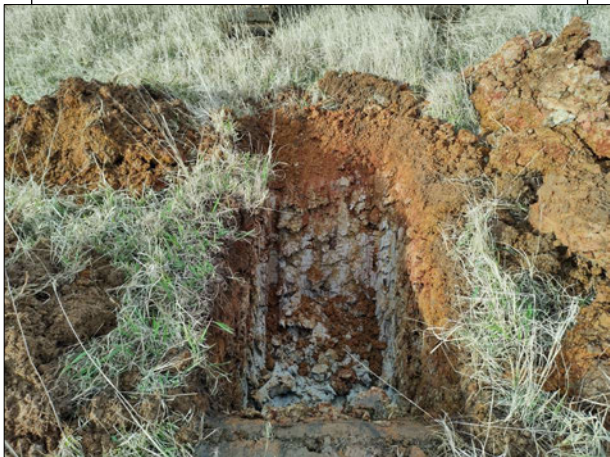
0.60m	0.5		CL-CI		w<PL		400	0.20: PID<1		
				ES 0.70m								0.60: PID<1		
				1.00m	1.0			CLAY: high plasticity, pale grey and mottled orange, with ironstone and shale gravel				1.00: PID<1		
				ES 1.10m			CH		w<PL

1.5		1.50m	EXCAVATION AEC35TP06 TERMINATED AT 1.50 m Target depth						
					2.0

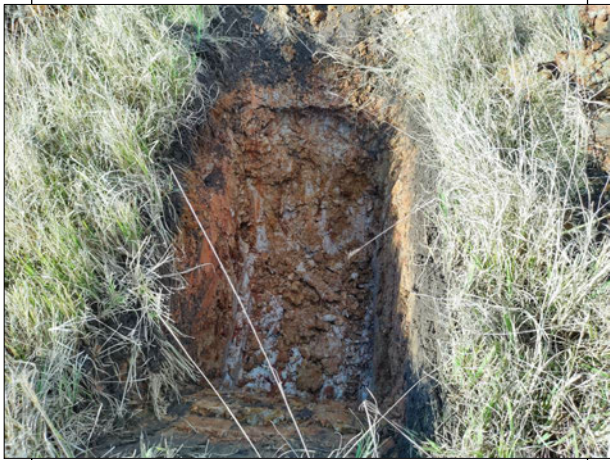
0.5		CI-CH	At 0.55m: high plasticity, red-brown and mottled grey, with shale ironstone gravel			
			0.90m ES 1.00m	1.0				w<PL		0.90: PID<1
			1.40m ES 1.50m	1.5		CL-CI	Silty CLAY: low to medium plasticity, pale grey and mottled orange, with ironstone and shale gravel	w<PL		1.40: PID<1

2.0			EXCAVATION AEC35TP07 TERMINATED AT 2.00 m Target depth			
				2.5

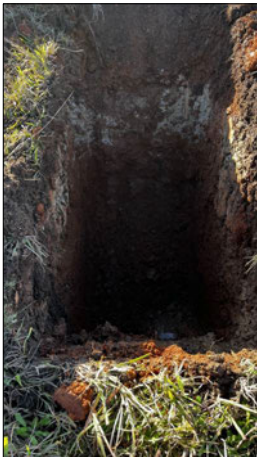
0.50m ES 0.60m	0.5		CH	CLAY: high plasticity, pale grey and orange, rootlets	w<PL			RESIDUAL SOIL 0.50: PID<1		
				1.20m ES 1.30m	1.0			Silty CLAY: low to medium plasticity, red-orange, with extremely weathered ironstone and organic matter, trace rootlets				1.20: PID<1

2.00m ES 2.10m	2.0		CL-Cl		w<PL			2.00: PID<1		
					2.30m			EXCAVATION AEC35TP09 TERMINATED AT 2.30 m Target depth						
					2.5

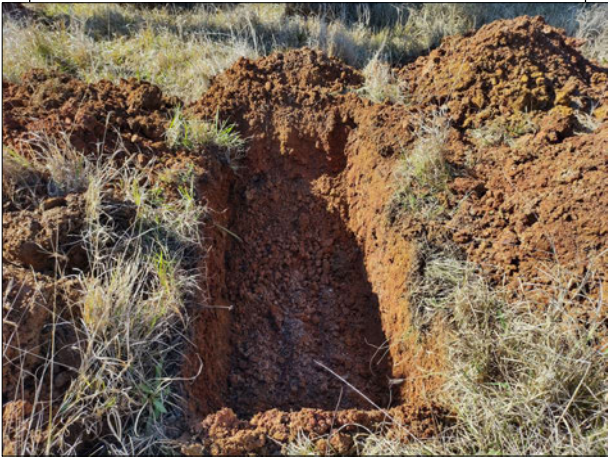
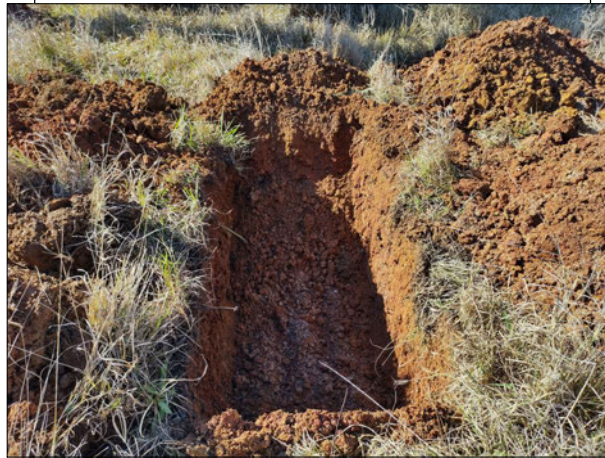
0.05m FILL: clayey SAND: fine to medium grained sand 0.20m FILL: silty CLAY: low to medium plasticity, red-orange and brown Silty CLAY: low to medium plasticity, red-orange and brown, ironstone gravel At 0.4m: becoming pale red-orange and mottled grey, with more ironstone gravel 0.90m	M w<PL			100 200 300 400		FILL 0.00: PID<1 0.10: PID<1 Field Replicate BD5/20220728 taken at 0.1-0.2m depth RESIDUAL SOIL 0.60: PID<1

1.0			EXCAVATION AEC35TP10 TERMINATED AT 0.90 m Target depth							
					1.5

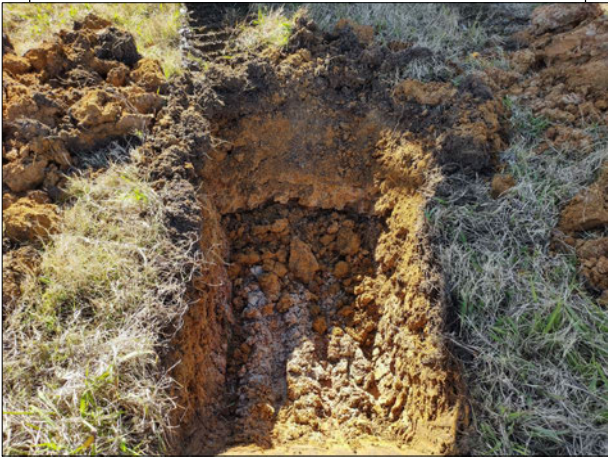
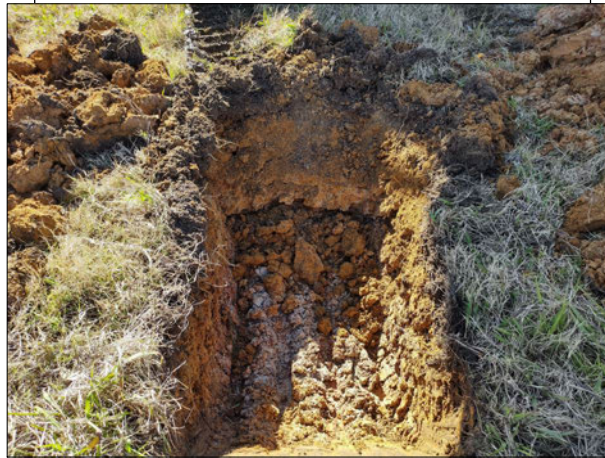
DRILLING				MATERIAL																		
SUPPORT				MATERIAL DESCRIPTION Soil Type, Colour, Plasticity or Particle Characteristic Secondary and Minor Components											MOISTURE CONDITION		CONSISTENCY RELATIVE DENSITY		HAND PENETRO- METER		STRUCTURE & Other Observations	
GROUND WATER LEVELS				SAMPLES & FIELD TESTS											100		200		300		400	
Not Observed				CL-Cl											w<PL		-				0.60: PID<1	
0.10m				0.15m											M						FILL 0.00: PID<1	
0.20m															w<PL						RESIDUAL SOIL 0.20: PID<1	
0.30m																						
0.60m																						
0.70m															w<PL							
				0.90m																		
				EXCAVATION AEC35TP12 TERMINATED AT 0.90 m Target depth

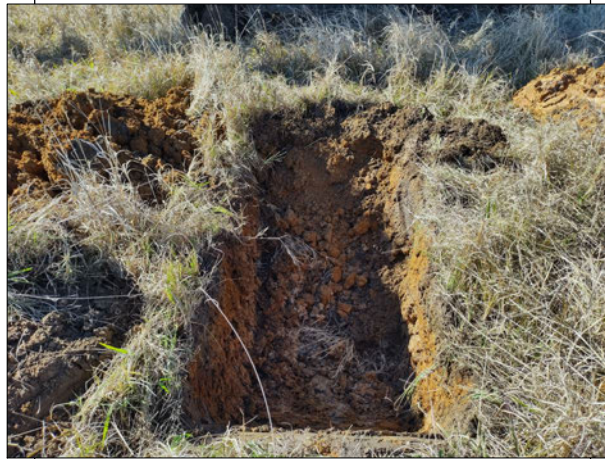
DRILLING						MATERIAL									
VE E F H			SUPPORT	GROUND WATER LEVELS	SAMPLES & FIELD TESTS	DEPTH (m)	GRAPHIC LOG	CLASSIFICATION SYMBOL	MATERIAL DESCRIPTION Soil Type, Colour, Plasticity or Particle Characteristic Secondary and Minor Components	MOISTURE CONDITION	CONSISTENCY RELATIVE DENSITY	HAND PENETRO- METER	STRUCTURE & Other Observations		
			Not Observed	ES	0.0		CL-CI	FILL: clayey SAND: dark brown, fine to medium grained sand, with clay, angular to subangular gravel and rootlets	M	-	100 200 300 400	FILL			
				0.10m	0.20m			Silty CLAY: low to medium plasticity, red-orange, rootlets	w<PL			0.00: PID<1			
				0.30m	At 0.5m: medium to high plasticity, becoming red-orange and mottled grey			RESIDUAL SOIL							
				ES								0.40m	0.30: PID<1		
0.70m	0.5	0.70: PID<1													
ES	0.80m	1.0	1.00m	EXCAVATION AEC35TP13 TERMINATED AT 1.00 m Target depth

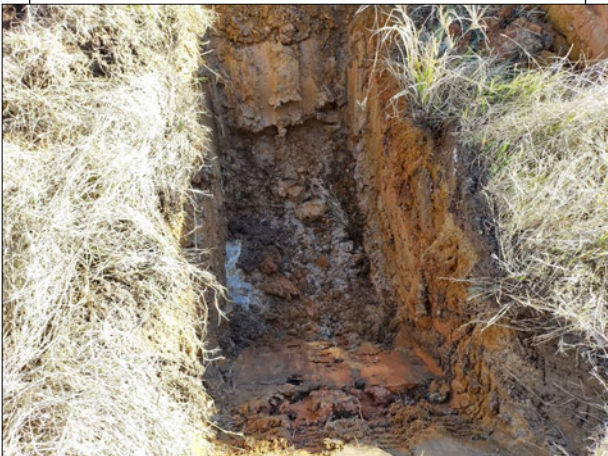
0.70m				w<PL									
0.80m				CL-CI									
1.40m				Silty CLAY: low to medium plasticity, pale grey and mottled orange, with ironstone gravel

1.50m				w<PL									
1.60m				CL-CI									
1.90m				EXCAVATION AEC35TP14 TERMINATED AT 1.90 m Target depth									
2.0

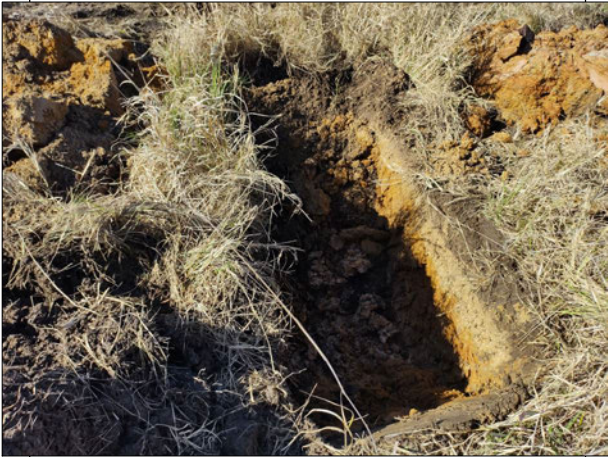
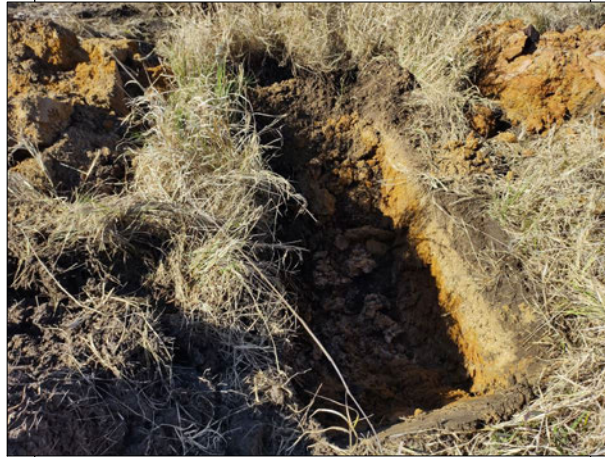
0.20m		M						
								FILL: silty SAND: pale grey and pale yellow, fine to medium grained sand, trace gravel								
								0.40m								
								Silty CLAY: medium to high plasticity, red-orange and mottled grey								
						CI-CH			w<PL

1.0			EXCAVATION AEC35TP15 TERMINATED AT 1.00 m Target depth								
					1.5

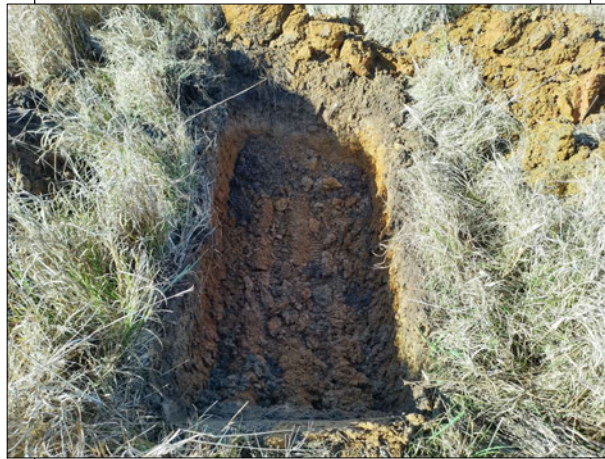
CL-CI	0.50m		FILL: silty SAND: pale grey, fine to medium grained sand, trace gravel and rootlets		M	200
				0.70m ES 0.80m	1.0		Silty CLAY: low to medium plasticity, red-orange, trace rootlets			w<PL		300

1.00m	EXCAVATION AEC35TP18 TERMINATED AT 1.00 m Target depth					400
