## Remediation Action Plan

Surface & Civil Alignment Works (SCAW) Package for  
Sydney Metro - Western Sydney Airport (SMWSA)  
Area of Environmental Concern (AEC) 36,  
Patons Lane, Orchard Hills

Prepared for  
CPB Contractors Pty Limited & United Infrastructure  
Pty Limited Joint Venture (CPBUI JV)

Project 204814.01  
July 2023

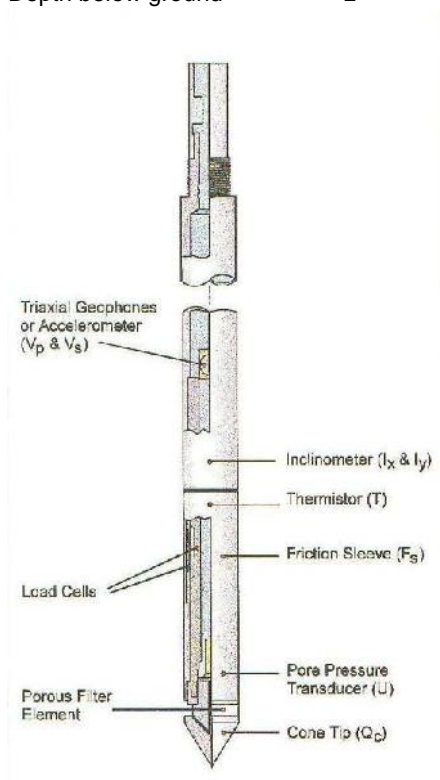
Figure 1: Cone Diagram

The soil parameters measured depend on the type of cone being used, however they always include the following basic measurements

- Cone tip resistance  $q_c$
- Sleeve friction  $f_s$
- Inclination (from vertical)  $i$
- Depth below ground  $z$

The inclinometer in the cone enables the verticality of the test to be confirmed and, if required, the vertical depth can be corrected.

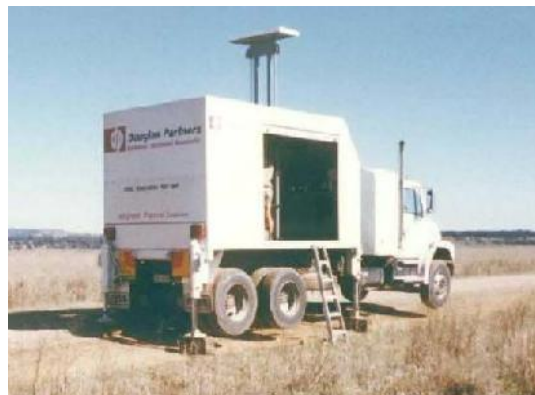
Figure 2: Purpose built CPT rig

The cone is thrust into the ground at a steady rate of about 20 mm/sec, usually using the hydraulic rams of a purpose built CPT rig, or a drilling rig. The testing is carried out in accordance with the Australian Standard AS1289 Test 6.5.1.

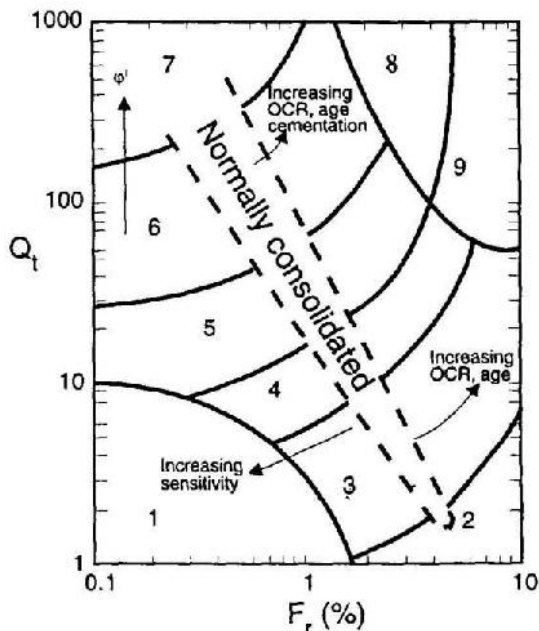
Figure 3: Soil Classification Chart

The CPT parameters can be used to infer the Soil Behaviour Type (SBT), based on normalised values of cone resistance ( $Q_t$ ) and friction ratio ( $Fr$ ). These are used in conjunction with soil classification charts, such as the one below (after Robertson 1990)

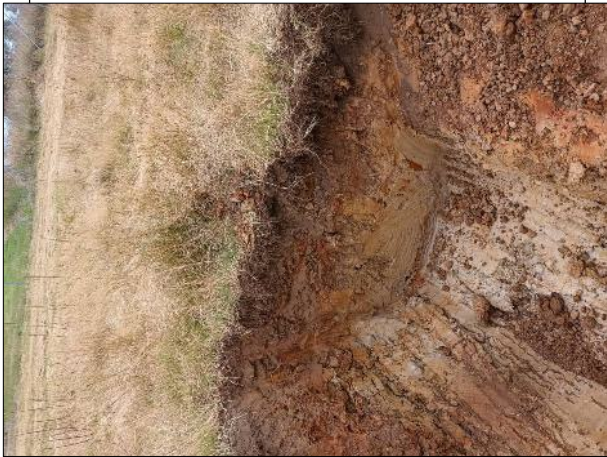
0.90m ES 1.00m		1.0						EXCAVATION AEC36TP67 TERMINATED AT 1.20 m Target depth								X		0.90: HP =190 kPa 0.90: PID<5	
										1.5

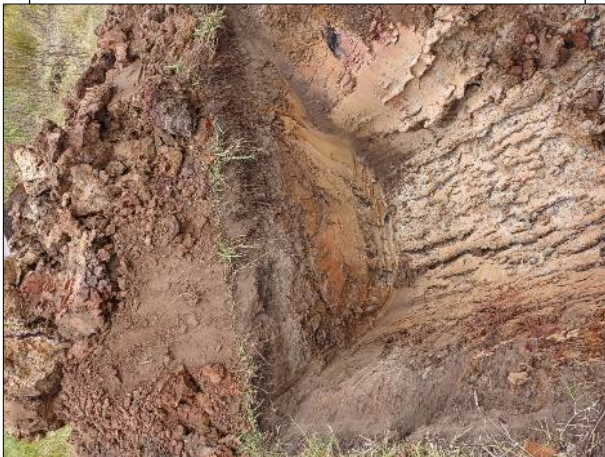
1.0						EXCAVATION AEC36TP69 TERMINATED AT 1.00 m Target depth													
										1.5

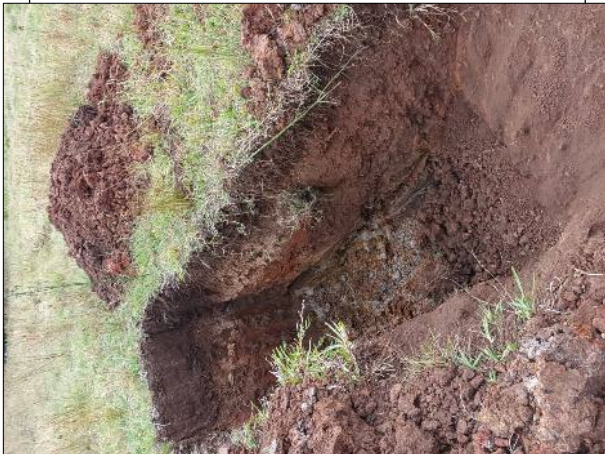
1.00m ES 1.10m	1.0				1.10m			X	1.00: HP =170 kPa 1.00: PID<5		
									EXCAVATION AEC36TP72 TERMINATED AT 1.10 m Target depth						
					1.5

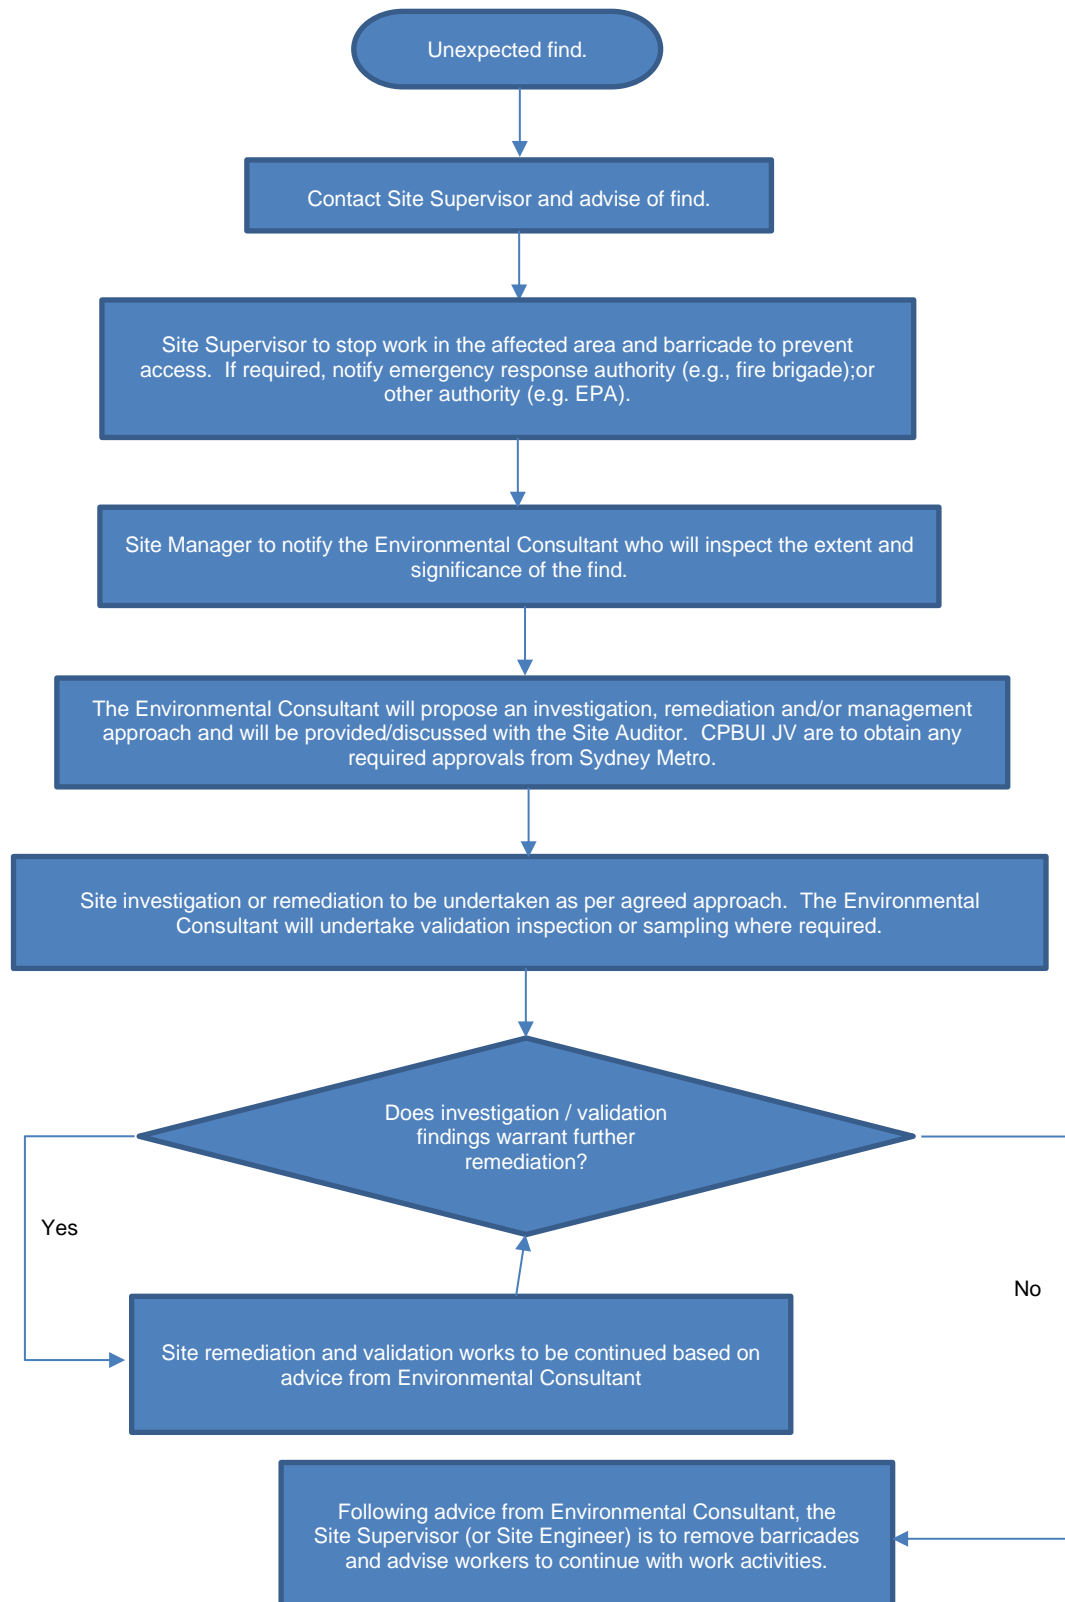
### Flow Chart for Unexpected Finds Protocol

A flow chart for the unexpected finds protocol is shown below.
