Remediation Action Plan

Surface & Civil Alignment Works (SCAW) Package for
Sydney Metro - Western Sydney Airport (SMWSA)
Area of Environmental Concern (AEC) 43, 1793
Elizabeth Drive, Badgerys Creek

Prepared for
CPB Contractors Pty Limited & United Infrastructure
Pty Limited Joint Venture (CPBUI JV)

Project 204814.01
May 2023

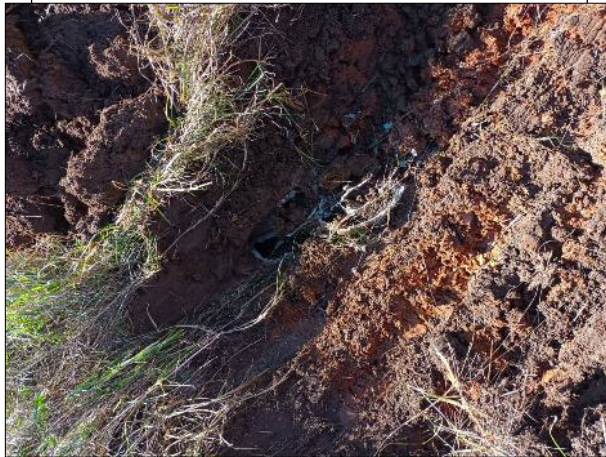
DRILLING					MATERIAL							
VE E F H		SUPPORT	GROUND WATER LEVELS	SAMPLES & FIELD TESTS	DEPTH (m)	GRAPHIC LOG	CLASSIFICATION SYMBOL	MATERIAL DESCRIPTION Soil Type, Colour, Plasticity or Particle Characteristic Secondary and Minor Components	MOISTURE CONDITION	CONSISTENCY RELATIVE DENSITY	HAND PENETRO- METER	STRUCTURE & Other Observations
Not Observed		ES 0.10m			0.0			FILL: sandy SILT: medium to high plasticity, dark brown, fine to medium sand, trace rootlets	w-PL			FILL 0.00: PID <1
					0.40m			EXCAVATION AEC43TP06 TERMINATED AT 0.40 m Services present - pipe presumed to contain asbestos				0.30: Pipe sample PACM1 taken at 0.3m depth
					0.5

A buried fibre-cement pipe (asbestos) was encountered at a depth of approximately 0.3 m below ground level at AEC43TP06. The pipe was observed to run in an (approximate) north to south direction. A section of fibre-cement pipe, approximately 0.3 m long, was also observed to be buried at a shallow depth (approximately 0.1 m) next to the pipeline.

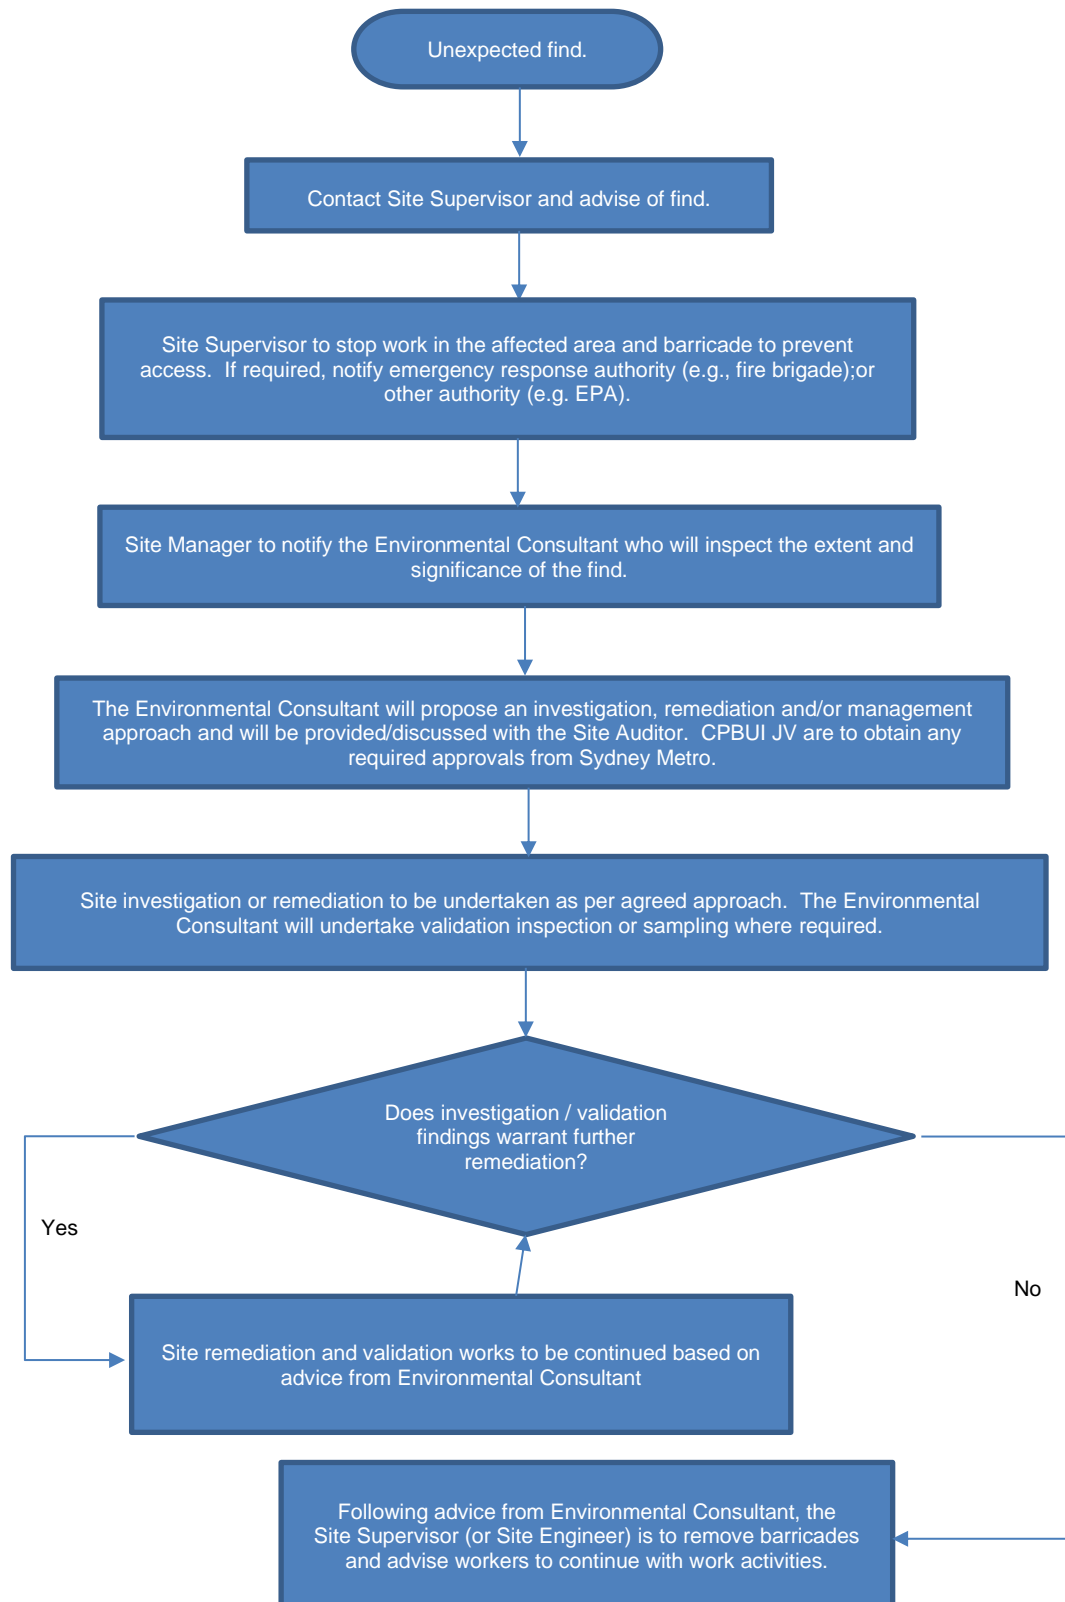
Flow Chart for Unexpected Finds Protocol

A flow chart for the unexpected finds protocol is shown below.
