Permanent Stockpile 105, 43B Luddenham Road, Orchard Hills

Audit Number: MP181\_14B

# Site Audit Report

## Long-term Environmental Management Plan

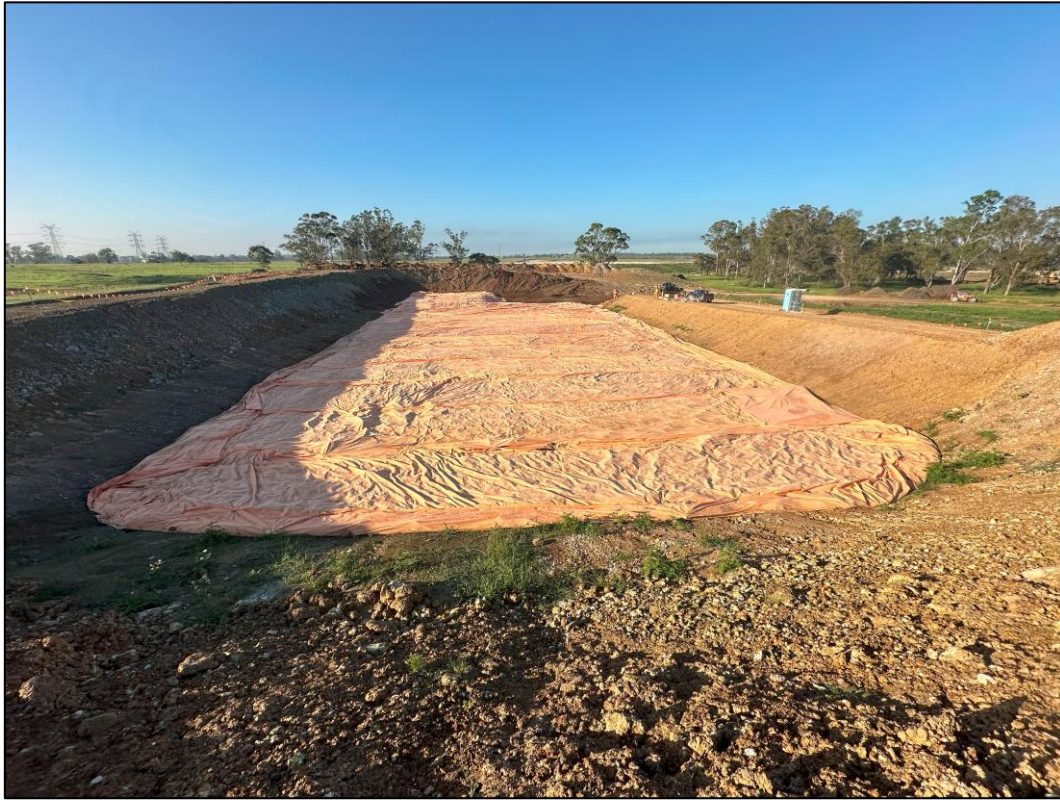
**Site Photograph 1. Top of PS105 containment cell, following placement of mastaTEX Orange Hi Vis Geotextile Warning Layer (facing east), as observed 1 February 2024.**

The marker layer is comprised of mastaTEX Orange Hi Vis Geotextile Warning Layer, photographed upon placement below.
