# Site Audit Statement

Site audit statement no. MP181\_14B

Address: 43B Luddenham Road, Orchard Hills, NSW

## Long-term Environmental Management Plan

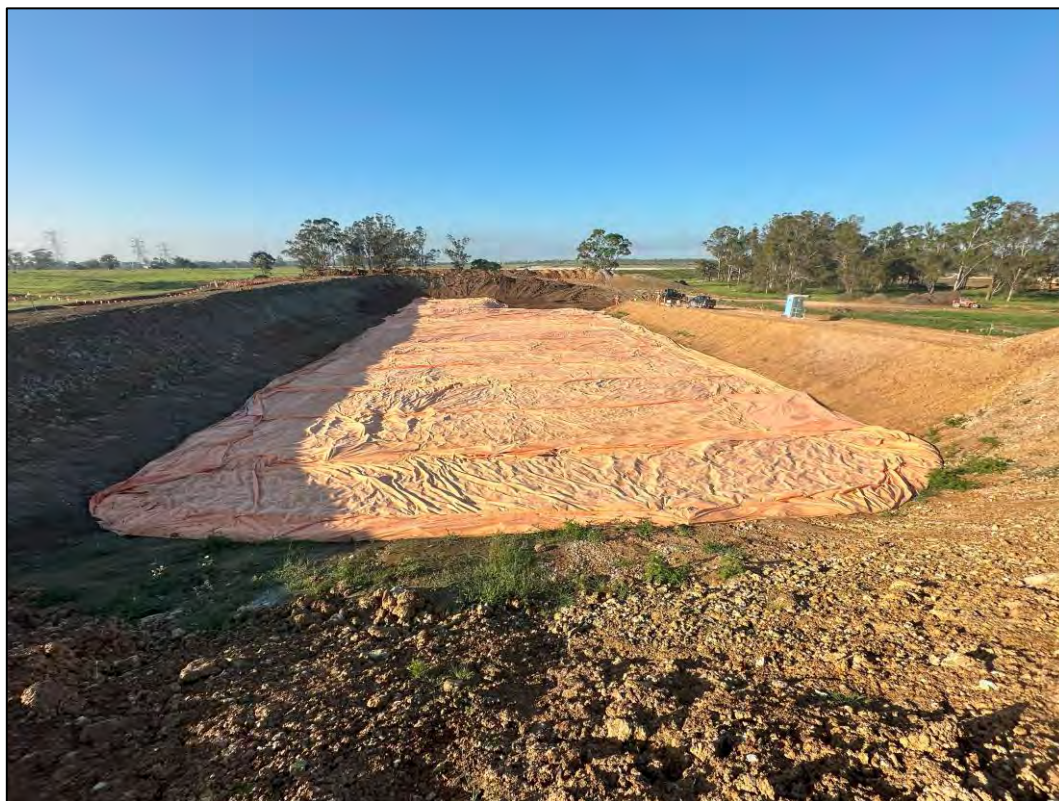
The marker layer is comprised of mastaTEX Orange Hi Vis Geotextile Warning Layer, photographed upon placement below.

**Site Photograph 1. Top of PS105 containment cell, following placement of mastaTEX Orange Hi Vis Geotextile Warning Layer (facing east), as observed 1 February 2024.**

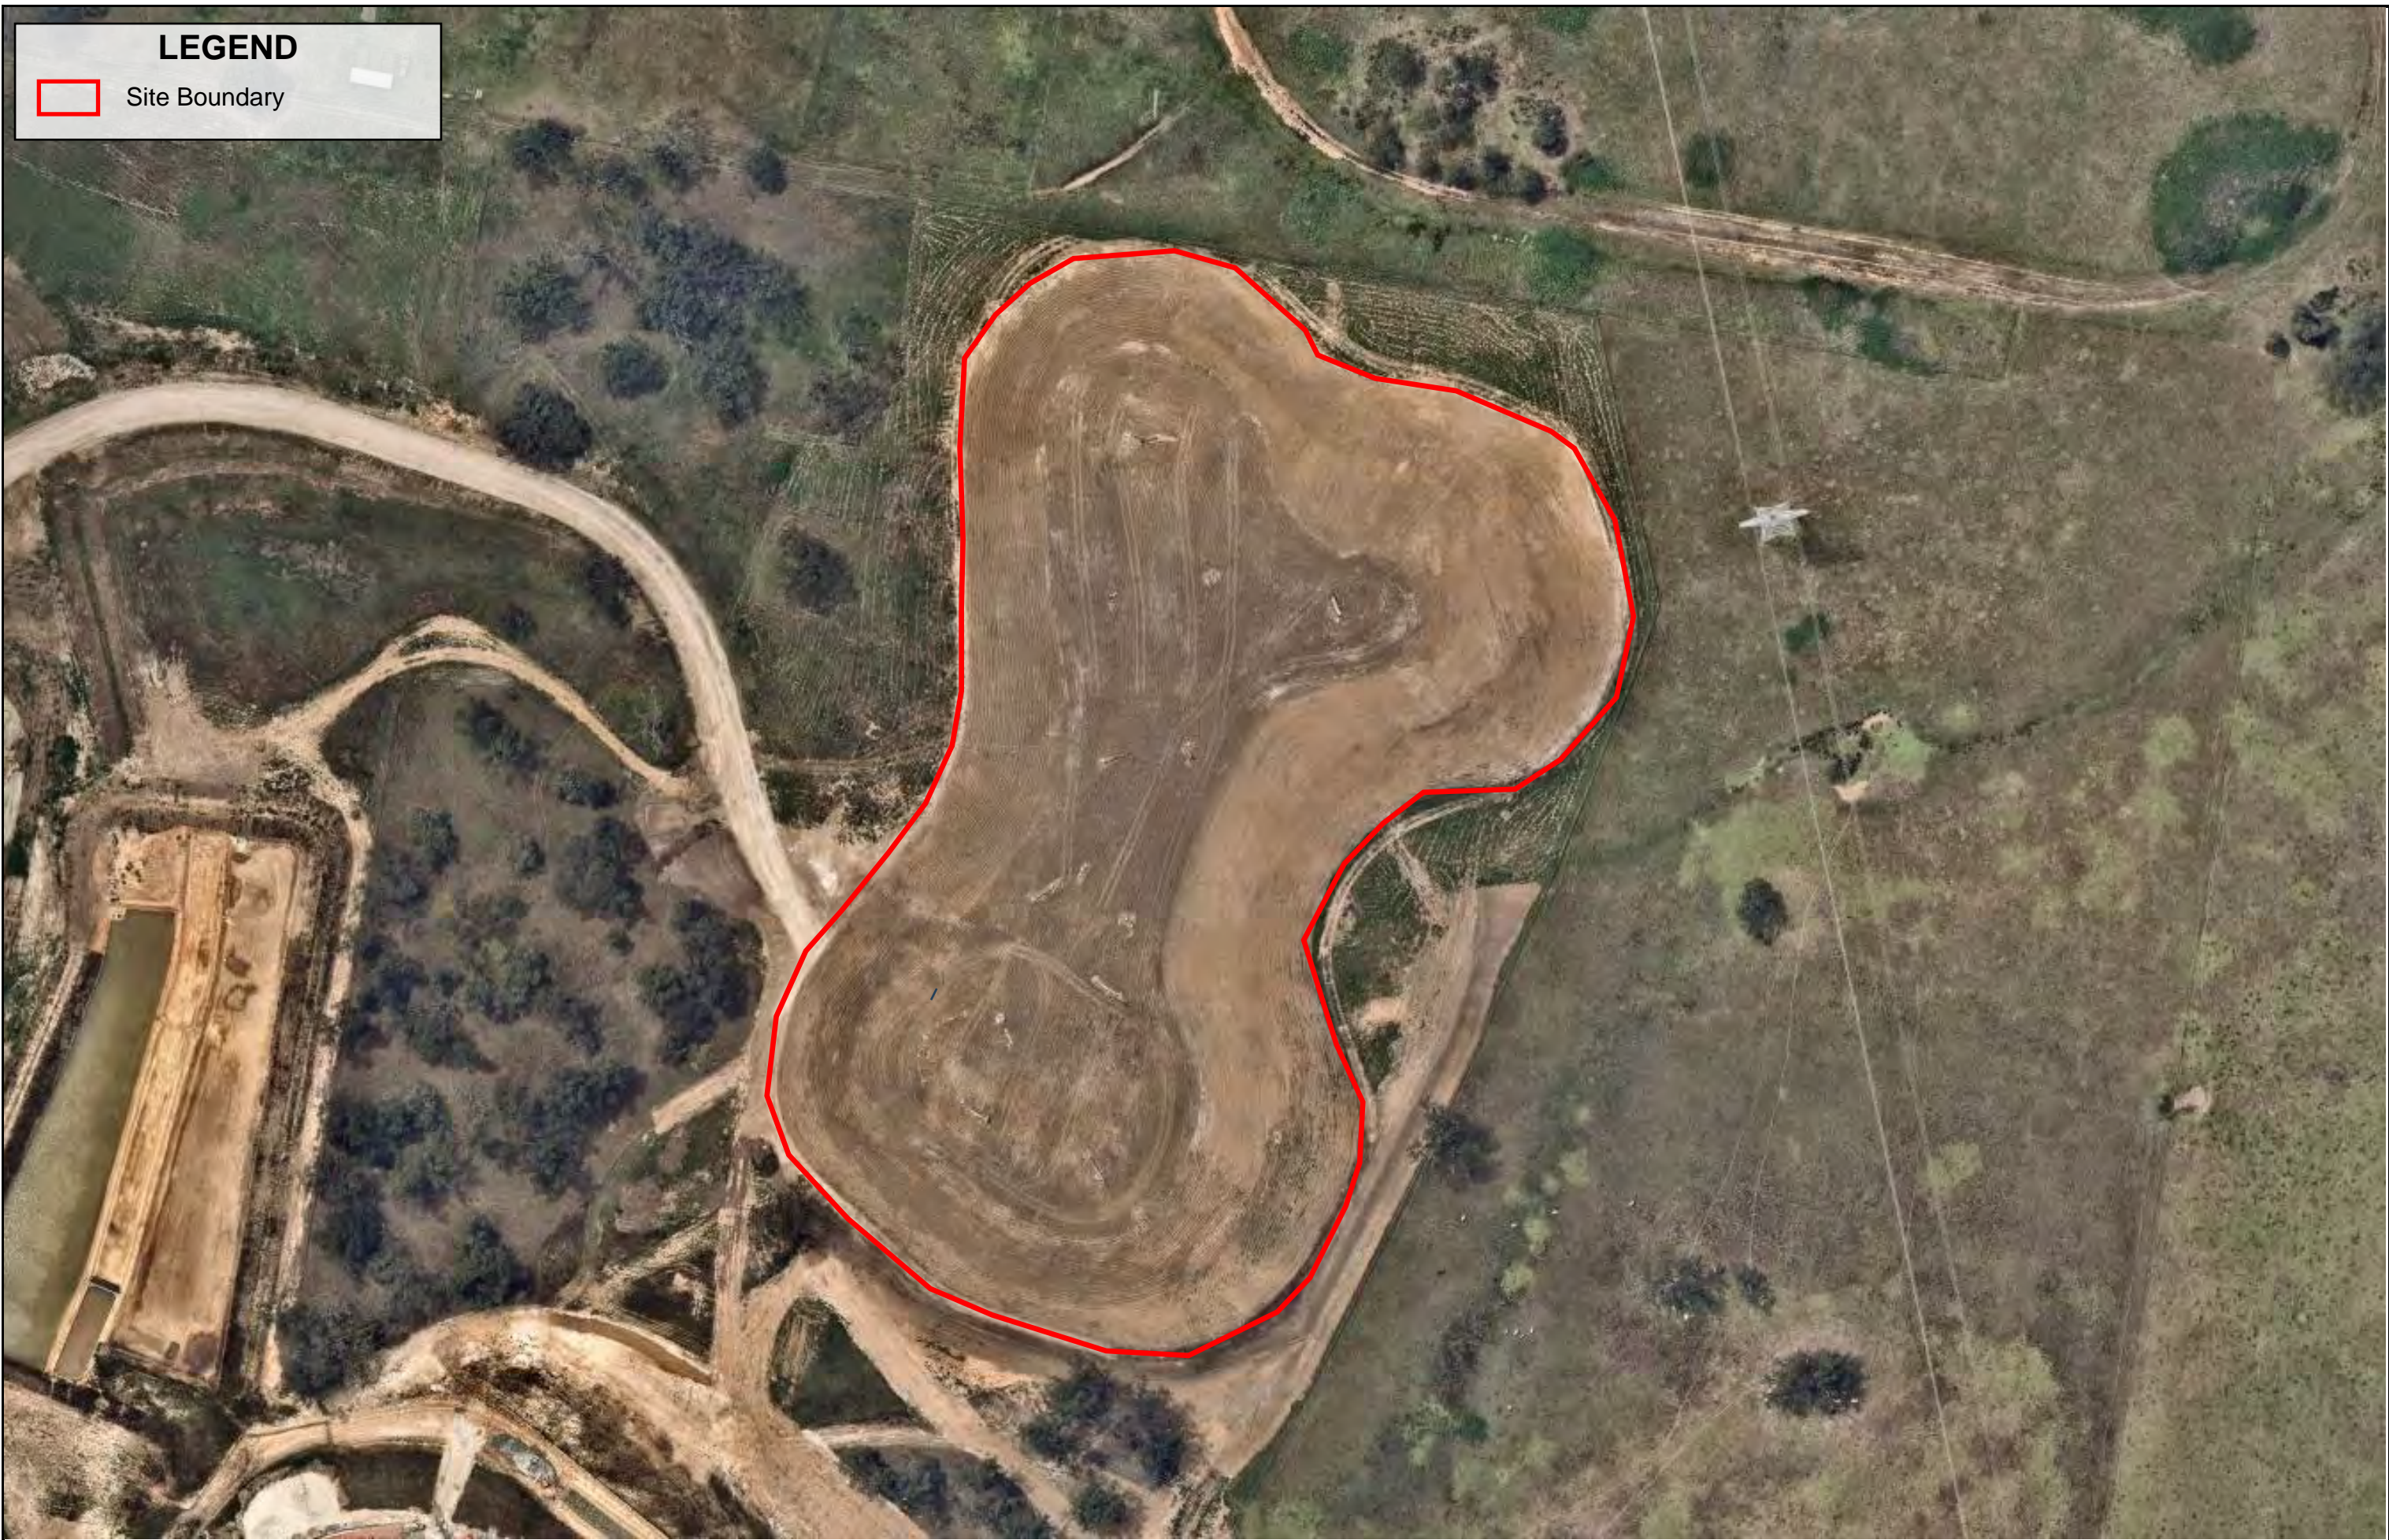
Figure Number:	2
	Project Name:	Site Validation Report – PS105				Figure Date:	2 December 2024
	Project Location:	CPBUIJC SCAW Project Compound, Orchard Hills NSW				Report Number:	1870-SVR-03-021224.v1f

This EMP describes conditions of the site and details passive management strategies to manage contained asbestos impacted soils. The protocols outlined in this EMP must be considered in future works that may result in a breach of the capping layer covering the asbestos impacted soils containment cell on-site (refer to **Figure 2** and **Attachment A – Containment Cell Survey**).
