Aerotropolis Detailed Site Investigation

Sydney Metro Western Sydney Airport Station Boxes and Tunnelling Works

Project number	WSA-200-SBT
Document number	SMWSASBT-CPBG-SWD-SW000-GE-RPT-040515
Revision date	13/11/2022
Revision	A.06

This report provides the findings of the Detailed Site Investigation (DSI) completed for the Aerotropolis site by TTMP.

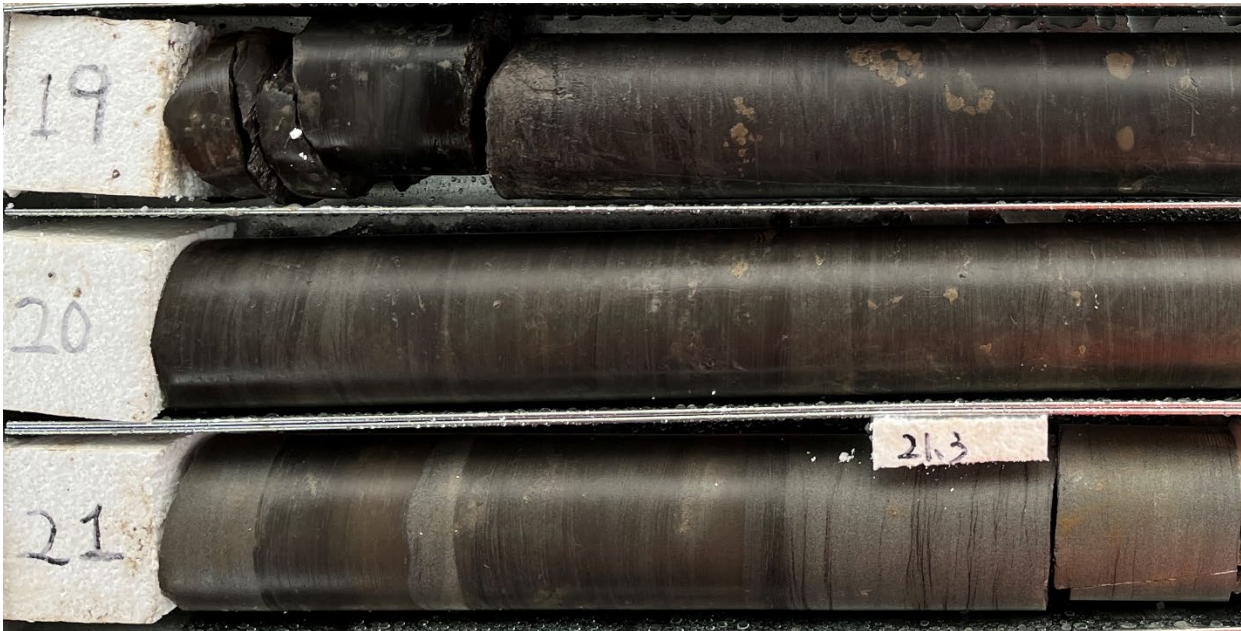
Figure 11-A Closeup of core log photograph from SBT-BH-4016

Figure 10-A and Figure 11-A are photographs of the core logs from SBT-BH-4016. Darker grey shale materials can be observed in the materials where the maximum TRH concentration was observed at approximately 19 m bgs. As noted previously the chromatogram of this sample was interpreted by ALS as shale oil.

In summary the low concentrations of organics reported in the Bringelly Shale at Aerotropolis are considered to be naturally occurring based on the following lines of evidence:

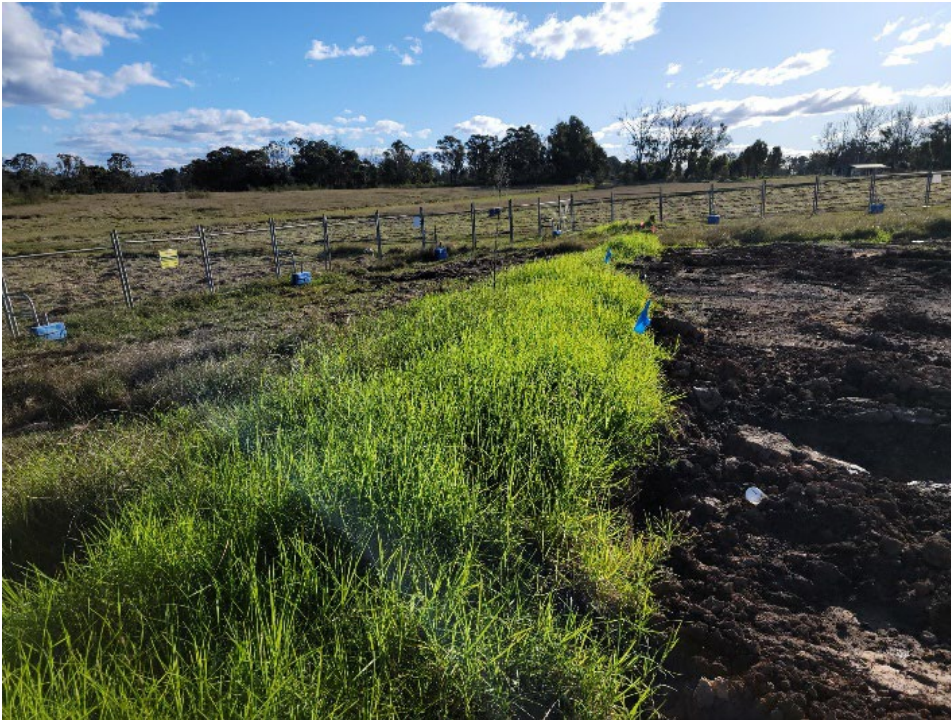
PAC 06 includes the former stockpile area. The southern extent of this area appears to be defined by a brick retaining wall / berm (refer to **Figure 8D, Appendix A**). Fill material on the northern side is approximately 1.1 m thick in SP01-TP92 and SP01-TP93. Previous investigations (GHD and TTC) have reported ACM and fibrous asbestos & asbestos fines in the fill material. Ground levels on the northern side of the wall are notably higher than the southern side as shown in the following photograph.

Plate 1: Photograph looking west with retaining wall present within grassed strip. Land on the northern side of the wall (right of grass strip in the photograph) is visibly higher than the southern side.

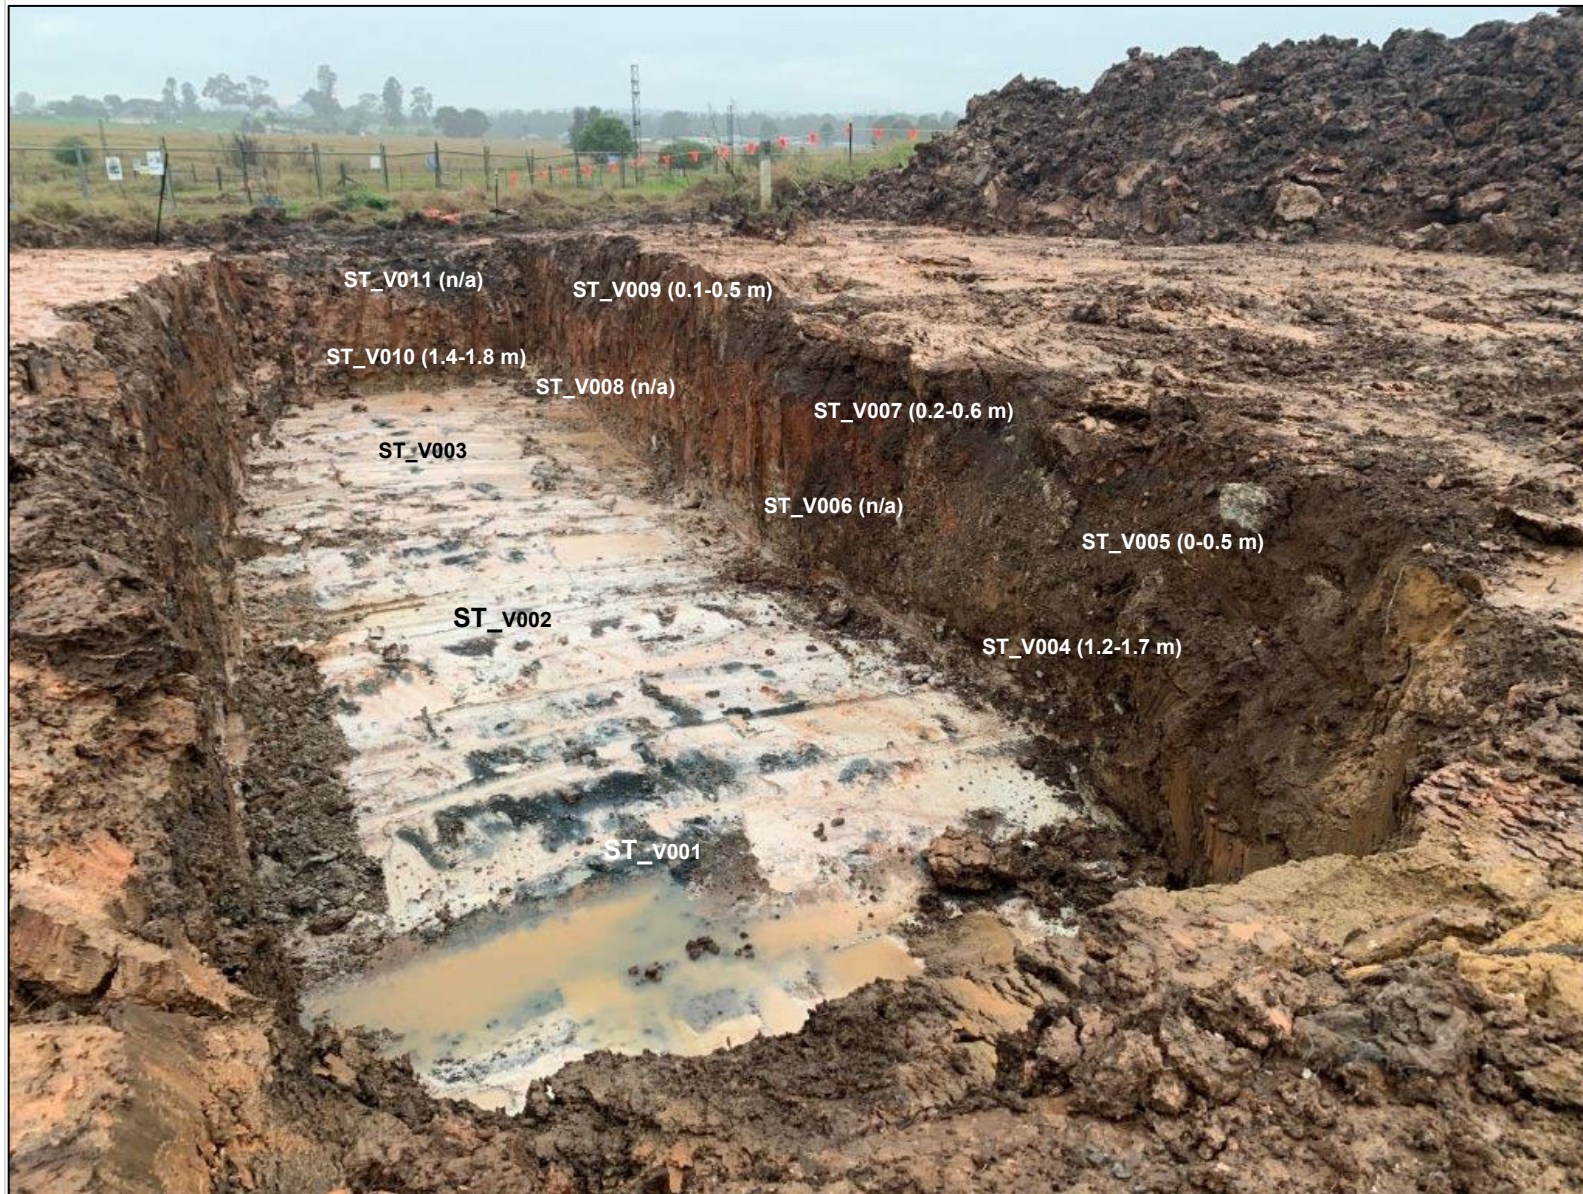
**Photograph 2 –
East wall and
base (base
samples 2.4 m)**

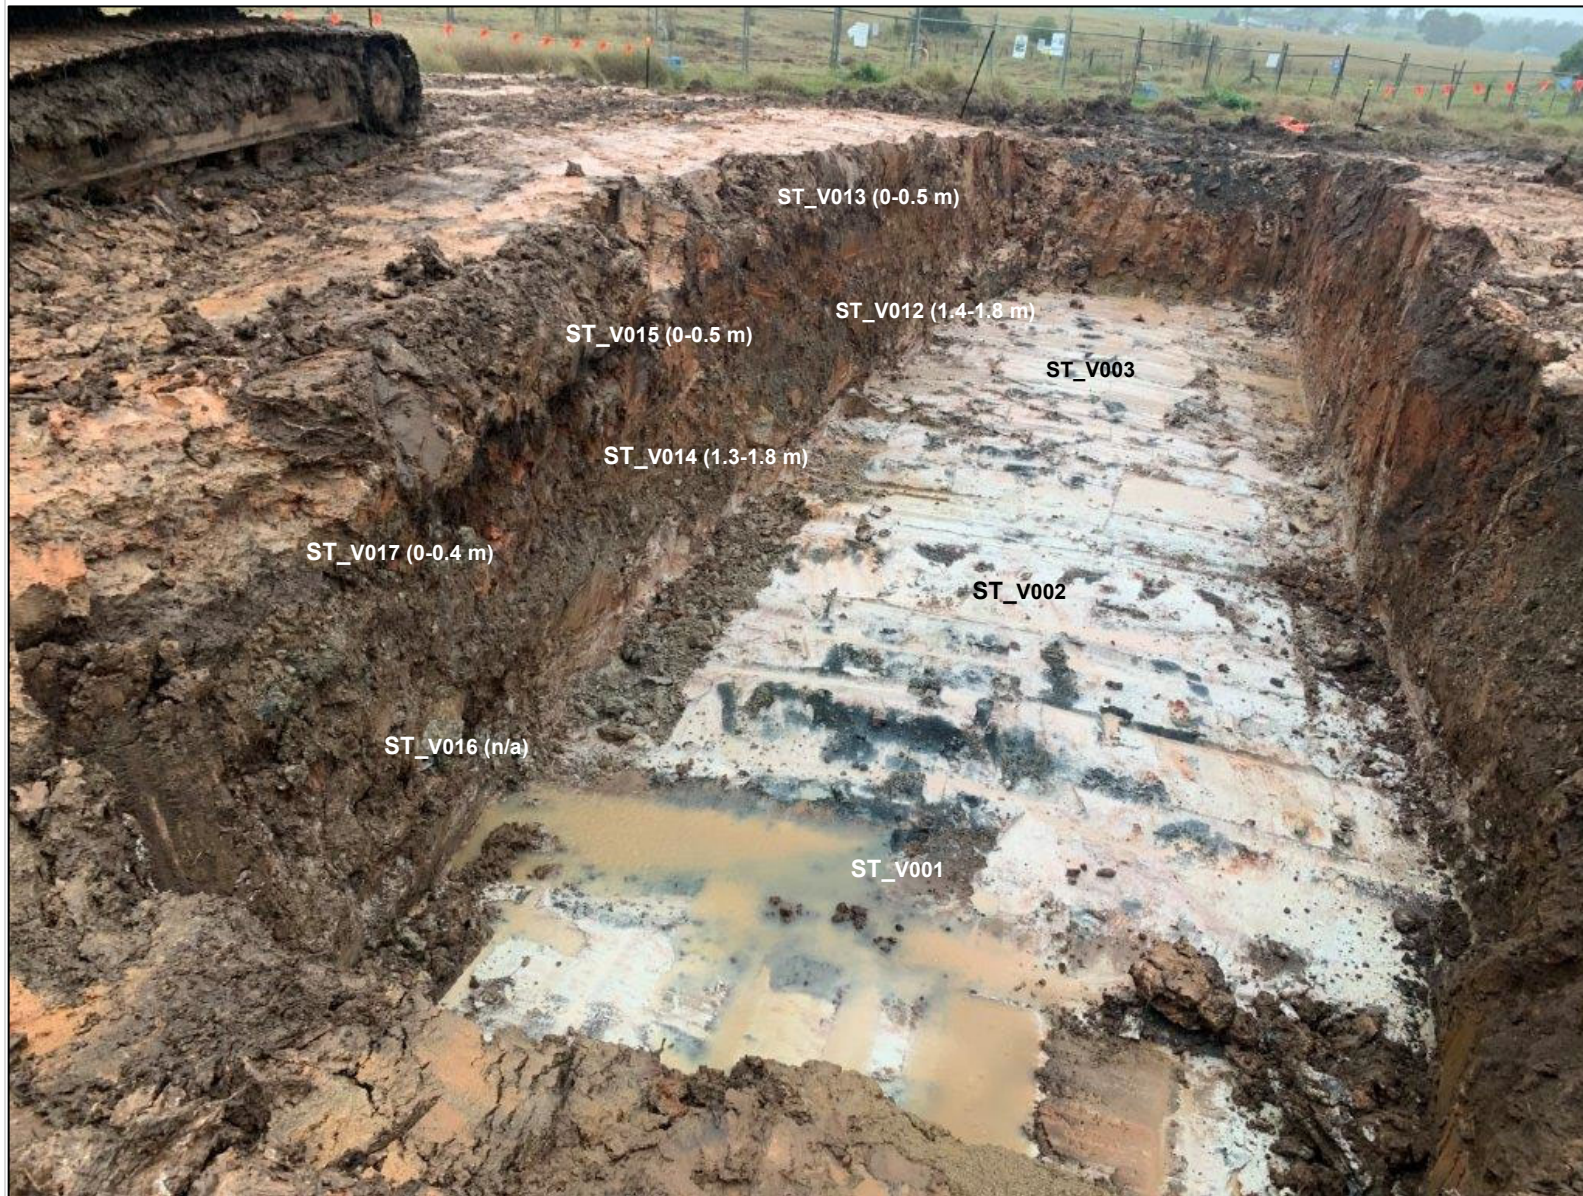
**Photograph 3 –
South Wall**

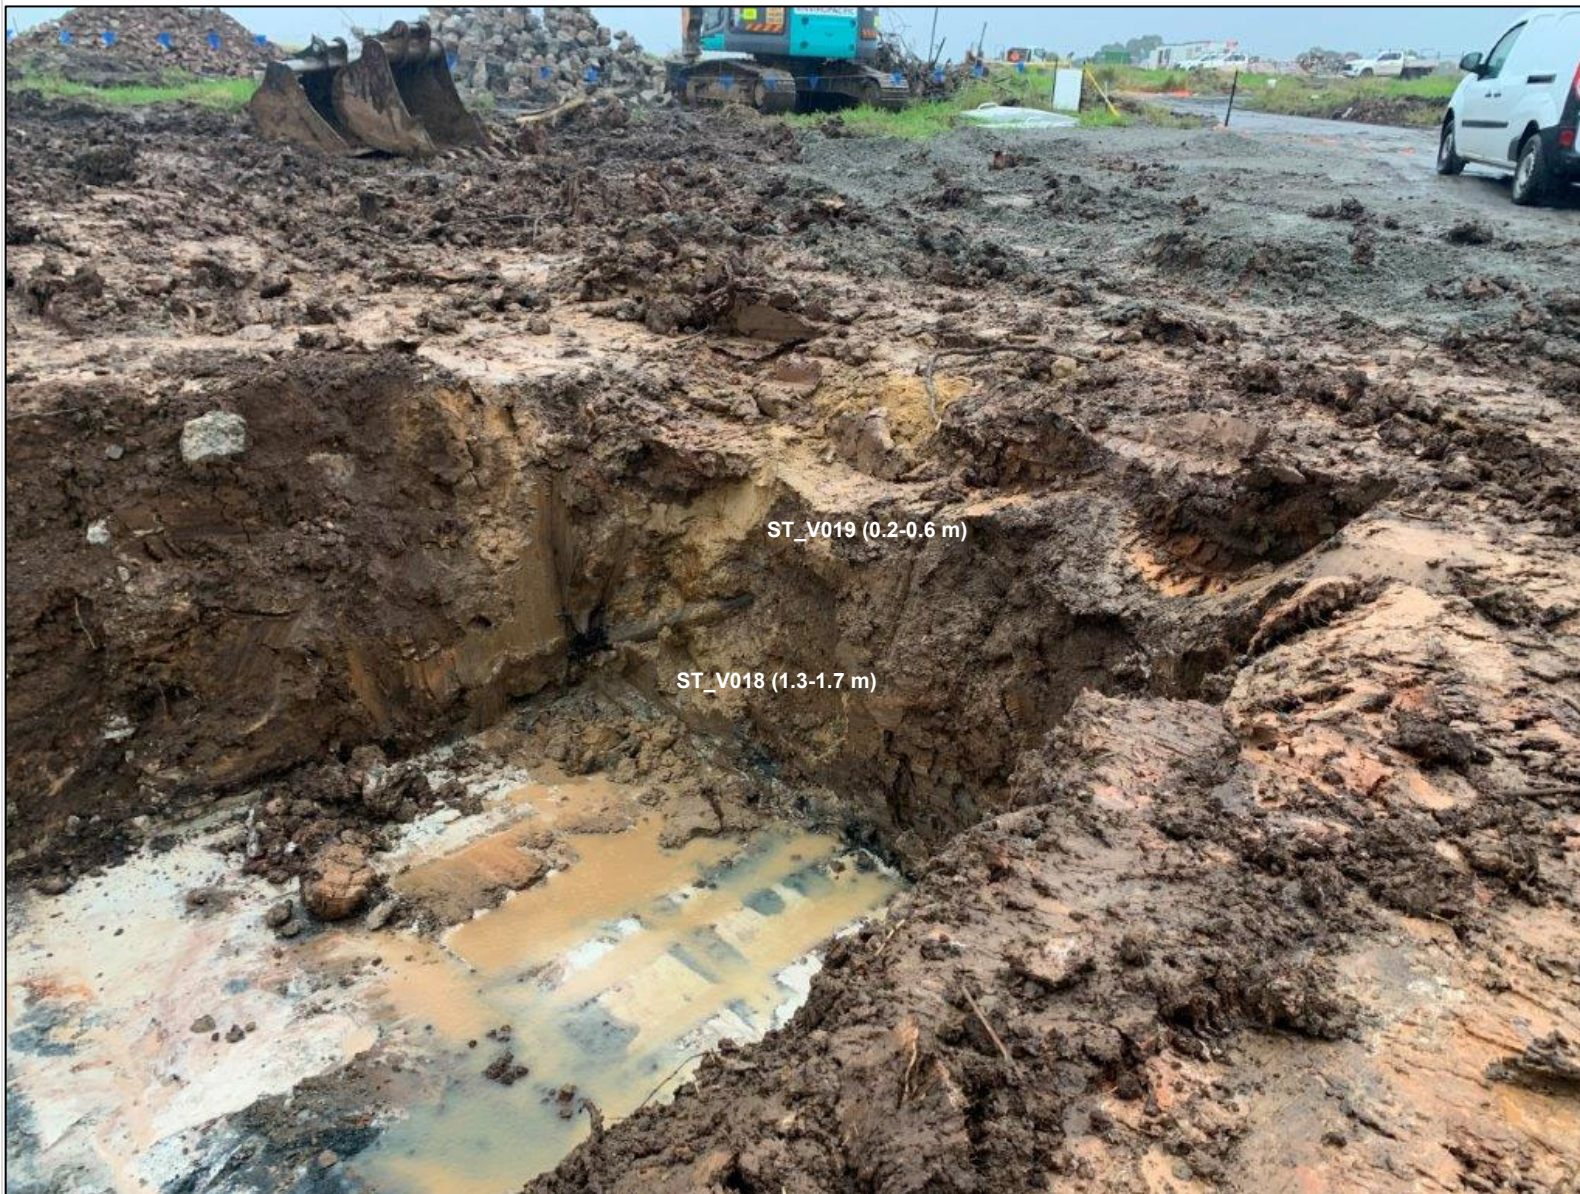
Photograph 4 –
Associated
pipework trench

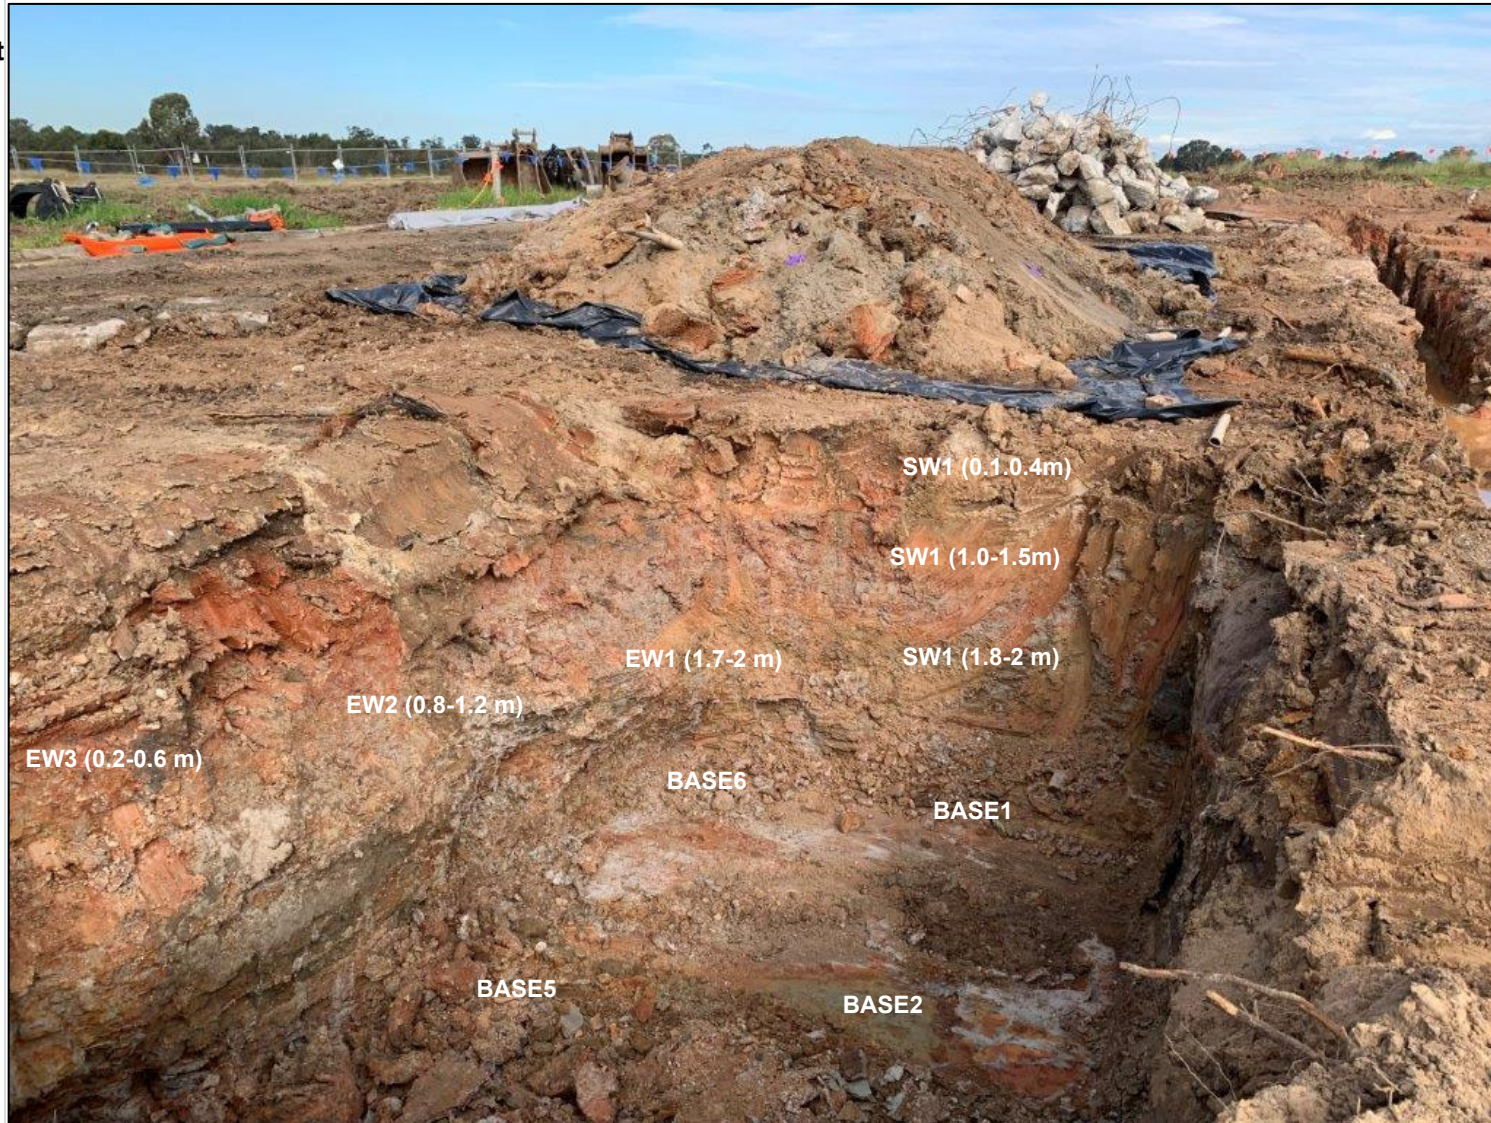
Photograph 1 – South Wall, east wall and partial base (base samples 2.4 m)

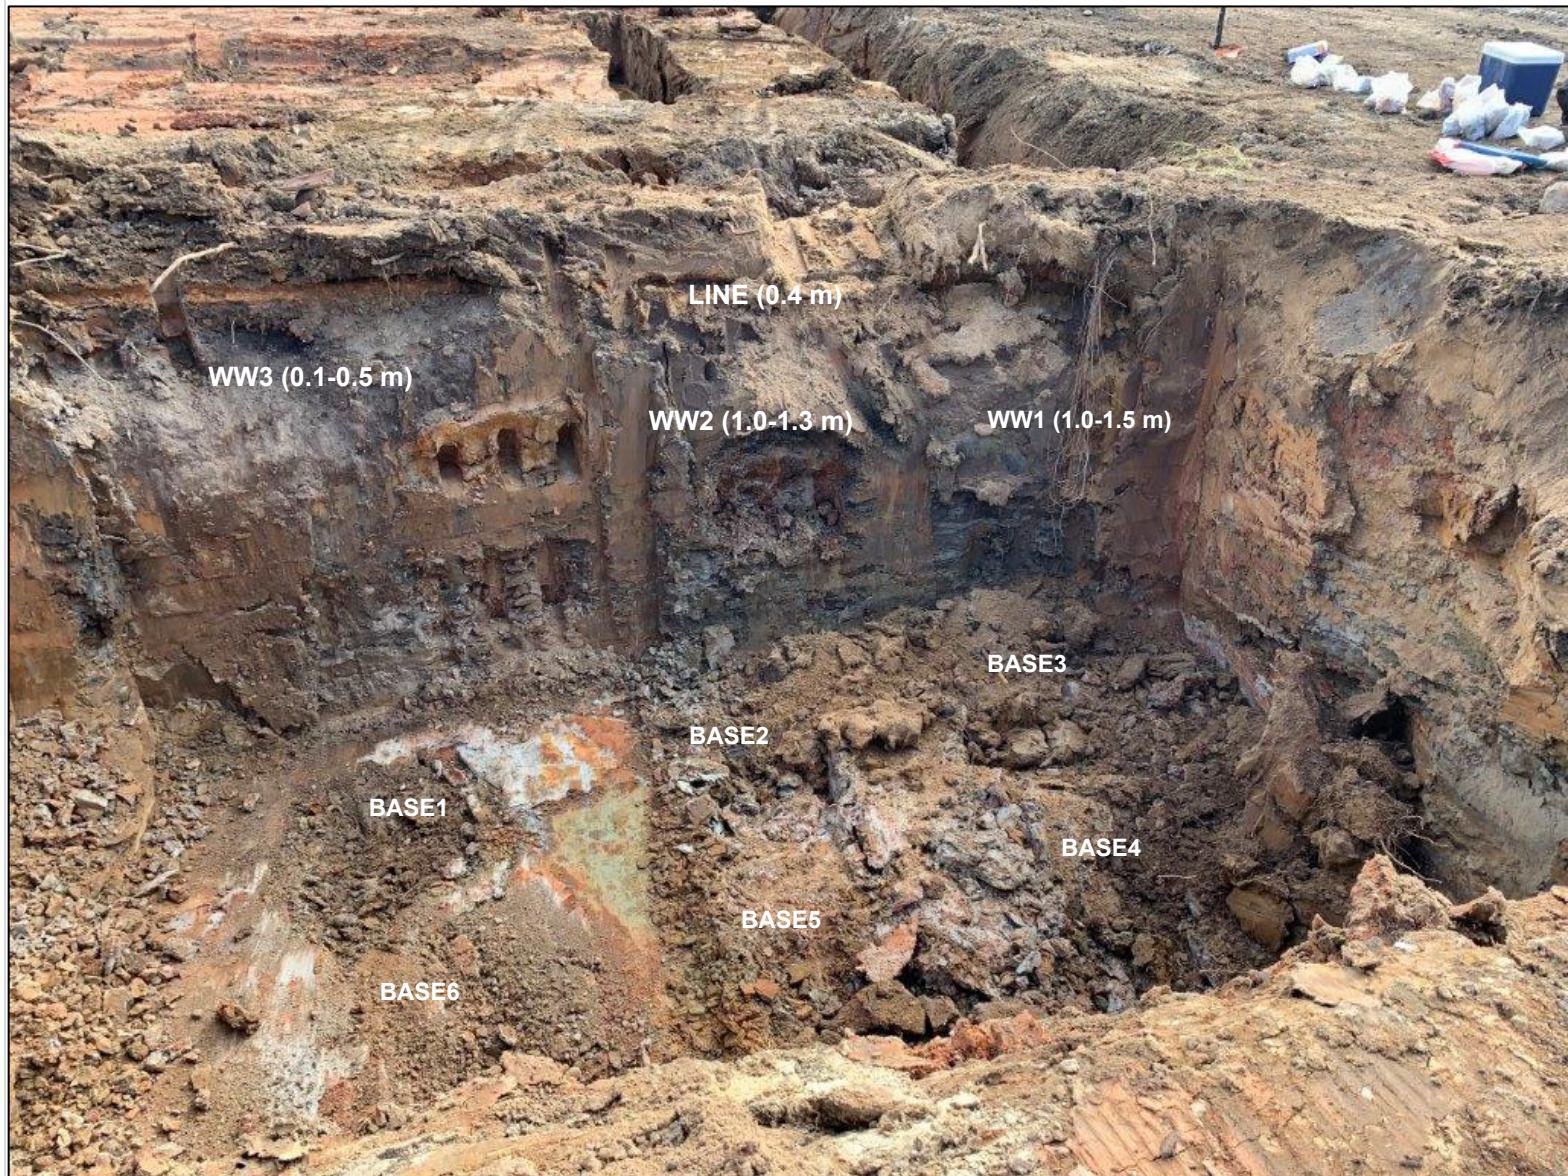
Photograph 2 –
West wall and
base (base
samples 2.4 m)

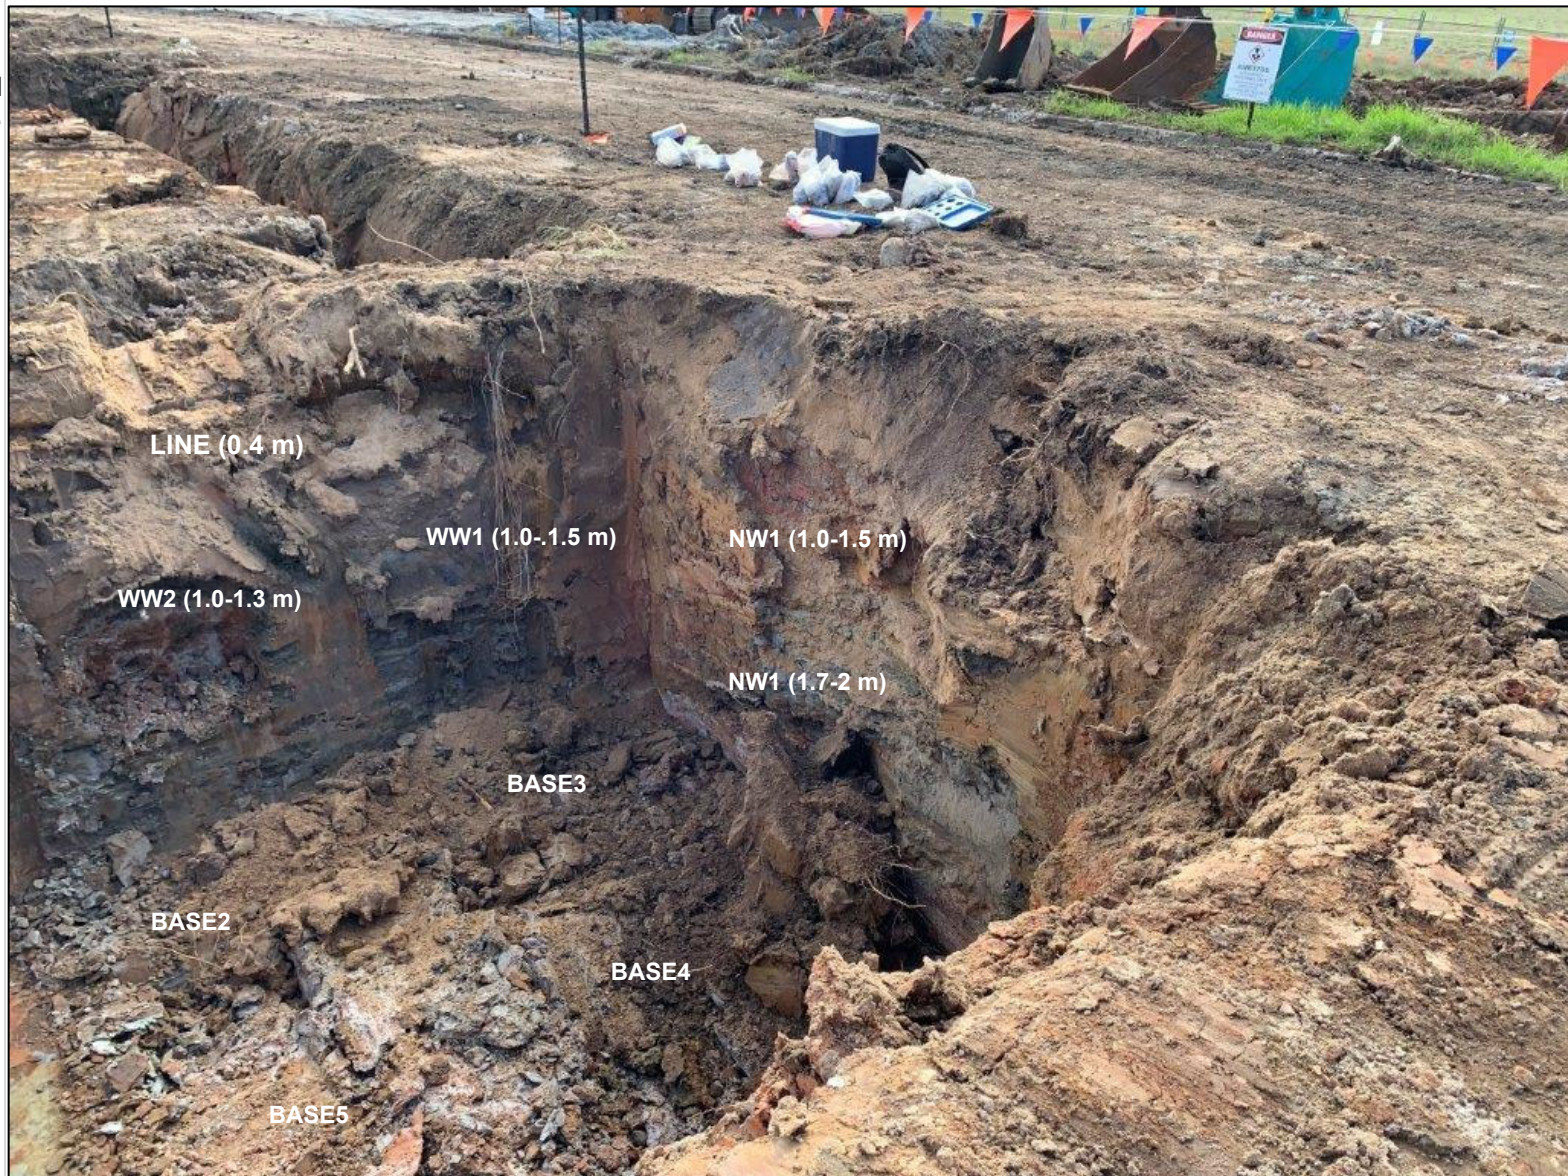
Photograph 3 – North Wall, partial west wall and partial base (base samples 2.4 m)

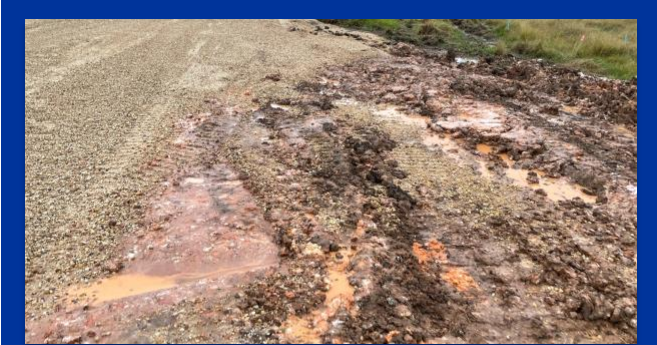
Photo 1

Soil surface of building footprint following the removal of ACM from surface.

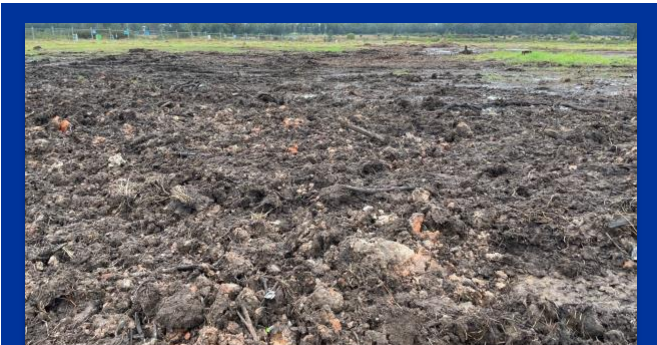
Photo 3

Soil surface of subject area following the removal of ACM from surface removal works.
