Bringelly Services Facility Detailed Site Investigation

Sydney Metro Western Sydney Airport Station Boxes and Tunnelling Works

Project number	WSA-200-SBT
Document number	SMWSASBT-CPG-SWD-SW000-GE-RPT-040512
Revision date	7 September 2022
Revision	C01

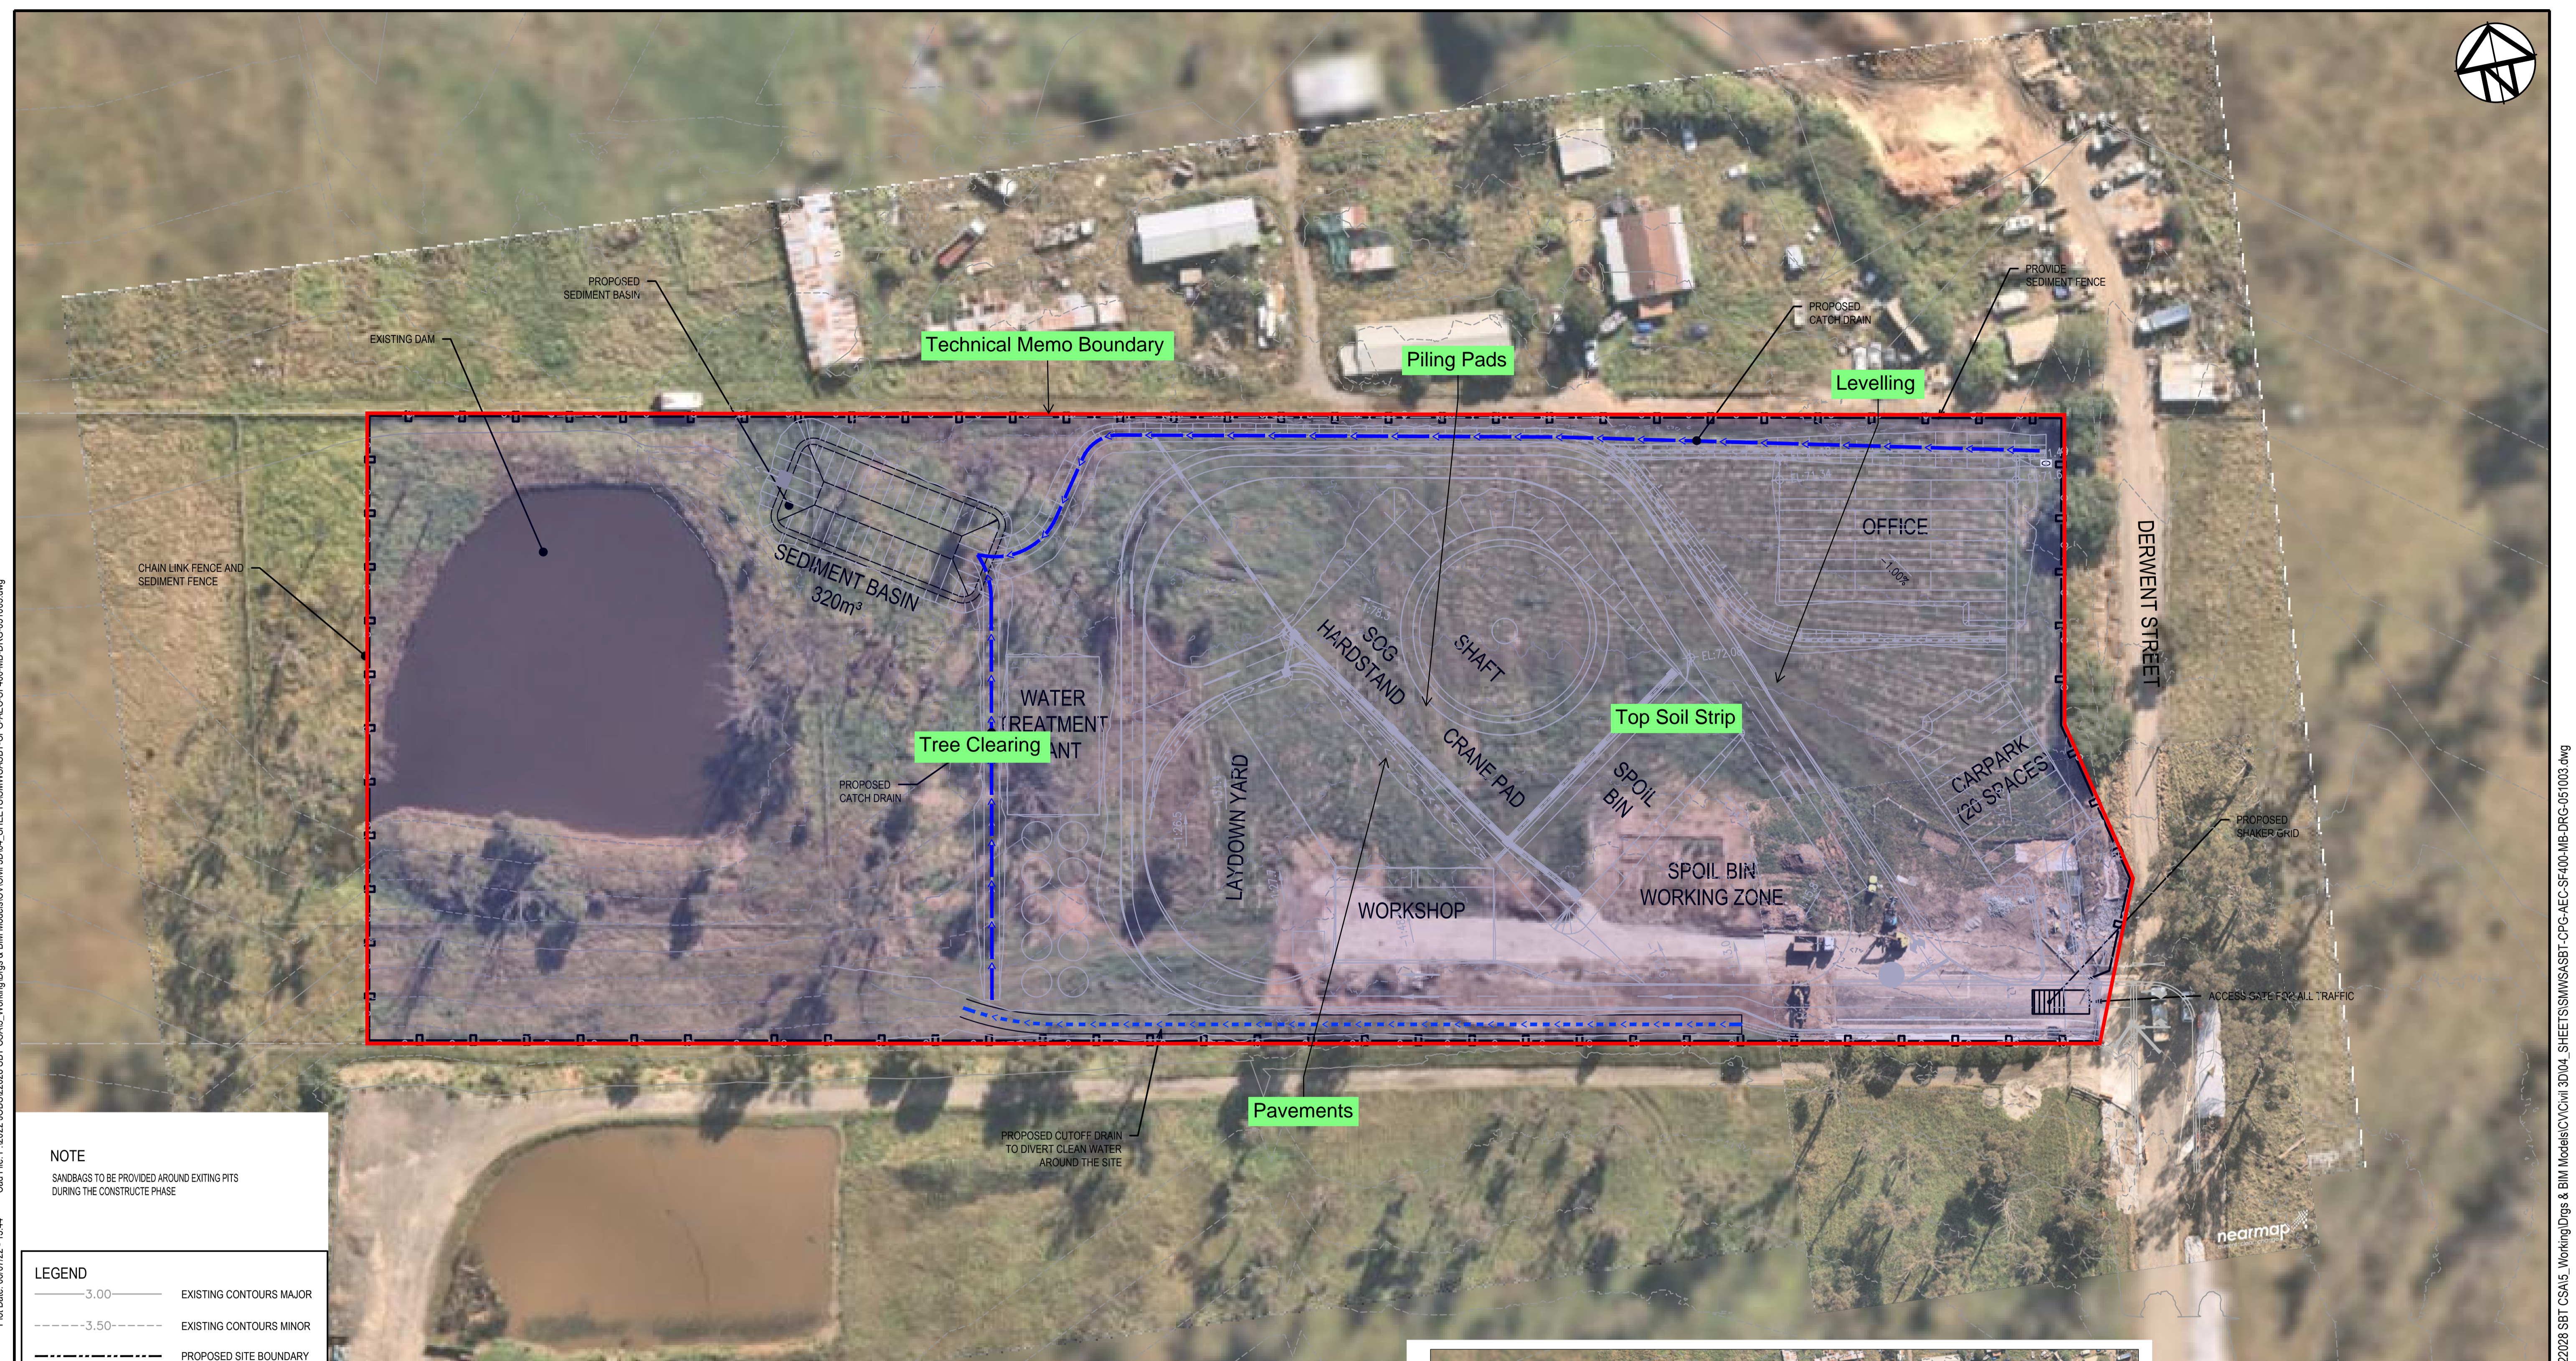
NOTE
SANDBAGS TO BE PROVIDED AROUND EXITING PITS DURING THE CONSTRUCTIVE PHASE
