**DETAILED SITE INVESTIGATION
FOR CLAREMONT MEADOWS
SERVICES FACILITY
ROAD AND RAIL EXCAVATIONS PTY LTD**

20 SEPTEMBER 2022

122045

Detailed Site Investigation – Claremont Meadows Services Facility, Sydney Metro – Western Sydney Airport

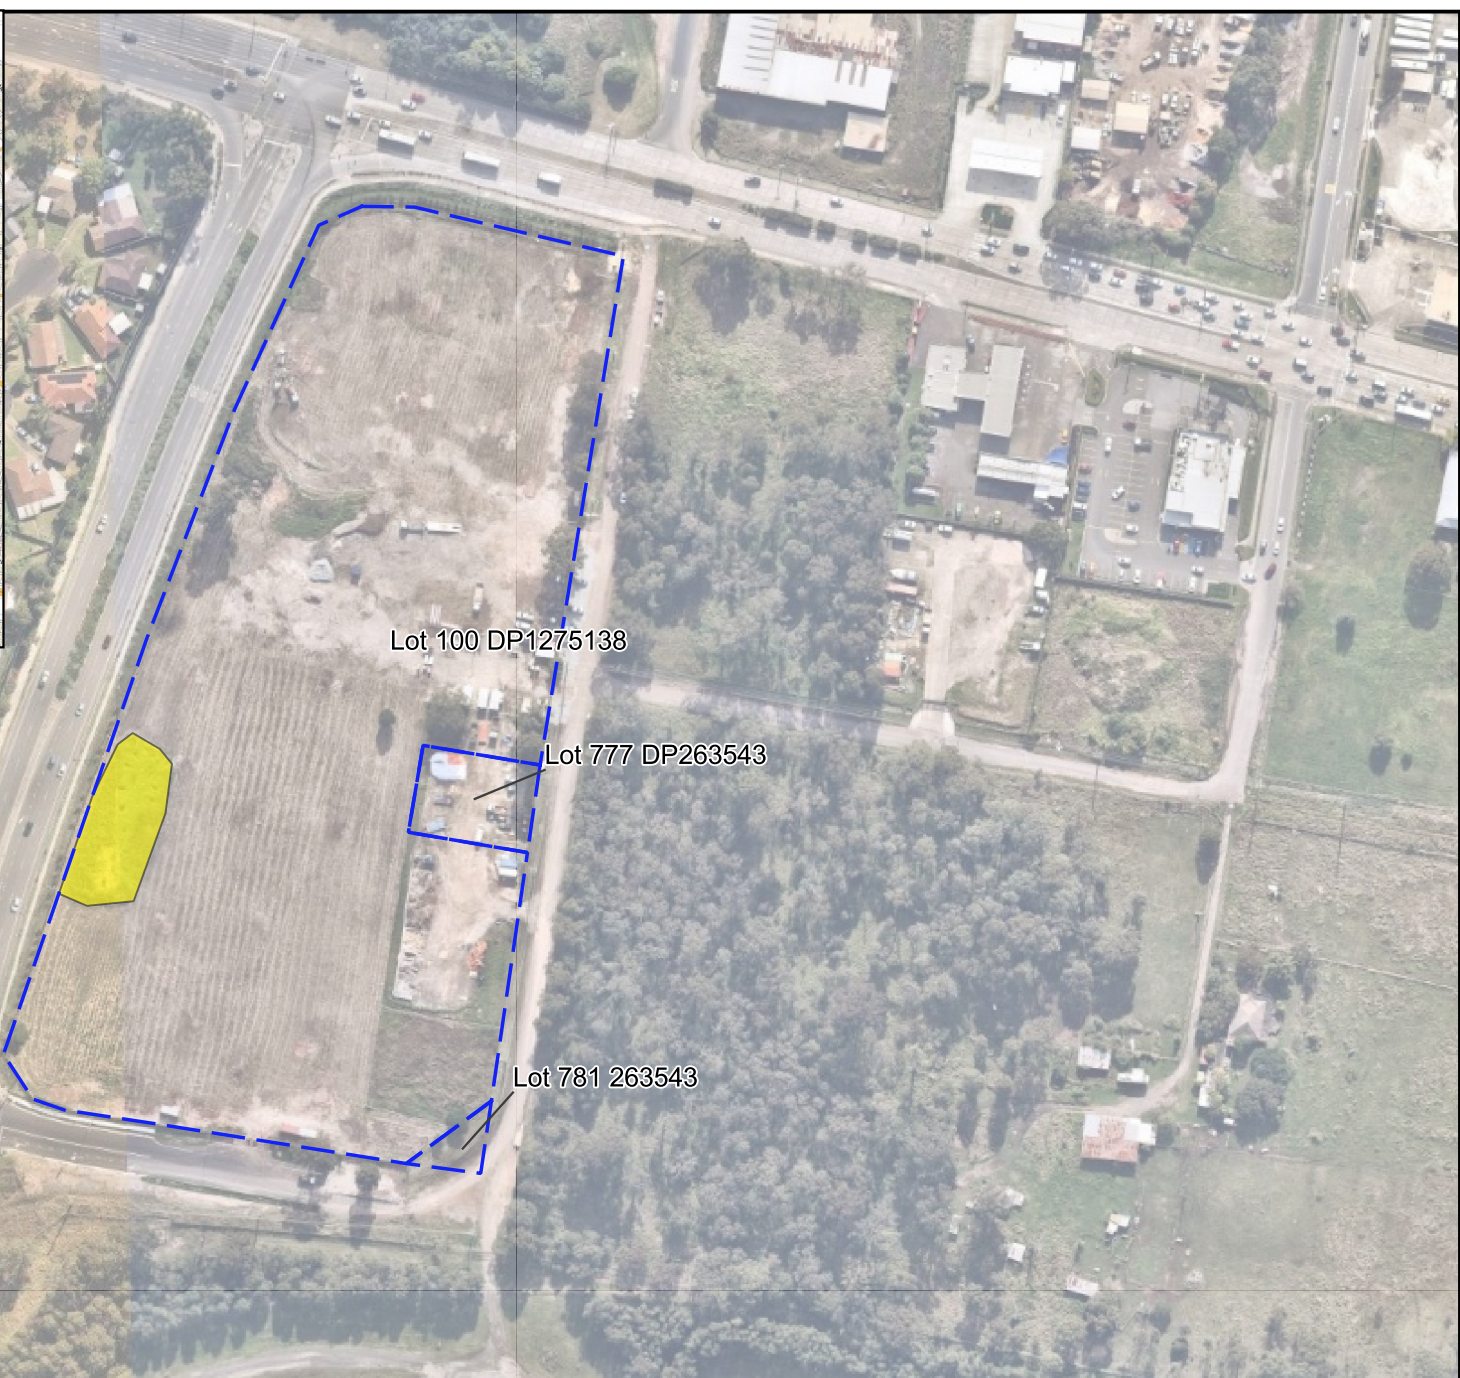
Figure 1

<p>ENVIRONMENTAL EARTH SCIENCES CONTAMINATION RESOLVED</p>	Title: Site Locality Map	
	Client: Road and Rail Excavations	
Location: 1-17 and 19 Claremont Meadows, NSW 2747		
Project Manager: SG	Scale: As Shown	Job No: 122045
Drawn By: SG	Date: June 2022

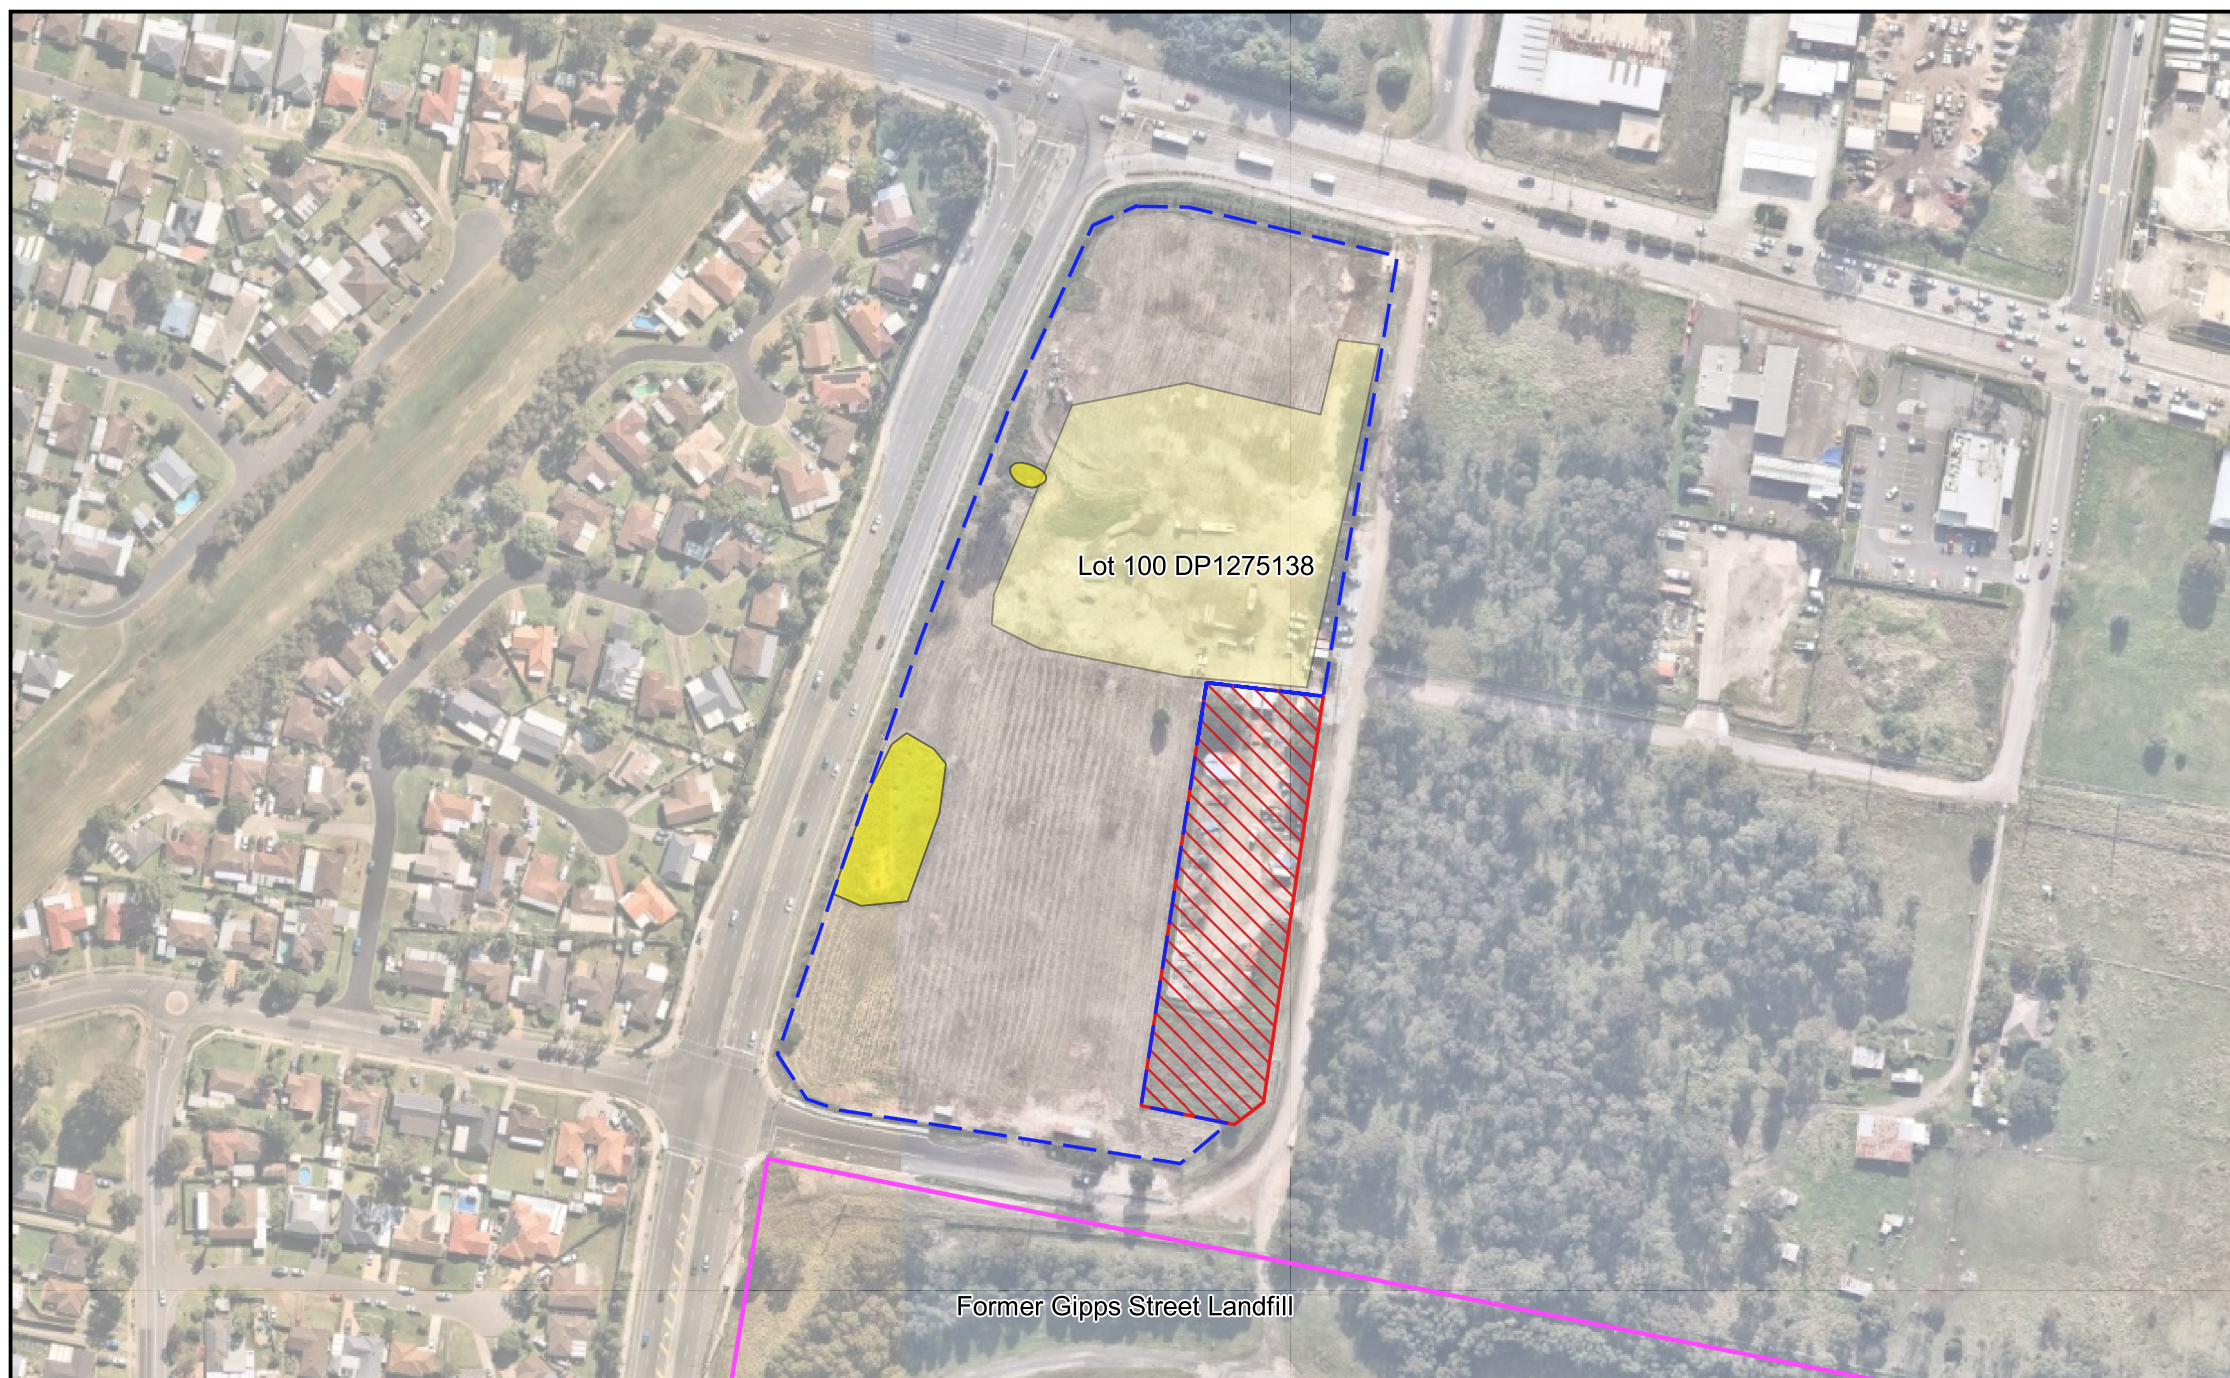
Title: Observed Site Layout

It is noted that a section of the site was fenced off, shown in **Figure 2**, and that CPBG, the principal contractor issued instructions to exclude that section from investigation. As such no data has been gathered from this area and it is not considered to form part of the site. The site boundary for this assessment has been defined as the construction site footprint, as outlined on **Figure 2**.

The site boundary and layout as observed during this DSI has been presented on **Figure 2** while the proposed site layout, has been presented on **Figure 3**.

The site's surface is predominantly unsealed cleared land with low (grassy) vegetation, there is an area of compacted gravel in the central-eastern area of the site (refer **Figure 2**). It is anticipated that precipitation at the site would slowly infiltrate the soil profile with a degree of run-off due to the low porosity and permeability of the natural clay soils.

A stockpile of soil material was observed located in the south west of the site that will be removed. It is understood to be the responsibility of others to manage the removal of this material. Groundwater and subsurface monitoring bores installed by other during earlier phases of investigation were observed. The general site layout from site observations has been presented in **Figure 2** (above).

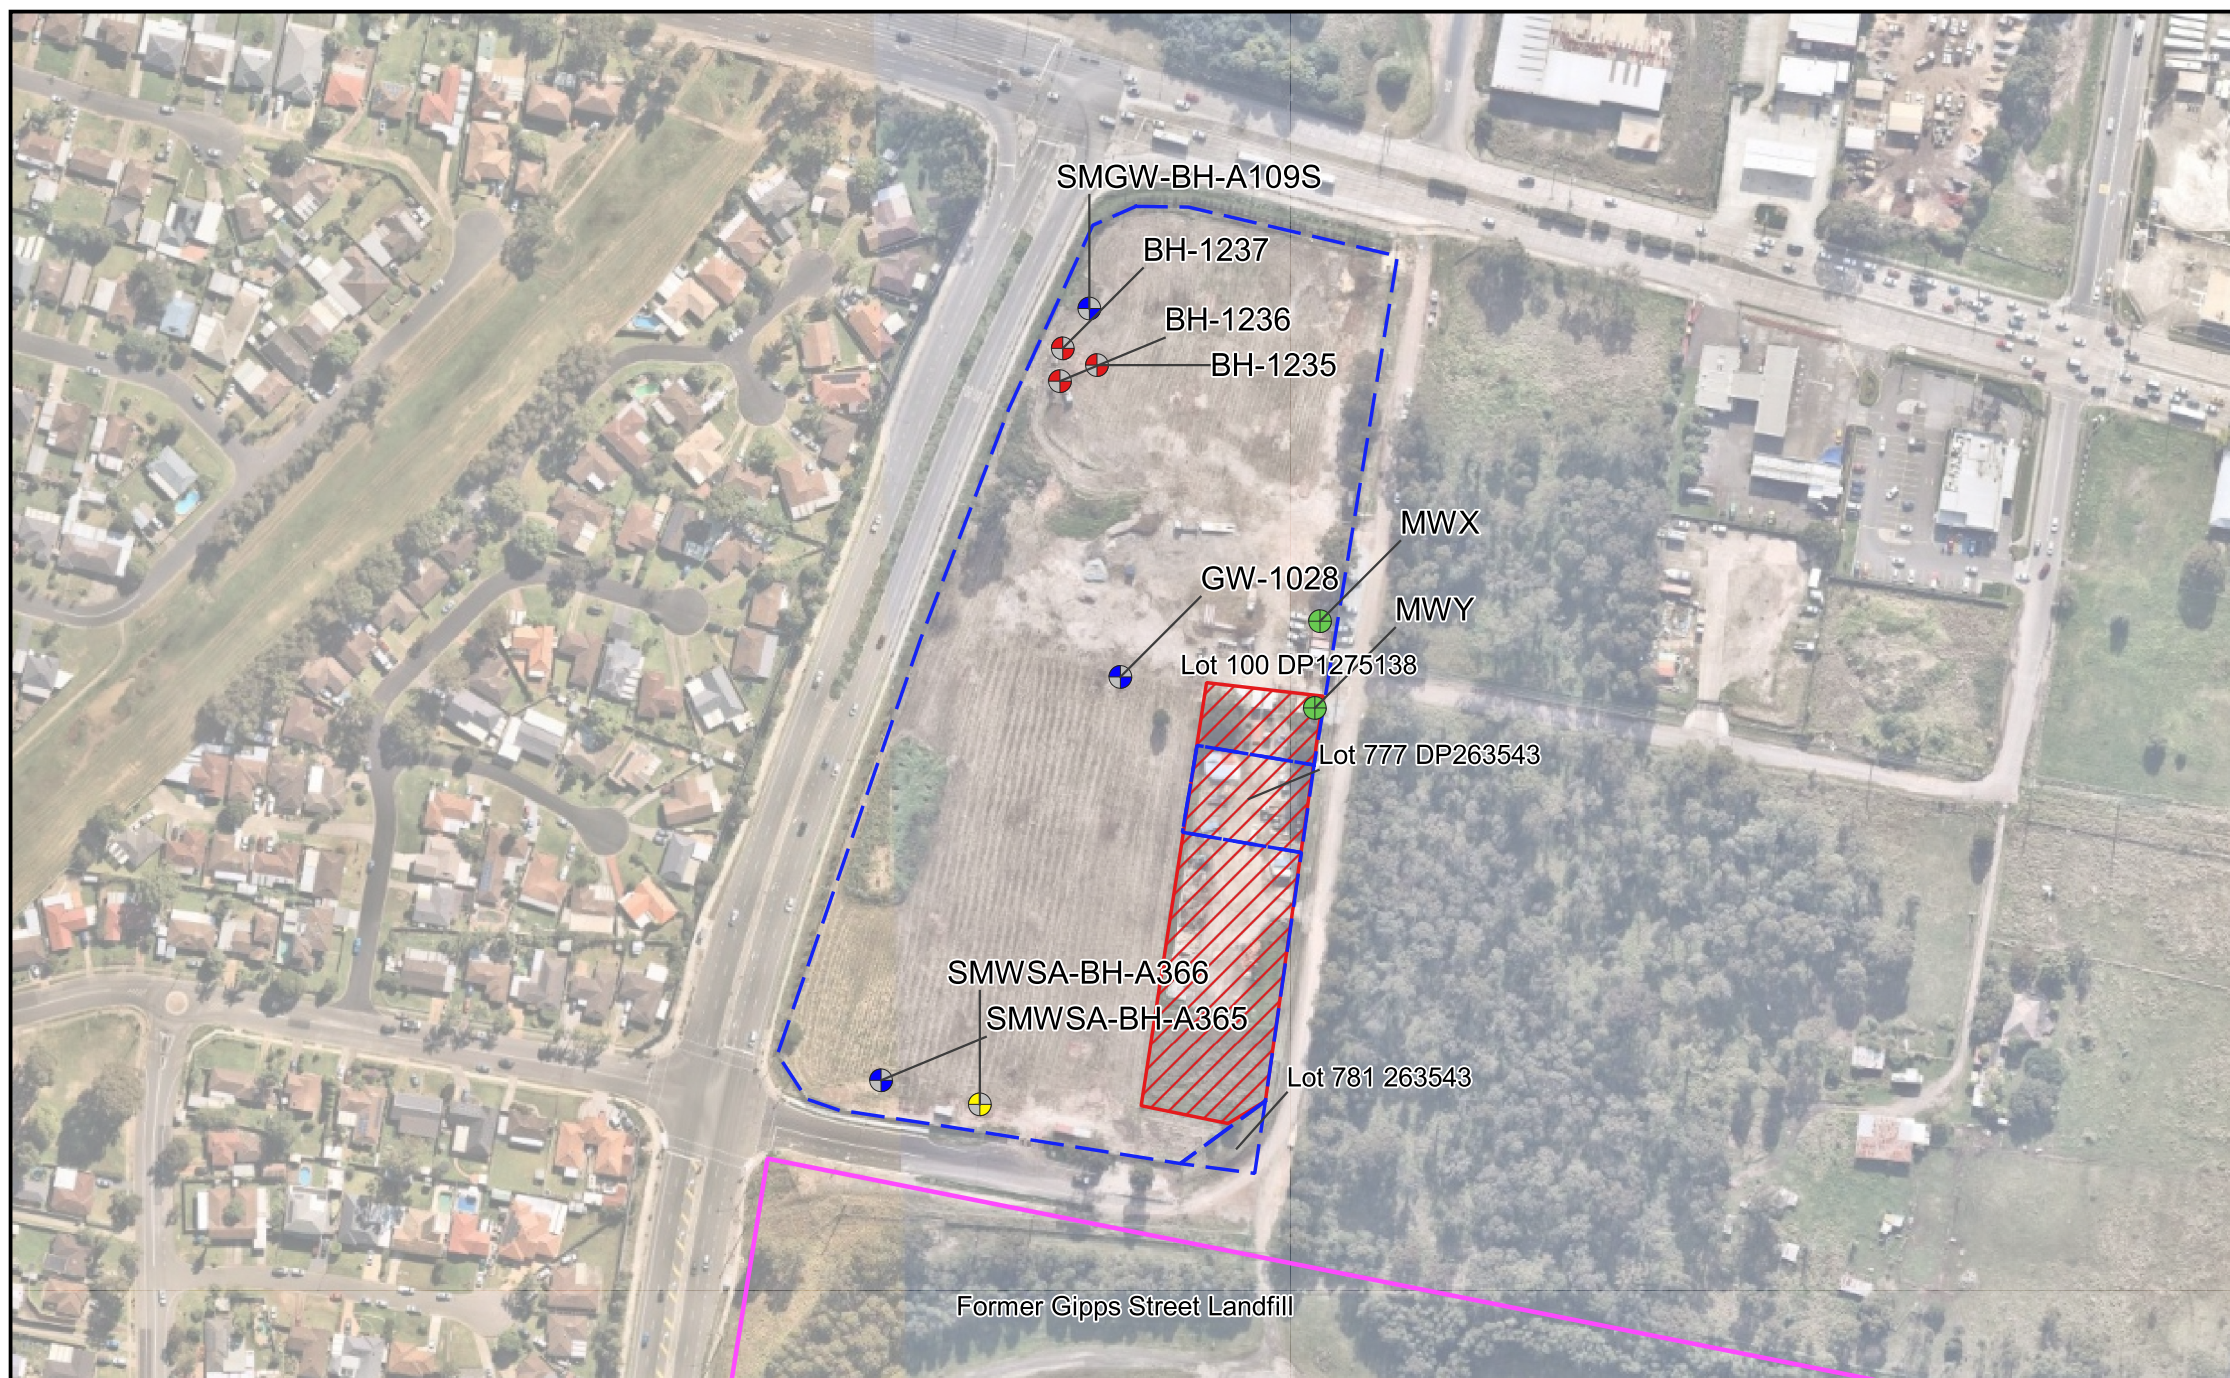
Title: Groundwater and Hazardous
Ground Gas Investigation Locations

- Site Boundary
- Excluded Area
- Groundwater Bore
- Soil/ Rock Bore
- Gas Bore
- Unknown Bores
- Former Gipps Street Landfill (approximate)

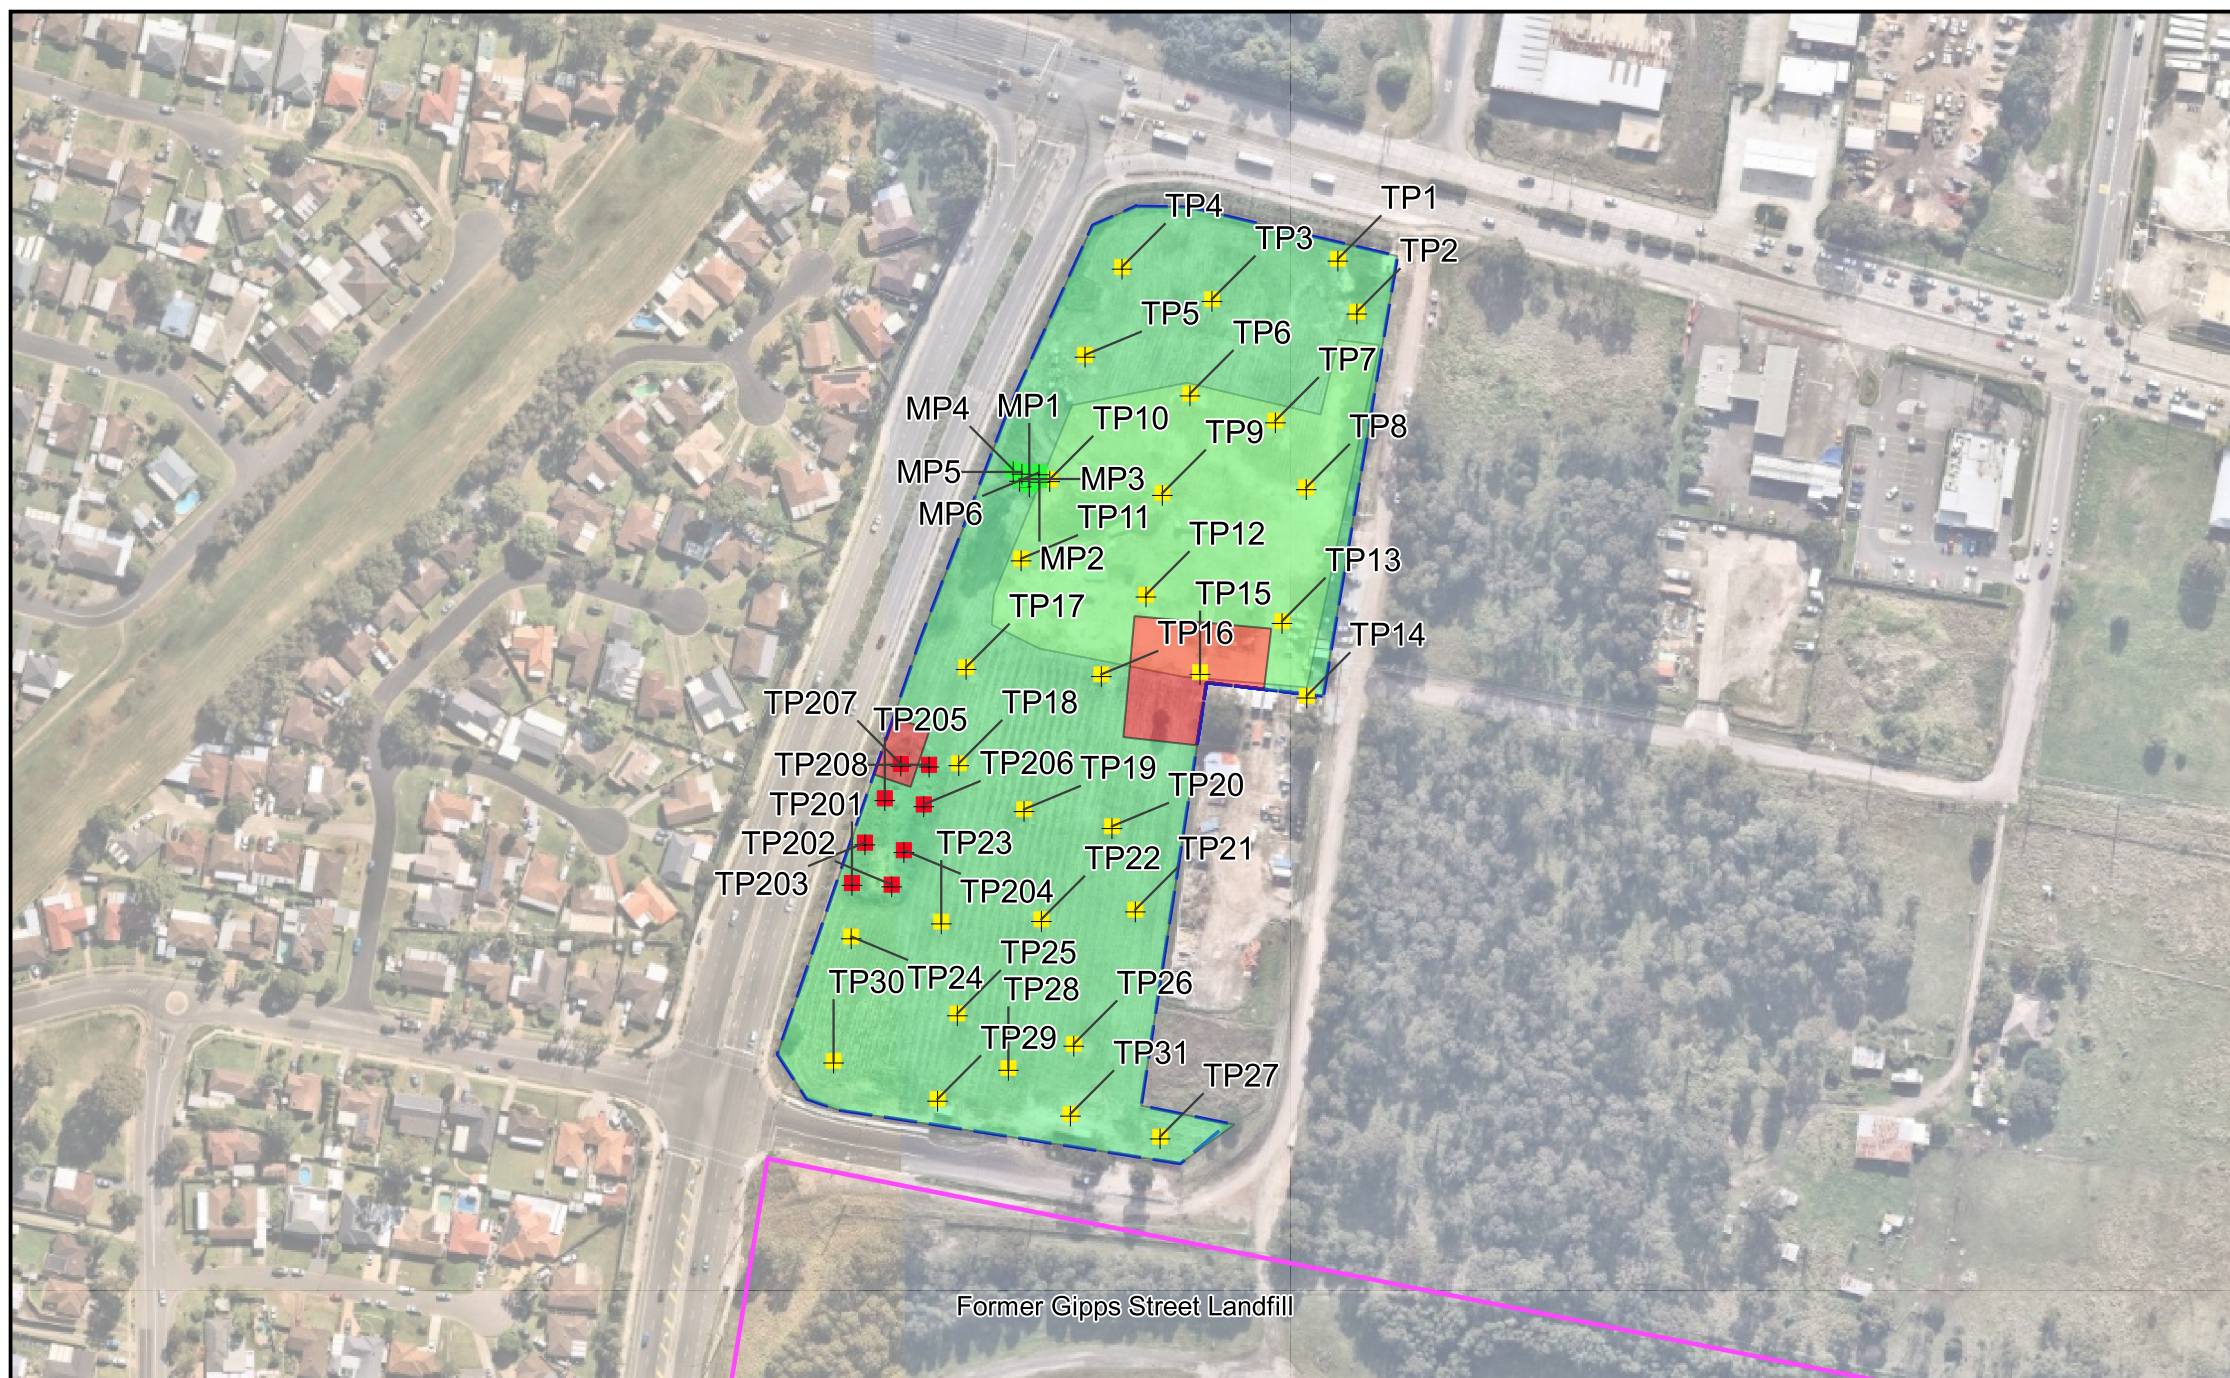
Figure 7

The waste classifications are summarised in **Table 22** and illustrated in **Figure 7**.

1. Note material around TP15 and TP207 is excluded due the detection of friable asbestos – see **Figure 7**.
2. Deep fill was encountered in TP4 and TP5 to ~2.4 mBGL while at TP9 was ~0.9 mBGL.
3. An area around TP15 and TP207 has been classified as 'special waste (Asbestos)' by considering the position of site investigation locations that were not reported to contain asbestos.
4. The extent of special waste (asbestos) should be validated prior issuing a clearance certificate to demonstrate appropriate management and removal of special waste (asbestos) – see **Section 16 Recommendations**.
