St Marys Station

Detailed Site Investigation

Sydney Metro Western Sydney Airport Station Boxes and Tunnelling Works

Project number	WSA-200-SBT
Document number	SMWSASBT-CPG-SWD-SW000-GE-RPT-040513
Revision date	27/09/2022
Revision	A03

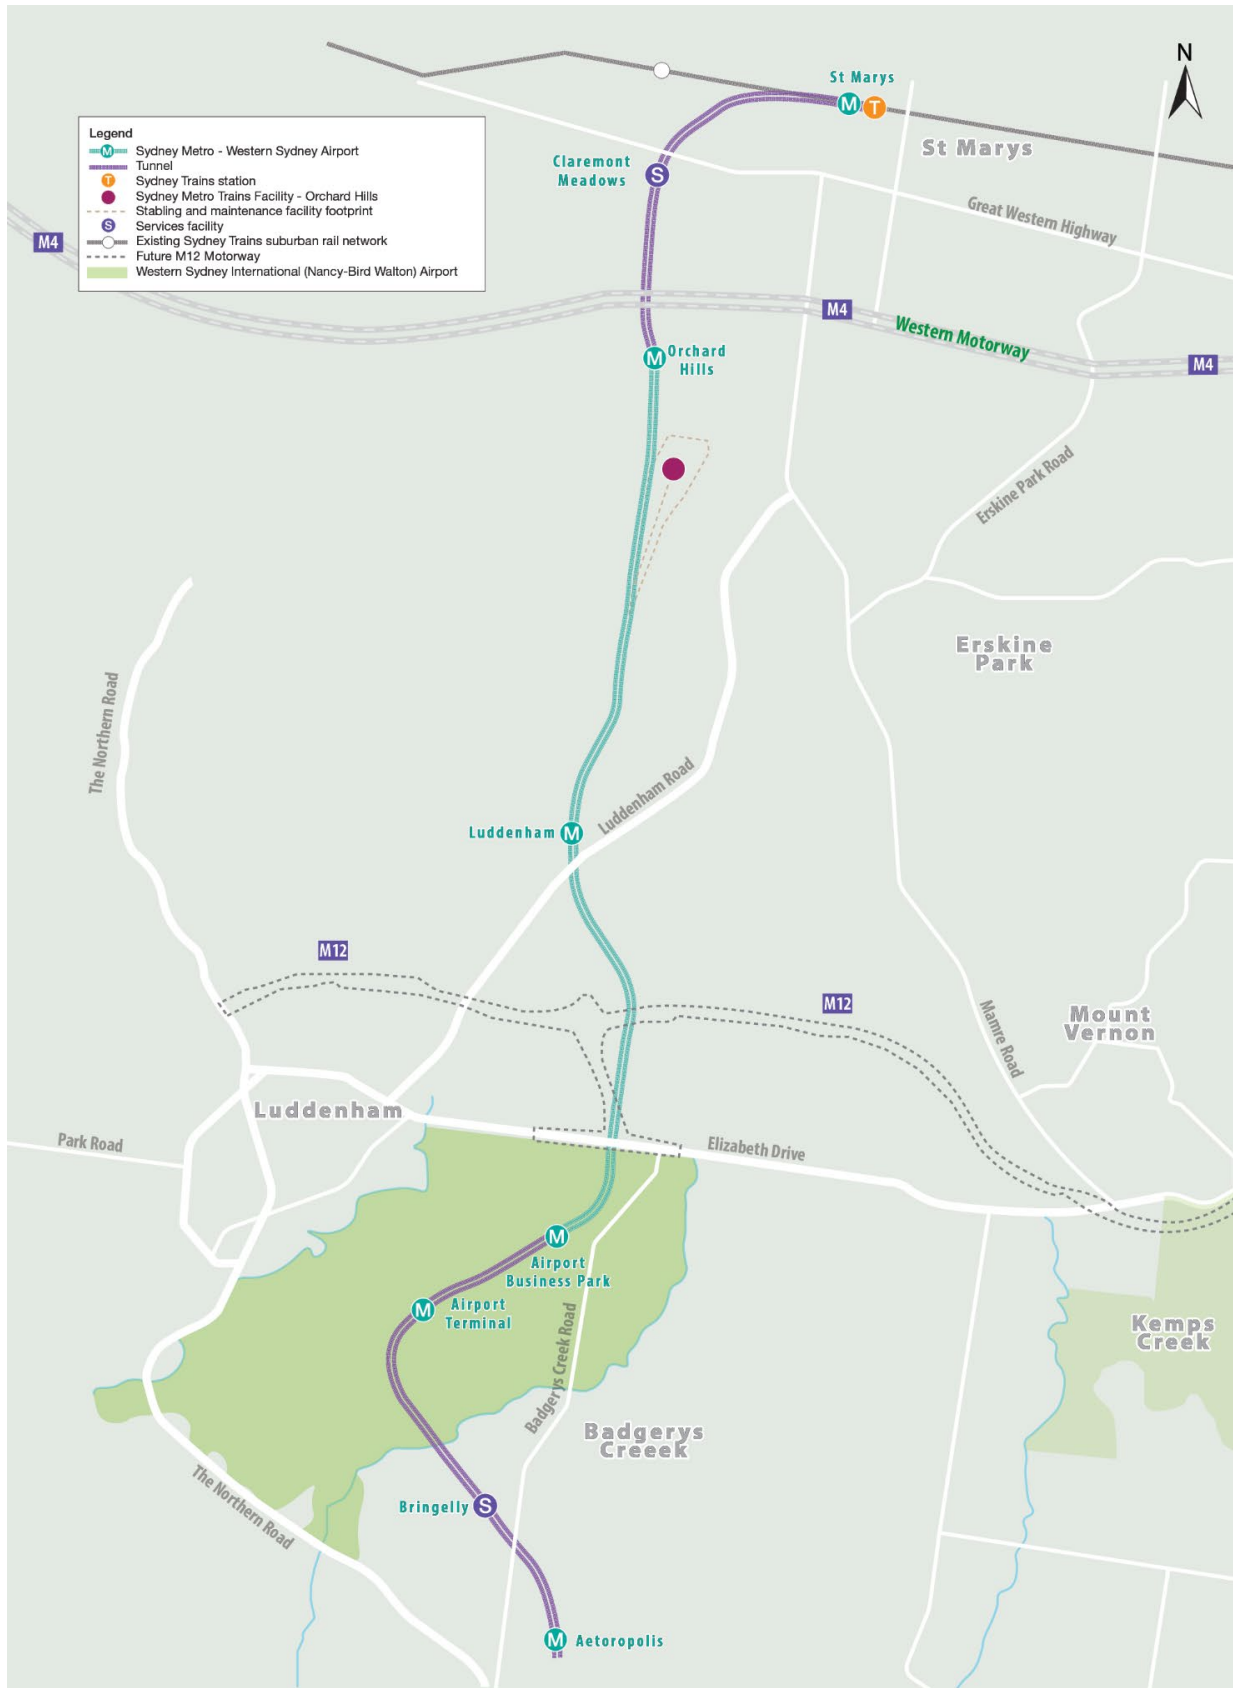
Figure 1.1: Scope of SBT Works

The SBT Works involves the construction and operation of a new 23 km metro rail line from the existing Sydney Trains suburban T1 Western Line (at St Marys) in the north and the Aerotropolis (at Bringelly) in the south. The Project includes tunnels and civil structures, including a viaduct, bridges, and surface and open-cut troughs between the two tunnel sections. Figure 1.1 shows the proposed alignment and key features of the Project.

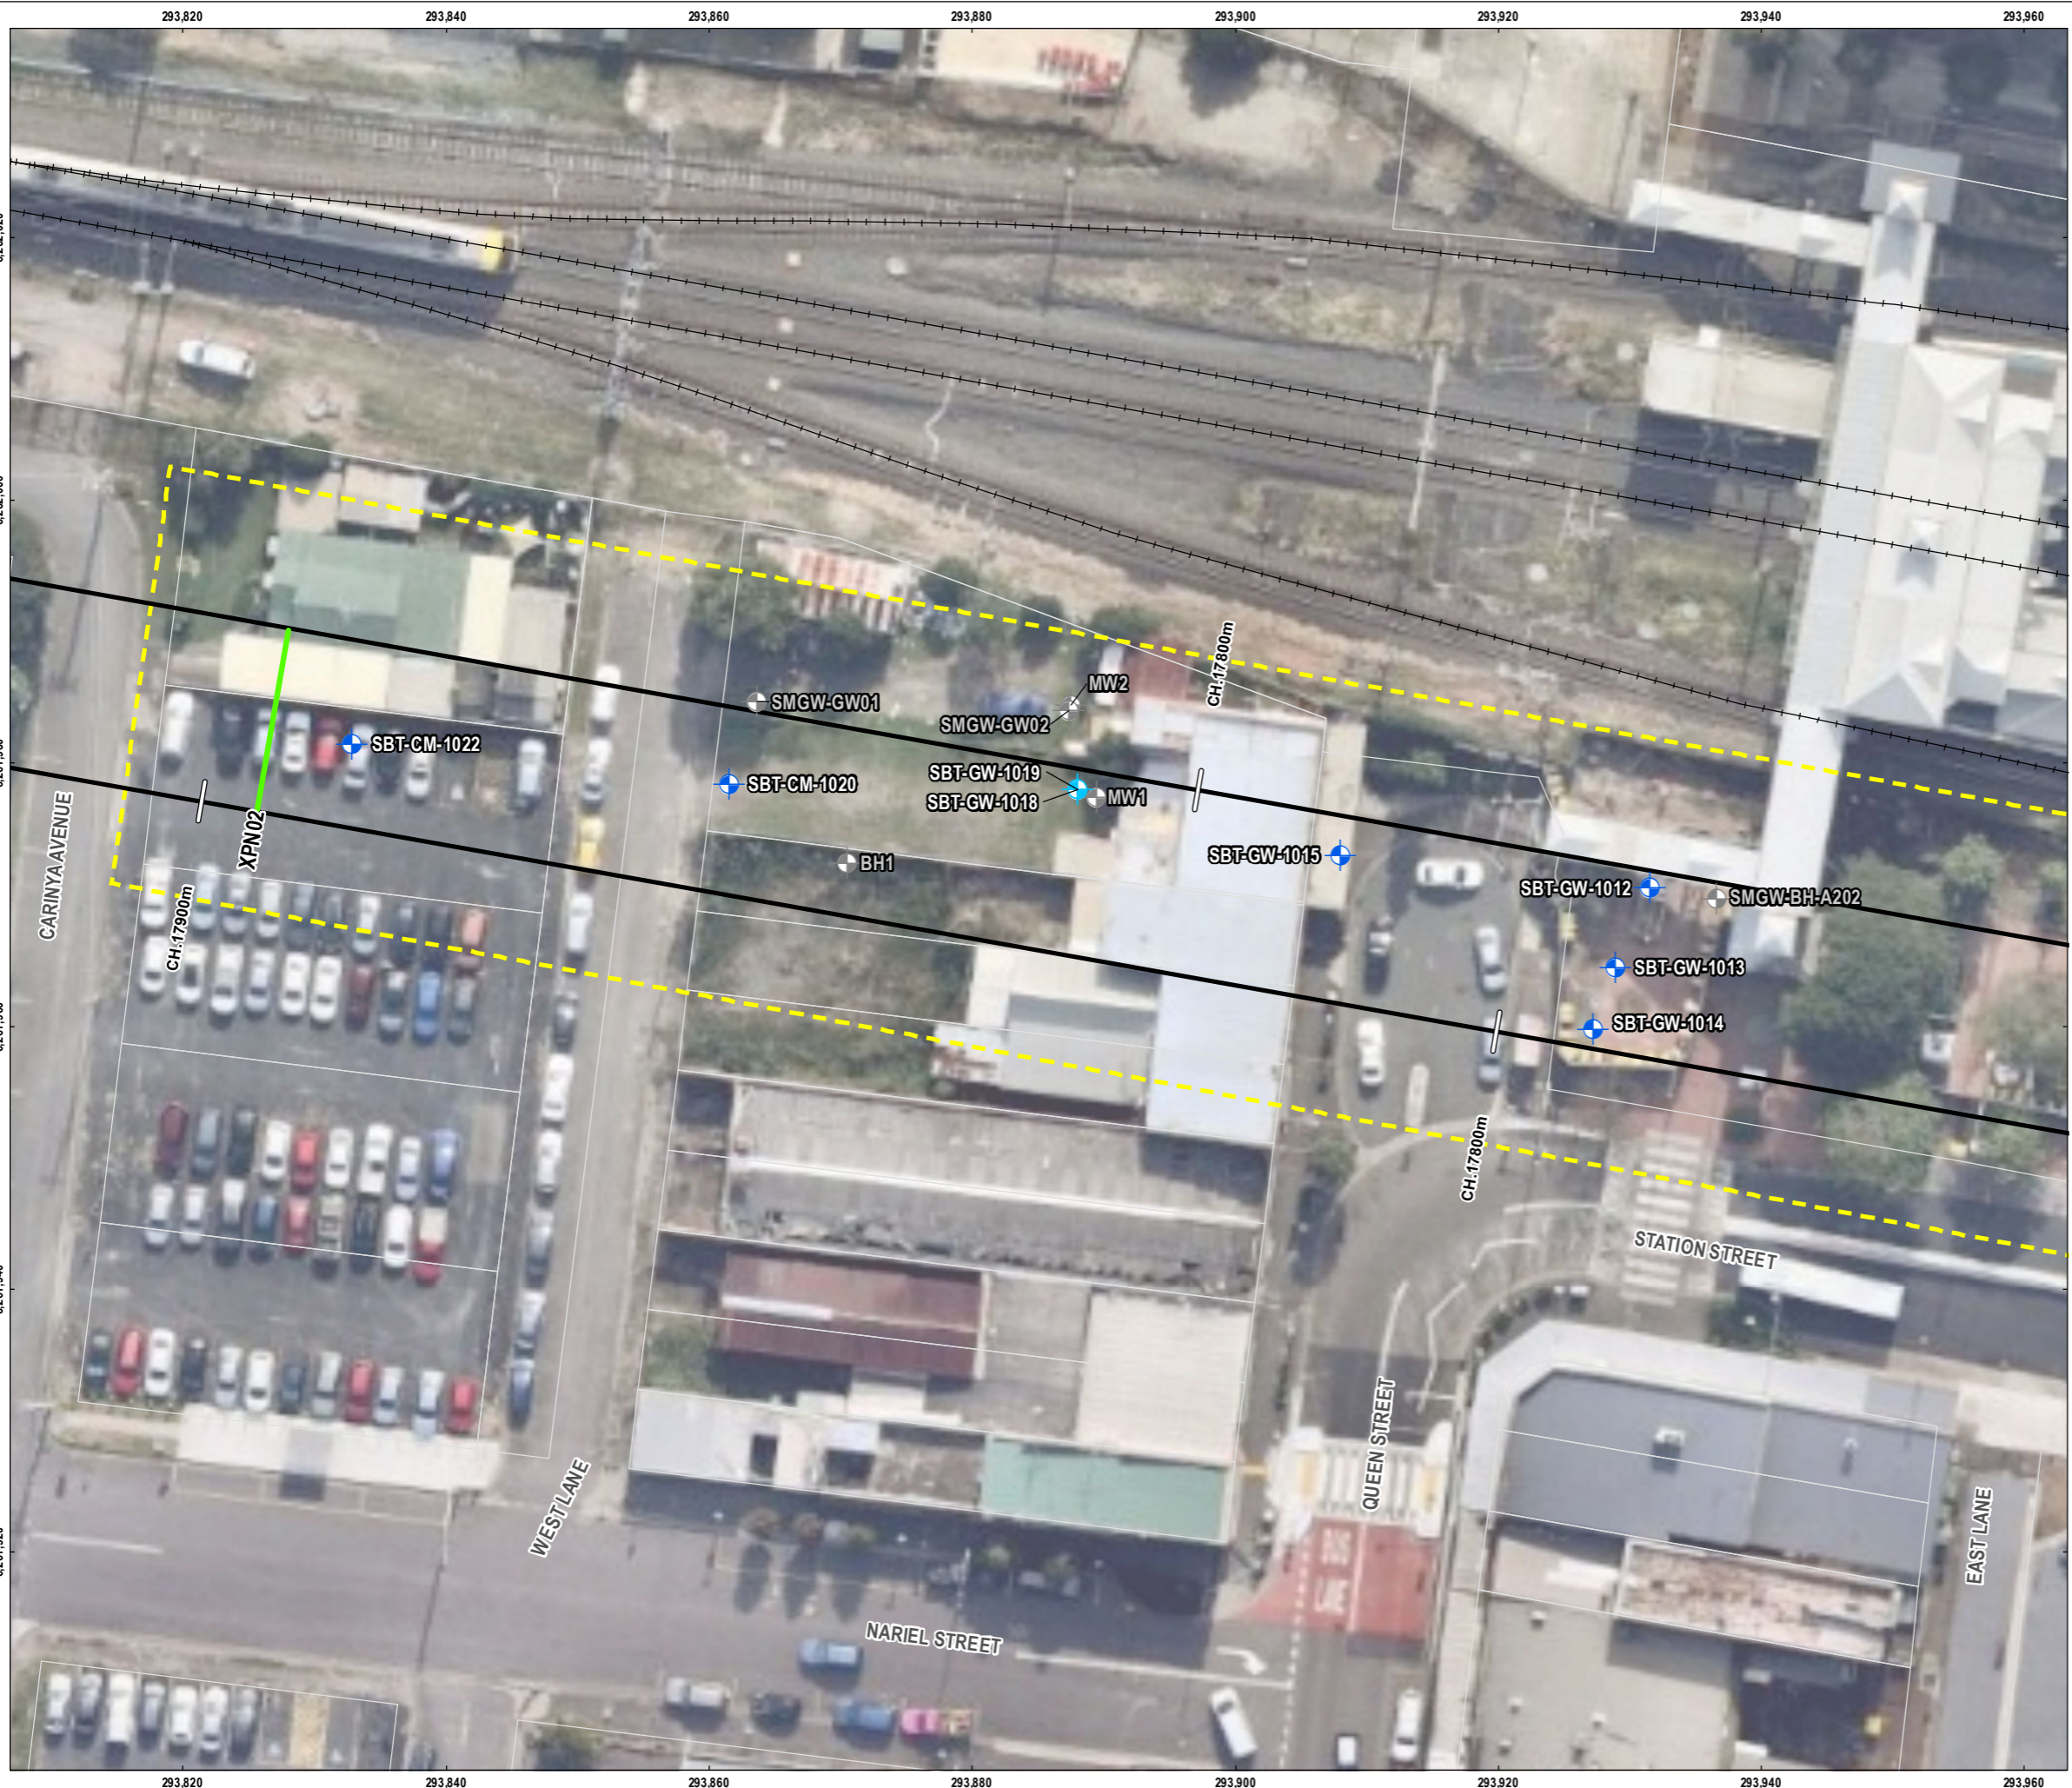
FIGURE 4A
Groundwater Investigation Locations
1-7 Queen Street

As noted in Section 8.3.2 at the time of writing the installation and sampling from the groundwater which were proposed to be installed in the SAQP is ongoing. Groundwater monitoring well locations are shown in Figure 4 and Figure 4A in Appendix B.

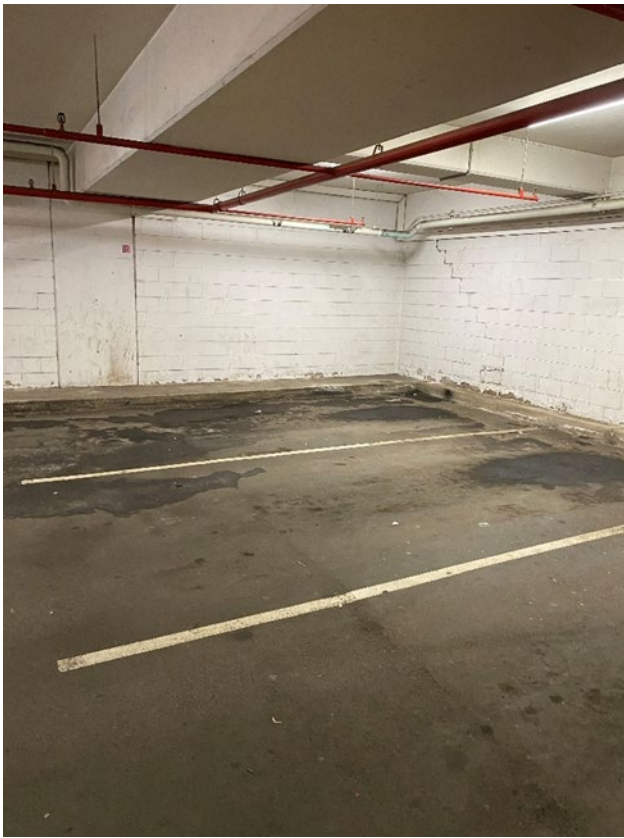
Minor oil staining from motor vehicles was present on the hardstand and a small area used for the storage of cleaning chemicals was observed. Risk to underlying soil materials where these observations were made is considered to be low based on the integrity of the hardstand observed.

St Marys Plaza Underground Carpark oil staining

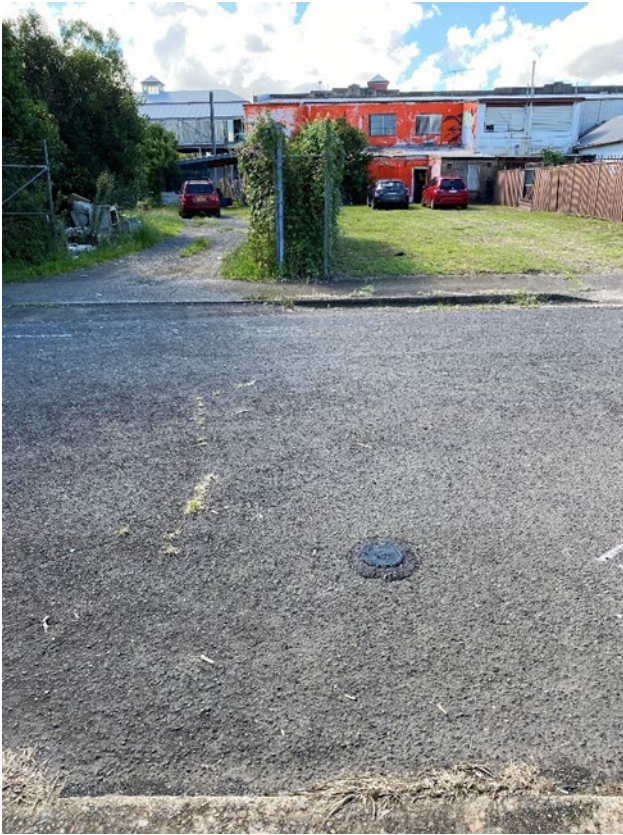
Fill material encountered in SBT-GW-1018 and SBT-GW-1019 to depths of between 0.3 m and 0.9 m included brick, terracotta tiles and potential ACM. It is noted that locations SBT-GW-1018 and SBT-GW-1019 were positioned adjacent to the former dry cleaner and this material will not be excavated as part of the proposed works. For this reason, confirmatory analysis of potential ACM was not completed. Elevated PID readings and hydrocarbon odours were not observed during drilling of SBT-GW-1018 and SBT-GW-1019.

- the survey suggested the presence of chlorinated hydrocarbons and the highest readings were reported closest to the building. The highest reading was reported at MIP-06 at 0.95 m bgs.
- the survey did not identify signs of NAPL within the strata investigated (to approximately 9 m bgs).
- the electrical conductivity (EC) measurements as part of the hydraulic profiling tool indicated the presence of clay. Silty and sandy clays were observed on the site during the drilling of SBT-GW-1018 and SBT-GW-1019.

Rear of 1-7 Queens Street (Former Dry Cleaners); photograph taken from West Lane

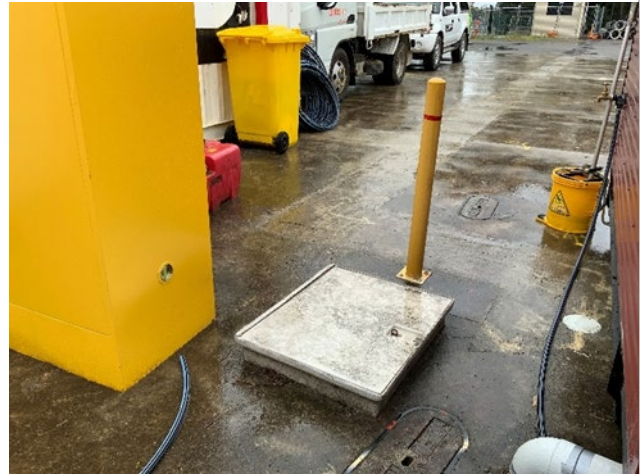
1-2 Station Street: Potential underground storage tank (UST) located in bus drives compound. Photograph provided by Sydney Metro of an area which has now been decommissioned.

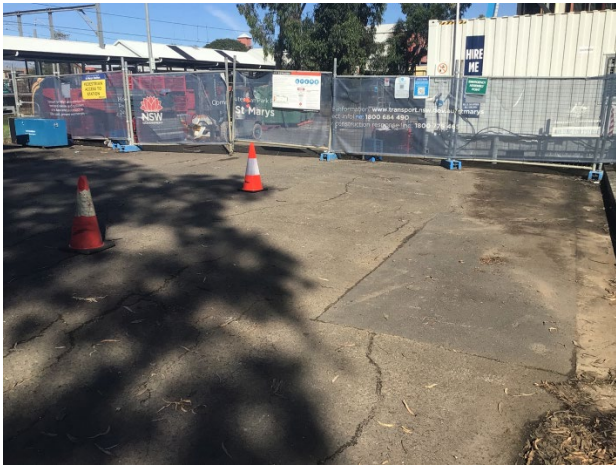
Potential Former UST Location, St Marys Station
Commuter Car Park

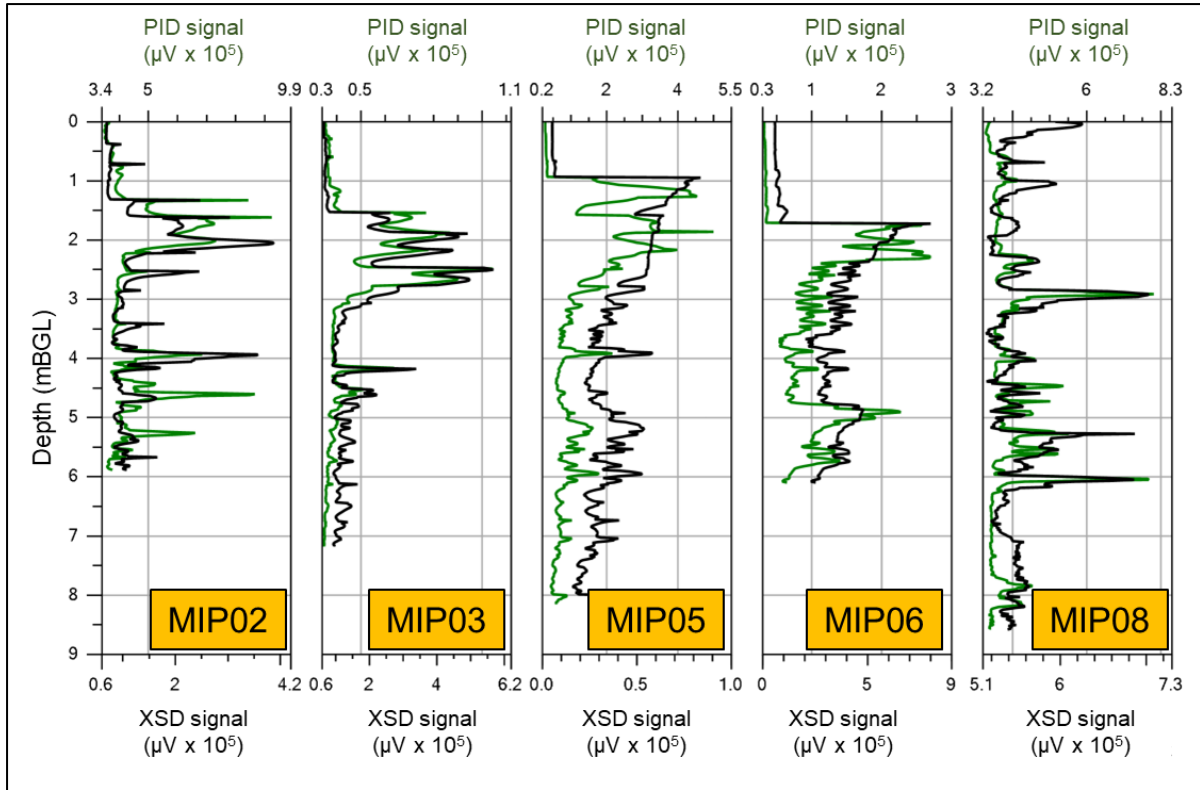
Figure 3. Consistency between PID (green line) and XSD (black line) profiles at several locations.

- There were no clear signs of NAPL in the locations investigated. NAPL commonly results in FID signals over 10 V and similarly high PID values; and
- Comparison of PID, FID, and XSD logs with EC, HPT pressure, and HPT flow logs repeatedly supported that contaminant transport was in part governed by subsurface features such as preferential migration pathways and low-permeability zones (which may also act as capillary barriers and storage zones). In general, increases in the response from chemical detectors could be associated to preferential pathways (as indicated by decreases in HPT pressure and/or EC or increases in HPT flow) within low-permeability intervals as depicted in **Figure 4**.

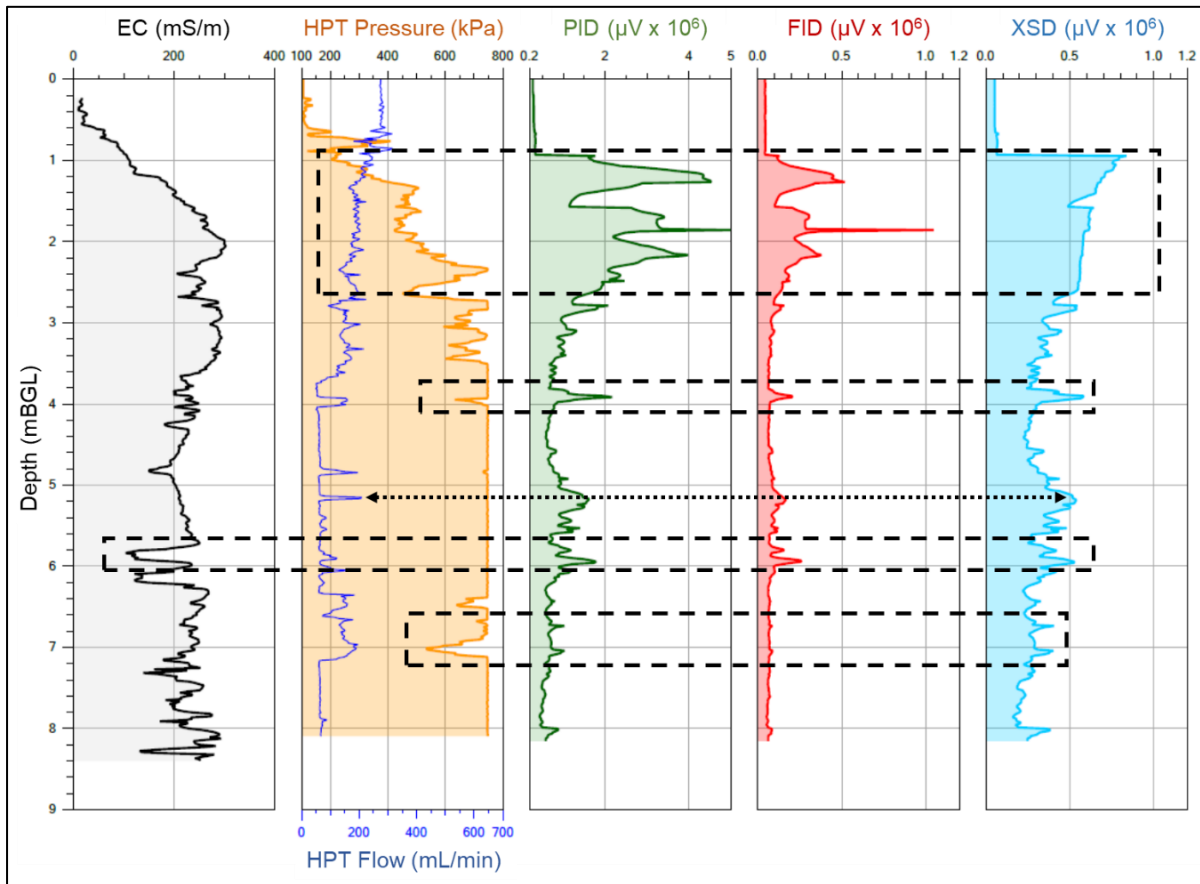
- The maximum PID, FID, and XSD reading were obtained at MIP05, where the PID maxed out (5 V at high gain settings) and the FID rose to 1.05 V at 1.86 m BGL. The maximum XSD response was 0.84 V at 0.95 mBGL. Given the high signals from the detectors (especially the PID), the MIP pressure was set at a higher value to reduce the amount of VOCs migrating through the MIP membrane and prevent the saturation of the system at this interval. Once the PID, FID, and XSD signals decreased, the MIP pressure was set back at the original value. Similarly, MIP06 exhibited high PID, FID, and XSD signals of 2.69 V (2.29 mBGL), 0.42 V (4.90 mBGL), and 0.80 V (1.72 mBGL), respectively. High FID responses of 0.46 V and 0.52 V were also measured at MIP02 (4.62 mBGL) and MIP03 (4.18 mBGL), respectively;

Figure 4. Correlation between chemical responses (PID in green, FID in red, XSD in cyan), HPT pressure (in orange), HPT flow (in blue), and EC (in black) at MIP05. The black dashed rectangles and dotted arrows highlight intervals of interest.

- Carryover effects can occur due to sorption and desorption cycles of VOCs in the MIP membrane and transfer lines. In general, the FID is less prone to carryover effects than the other detectors, so its interpretation may help to better infer the vertical distribution of VOCs. For instance, the high XSD values recorded between 0.95 and 2.59 mBGL at MIP05 (see **Figure 4**) may have been partly due to carryover effects.

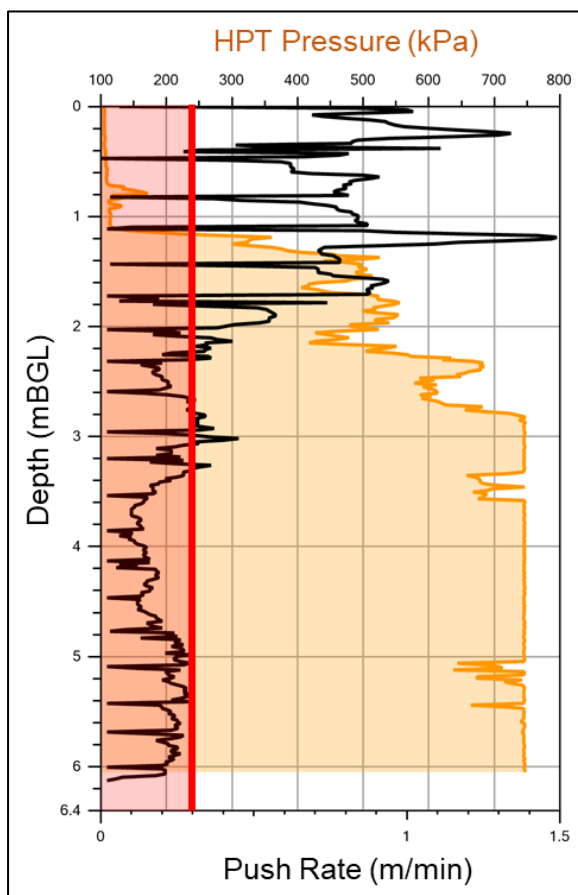
- The daily production rate was relatively low due to the hard materials encountered in the subsurface. In general, push rates below 0.3 m/min are considered refusal. However, as depicted in **Figure 5**, the probe was advanced even at lower rates to manage to go through the formation. This did not avoid a shallow refusal at MIP04 (4.56 mBGL);

Figure 5. Push rate (in black) and HPT pressure (in orange) at MIP06. Geoprobe typically considers refusal when the push rate is lower than 0.3 m/min (indicated by the red line). Note how the probe was stopped every ~0.3 m to heat up the formation.

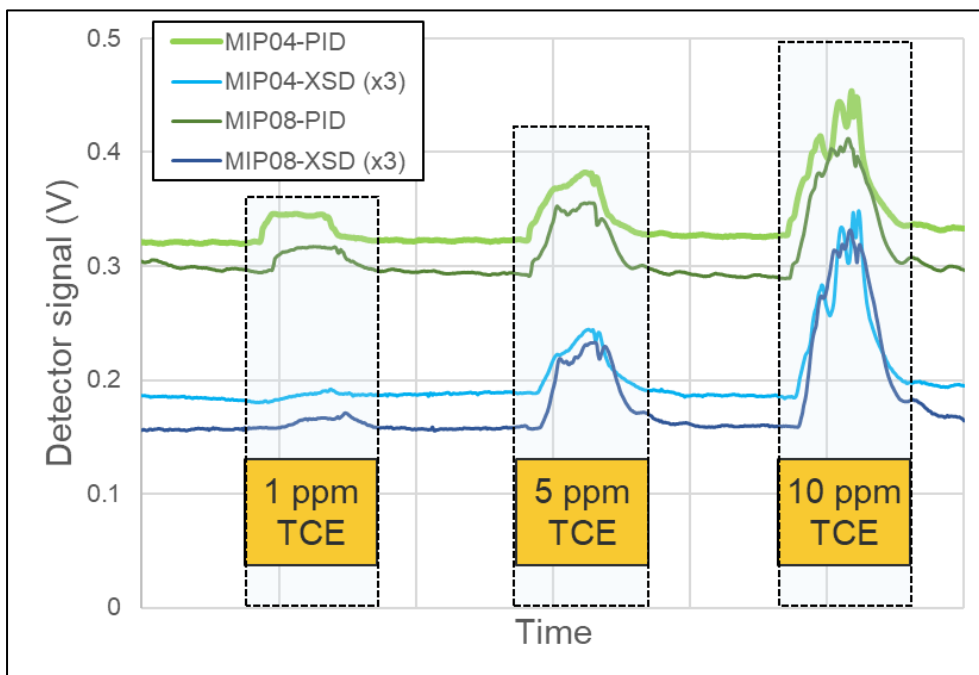
Figure 6. Post-log response tests at MIP04 and MIP08. For illustrative purposes, XSD signals are multiplied by three and PID and XSD peaks are aligned.

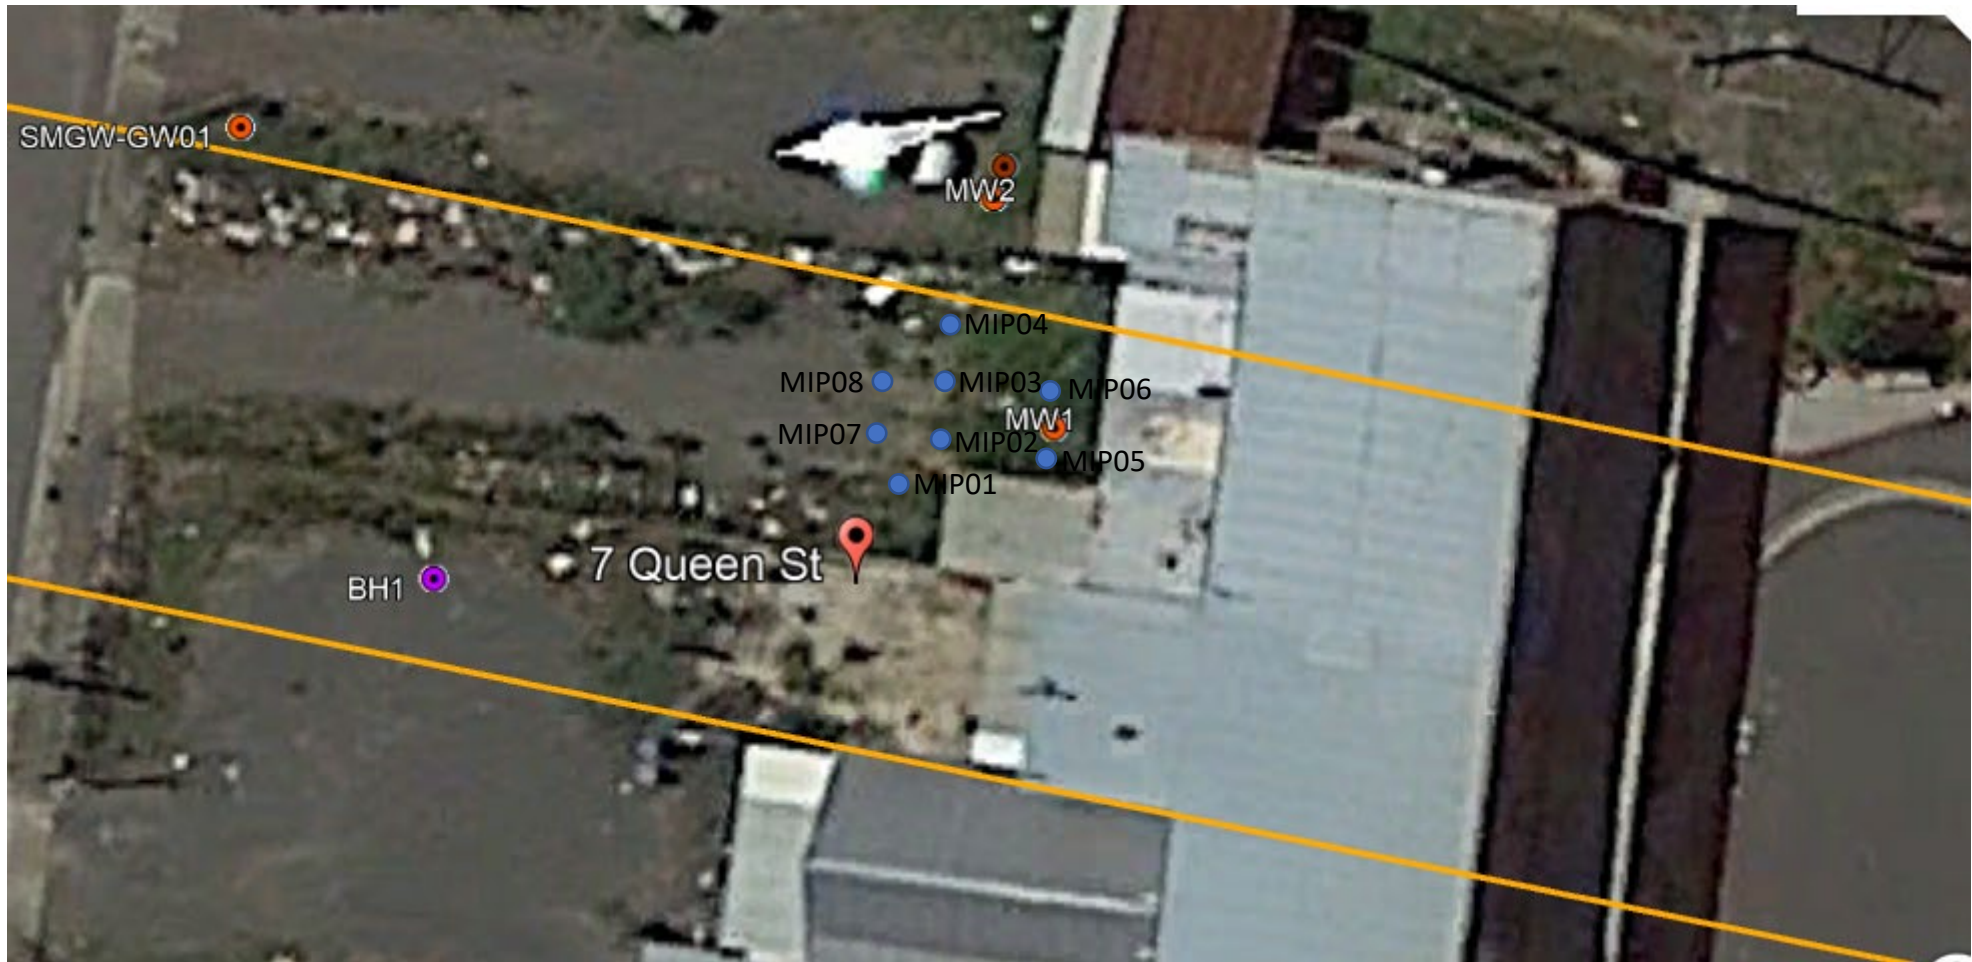
Company:	Tetra Tech Coffey	Operator:	JGR	File:	MIP08.MHP
Project ID:	SYDGE292575	Client:	Sydney Metro	Date:	8/06/2022
				Location:	St Marys, NSW
