**SYDNEY METRO - WESTERN SYDNEY AIRPORT
STATION BOXES AND TUNNELLING WORKS**

6-Monthly Surface Water Monitoring Report: April to October 2024

Project number	WSA-200-SBT
Document number	SMWSASBT-CPG-SWD-SW000-EN-RPT-295460
Revision date	08/11/2024
Revision	01

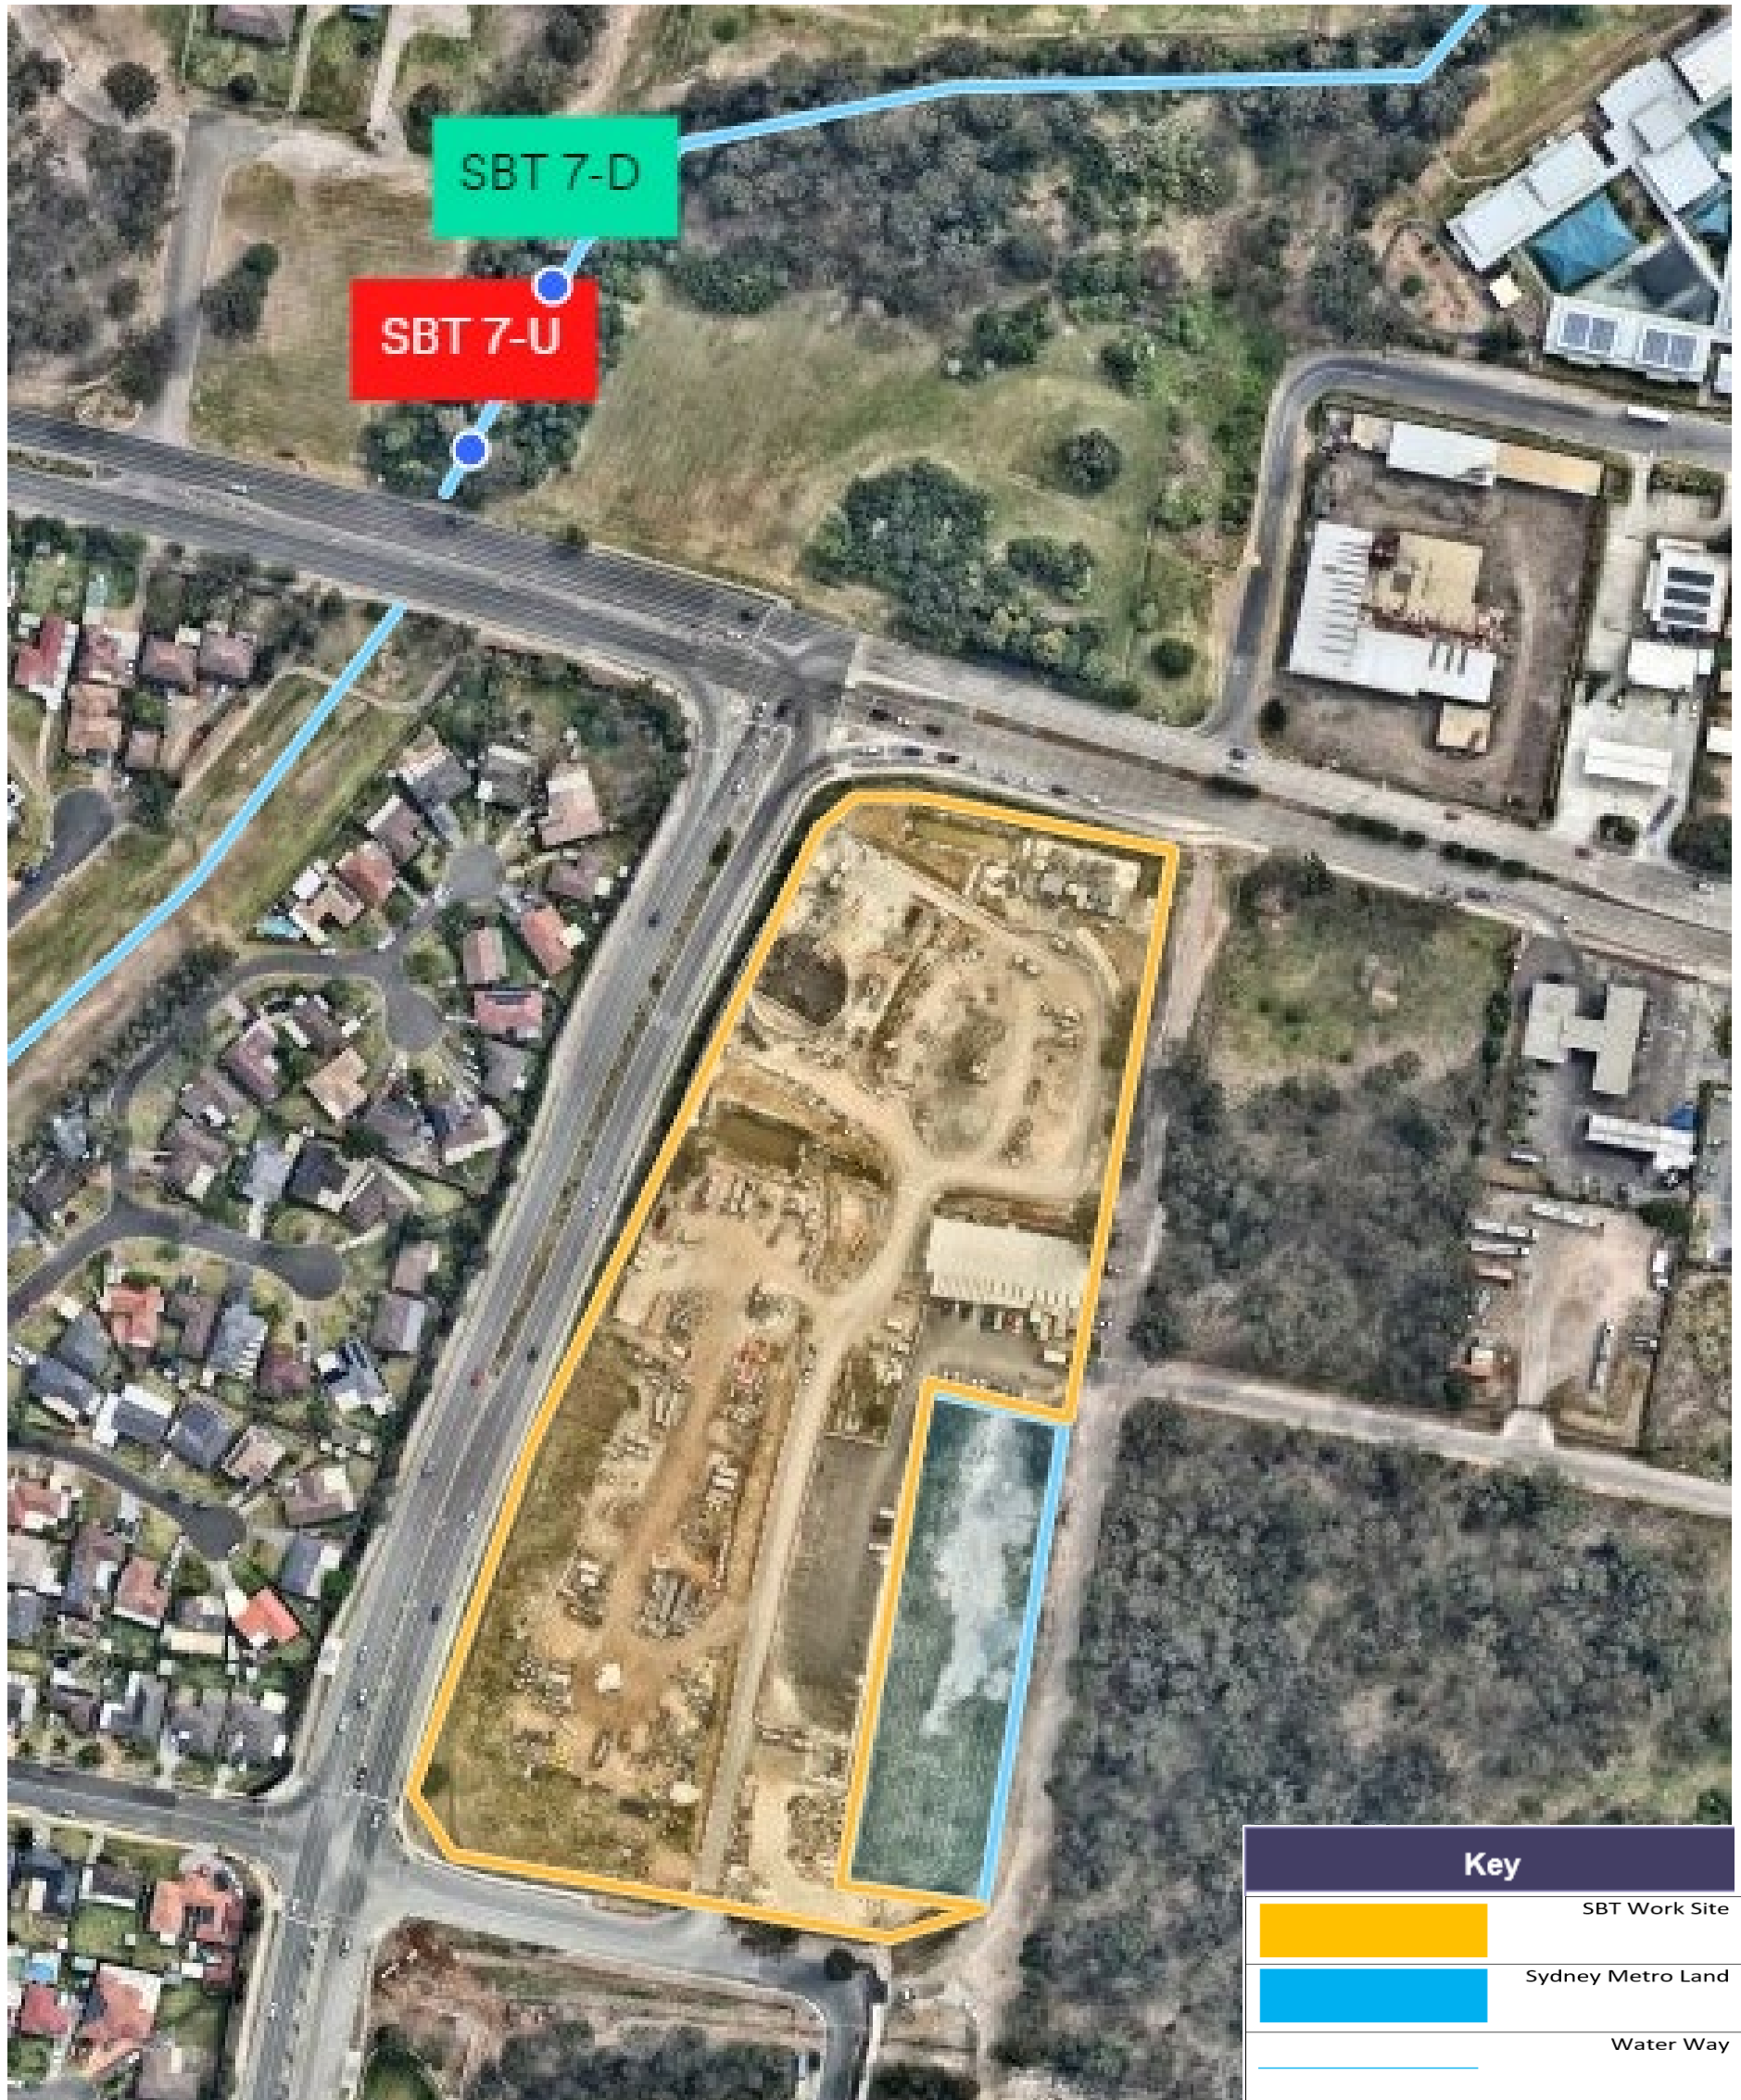
FIGURE 3: CLAREMONT MEADOWS SAMPLING LOCATION SBT-7

- SBT-7U and SBT-7D is a drainage line which collects water off road surfaces from Gipps Street and the Great Western Highway. Following rainfall, the water has the potential to pick up road residue and discharge it to the waterway.
- SBT-9U and SBT-9D is downstream of the Western Sydney Airport catchment and surrounding farmlands which have historically contributed runoff to the waterway. As noted in the WSA EIS, nutrient loads are typically high and above ANZECC guidelines. This creek is also ephemeral and as a result samples cannot always be taken.

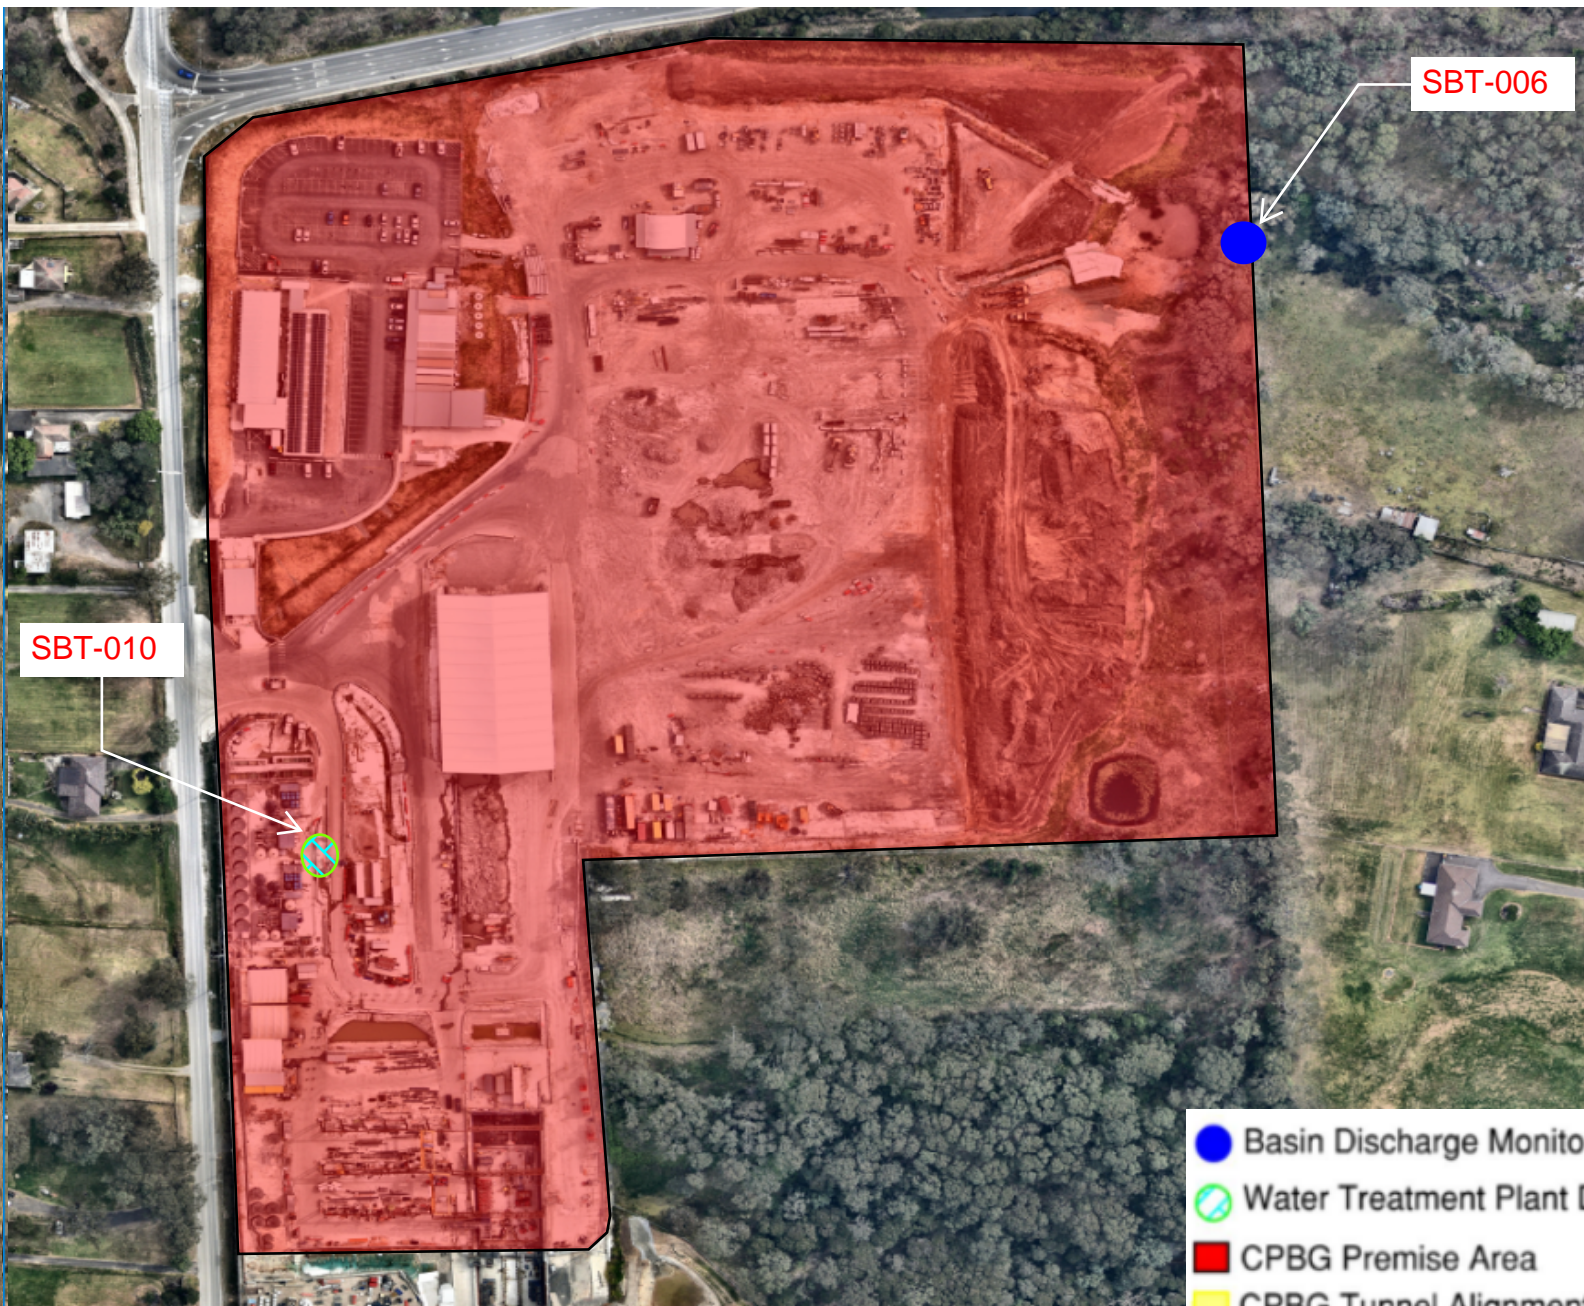
EPL Premise Map - Orchard Hills North

Rev	Description	Date
M	Temporary Premise area removed, SBT-016 Removed	02/10/2024
L	Temporary Premise area added	27/09/2024
K	Premise area decreased	28/03/2024
J	Premise area increased	18/01/2024
I	SBT-015	15/12/2023
H	Premise area decreased	24/11/2023

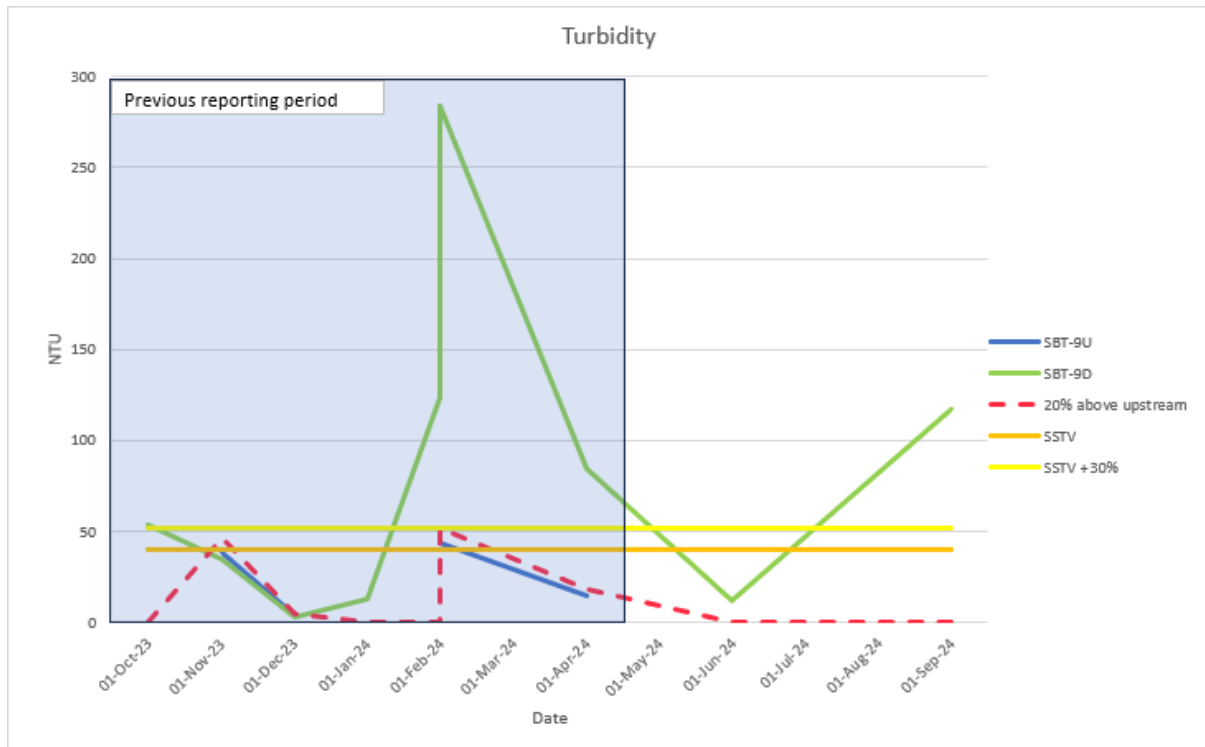
During the monitoring period one downstream sample was above the SSTV and the SSTV 30% threshold. On investigation, SBT did not discharge to waterways, nor had water leave site, around this sampling time, therefore SBT site activities were unlikely to be the cause of this event.

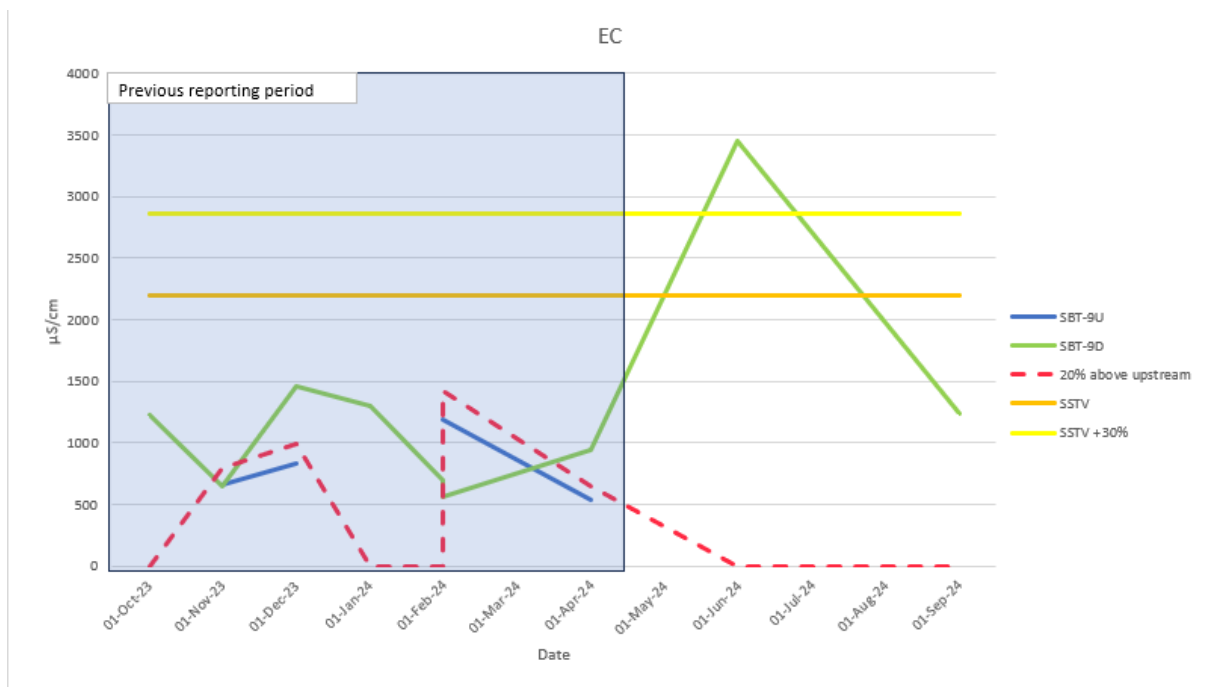
During the monitoring period one downstream sample was above the SSTV and the SSTV 30% threshold. On investigation, SBT did not discharge to waterways, nor had water leave site, around this sampling time, therefore SBT site activities were unlikely to be the cause of this event.

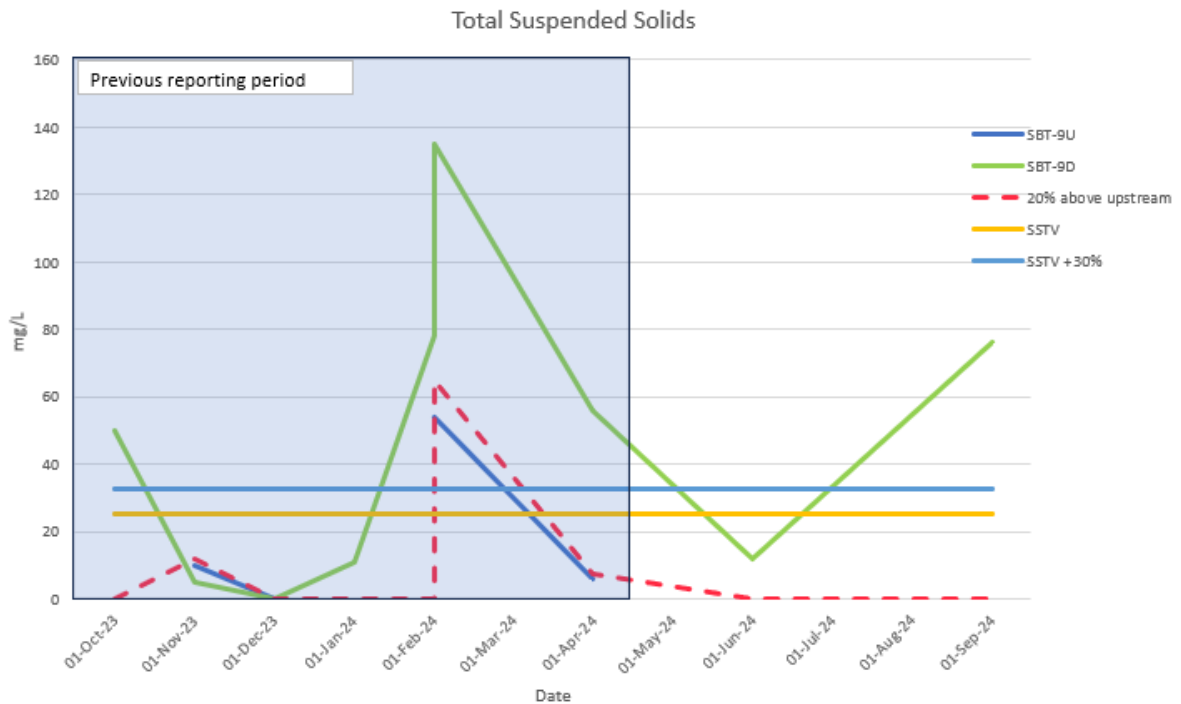
During the monitoring period one downstream sample was above the SSTV and the SSTV 30% threshold. On investigation, SBT did not discharge to waterways, nor had water leave site, around this sampling time, therefore SBT site activities were unlikely to be the cause of this event.

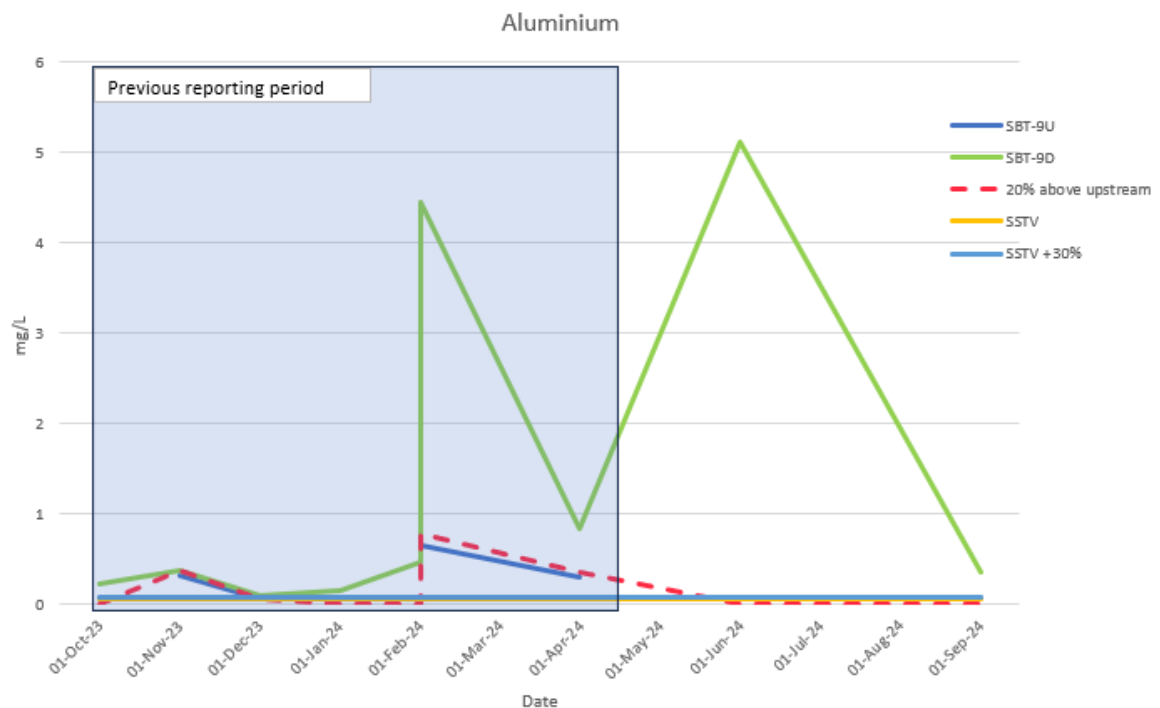
During the monitoring period two downstream sample was above the SSTV and the SSTV 30% threshold. On investigation, SBT did not discharge to waterways, nor had water leave site, around this sampling time, therefore SBT site activities were unlikely to be the cause of this event.

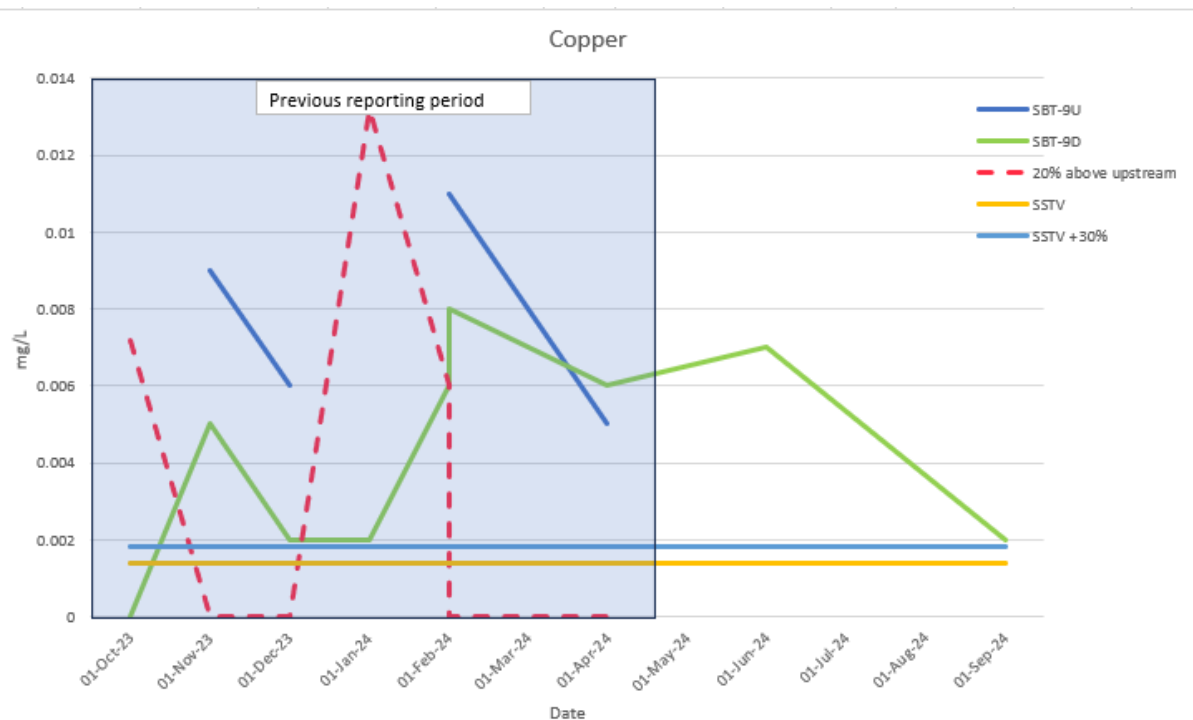
During the monitoring period two downstream sample was above the SSTV and the SSTV 30% threshold. On investigation, SBT did not discharge to waterways, nor had water leave site, around this sampling time, therefore SBT site activities were unlikely to be the cause of this event.

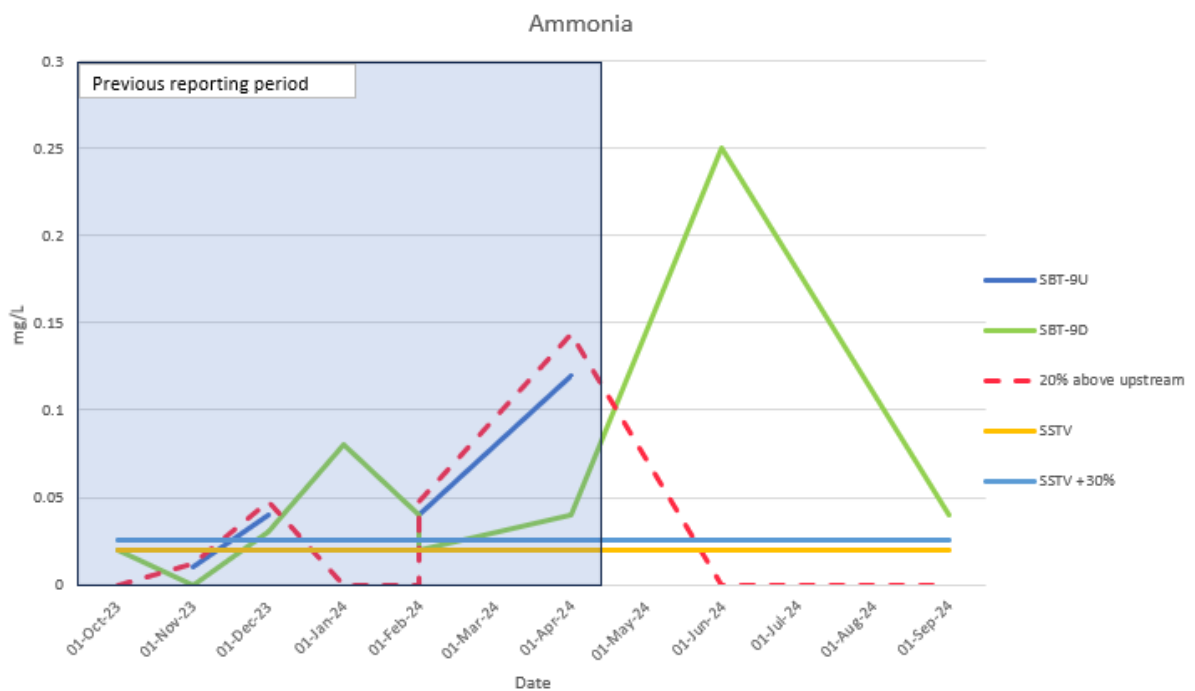
During the monitoring period two downstream sample was above the SSTV and the SSTV 30% threshold. On investigation, SBT did not discharge to waterways, nor had water leave site, around this sampling time, therefore SBT site activities were unlikely to be the cause of this event.

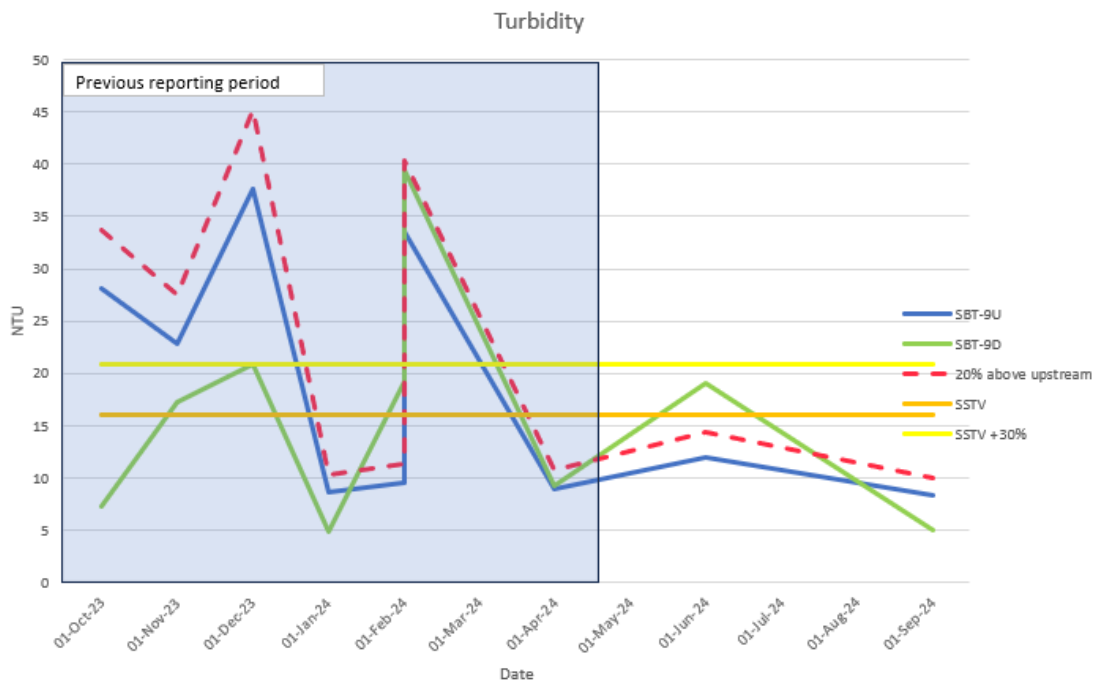
During the monitoring period one downstream sample was above the SSTV and the 20% above upstream sample threshold. On investigation, SBT did not discharge to waterways, nor had water leave site, around this sampling time, therefore SBT site activities were unlikely to be the cause of this event.

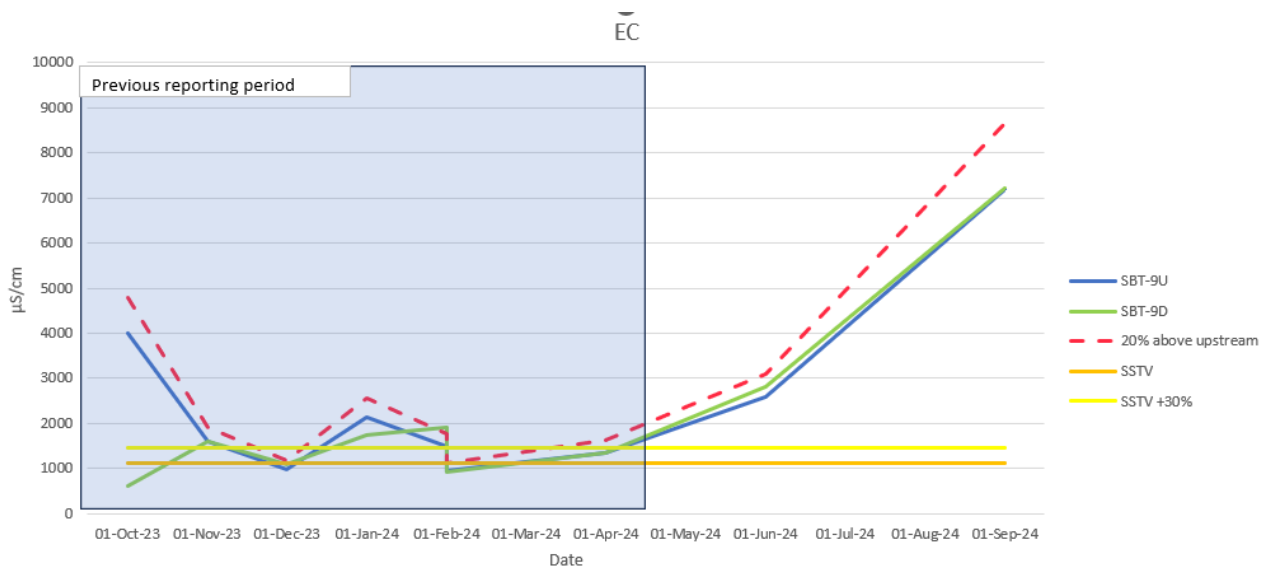
During the monitoring period two downstream and two upstream samples were above the SSTV and the SSTV 30% threshold. On investigation, SBT did not discharge to waterways, nor had water leave site, around this sampling time, therefore SBT site activities were unlikely to be the cause of this event.

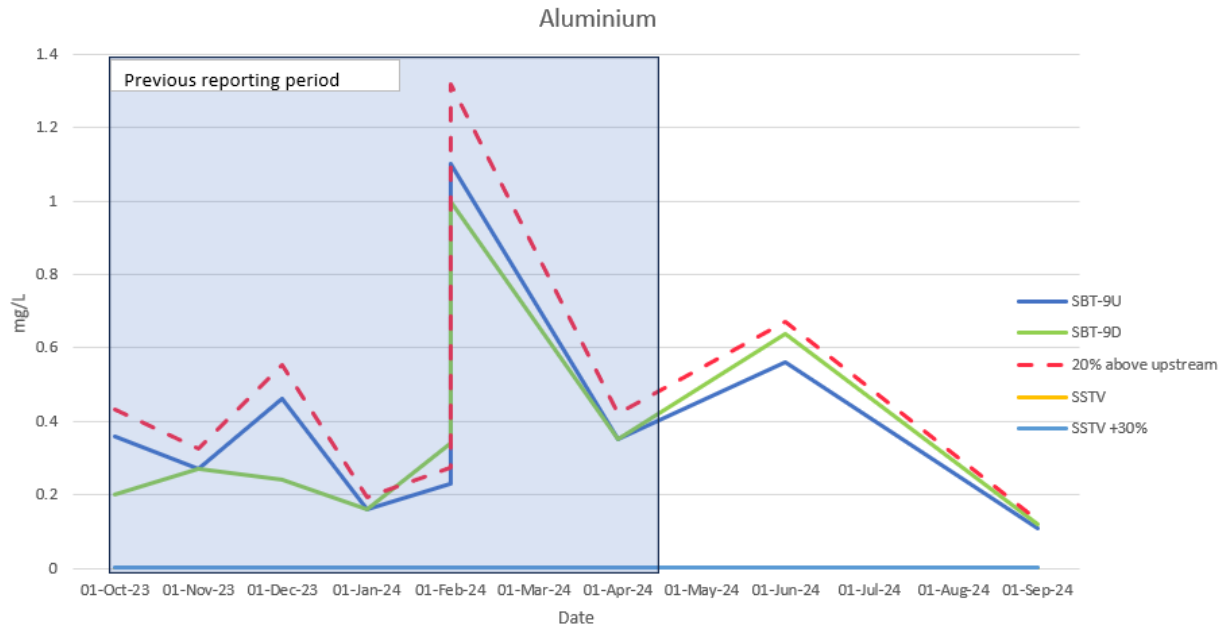
During the monitoring period two downstream and two upstream samples were above the SSTV and the SSTV 30% threshold. On investigation, SBT did not discharge to waterways, nor had water leave site, around this sampling time, therefore SBT site activities were unlikely to be the cause of this event.

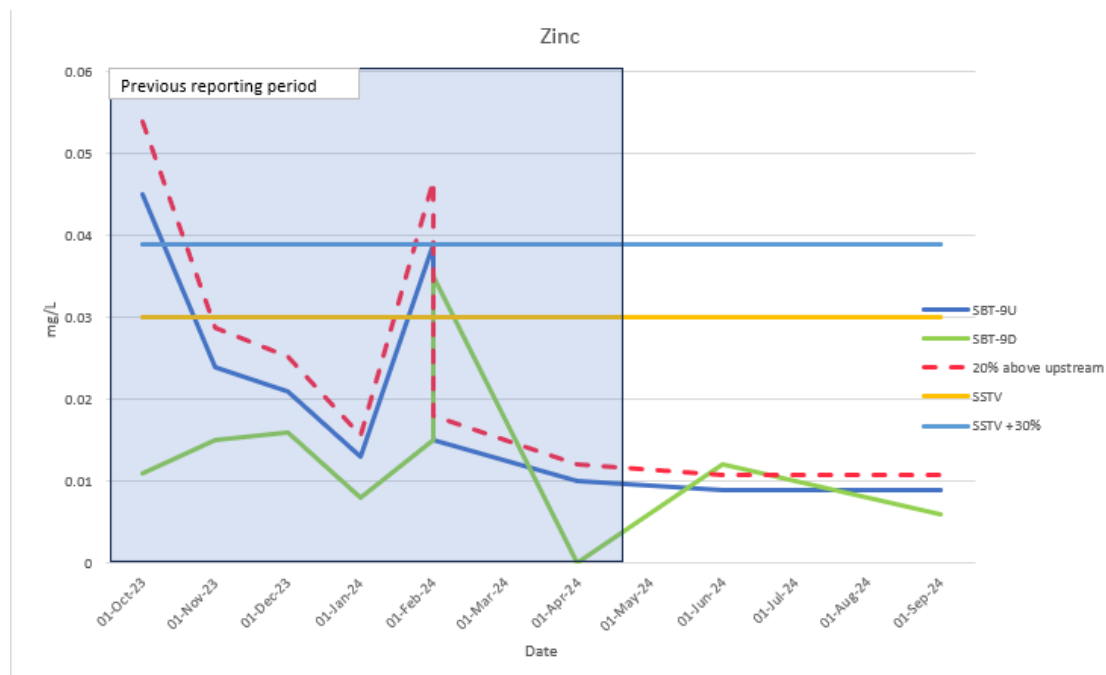
During the monitoring period one downstream sample was above the 20% above upstream sample threshold. On investigation, SBT did not discharge to waterways, nor had water leave site, around this sampling time, therefore SBT site activities were unlikely to be the cause of this event.

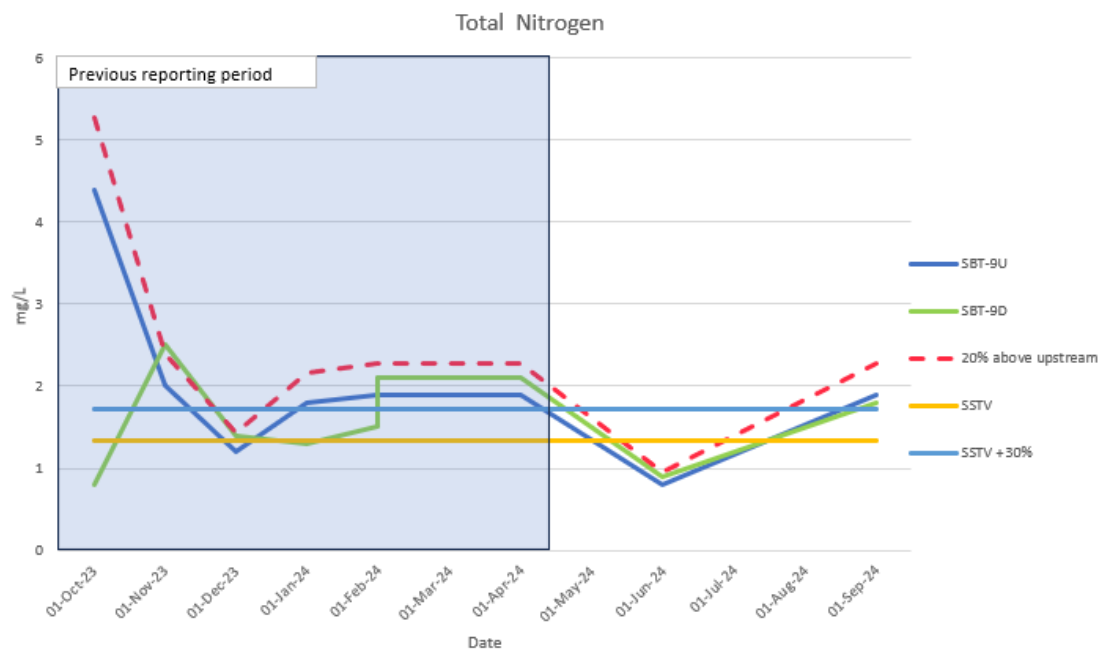
During the monitoring period one downstream and one upstream sample were above the SSTV and the 20% above upstream sample threshold. On investigation, SBT did not discharge to waterways, nor had water leave site, around this sampling time, therefore SBT site activities were unlikely to be the cause of this event.

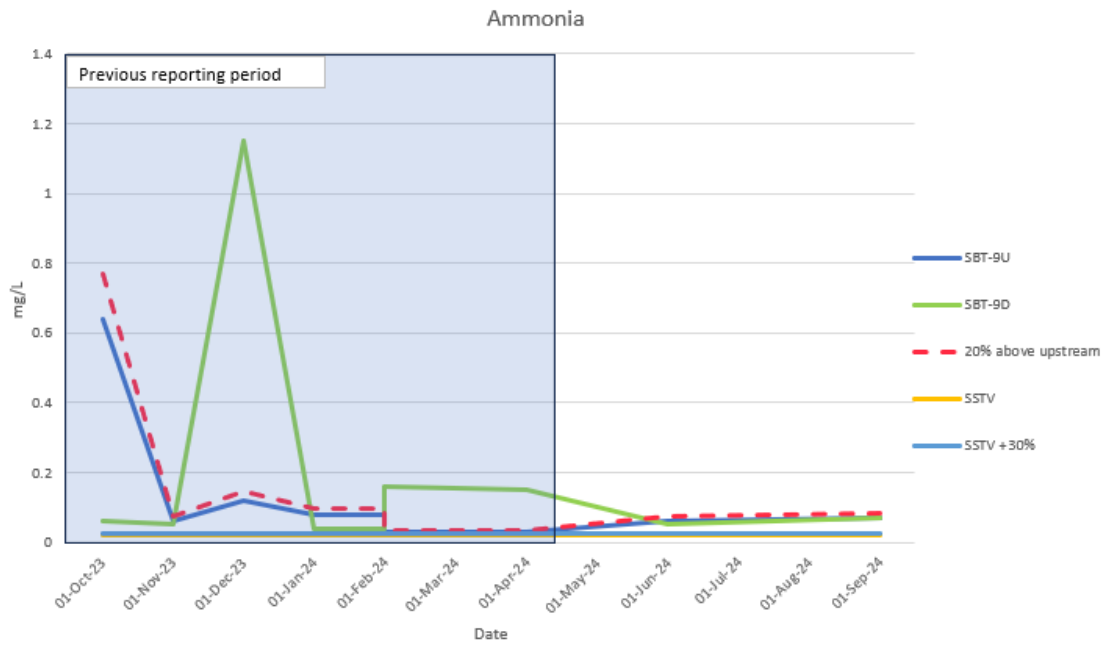
During the monitoring period two downstream and two upstream sample were above the SSTV and the SSTV 30% threshold. On investigation, SBT did not discharge to waterways, nor had water leave site, around this sampling time, therefore SBT site activities were unlikely to be the cause of this event.

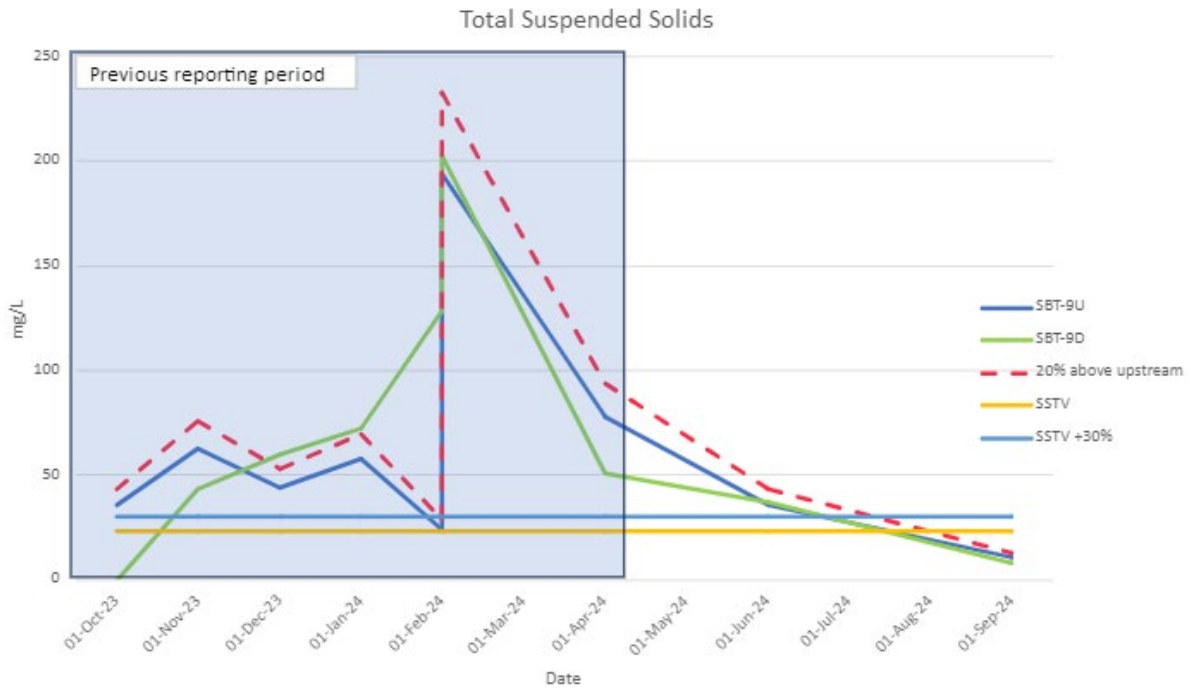
During the monitoring period one downstream and one upstream sample were above the SSTV and the SSTV 30% threshold. On investigation, SBT had discharged surface water from site around the June 2024 sampling event, however this was to vegetated ground near the sediment basin and due to the volume of water discharged and distance to the waterway, it is unlikely the flow would reach the waterway before infiltrating into the surface. It is not likely SBT activities would have resulted in this impact on water quality.

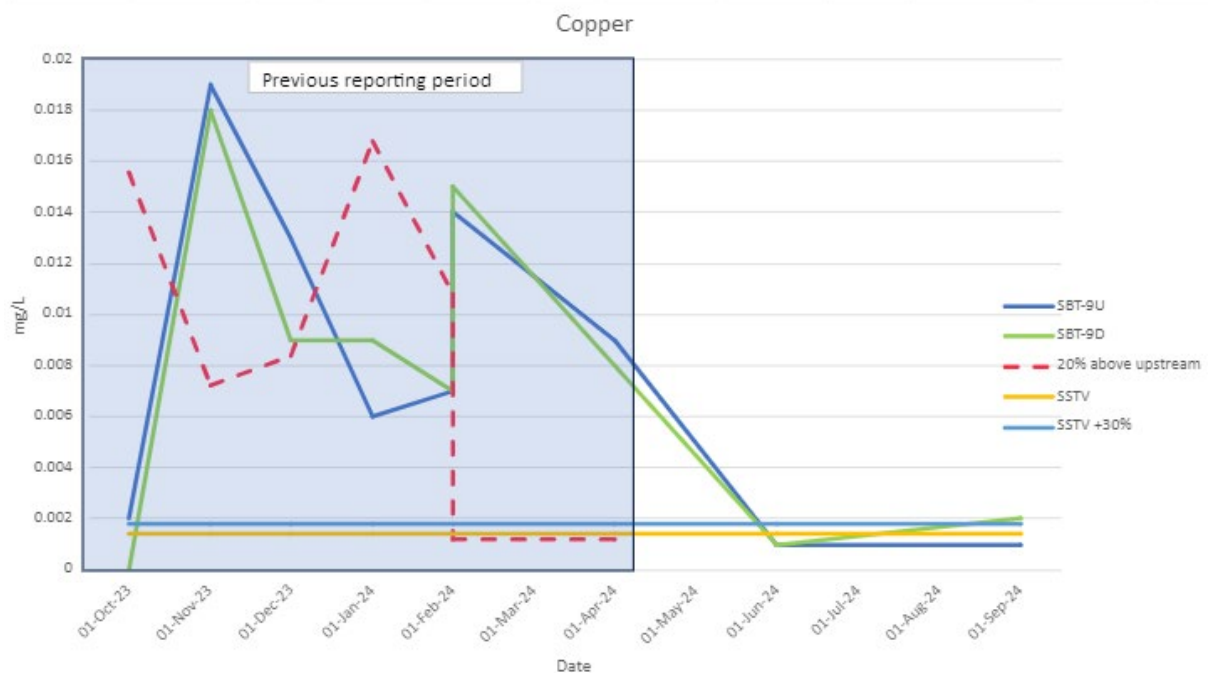
During the monitoring period one downstream sample was above the SSTV and the SSTV 30% threshold. On investigation, SBT did not discharge to waterways, nor had water leave site, around this sampling time, therefore SBT site activities were unlikely to be the cause of this event.

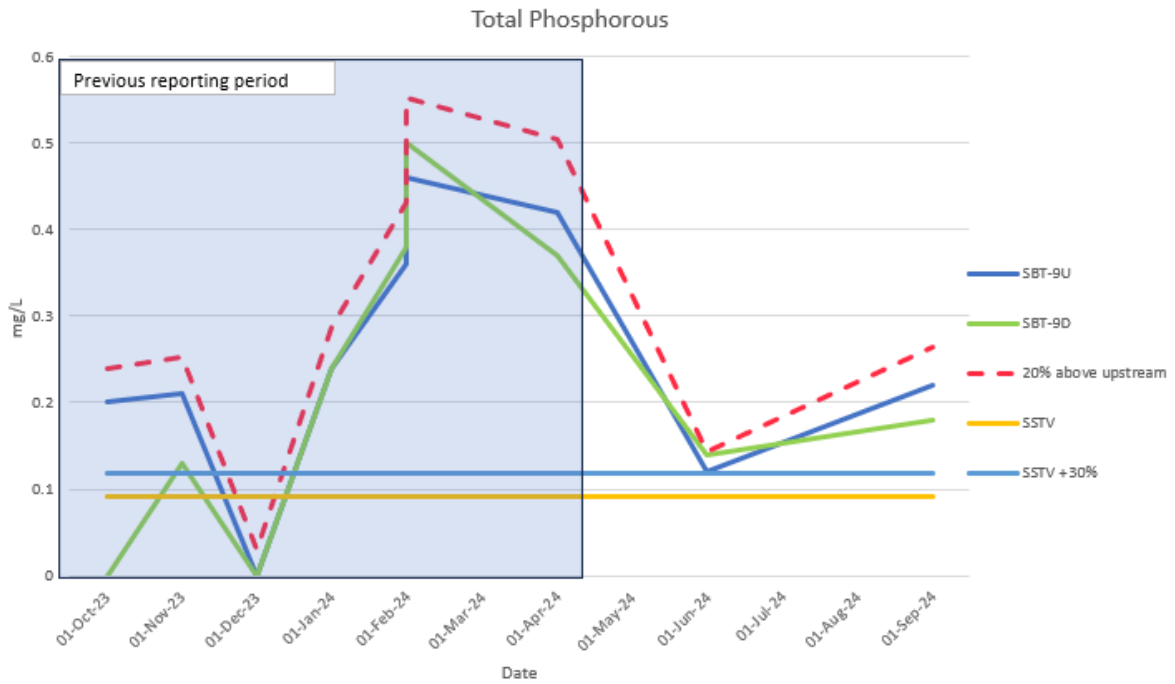
During the monitoring period two downstream and two upstream sample were above the SSTV and the SSTV 30% threshold. On investigation, SBT had discharged surface water from site around the June 2024 event, however this was to vegetated ground near the sediment basin and due to the volume of water discharged and distance to the waterway, it is unlikely the flow would reach the waterway before infiltrating into the surface. It is not likely SBT activities would have resulted in this impact on water quality. The previous sampling also shows total phosphorus is higher than the SSTV.

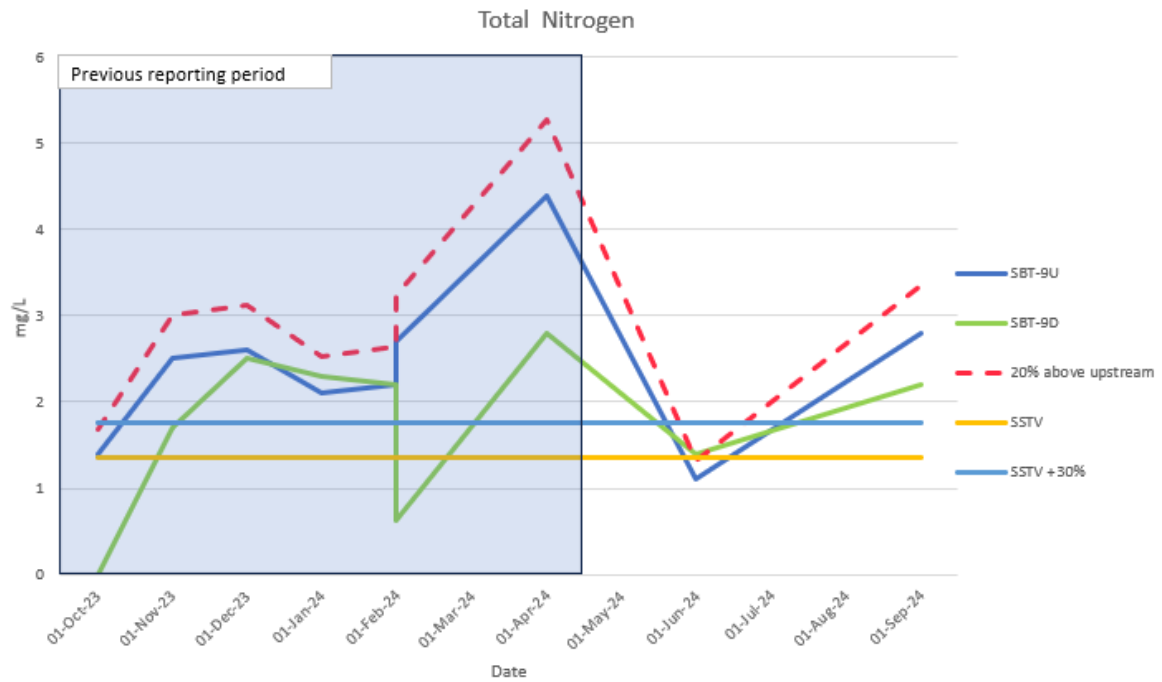
During the monitoring period one downstream and one upstream sample were above the SSTV and the SSTV 30% threshold. SBT did not discharge basins, nor had water leave site, around this sampling event. SBT do not believe this exceedance is due to site activity.

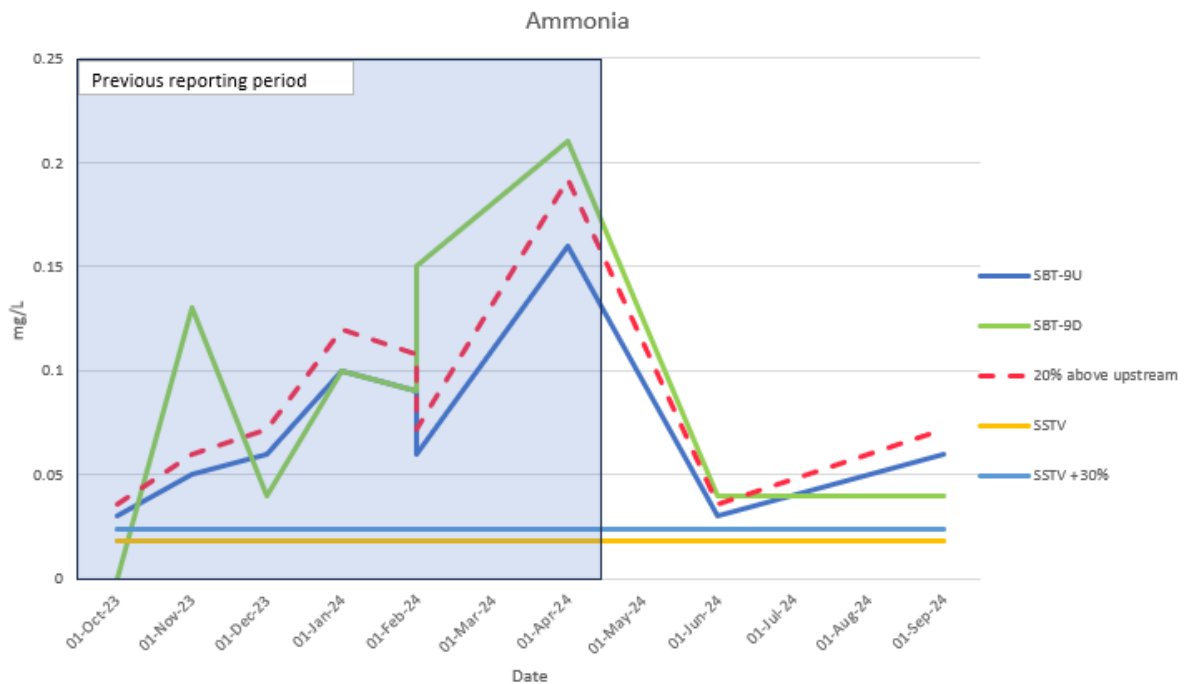
During the monitoring period two downstream and two upstream sample were above the SSTV and the SSTV 30% threshold. SBT had discharged surface water from site during the June 2024 event, however it is not likely for SBT water to have an impact on water quality. The previous sampling also shows Ammonia is higher than the SSTV.
