# Aerotropolis Validation Report

## Sydney Metro Western Sydney Airport Station Boxes and Tunnelling Works

<b>Project number</b>	WSA-200-SBT
<b>Document number</b>	SMWSASBT-CPG-SWD-SW000-GE-RPT-040559
<b>Revision date</b>	18/09/2023
<b>Revision</b>	0

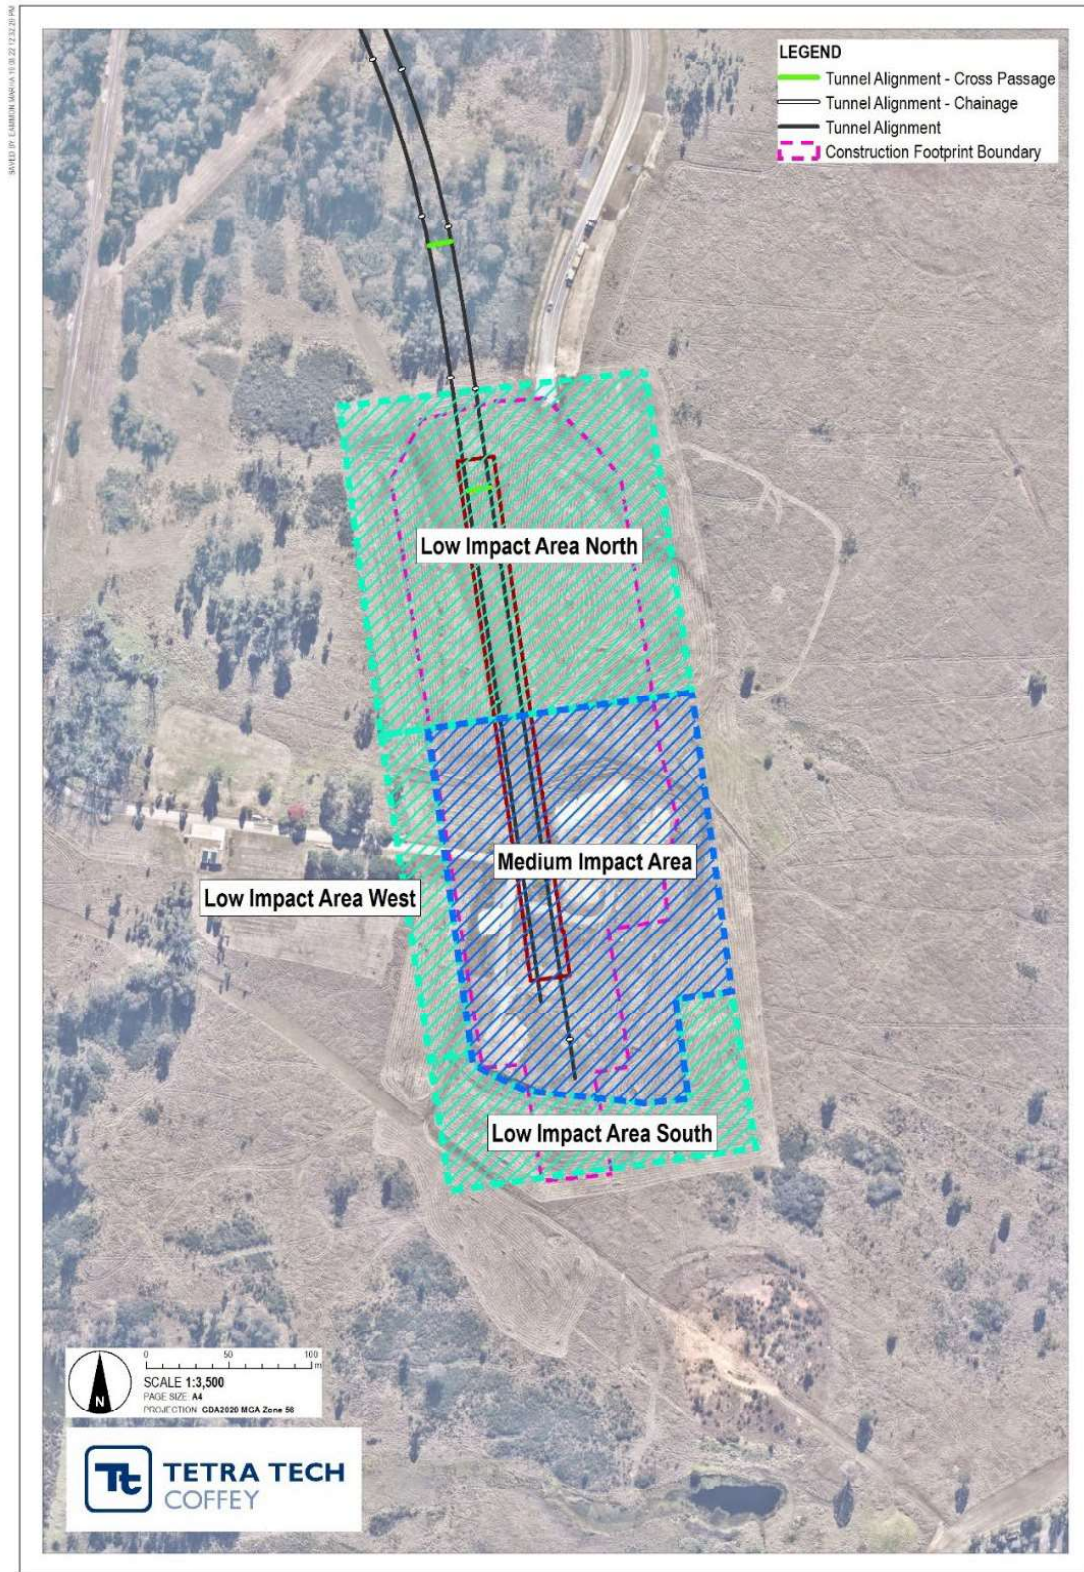
Aerotropolis Low and Medium Impact Areas

The Detailed Site Investigation (DSI) for the SBT Site identified the requirement for the remediation of materials in the Medium Impact Area (refer to Figure on next page) including topsoil/fill materials with asbestos and soil materials impacted with PFAS. Materials in the Low Impact Areas are not considered to pose unacceptable risks to human health or the environment for a commercial/industrial land use. As such, it is considered that remediation is not required for the Low Impact Areas.

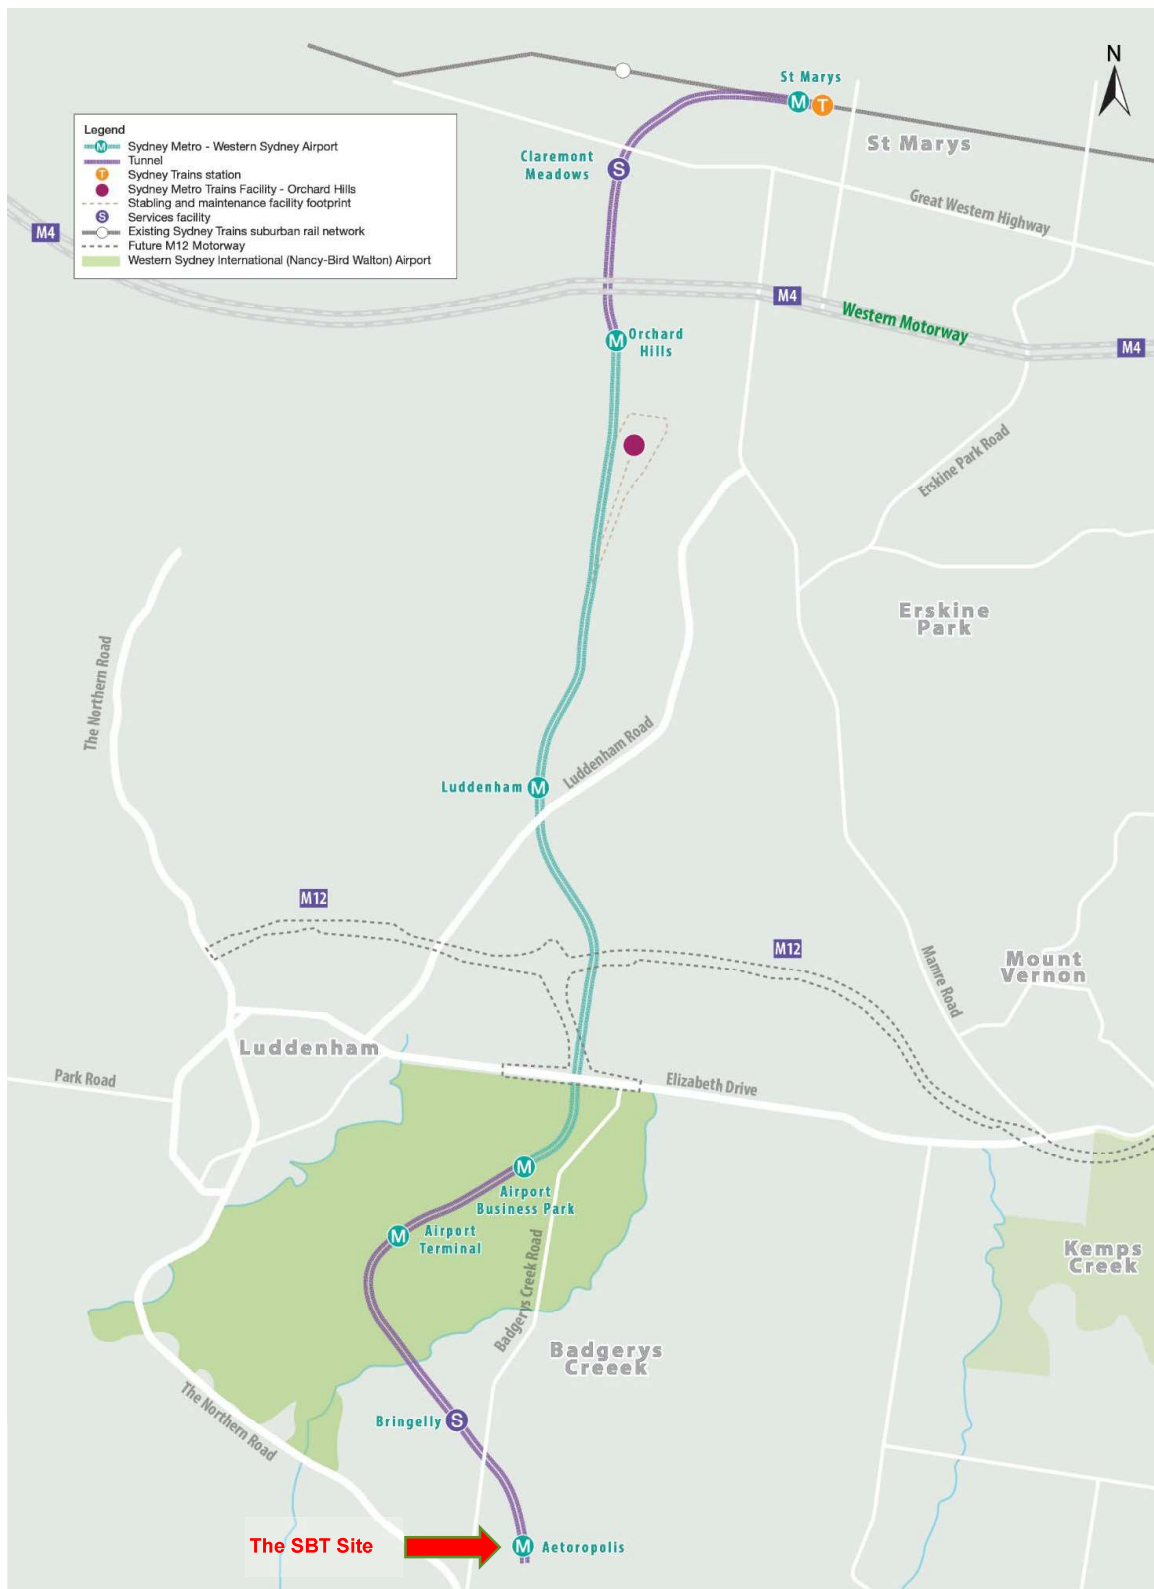
Figure A: Overview of SBT Works

- Two sections of twin tunnels with a combined length of approximately 9.8 km, plus associated portal structures. This includes one section from St Marys to Orchard Hills and the other under Western Sydney International (WSI) airport to the new Aerotropolis Sydney Metro Station.
- Excavations at either end to enable trains to turn back, and stub tunnels to enable future extensions.
- Station box excavations with temporary ground support for four new Metro stations at St Marys, Orchard Hills, Airport Terminal and Aerotropolis (i.e. the SBT Site).
- Excavations associated with two intermediate services facilities; one in each of the tunnel sections at Claremont and Bringelly.

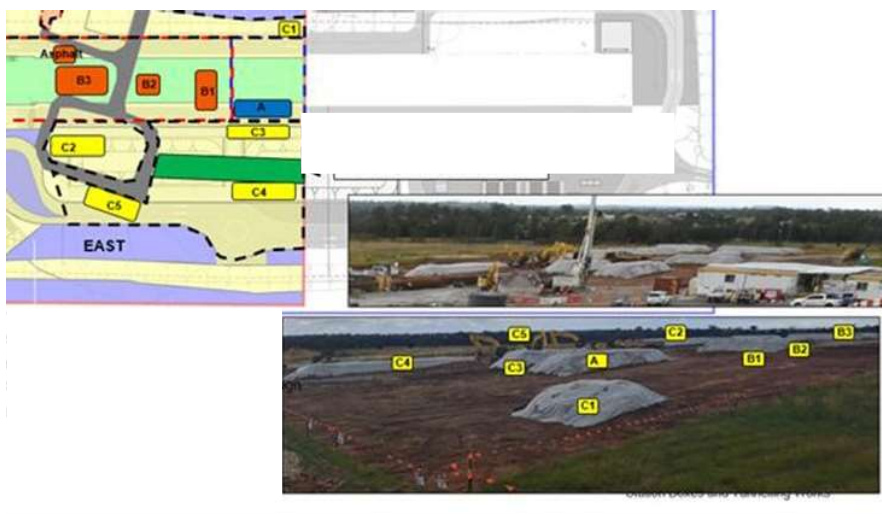
Figure D: Stage 1 Excavation of Fill Materials (areas shown with yellow polygons)

Stage 1 involved the excavation of fill materials within CPBG construction disturbance footprint. These areas are shown in the polygons in yellow in Figure D. Material excavated in Stage 1 was disposed by CPBG off site at an appropriately licenced waste management facility (refer to Section 11.6).

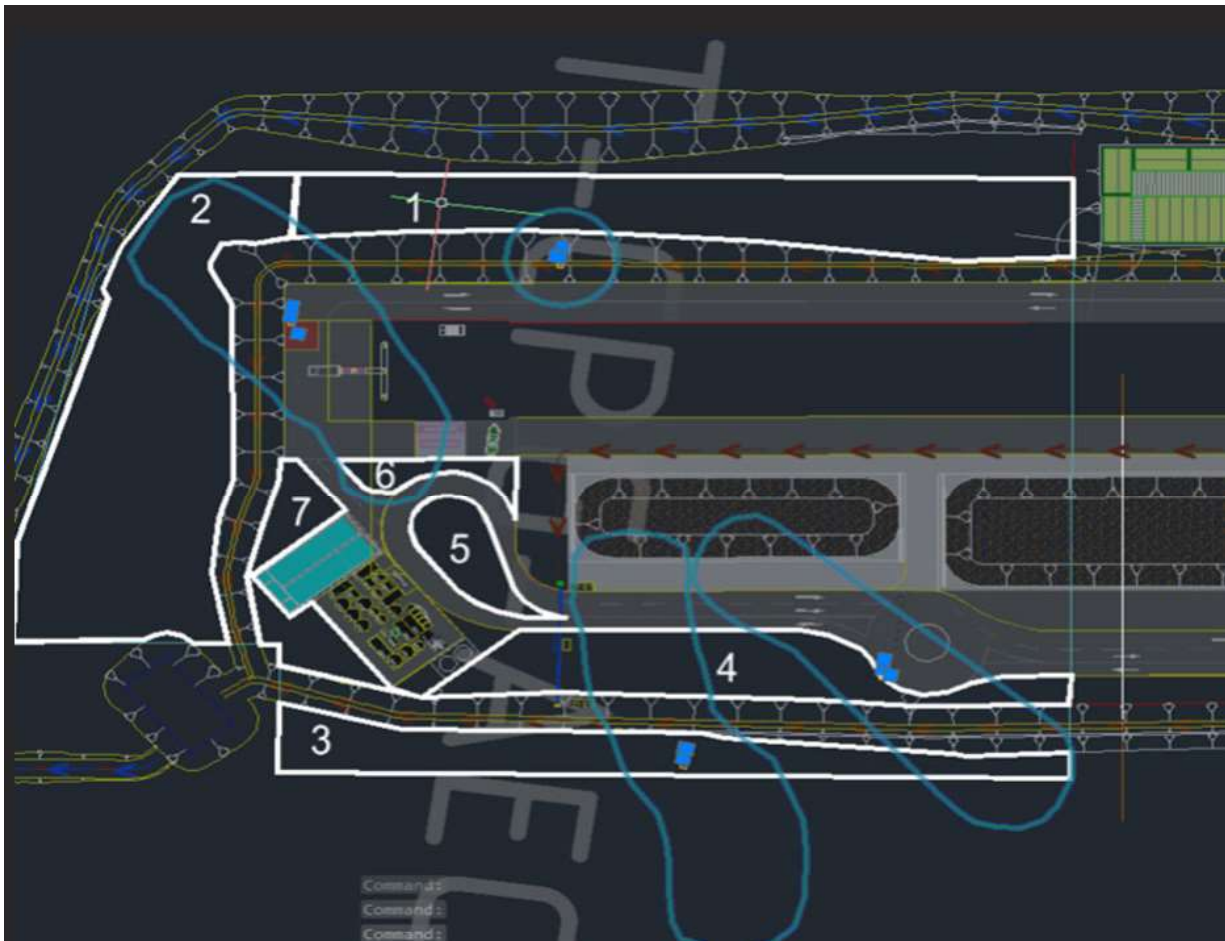
Figure E: Stage 2 Excavation of Fill Materials (areas within the numbered polygons 1 to 7)

Stage 2 involved the excavation of fill materials within the Medium Impact Area and outside of the CPBG construction disturbance footprint. Materials which have been excavated in Stage 2 are shown as the labelled polygons 1 to 7 in Figure E. These materials were stockpiled in ACM Remediation Area 1 shown in Figure 7A, Appendix 1.

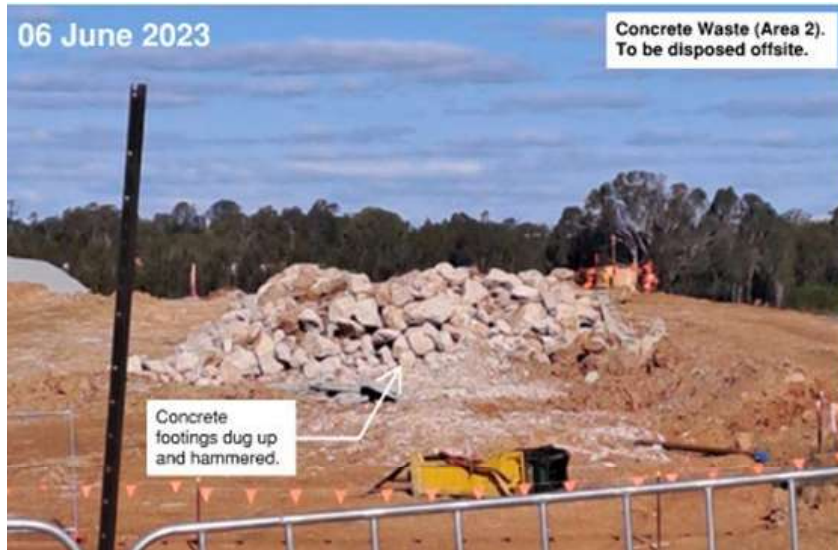
Figure F: Concrete footings from for RAAF Receiving Station

Concrete materials which have been excavated from the footings of the former RAAF receiving station are pre-classified as General Solid Waste Non-Putrescible and accordingly a material classification assessment of these materials is not required. Concrete materials were disposed off-site by CPBG as GSW Non-Putrescible (refer to Item 13 and Item 14 in Appendix 12).
