# Bringelly

CPB Contracting and Ghella Joint Venture

## Validation Report

JBS&G 63723 | 154,941 (Rev 0)

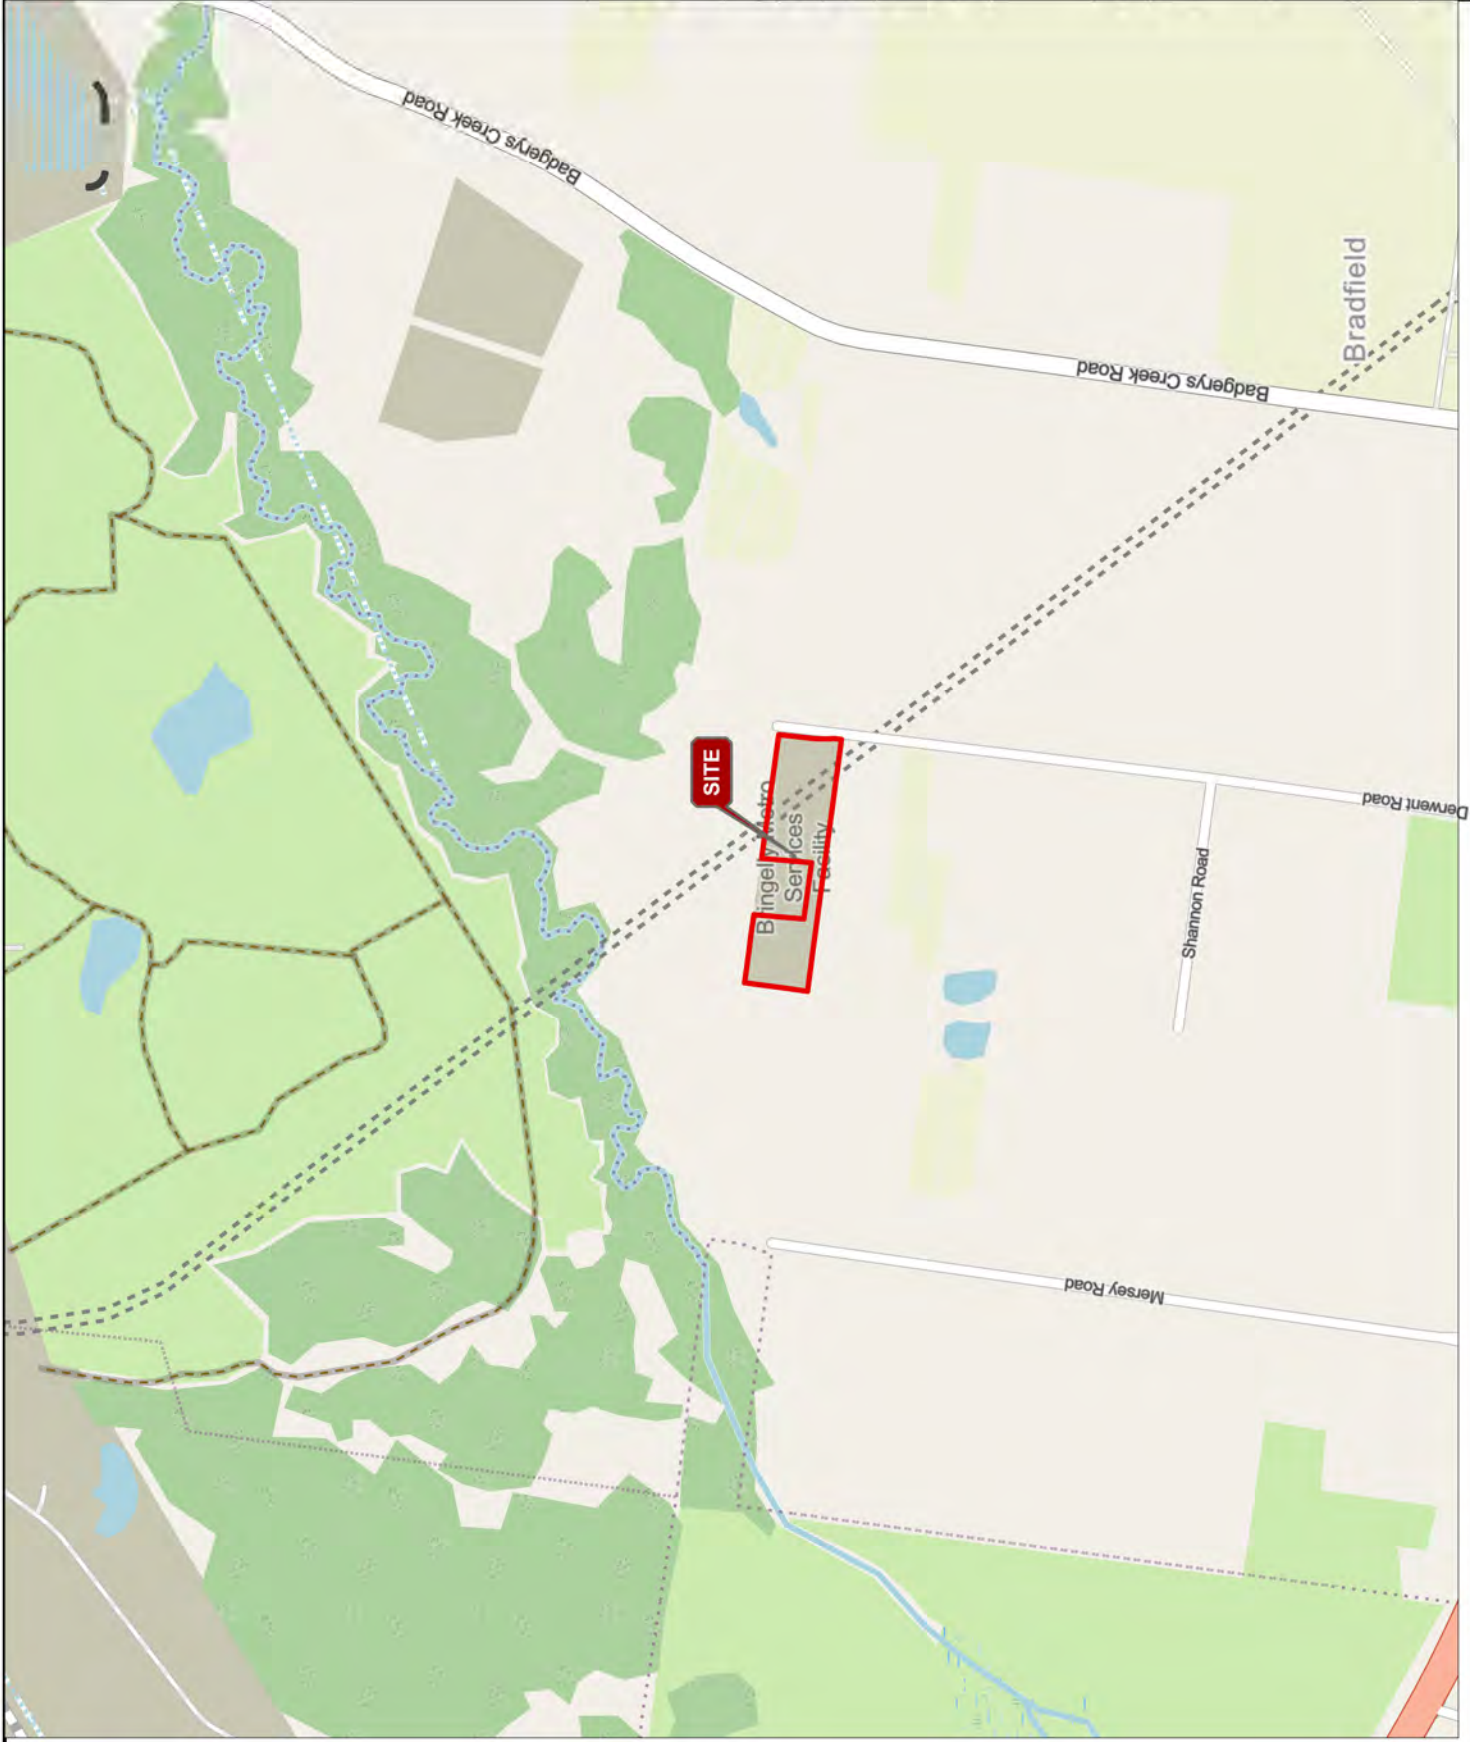
FIGURE 2

SITE LAYOUT

It is noted that the RAP was prepared specifically for the construction footprint, as shown on **Figure 2** (located within the eastern half of the site). However, the Validation Report has been prepared for the whole site. This was completed considering there was a minimal extent of remediation identified within the construction footprint, which warranted a RAP, no remediation was identified outside of this, and a formal RAP was not required for areas outside of this. Noting that waste has been generated on the project and materials moved / relocated, the Validation Report has been prepared as specific to the whole site to ensure the Site Auditor opportunity to confirm waste compliance across the extent of the project.

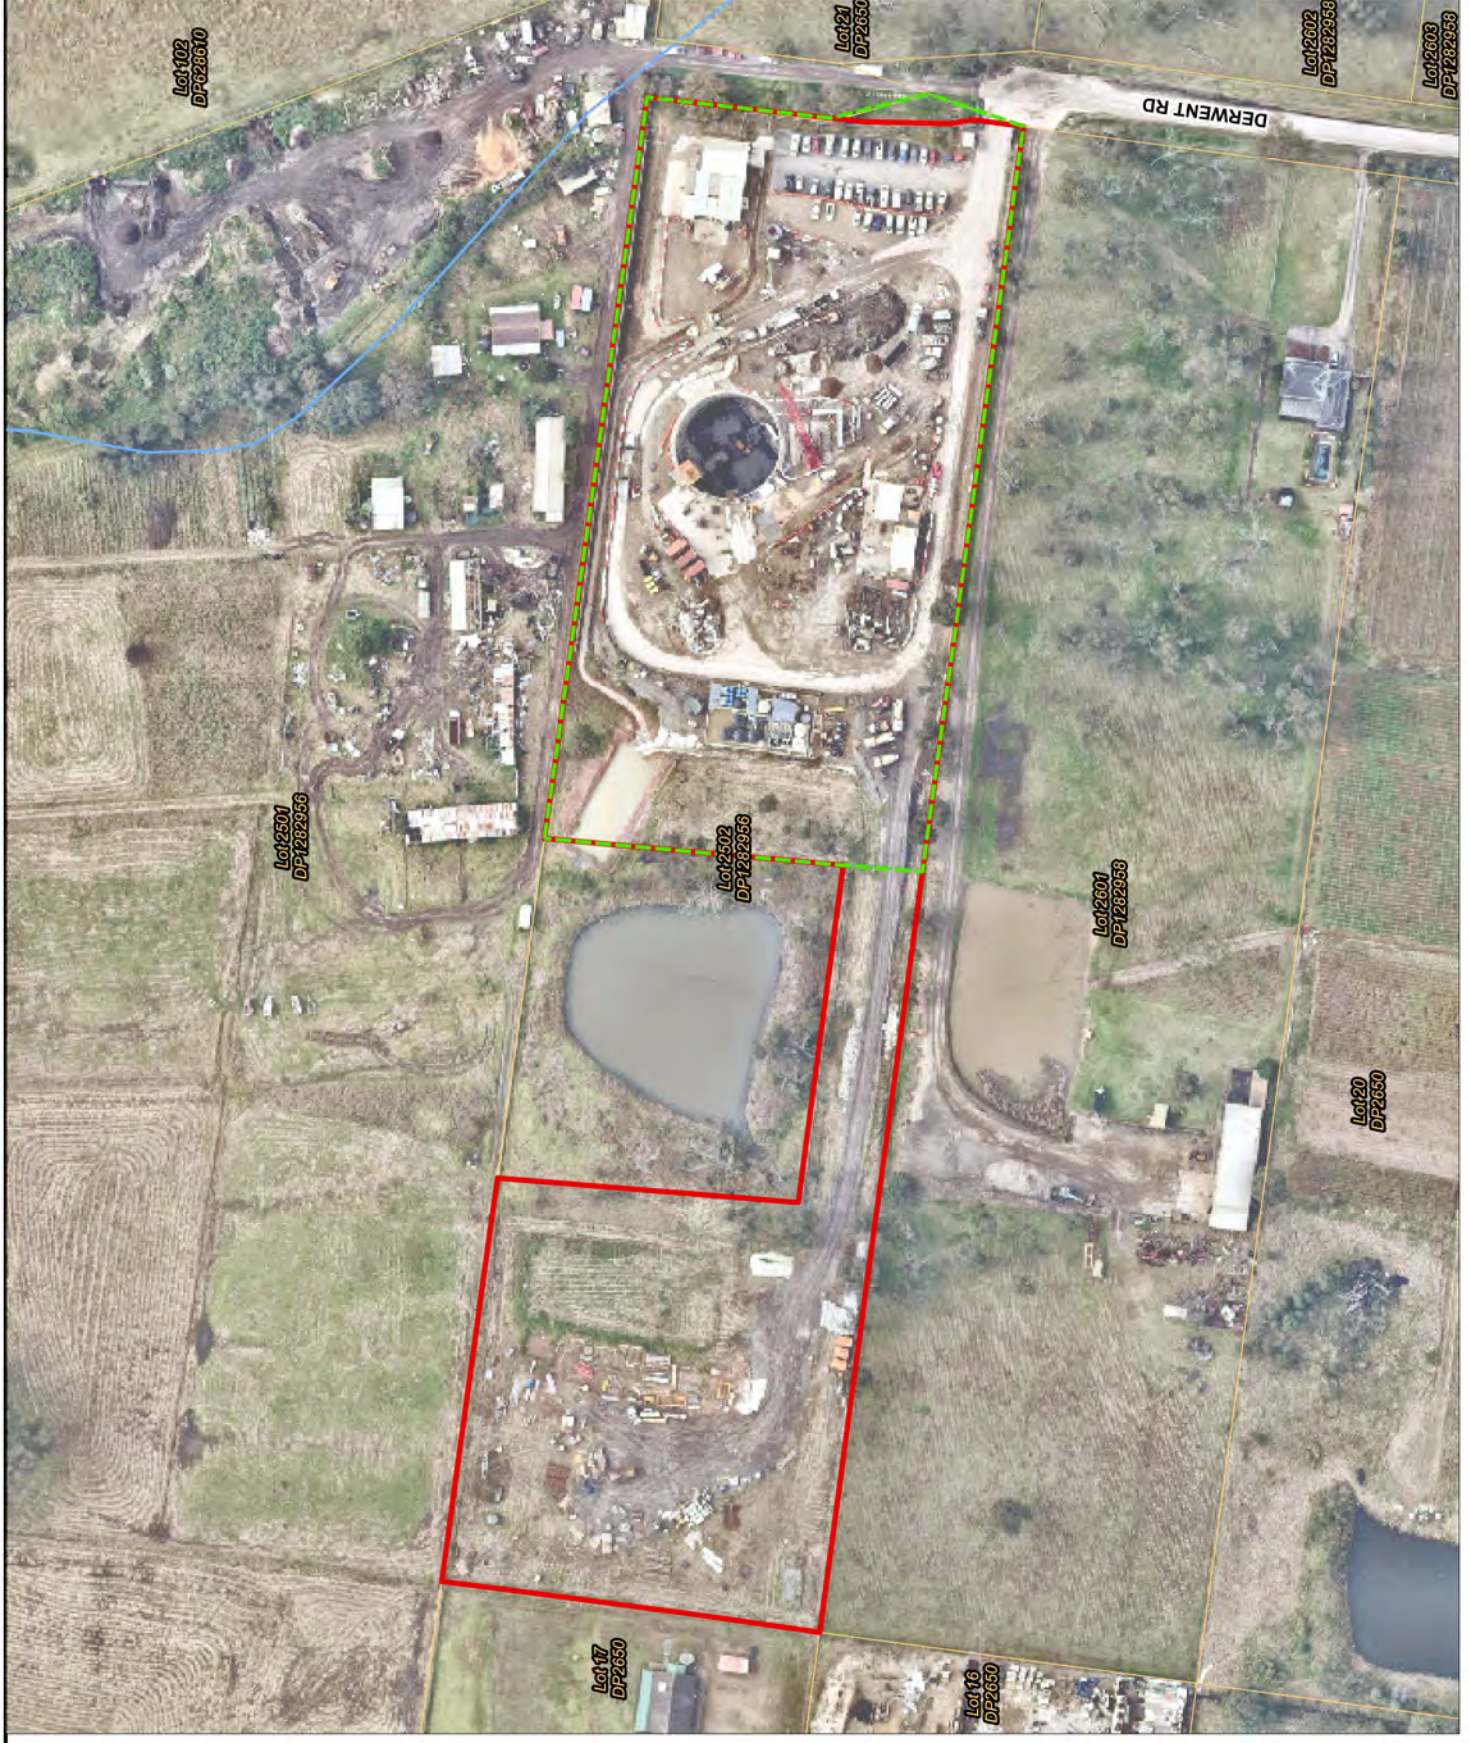
FIGURE 4

ASBESTOS SOURCE ZONE

Excavation of the Asbestos Source Zone was completed by CPBG-JV as the extent indicated in the RAP, as shown on **Figure 4**, the vertical extent of removal was between 300 mm to 500 mm. CPBG-JV completed an inspection of the Asbestos Source Zone and Remaining Building Footprint progressively as materials were removed and stockpiled, with no visual signs of contamination or ACM observed by CPBG-JV. Photographs provided by CPBG-JV of the inspection following removal of the Asbestos Source Zone are provided as **Photograph 14, 15 and 16, Appendix D**.

JBS&G completed an additional validation inspection on 13 September 2023 of the Asbestos Source Zone including two former building footprints (residential house and shed) as shown in **Figure 4**. The residential house footprint was obstructed by an ENM spoil stockpile from the shaft construction and compacted DGB hardstand underneath. No remaining fill, ACM or any signs of contamination were observed. The shed footprint comprised a concrete slab with a recently built shed occupying the footprint area. No remaining fill, ACM or any signs of contamination were observed.

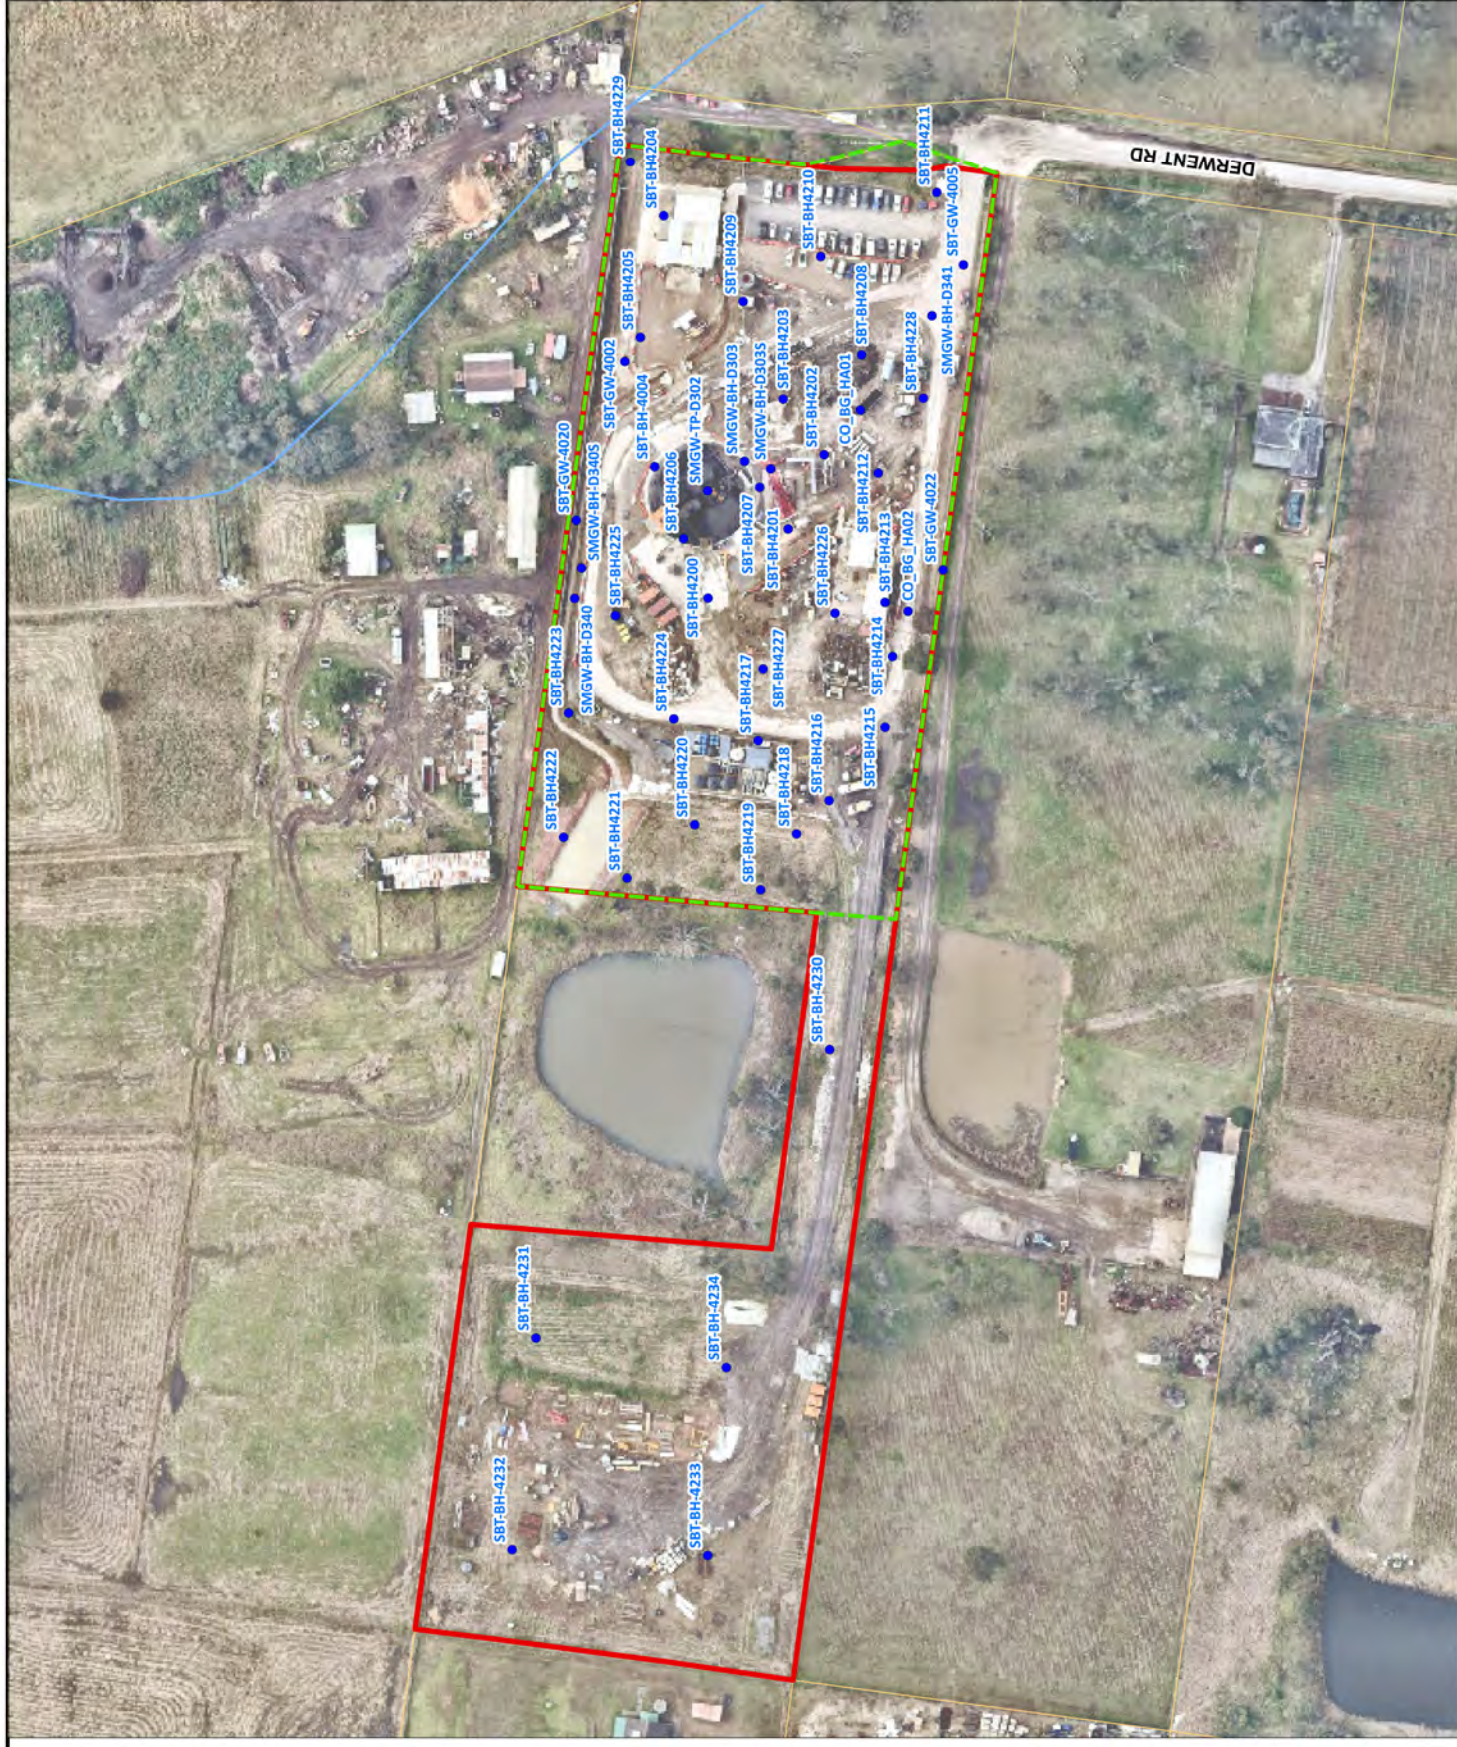
- Approximate Site Boundary
- Construction Footprint
- NSW Cadastre
- Asbestos Source Zone (RAP, TTMP 2022b)
- JBS&G Visual Inspection Area - 13
- September 2023

The location of the site is shown on **Figure 1** and the site layout is shown on **Figure 2**. The site details are summarised in **Table 2.1**, with the site described in detail in the following sections.

The boundary for the site is shown on **Figure 2** and is defined as the Bringelly site on the survey included as **Appendix A**. The site is formally identified as Lot 2502 DP1282956.

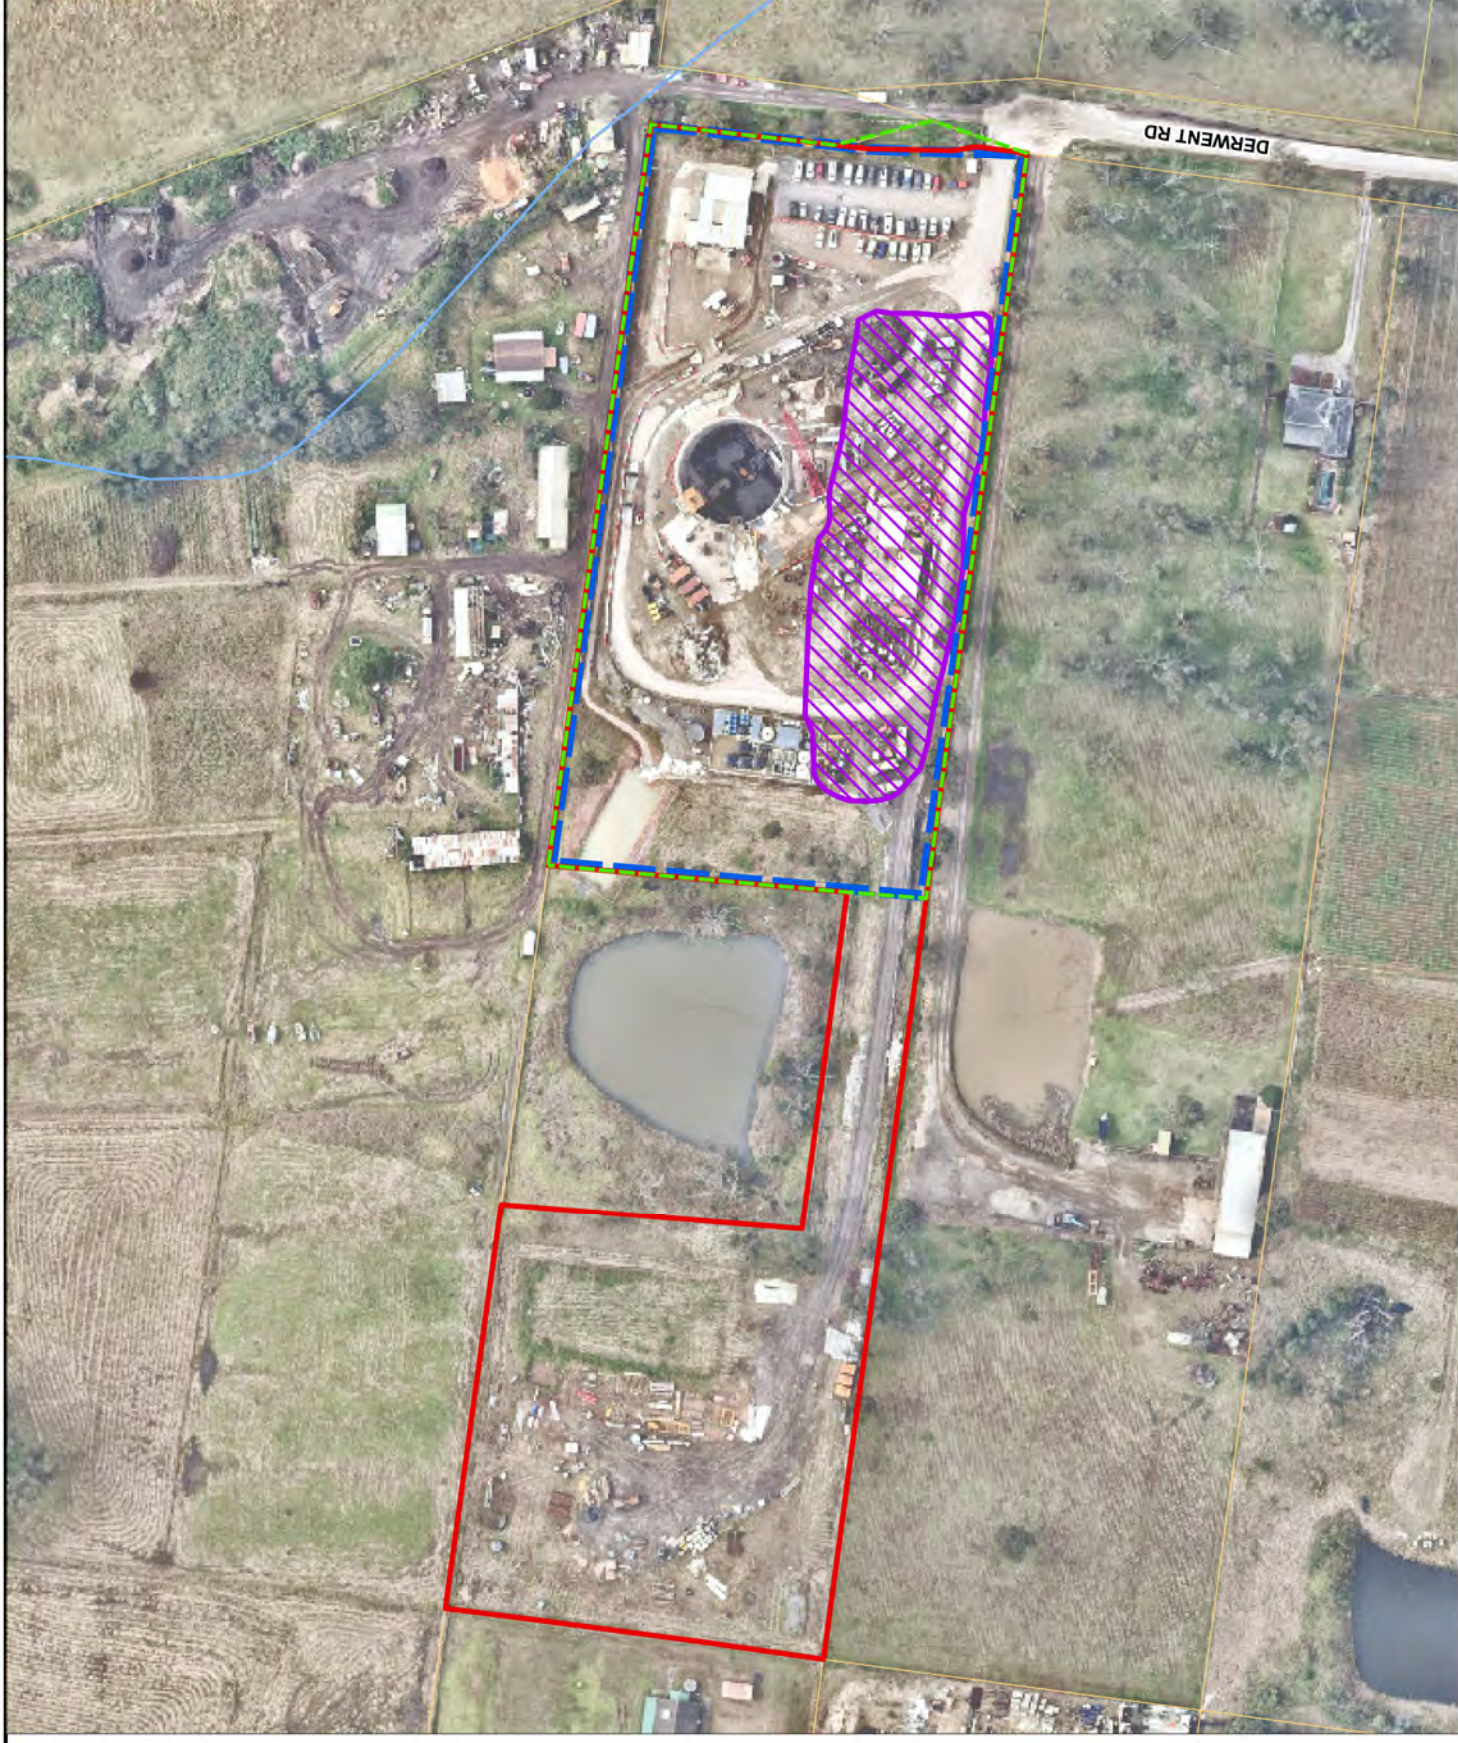
FIGURE 5

ASBESTOS SOURCE ZONE STOCKPILE  
SAMPLE LOCATIONS

The stockpile was located in the western portion of the site as shown on **Figure 5** and was sourced from the excavation of the Asbestos Source Zone. The estimated stockpile volume was 2000 m<sup>3</sup>. It is noted the Asbestos Source Zone was identified in the RAP based on the identification of one ACM fragment in the vicinity of HA01. The consultant complete laboratory assessment on the fragment which confirmed the presence of asbestos and also indicated the fragment was removed at the time of the assessment. Based on the identification of the ACM fragment the RAP was conservatively developed to classify all surficial materials in the vicinity of the dwelling and shed as the Asbestos Source Zone requiring remediation. Additionally, the DSI did not report any other contaminants of concern in these materials, as such asbestos was the only identified contaminant of potential concern for this stockpile.

Visual inspection of the stockpile and sampling of the stockpile was completed on 10 and 11 September 2024. At the time of the assessment the surface of the stockpile was densely covered with grass. The materials consisted of red/brown, silty gravelly clay with trace inclusions of roots/rootlets, wood and gravels (concrete and shale). In some location's bricks, pipe, wire, bone fragments, asphalt and ACM fragments were observed. No odours or staining was observed. No ACM was observed on the stockpile surface.

Eighty 10 L AQ assessments were completed on the stockpile with one fragment of ACM identified in the sample at B-TP24\_1-1.5 and B-TP26\_1-1.5 at a weight of 6 g and 7 g, respectively, and based on the 10L sample volume, at a concentration of 0.005% w/w and 0.006% w/w, respectively, which was below the site criterion of 0.05% w/w. Asbestos as asbestos fines (AF) was reported in laboratory analysis of sample B-TP24\_1-1.5 with a concentration of 0.000017% w/w, which was below the laboratory LOR and site criterion of 0.001% w/w. An ACM fragment was also observed at location B-TP23 in material excavated from the test pit, but not within the 10 L AQ. Laboratory analysis of the material fragments collected in the 10 L AQ samples B-TP24\_1-1.5 and B-TP26\_1-1.5 and within the test pit B-TP23 confirmed the presence of asbestos as chrysotile, amosite and / or crocidolite.

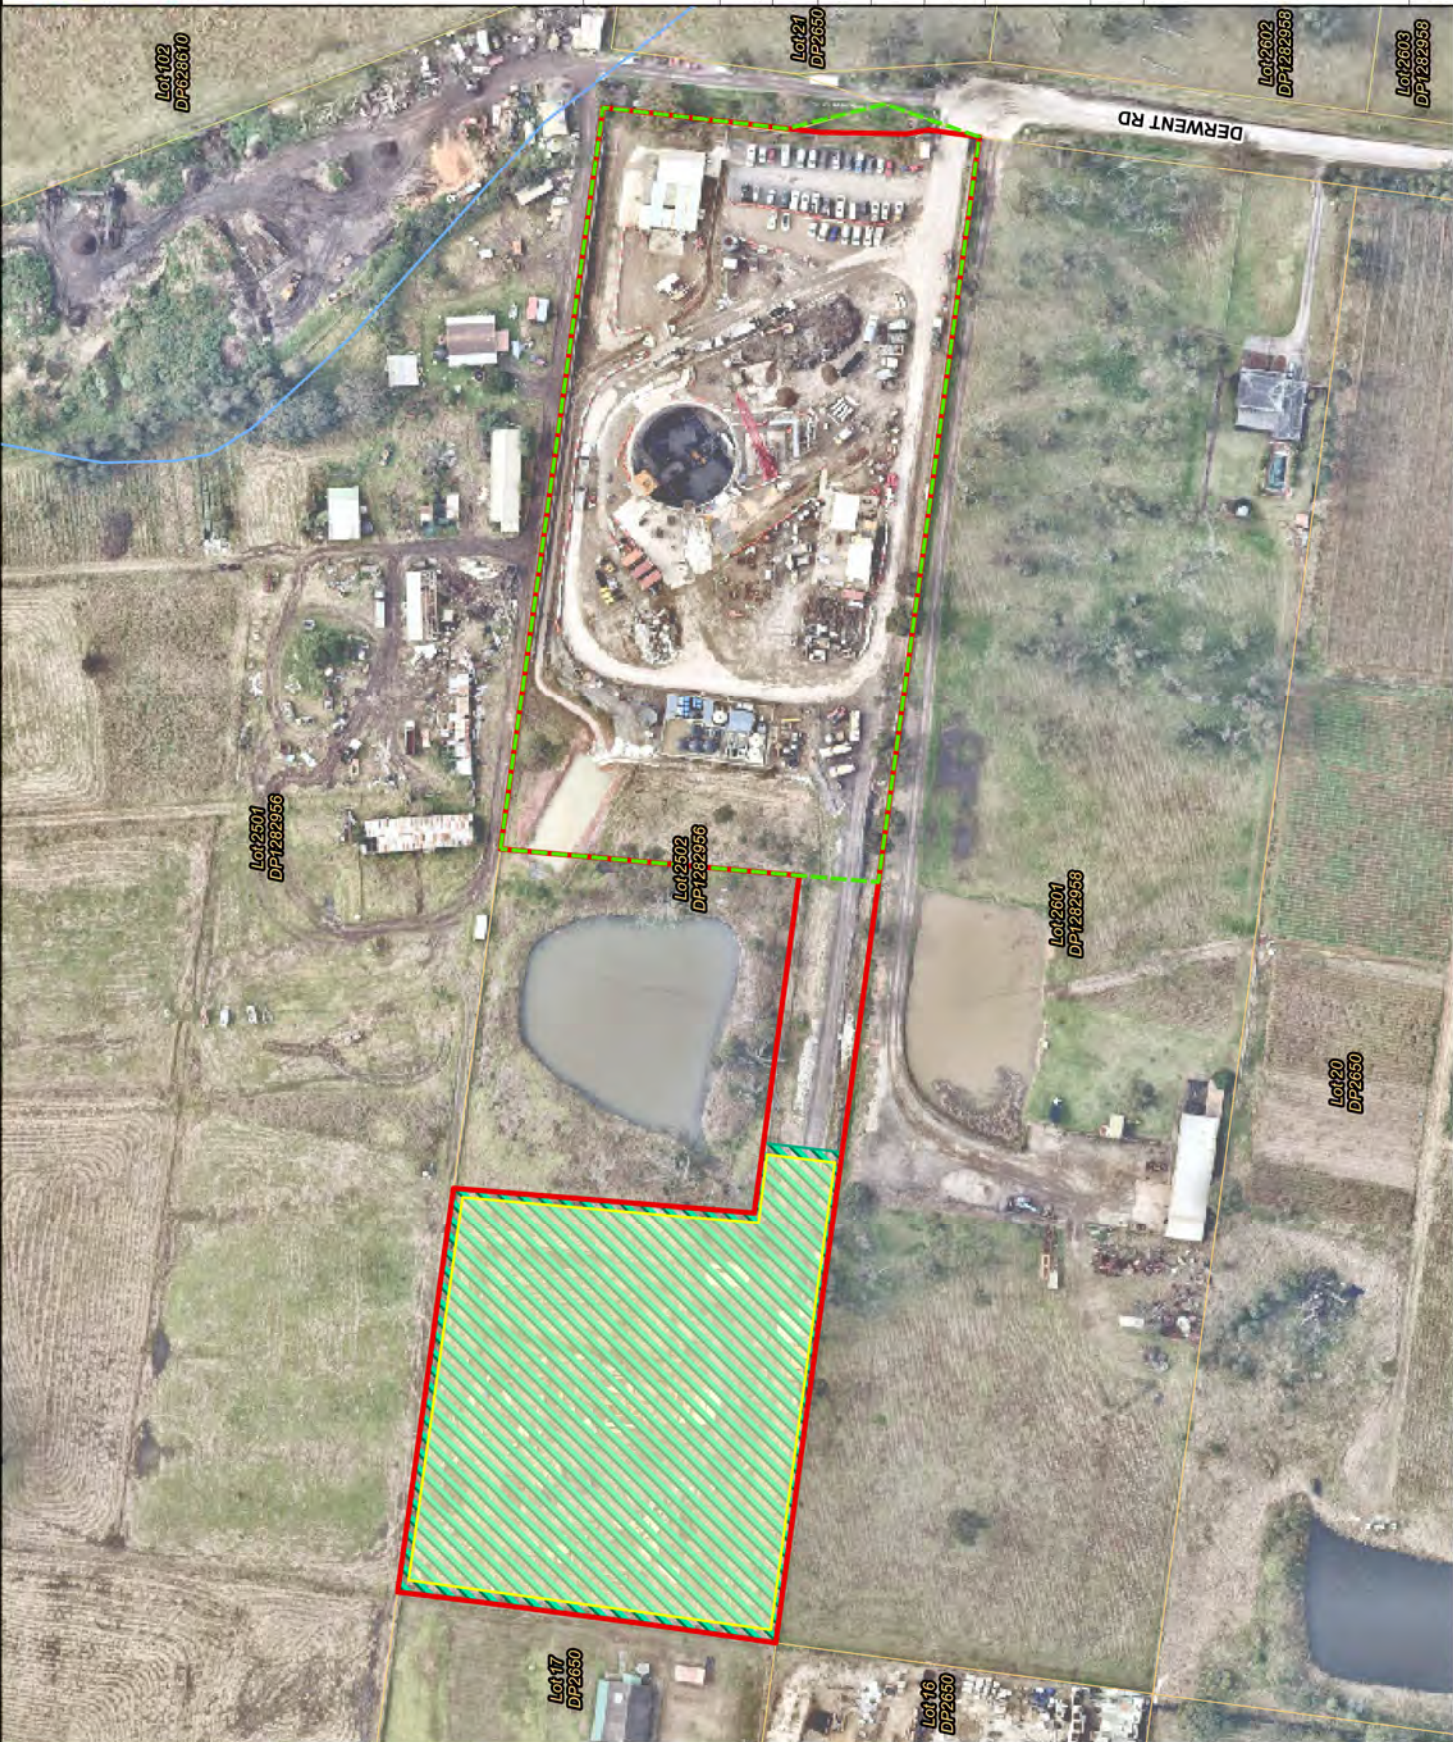
FIGURE 6

ASBESTOS SOURCE ZONE MATERIAL  
PLACEMENT (AIRSAFE, 2024)

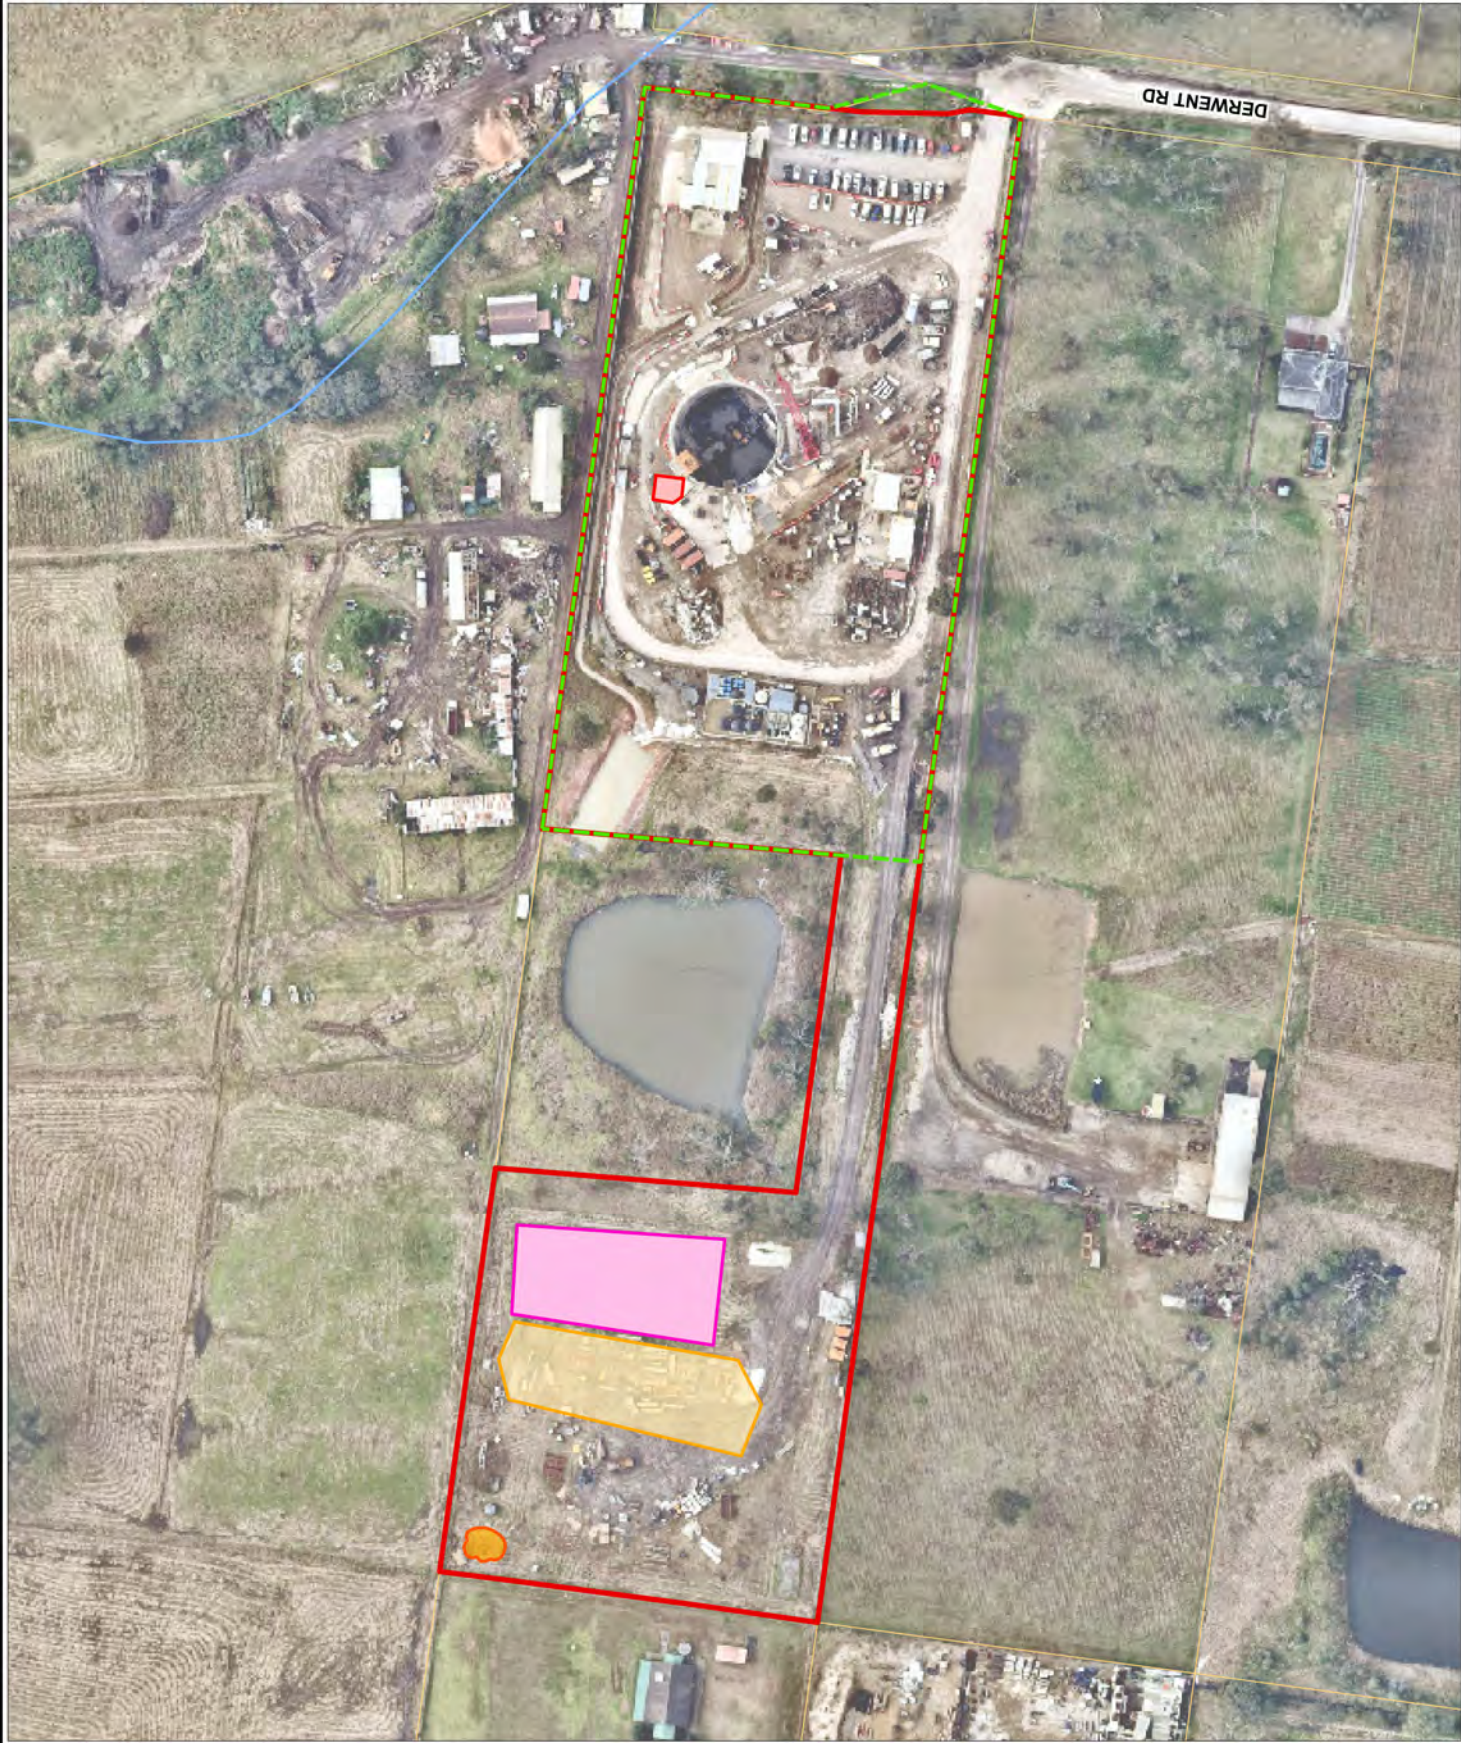
**FIGURE 7**

**STOCKPILE LOCATIONS**

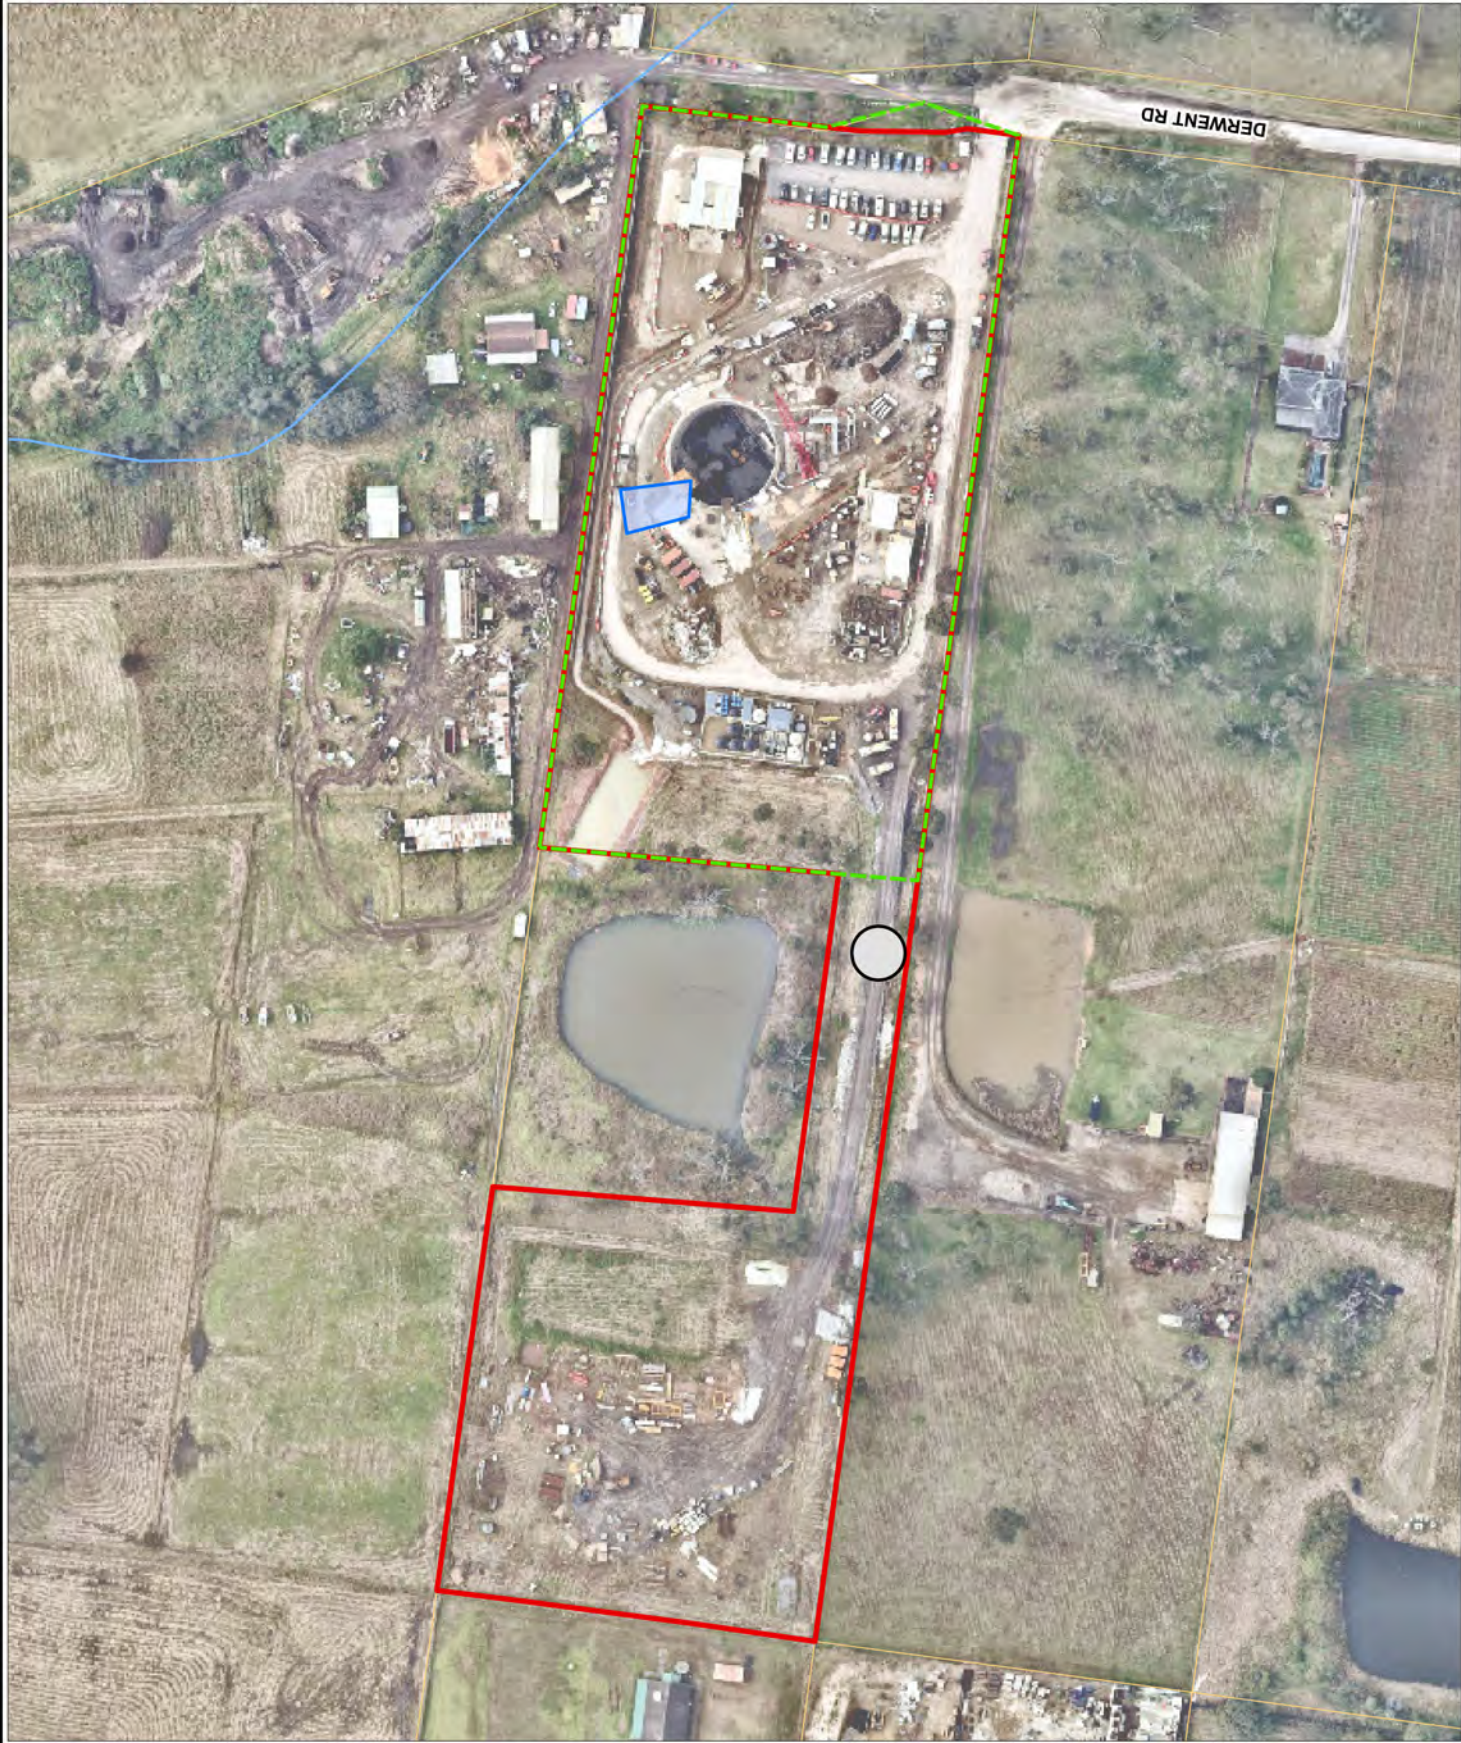
- Approximate Site Boundary
- Construction Footprint
- NSW Cadastre
- Asbestos in Soil - Unexpected Finds
- Suspected Asbestos Fragments
- Unexpected Find

- Suspected asbestos fragments at Bringelly (Event ID: T80080.W4.SAF.121022.00311088): On the 12 October 2022, three small suspected asbestos fragments were identified on the ground surface at the southern haul road, adjacent to the southern boundary of site. CPBG implemented the unexpected finds procedure as per the Asbestos Management Plan. The three fragments were managed and removed as per the unexpected finds procedure noted in the AMP. CPBG reported, as per WHS regulation and the AMP, the suspected fragments were less than 10 m<sup>2</sup> and did not require an Asbestos Removal Control Plan (ARCP). The fragments were removed on 12 October 2022 and disposed offsite with asbestos materials from the unexpected find discussed below on 13 October 2022 at Bingo Eastern Creek Recycling Ecology Park (and Landfill), with more information provided in **Section 9**.

- Asbestos in soil at Bringelly (Event ID: T80080.W4.SAF.260822.00307247): On the 26 August 2022, a redundant asbestos pipe mixed with spoil was discovered. Laboratory analysis identified chrysotile asbestos found loose and bound to fibrous cement sheet fragments within the soil sample (above reporting limit of 0.1g/kg). Upon identification the asbestos was covered and bunted off with signage
