**Claremont Meadows Service Facility**

**CPB Contracting and Ghella Joint Venture**

**Validation Report**

**JBS&G 63723 | 162,154 (Rev 0)**

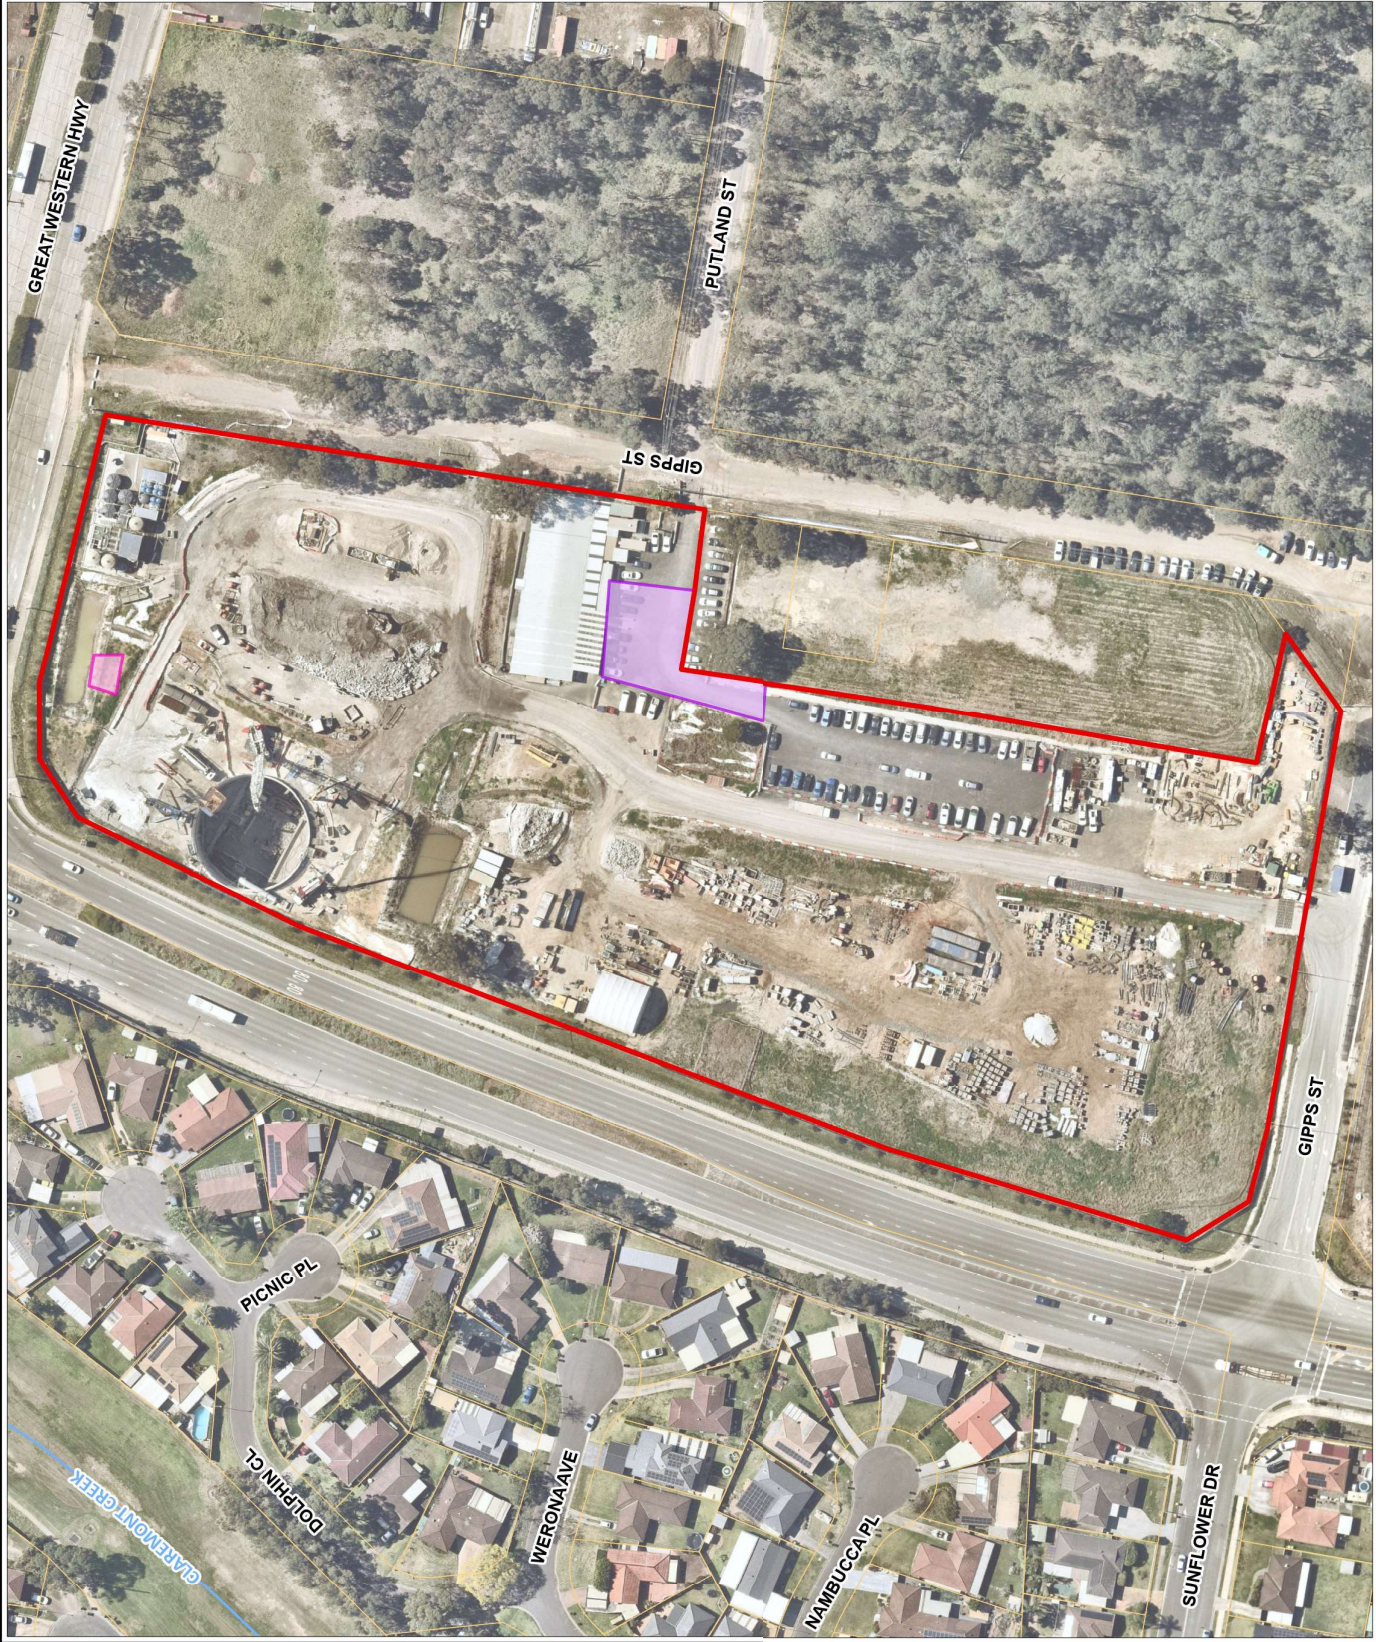
- Approximate Site Boundary
- Unexpected Finds
- Car Park CMSF
- North Area CMSF

Two unexpected finds were identified during the site works (North Area CMSF and Car Park Area CMSF). Both unexpected finds were remediated by excavation and off-site disposal. Validation was completed in general accordance with the requirements of the RAP (EES 2022a).
