**Re: Direction made under condition A5 of Sydney Metro Western Sydney Airport project (SSI-10051) for Erosion and Sediment Control**

Sydney Metro Western Sydney Airport  
Station Boxes and Tunnelling Works

**Soil Conservationist Inspection of Erosion and Sediment Controls;  
Various Sites, Airport Metro SBT; 29 May and 9 June 2023**

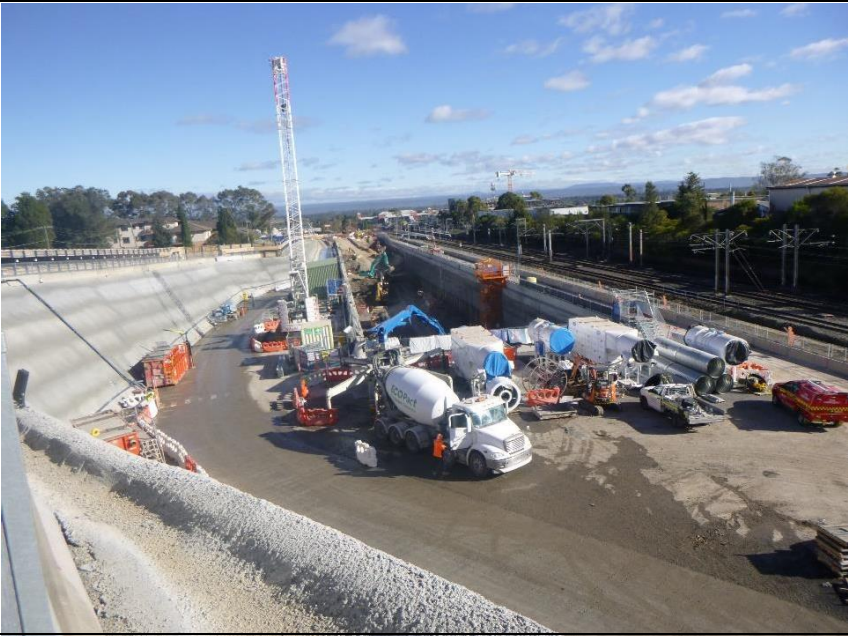
No	Location	Details	Photo (if Applicable)	Action or Recommendation	Priority (at the time of inspection)
1.	St Marys	<p>Positive feedback:</p> <p>Excellent use of long-term ground cover (concrete) to create a stable site.</p>

Positive feedback	N/A
2.	St Marys	<p>Positive feedback:</p> <p>Excellent wheel wash facilities and appears to be working well. Little or no sediment tracking offsite.</p>

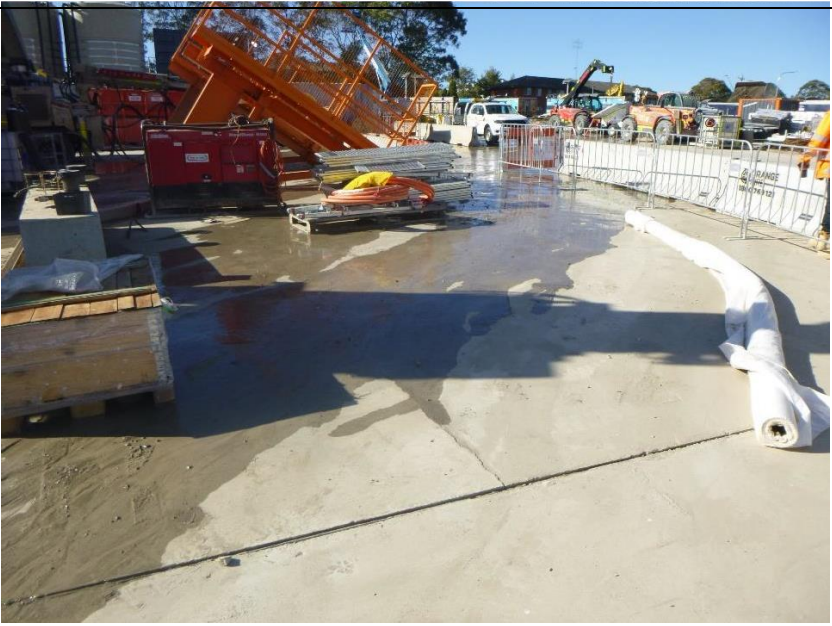
No	Location	Details	Photo (if Applicable)	Action or Recommendation	Priority (at the time of inspection)
3.	St Marys	<p>Positive feedback:</p> <p>Multiple levels of control around pit in laydown yard.</p>	 	Positive feedback	N/A
4.	St Marys	<p>Runoff from the wheel wash trickles through the laydown yard and picks up small amounts of sediment on its way.</p>

<p>Continue to sweep the yard regularly and remove as much sediment as possible.</p> <p>Consider diverting runoff from the wheel wash to a sump close to the wheel wash for re-use or pumping to the WTP.</p>	Medium

Consider diverting runoff from the wheel wash to a sump close to the wheel wash for re-use or pumping to the WTP sump.	In progress	A permanent diversion for this area is currently being designed and scheduled for completion by the 14th July 2023. In the interim, the maintenance schedule has been increased to ensure ersed controls are checked on a daily basis. Additional ERSED controls have been installed in this area. Pit blockers, Cair logs (inspected daily and replaced if required)	A Permanent contaminated water diversion is currently being constructed (50% complete). The sump will capture runoff from the wheel wash, stockpiles and haul roads. This runoff will be directed into the newly constructed sump. Water from the sump will be pumped to the Water Treatment Plant (WTP).	Target date for the permanent diversion: <b>14th July 2023</b> Interim measure: Completed and ongoing	N/A

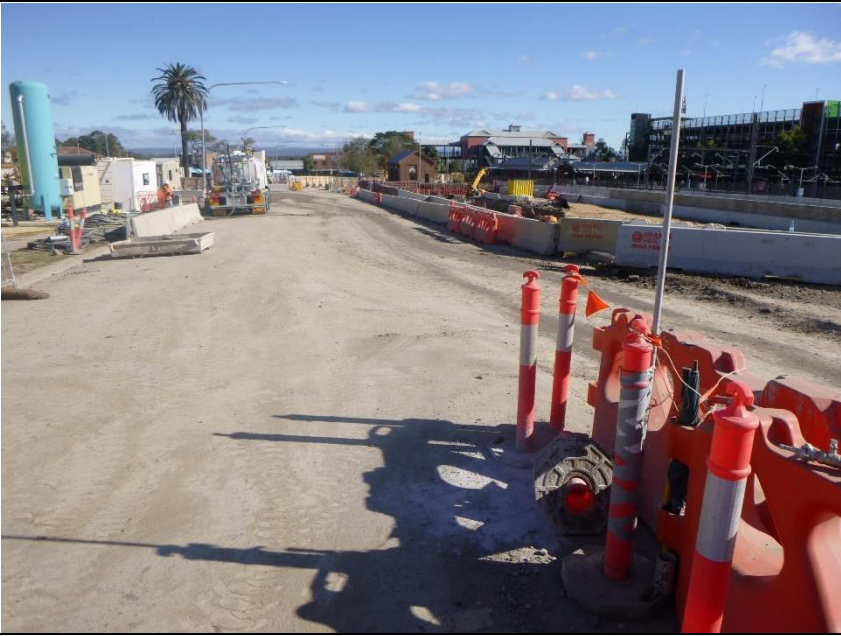
No	Location	Details	Photo (if Applicable)	Action or Recommendation	Priority (at the time of inspection)
5.	St Marys	<p>Moxy haul road shows significant sediment build-up.</p> <p>Sumps are in place, but ongoing sweeping is required.</p>

5	St Marys	Moxy haul road shows significant sediment build-up. Sumps are in place, but ongoing sweeping is required.

<p>Continue to sweep this clean prior to forecast rainfall to minimise the amount of sediment that runs to the sump.</p> <p>No other action is required here – the controls in place are appropriate.</p>	Ongoing medium priority
6.	St Marys	<p>Sump at entrance to moxy haul road.</p> <p>Risk of dirty water splashing over the kerb and missing the sump.</p>

Continue to sweep this clean prior to forecast rainfall to minimise the amount of sediment that runs to the sump	Closed	A dedicated yard supervisor has been engaged and instructed to ensure the area is well maintained at all times. The Street sweeper and water cart onsite have been instructed to continuously monitor this area.	N/A	N/A	N/A

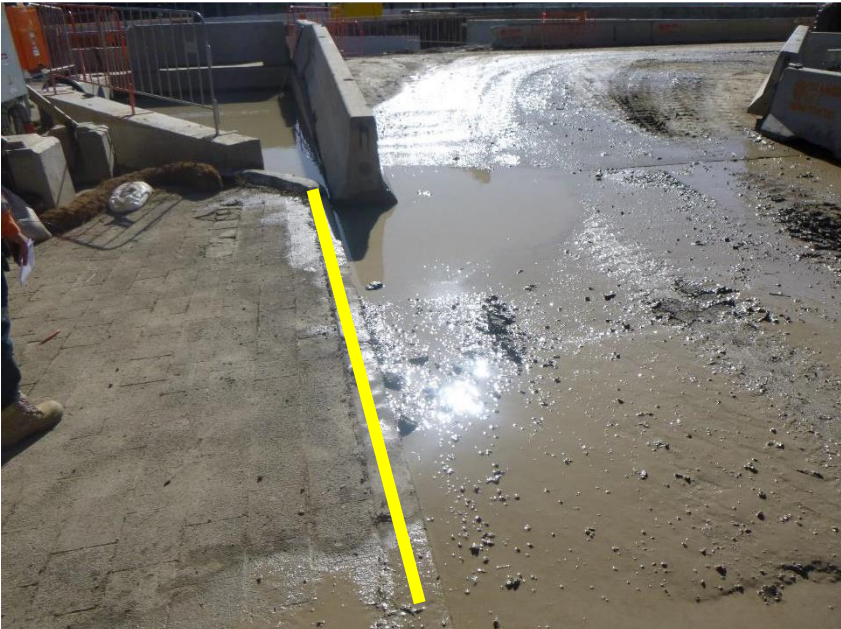
6	St Marys	Sump at entrance to moxy haul road. Risk of dirty water splashing over the kerb and missing the sump.

<p>Extend the concrete lip on top of the kerb along the alignment shown (and as discussed onsite). Raise it by about 100mm.</p>	Medium

Extend the concrete lip on top of the kerb along the alignment shown (and as discussed onsite). Raise it by about 100mm.	In progress	The extension of the concrete lip along the kerb is being constructed as part of the drainage sump redesign.	Completion of the bund will be completed during permanent diversion works (line item no. 4)	Target date: <b>14th July 2023</b>	N/A

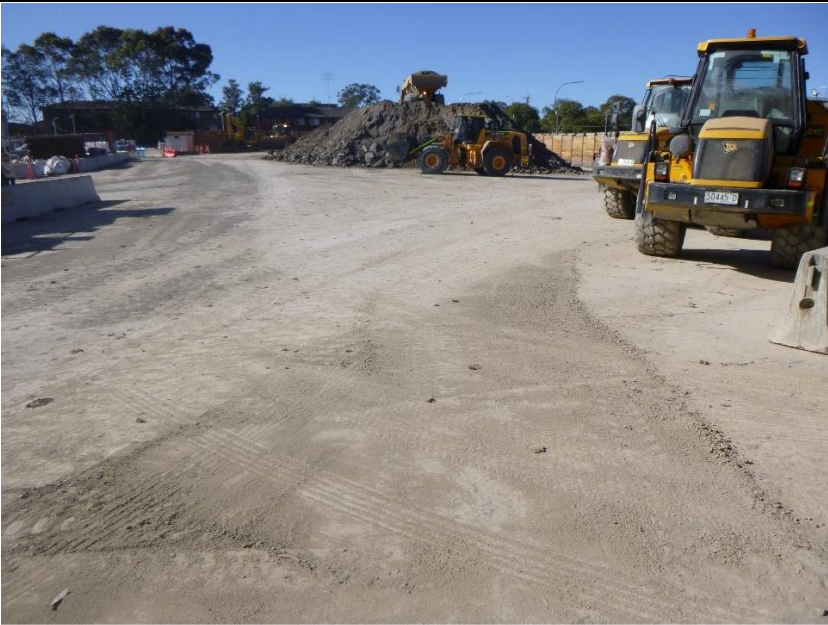
No	Location	Details	Photo (if Applicable)	Action or Recommendation	Priority (at the time of inspection)
7.	St Marys	<p>Positive feedback:</p> <p>Stockpiling is only occurring on the south side of the ridge in the concrete pad.</p> <p>This ensures that all sediment-laden runoff from the stockpiling area runs to the nib wall, not off to the north.</p>

Positive feedback	N/A
8.	St Marys	<p>Nib wall is working well to trap dirty water runoff from the stockpiling area.</p> <p>However, no materials should be stored here – they reduce the capacity of the sump created by the nib wall.</p>

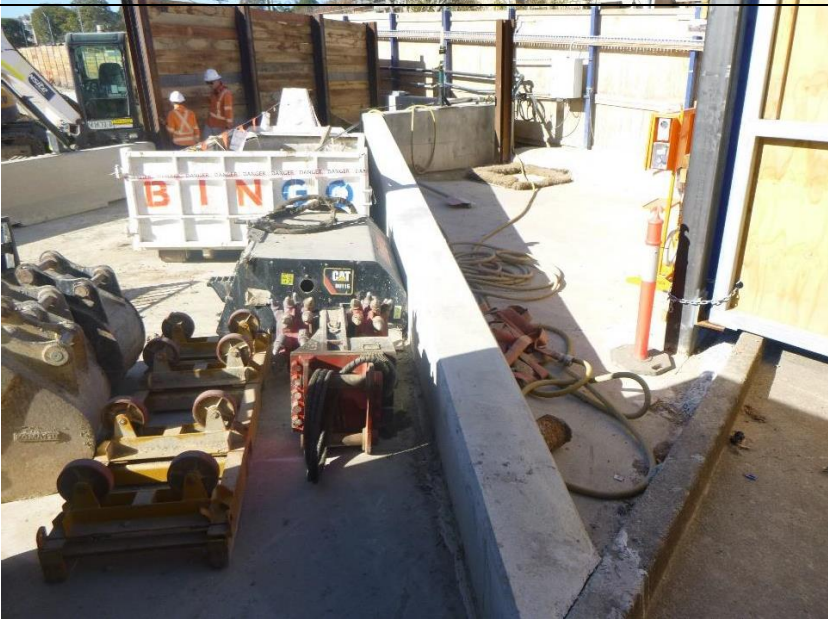
8	St Marys	Nib wall is working well to trap dirty water runoff from the stockpiling area. However, no materials should be stored here – they reduce the capacity of the sump created by the nib wall.

Remove materials and bin from the nib wall sump area.	Medium

Remove materials and bin from the nib wall sump area.	Closed	Items have been removed as per recommendation. The Yard supervisor has been instructed to keep this area free from bins and materials.	N/A	N/A	N/A

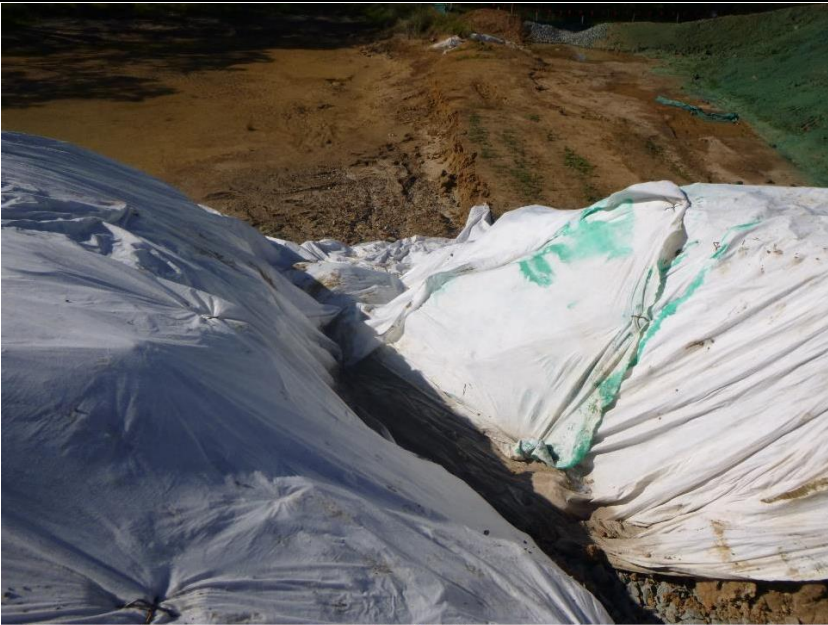
No	Location	Details	Photo (if Applicable)	Action or Recommendation	Priority (at the time of inspection)
11.	Orchard Hills	<p>Fabric is incorrectly laid.</p> <p>Needs to be lapped correctly, similar to roof tiles.</p>

<p>Lap the fabric correctly so that water won't go under the fabric.</p> <p>Upslope fabric must go over the downslope fabric.</p> <p>Note that the chutes are fine otherwise – there's no need for rock as well.</p>	Medium
12.	Orchard Hills	<p>Basin capacity needs to be checked to ensure it meets the ESCP minimum.</p>

Spray this area with polymer binder and seed.	Closed	The Fabric has been installed as per recommendation and the batters have been sprayed with polymer binder.	N/A	N/A	N/A

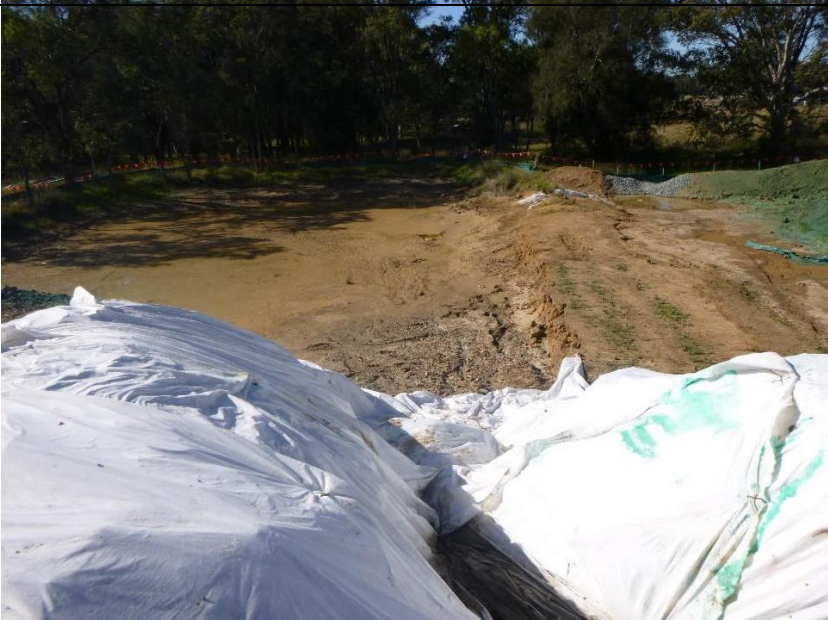
12	Orchard Hills	Basin capacity needs to be checked to ensure it meets the ESCP minimum.	 	Basin has accumulated plenty of sediment, and needs to be de-silted if the capacity falls below the minimum required under the ESCP. Check capacity against the ESCP.	In progress	The sediment basin is being maintained and will be surveyed week ending 14th July to ensure capacity meets the minimum required under the ESCP.	Subject to survey results the sediment basin capacity will be adjusted to meet the ESCP minimum requirement.	14th July 2023	N/A

<p>Basin has accumulated plenty of sediment, and needs to be de-silted if the capacity falls below the minimum required under the ESCP.</p> <p>Check capacity against the ESCP.</p>	Medium

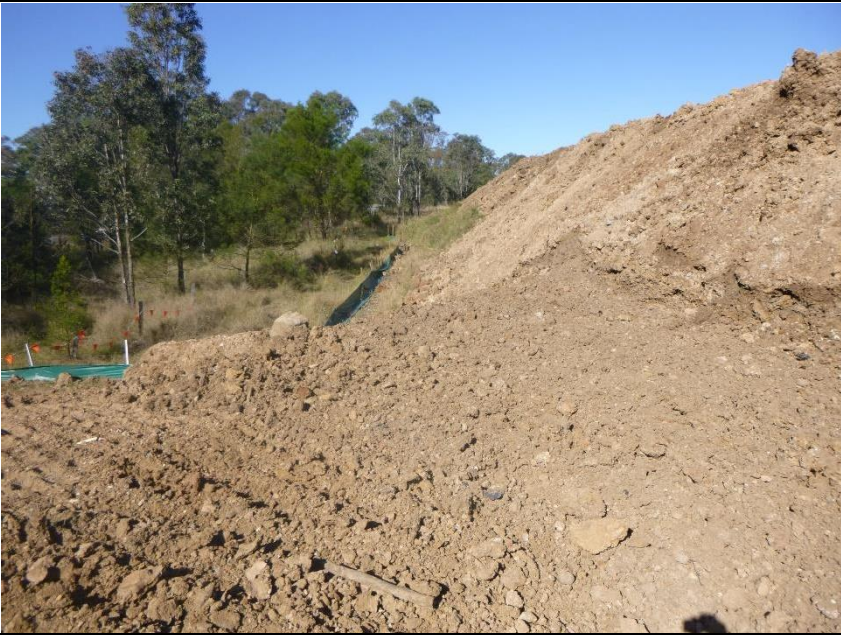
No	Location	Details	Photo (if Applicable)	Action or Recommendation	Priority (at the time of inspection)
13.	Orchard Hills	<p>Backside of the stockpile site:</p> <p>Inadequate installation of silt fence – not dug in properly.</p> <p>And</p> <p>Stockpiles require ground cover to reduce the risk of erosion.</p>

13	Orchard Hills	Backside of the stockpile site: Inadequate installation of silt fence – not dug in properly. And Stockpiles require ground cover to reduce the risk of erosion.	 	Install the silt fence properly – trench it firmly into the ground to at least 150mm. And Spray the backside (east face) of the stockpile with polymer binder.	In progress.	The silt fence has been repaired and reinstalled and polymer is being applied to the earth batter. The stockpile is currently being sprayed and will have mulch applied as ground cover to all flat surfaces.	The silt fence has been replaced to meet specifications. A polymer is currently being applied to all batters and is 90% complete.	Mulch application scheduled for 10th-11th July 2023 The Polymer application is due for completion by the 14th July 2023.	N/A	 
14	Orchard Hills	Runoff from part of the stockpile would miss the basin.	 	Extend the bund as shown to ensure that as much as possible of the stockpile will direct runoff to the basin.	Closed	The bund has been extended allowing water to flow from the batter to the basin.	N/A	N/A	N/A

<p>Install the silt fence properly – trench it firmly into the ground to at least 150mm.</p> <p>And</p> <p>Spray the backside (east face) of the stockpile with polymer binder.</p>	<p>High</p> <p>High</p>
14.	Orchard Hills	Runoff from part of the stockpile would miss the basin.

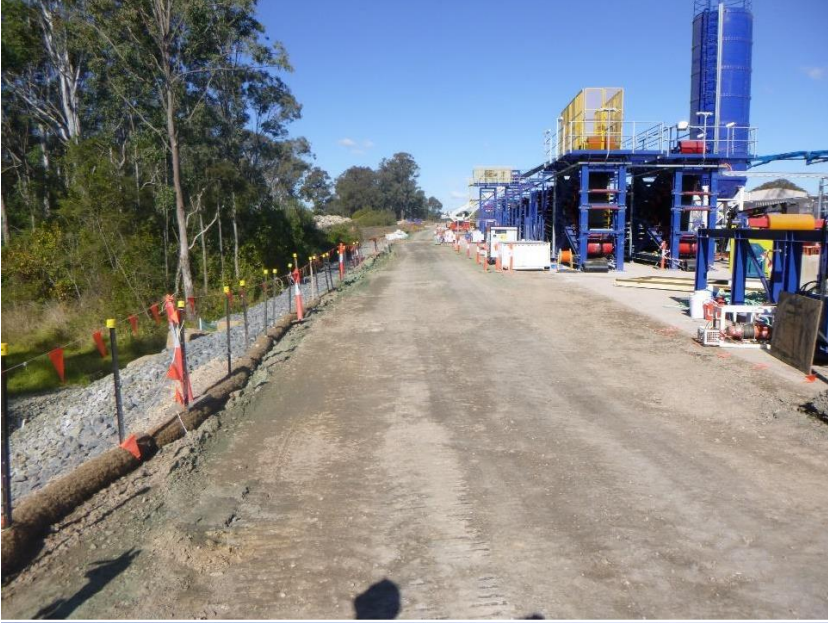
No	Location	Details	Photo (if Applicable)	Action or Recommendation	Priority (at the time of inspection)
17.	Orchard Hills	<p>Eastern haul road:</p> <p>Coir logs require minor housekeeping.</p> <p>And</p> <p>Polymer binder is good but top-dressing it on the road makes it slippery and it doesn't last very long. Use an alternative methodology to get better results.</p>

17	Orchard Hills	Eastern haul road: Coir logs require minor housekeeping. And Polymer binder is good but topdressing it on the road makes it slippery and it doesn't last very long. Use an alternative methodology to get better results.

<p>Tidy up the controls along this edge so they provide adequate filtering of dirty water runoff from the haul road.</p> <p>And</p> <p>In future, blend the trafficable polymer into the road by:</p> <ol style="list-style-type: none"> <li>1. Ripping the road to 100mm with a grader or a toothed excavator bucket.</li> <li>2. Spraying the trafficable binder (e.g. Vital HR), then</li> <li>3. Rolling the road to blend the polymer binder and the road material together.</li> </ol>	<p>Meduim</p> <p>Low</p>

Tidy up the controls along this edge so they provide adequate filtering of dirty water runoff from the haul road. And In future, blend the trafficable polymer into the road by: 1. Ripping the road to 100mm with a grader or a toothed excavator bucket. 2. Spraying the trafficable binder (e.g. Vital HR), then 3. Rolling the road to blend the polymer binder and the road material together.	In progress	All coir Logs have been replaced and are now inspected daily.	A Polymer application is scheduled for this road by 21 st July 2023.	Control tidy completed. Polymer application to road: <b>21st July 2023</b>	N/A

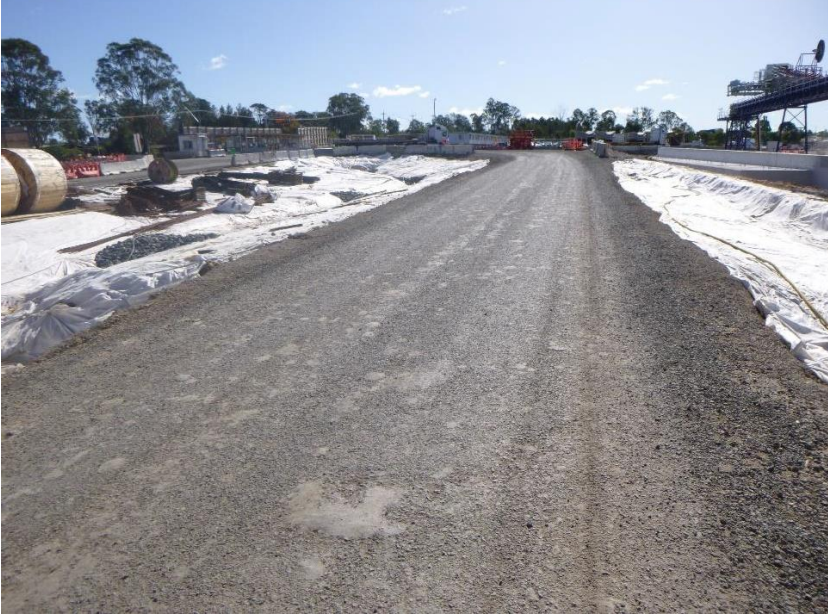
18.	Orchard Hills	<p>Positive feedback:</p> <p>Good use of ground covers to establish clean water flowpaths.</p>

Positive feedback	N/A

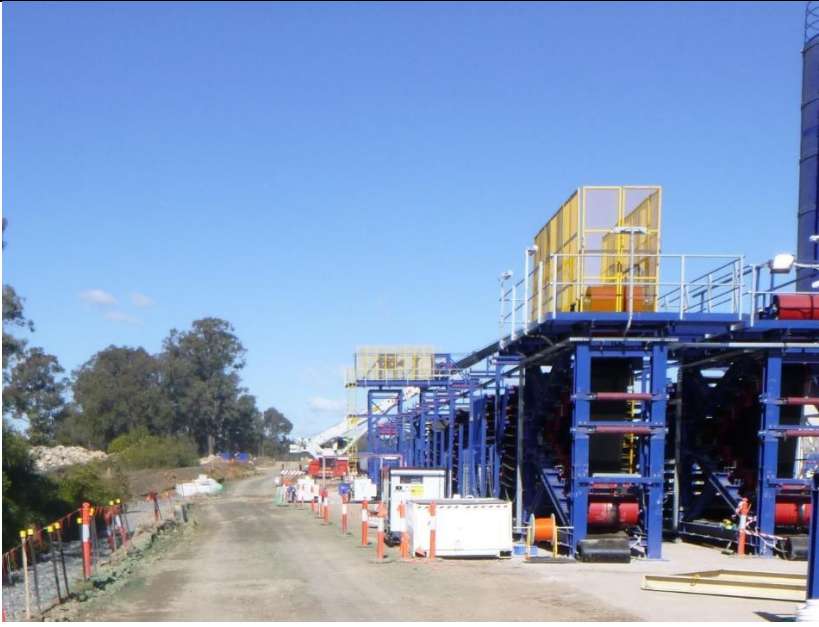
No	Location	Details	Photo (if Applicable)	Action or Recommendation	Priority (at the time of inspection)
21.	Orchard Hills	The proposed vegetation removal along the eastern boundary should include mulch bunds (or earth bunds) along the eastern edge.

21	Orchard Hills	The proposed vegetation removal along the eastern boundary should include mulch bunds (or earth bunds) along the eastern edge.

If possible, reuse the mulched vegetation to create a mulch bund at least 500mm high along the eastern edge of the cleared area.	Low
22.	Orchard Hills	Swale drain along western edge, south of Lansdowne Road is suitable as is, and does not need to be stabilised further.

If possible, reuse the mulched vegetation to create a mulch bund at least 500mm high along the eastern edge of the cleared area.	Closed	The mulch bund has been constructed as per recommendation.	N/A	Complete.	N/A

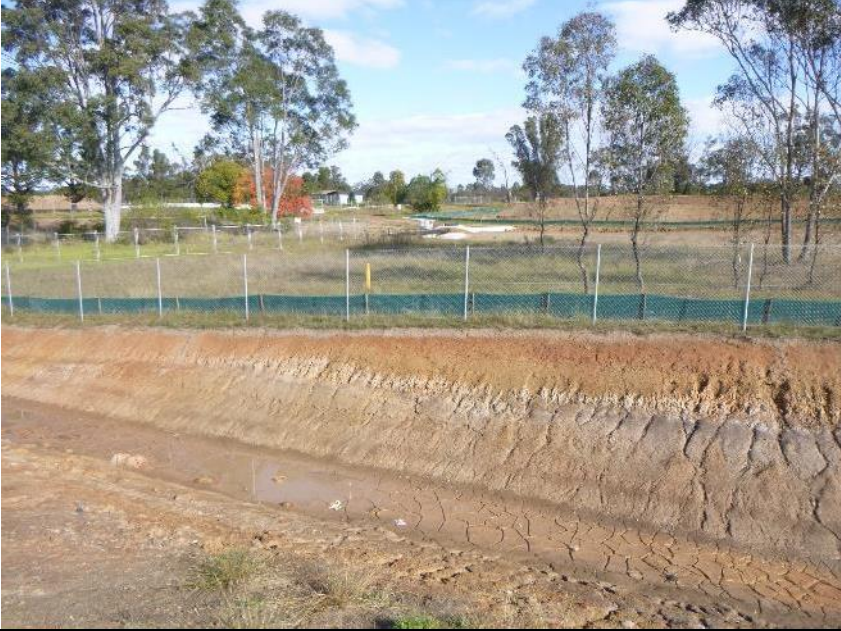
No	Location	Details	Photo (if Applicable)	Action or Recommendation	Priority (at the time of inspection)
23.	Aerotropolis	<p>The upslope catchment is being developed now, which will dramatically increase the amount of run-on into the Aerotropolis site.</p> <p>The clean water drain is still not complete.</p>

23	Aerotropolis	The upslope catchment is being developed now, which will dramatically increase the amount of run-on into the Aerotropolis site. The clean water drain is still not complete.	 	The clean water drain should be completed and lined as soon as practicable. There is currently little or no rain on the forecast, so this is not a significant issue at this time. However, if the forecast changes and significant rain is likely, the present setup of this drain is likely to contribute to:  A. A high risk of dirty water discharging from the site; and B. Additional volumes of water for the project to have to flocculate, test and discharge. Completing this drain will take time, so should be prioritized as much as practicable.	In progress	Sampling is underway and access will be unlikely until late July at this stage.	The clean water drain will be completed and lined as per the recommendation however works have been delayed due to access issues and friable asbestos contamination. The clean water swale drain will be lined with Jute matting and hand seeded as soon as the entirety of the drain is accessible (27 July 2023)	Target date for hydroseeding: <b>27th July 2023</b>	N/A

<p>The clean water drain should be completed and lined as soon as practicable.</p> <p>There is currently little or no rain on the forecast, so this is not a significant issue at this time. However, if the forecast changes and significant rain is likely, the present setup of this drain is likely to contribute to:</p> <ul style="list-style-type: none"> <li>A. A high risk of dirty water discharging from the site; and</li> <li>B. Additional volumes of water for the project to have to floc, test and discharge.</li> </ul> <p>Completing this drain will take time, so should be prioritized as much as practicable.</p>	High

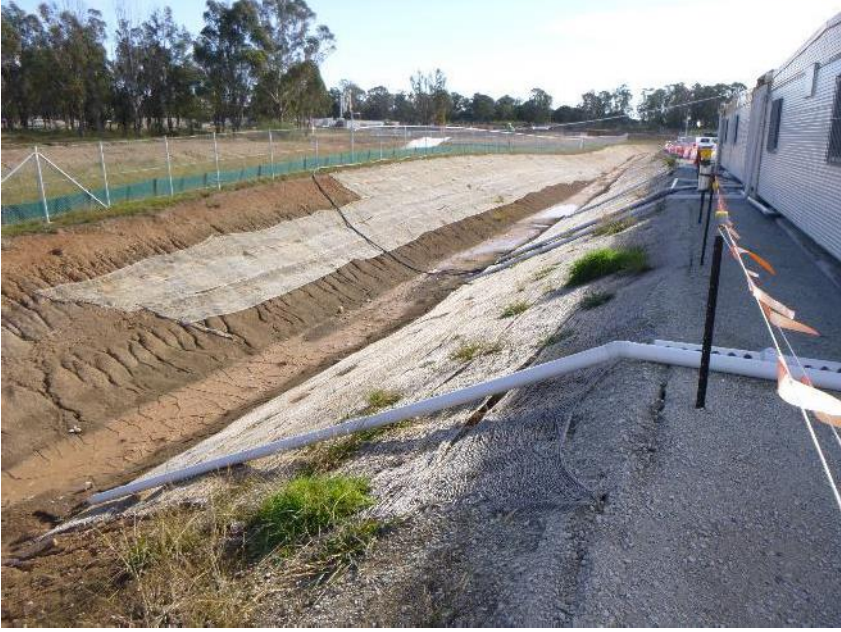
24.	Aerotropolis	Clean water drain not lined. As a result, any water in this drain must be managed as dirty water.

24	Aerotropolis	Clean water drain not lined. As a result, any water in this drain must be managed as dirty water.

<p>If this drain needs to be vegetated, it will need to be veneered with topsoil prior to seeding.</p> <p>Alternatively, a compost blanket could be sprayed onto the drain (note that the cost of compost blanket is generally quite high and the lead time could be long because of the quantities of compost that are required).</p> <p>A biodegradable mat or mesh (e.g. jute mesh) should be placed over the topsoil or compost blanket in the invert of the channel.</p> <p>If the channel doesn't require vegetation, consider just using thick jutemat (700gsm), shotcrete or concrete canvas (or a similar GCCM)</p>	High

If this drain needs to be vegetated, it will need to be veneered with topsoil prior to seeding. Alternatively, a compost blanket could be sprayed onto the drain (note that the cost of a compost blanket is generally quite high and the lead time could be long because of the quantities of compost that are required). A biodegradable mat or mesh (e.g. jute mesh) should be placed over the topsoil or compost blanket in the invert of the channel. If the channel doesn't require vegetation, consider just using thick jute mat (700gsm), shotcrete or concrete canvas (or a similar GCCM)	In progress	Load out of the stockpiled ACM material has commenced and the lining of the drain will commence as soon as access to the entirety of the drain can be maintained.	The clean water drain will be completed and lined as soon as per the recommendation, however, due to a number of site constraints, largely the location of the ACM stockpile, the swale drain in the southern portion of the site is inaccessible. Swale drain to be lined and seeded once accessible however no later than the 27th July.	Target date for works: <b>27th July 2023</b>	N/A

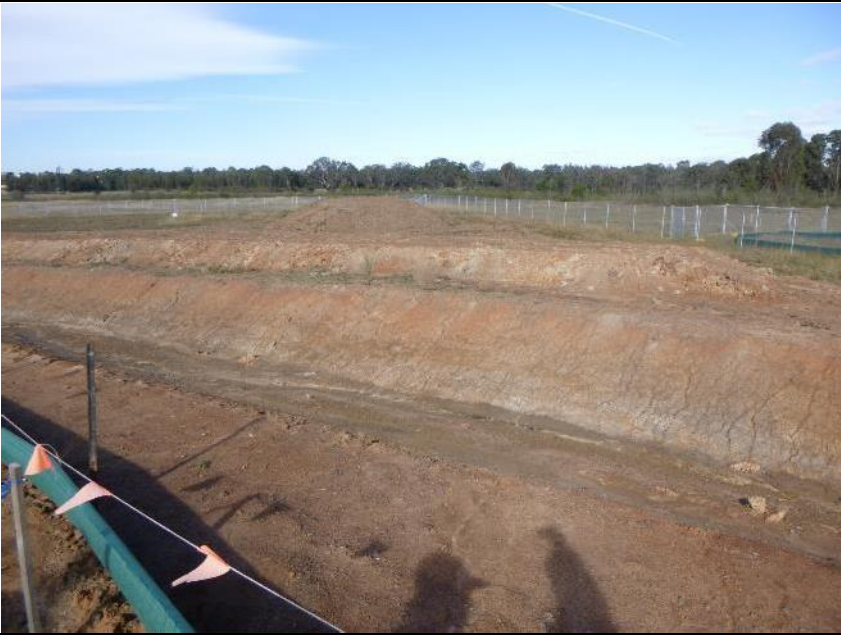
No	Location	Details	Photo (if Applicable)	Action or Recommendation	Priority (at the time of inspection)
25.	Aerotropolis	<p>Stockpiles in the southern corner are not ground covered as per Blue Book guidelines.</p> <p>Note that this is a low risk in terms of sediment pollution, but is a potential non-conformance.</p>

25	Aerotropolis	Stockpiles in the southern corner are not ground covered as per Blue Book guidelines. Note that this is a low risk in terms of sediment pollution, but is a potential non-conformance.

Spray the stockpiles with soil binder (or an alternative ground cover)	Low
26.	Aerotropolis	<p>Sediment basin spillway is not complete and doesn't extend to the boundary.</p>

Spray the stockpiles with soil binder (or an alternative ground cover)	In progress	The polymer is booked for application on the 14th July 2023.	The polymer is booked for application on the 14th July 2023.	<b>14th July 2023.</b>	N/A	 
26	Aerotropolis	Sediment basin spillway is not complete and doesn't extend to the boundary.

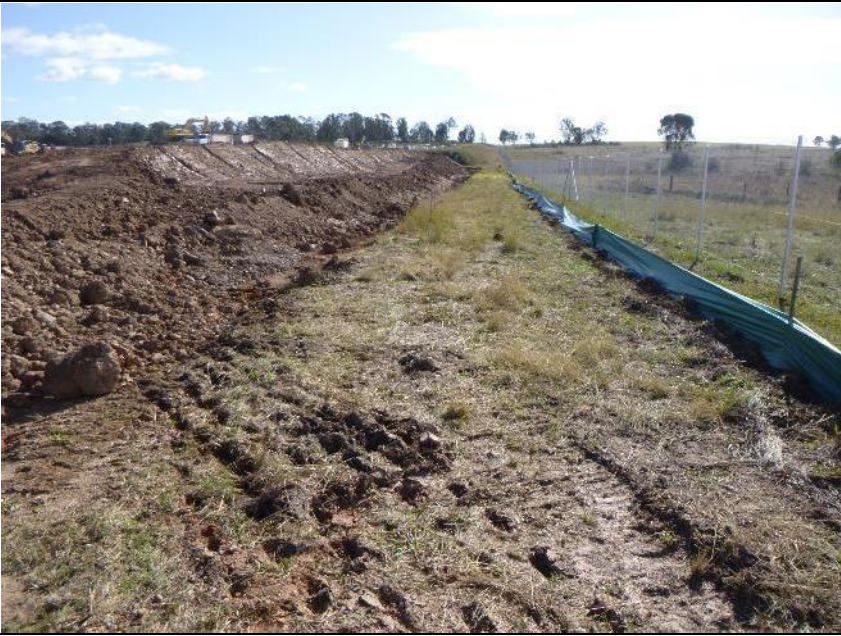
No	Location	Details	Photo (if Applicable)	Action or Recommendation	Priority (at the time of inspection)
29.	Aerotropolis	Dirty water runoff from this batter would flow to the low point, where there are only minimal controls.

Finish off the batter, veneer it with topsoil and vegetate it.	Medium
30.	Aerotropolis	Stockpile adjacent to the basin blocks a large amount of site water from reaching the basin.

Finish off the batter, veneer it with topsoil and vegetate it.	In progress	The grassed area in this image is an ACM remediation area. Once the material in this area has been stripped, a batter will be formed and stabilised. Stripping of the topsoil impacted material is expected to be complete by the 14/07/2023. Once ACM removal is complete, the batter will be extended to the site boundary where the ACM material is to be removed and appropriately stabilised. Target completion for this action is 17/07/2023 - 21/07/2023. It should be noted that a substantial bund has been formed at the top of the existing batter to limit flows to this area should a rain event occur prior to works being completed in this area.	Once ACM removal is complete, the batter will be extended to the site boundary where the ACM material is to be removed and appropriately stabilised. Target completion for this action is 17/07/2023 - 21/07/2023.	Target completion <b>17th - 21st July 2023</b>	N/A

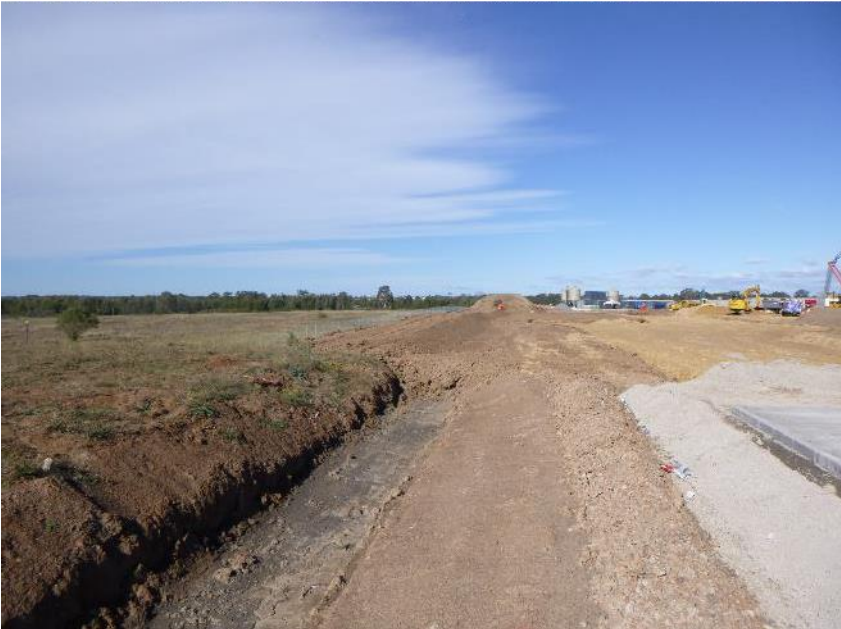
30	Aerotropolis	Stockpile adjacent to the basin blocks a large amount of site water from reaching the basin.

Remove the stockpile and form up the drain to direct all site water into the basin.	Medium

Remove the stockpile and form up the drain to direct all site water into the basin	In progress	At the time this image was taken, the stockpile visible in the image was formed intentionally to break up the catchment and limit flows to the remediation area adjacent the eastern boundary of the site. Excavation of the drain is progressing however completion is reliant on the removal of the stockpile noted in Item No. 28.	Stockpile to be removed and drain to be completed as soon as practical.	Target completion <b>28th July 2023</b>	N/A	
33	Bringelly	Stockpiles in the western corner are not ground covered as per Blue Book guidelines. Note that this is a low risk in terms of sediment pollution, but is a potential non-conformance

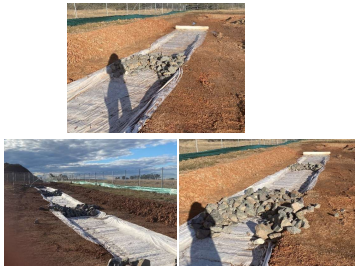
28	Aerotropolis	Stockpile adjacent to the basin blocks a large amount of site water from reaching the basin.
