**SYDNEY METRO - WESTERN SYDNEY AIRPORT  
STATION BOXES AND TUNNELLING WORKS**

# Biannual Groundwater Monitoring Report December 2023 to June 2024

<b>Project number</b>	WSA-200-SBT
<b>Document number</b>	SMWSASBT-CPG-SWD-SW000-GE-RPT-040419
<b>Revision date</b>	26/09/2024
<b>Revision</b>	00

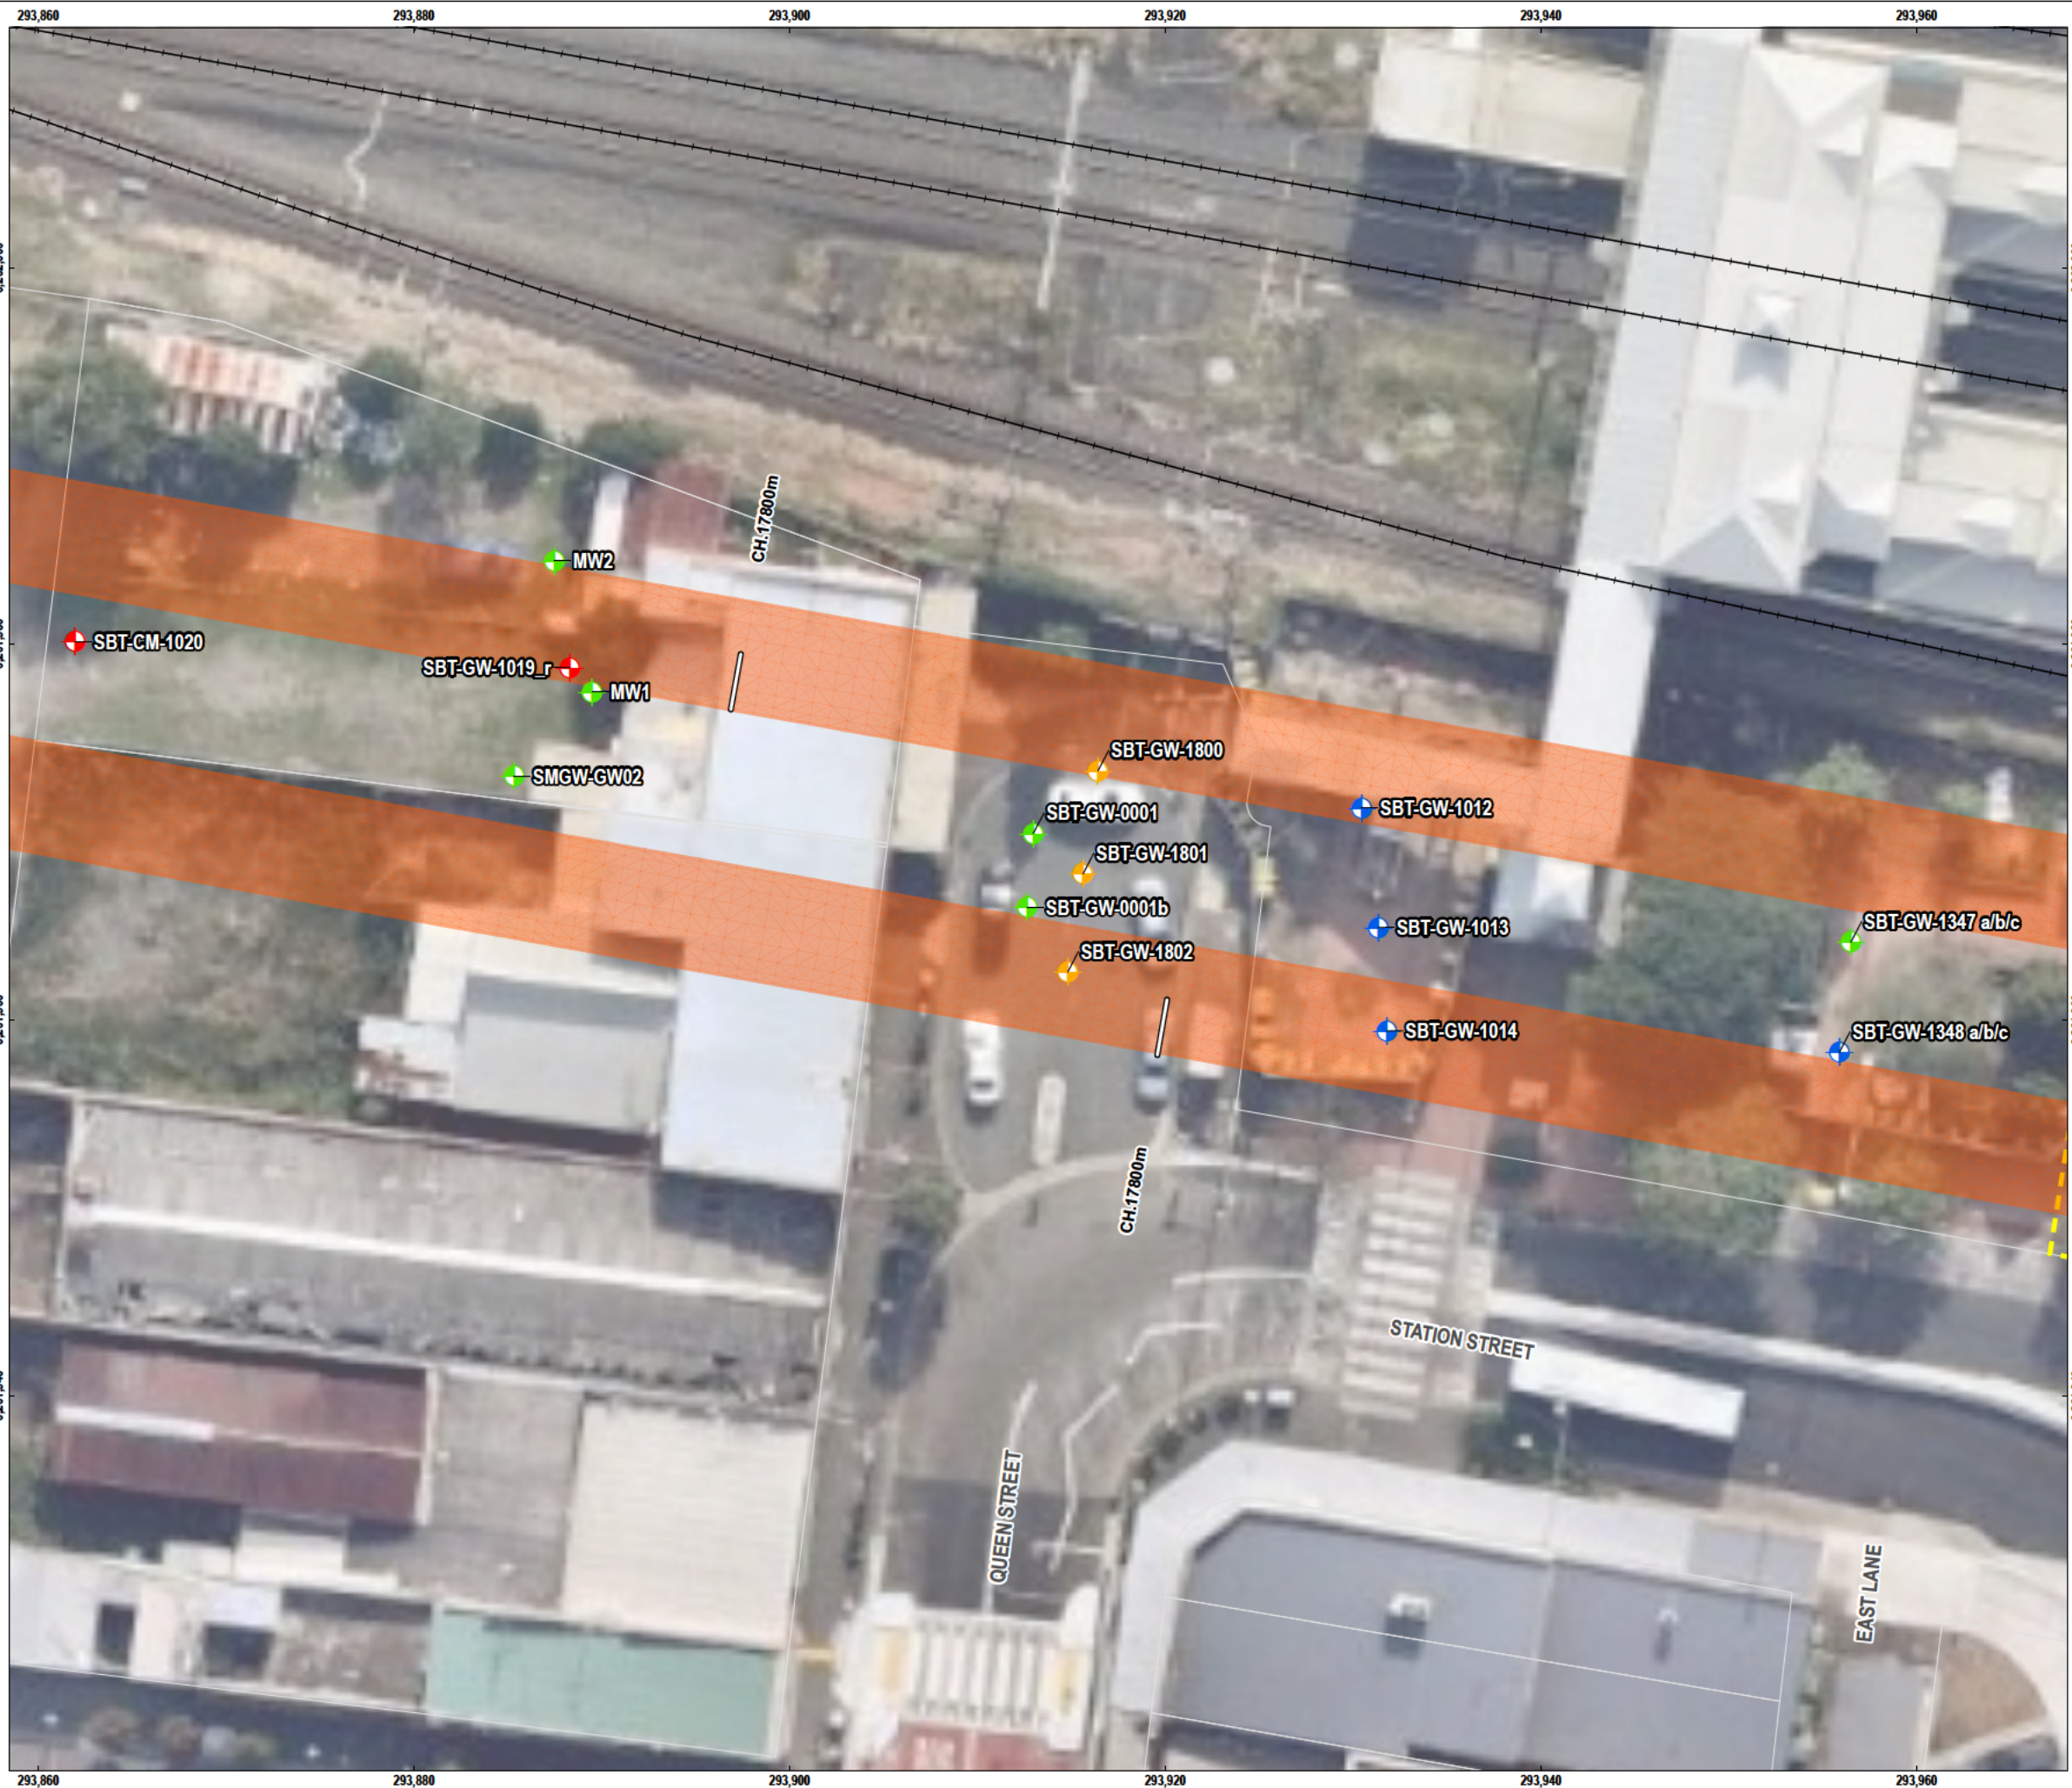
**FIGURE 2**  
**Ongoing Mitigation Monitoring Wells – St Marys**

**Bold** indicates wells to be sampled from April 2024 onward. Other monitoring wells decommissioned prior to TBM passing through area.

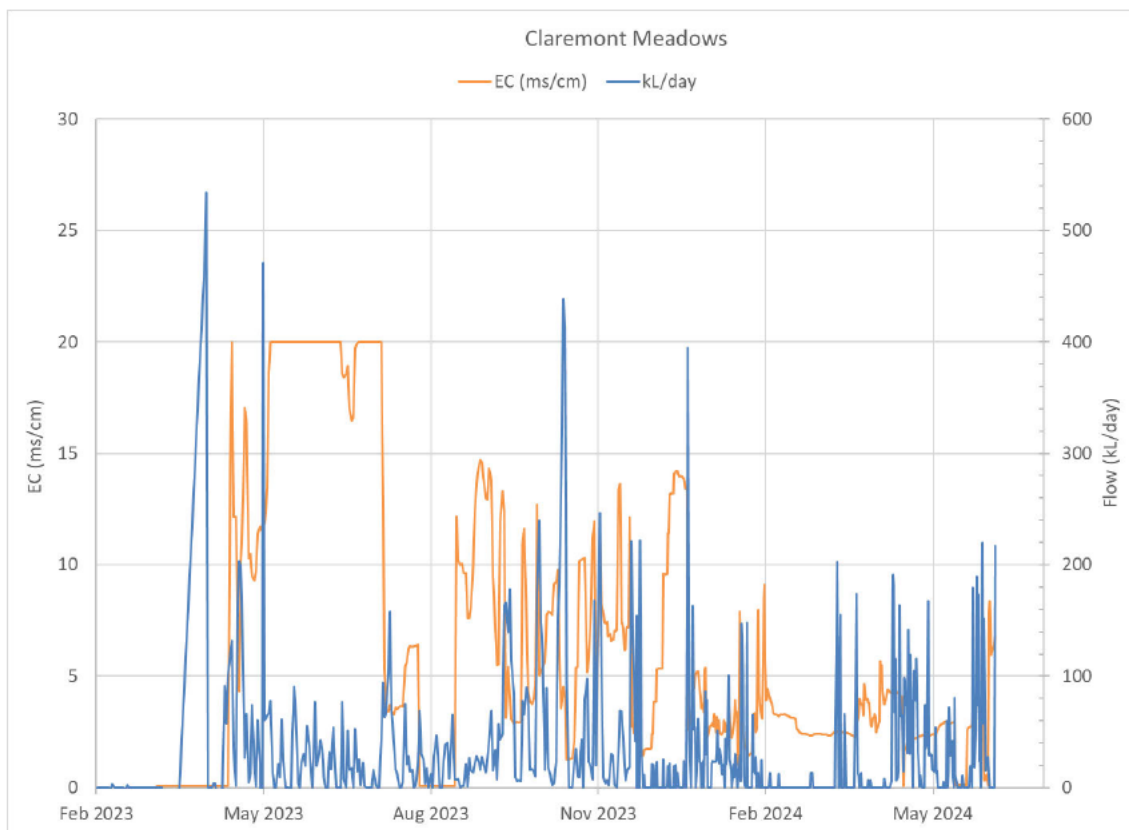
Figure 6-1: Daily inflows and EC at Claremont Meadows Offsite Tanks

In total there has been approximately 22 ML of inflow to the Claremont Meadow shaft.

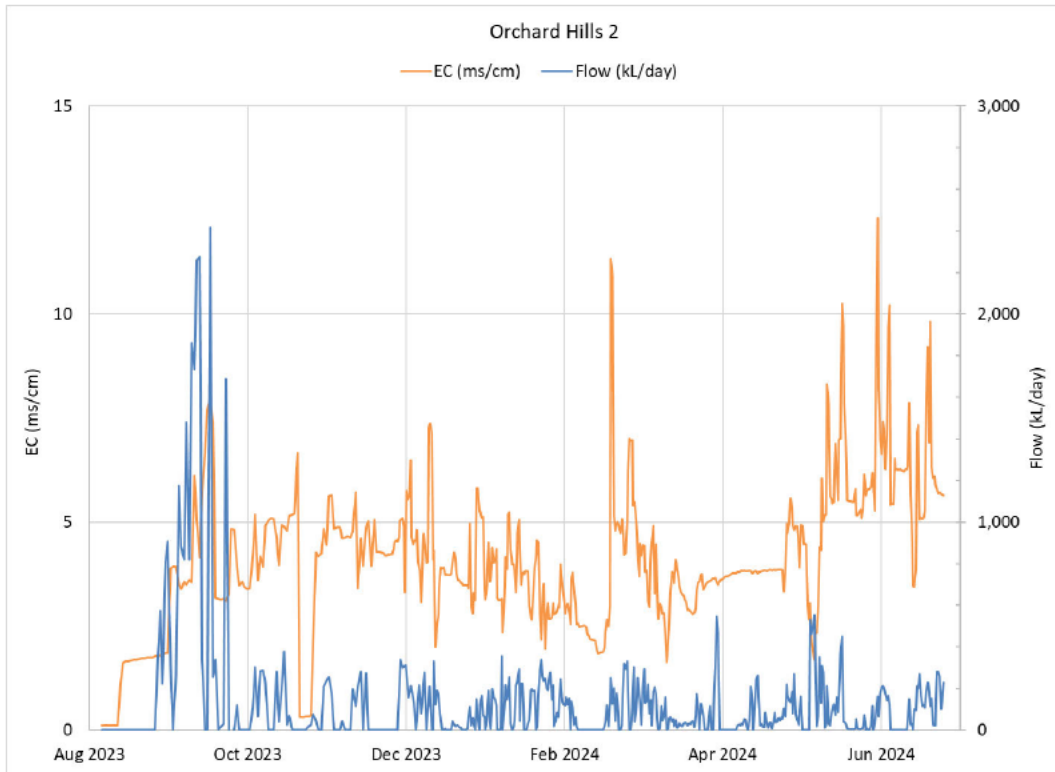
Figure 6-5: Daily inflows and EC at WTP feed for Orchard Hills 2

Water from Orchard Hills 2 is fed into the plant (included in OH1) of offsite tanks at Airport Dive to be used for dust suppression (Figure 6-5). The highest flows were reported in September and October 2023 of over 2,400 KL/day. In the past eight months daily flows have significantly reduced, and have averaged around 90 KL/day since December 2023, similar to OH1.

Electrical conductivity data indicates that excavation inflows were relatively fresh (~2 mS/cm) and increased slightly over time to around 5 mS/cm, which is lower than expected based on average groundwater EC in all aquifers (Table 6-3). EC has been variable in 2024, with relatively fresh (~3 mS/cm) inflows reported at both OH1 and OH2 until May 2024. The EC at both OH1 and OH2 in June 2024 has been the highest reported, indicating increasingly saline water is being drawn into the excavation.

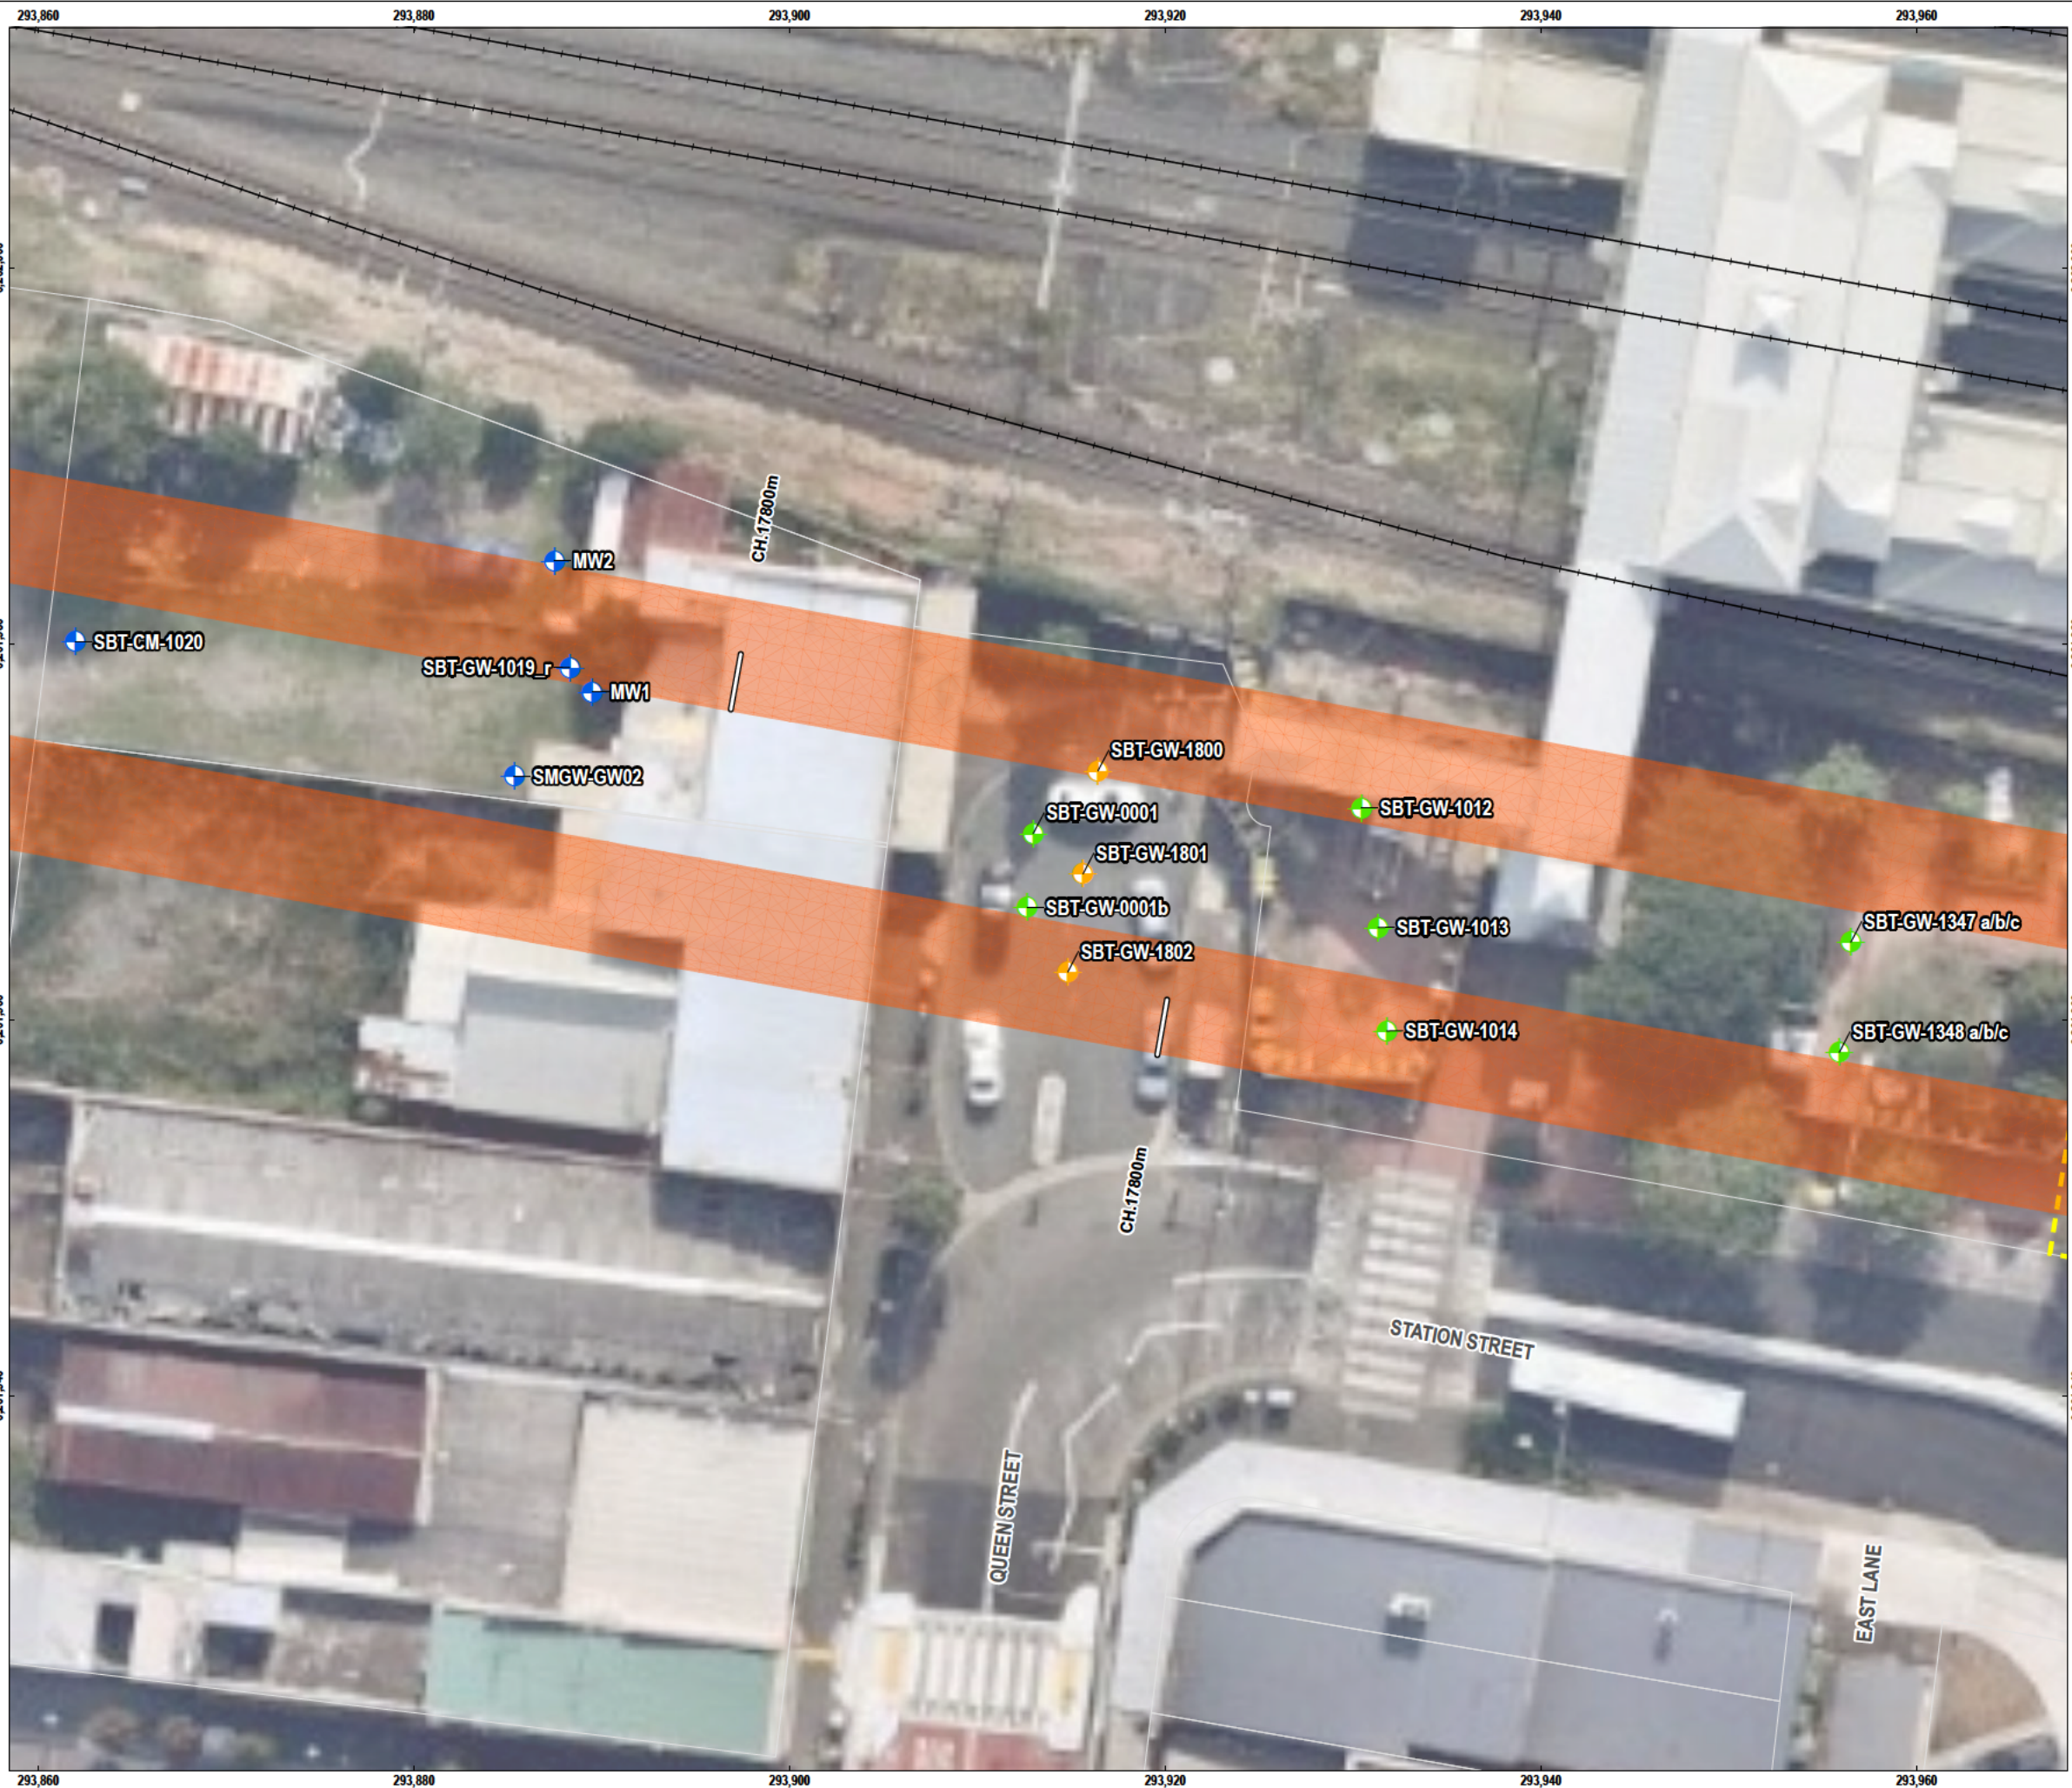
The locations of the PRB injection wells and associated monitoring well network, and wells monitored in the source area in June 2024 are shown in Figure 1.

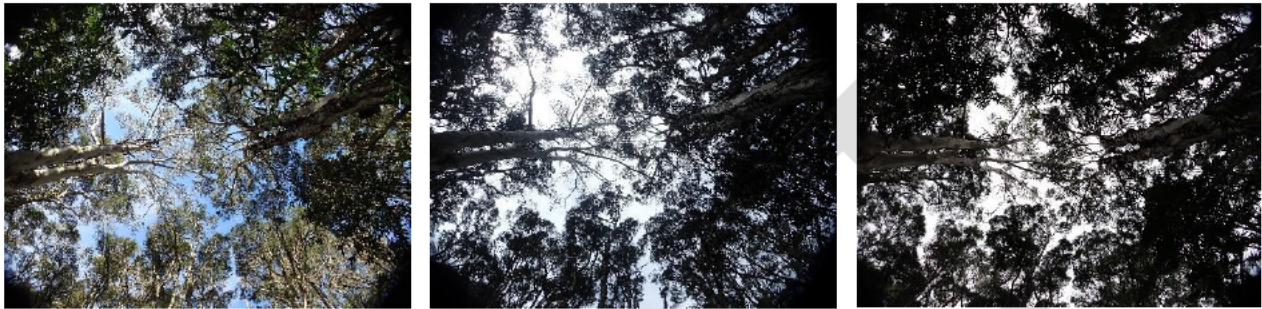
Canopy at all transects was observed to be in good condition, despite some minor canopy dieback observed at Transect 1 during survey 2, none was observed during survey 3. Survey 2 recorded a reduction of shrubs at Transects 1 and 2 which contributed to a reduced calculated canopy cover, particularly at transect 1 (Table 2; Table 3). However, survey 3 recorded a slight increase in shrub cover, which contributed to an increase in the average canopy cover (Table 2; Table 3). Overall canopy cover, in survey 3, increased to a similar cover recorded in survey 1 for Transects 1 and 2 (Table 2; Plate 1). Canopy cover at Transect 3 was found to be relatively consistent across all three surveys. Shrub cover had very little impact on canopy cover percentage at Transect 3 as the positioning of the camera excluded shrubs from the frame.

**Plate 1:** Example canopy monitoring photograph from Transect point 1.4 during baseline survey 1 (left, 87%) survey 2 (middle, 69% cover) and survey 3 (right, 87% cover), showing a decrease in canopy and shrub cover during survey 2, and an increase during survey 3.

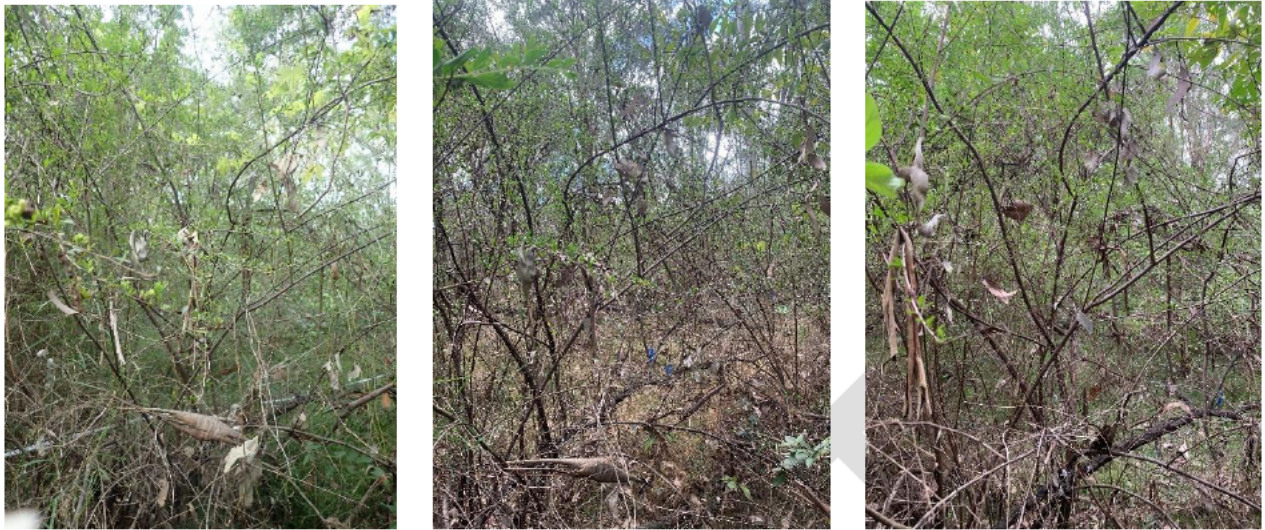
**Plate 2:** *Bursaria spinosa* (Transect 2 (control), point 2.2) with good leaf cover and leaf condition in survey 1 (left), moderate leaf cover and good leaf condition in survey 2 (middle) and moderate cover and good leaf condition in survey 3 (right). In all three surveys the plant had buds and no signs of disease.

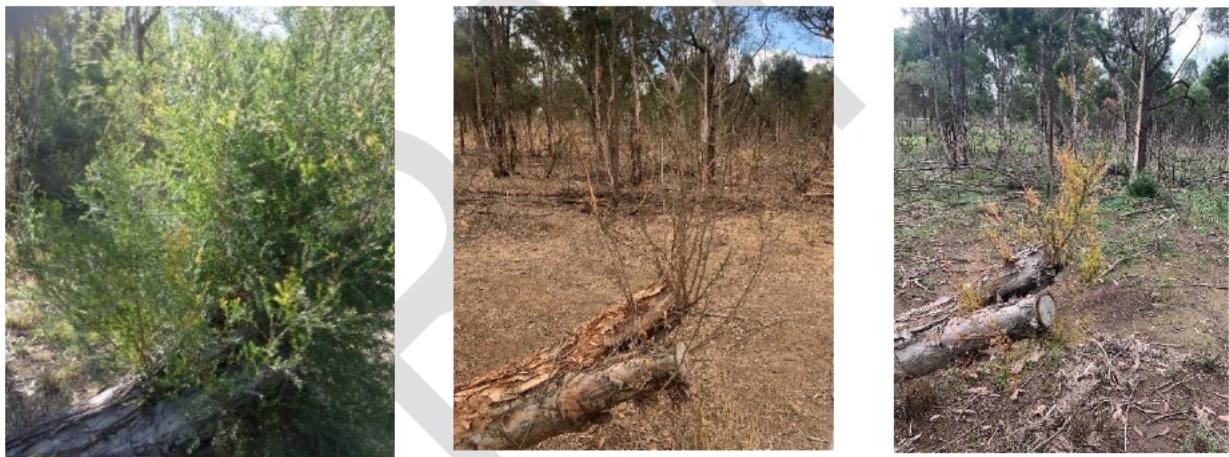
**Plate 3:** *Melaleuca decora* (Transect 3 (study area), point 3.4) in good condition and leaf cover during baseline survey 1 (left), in very poor condition and leaf cover in survey 2 (middle) and in poor leaf cover and good condition in survey 3 (right).

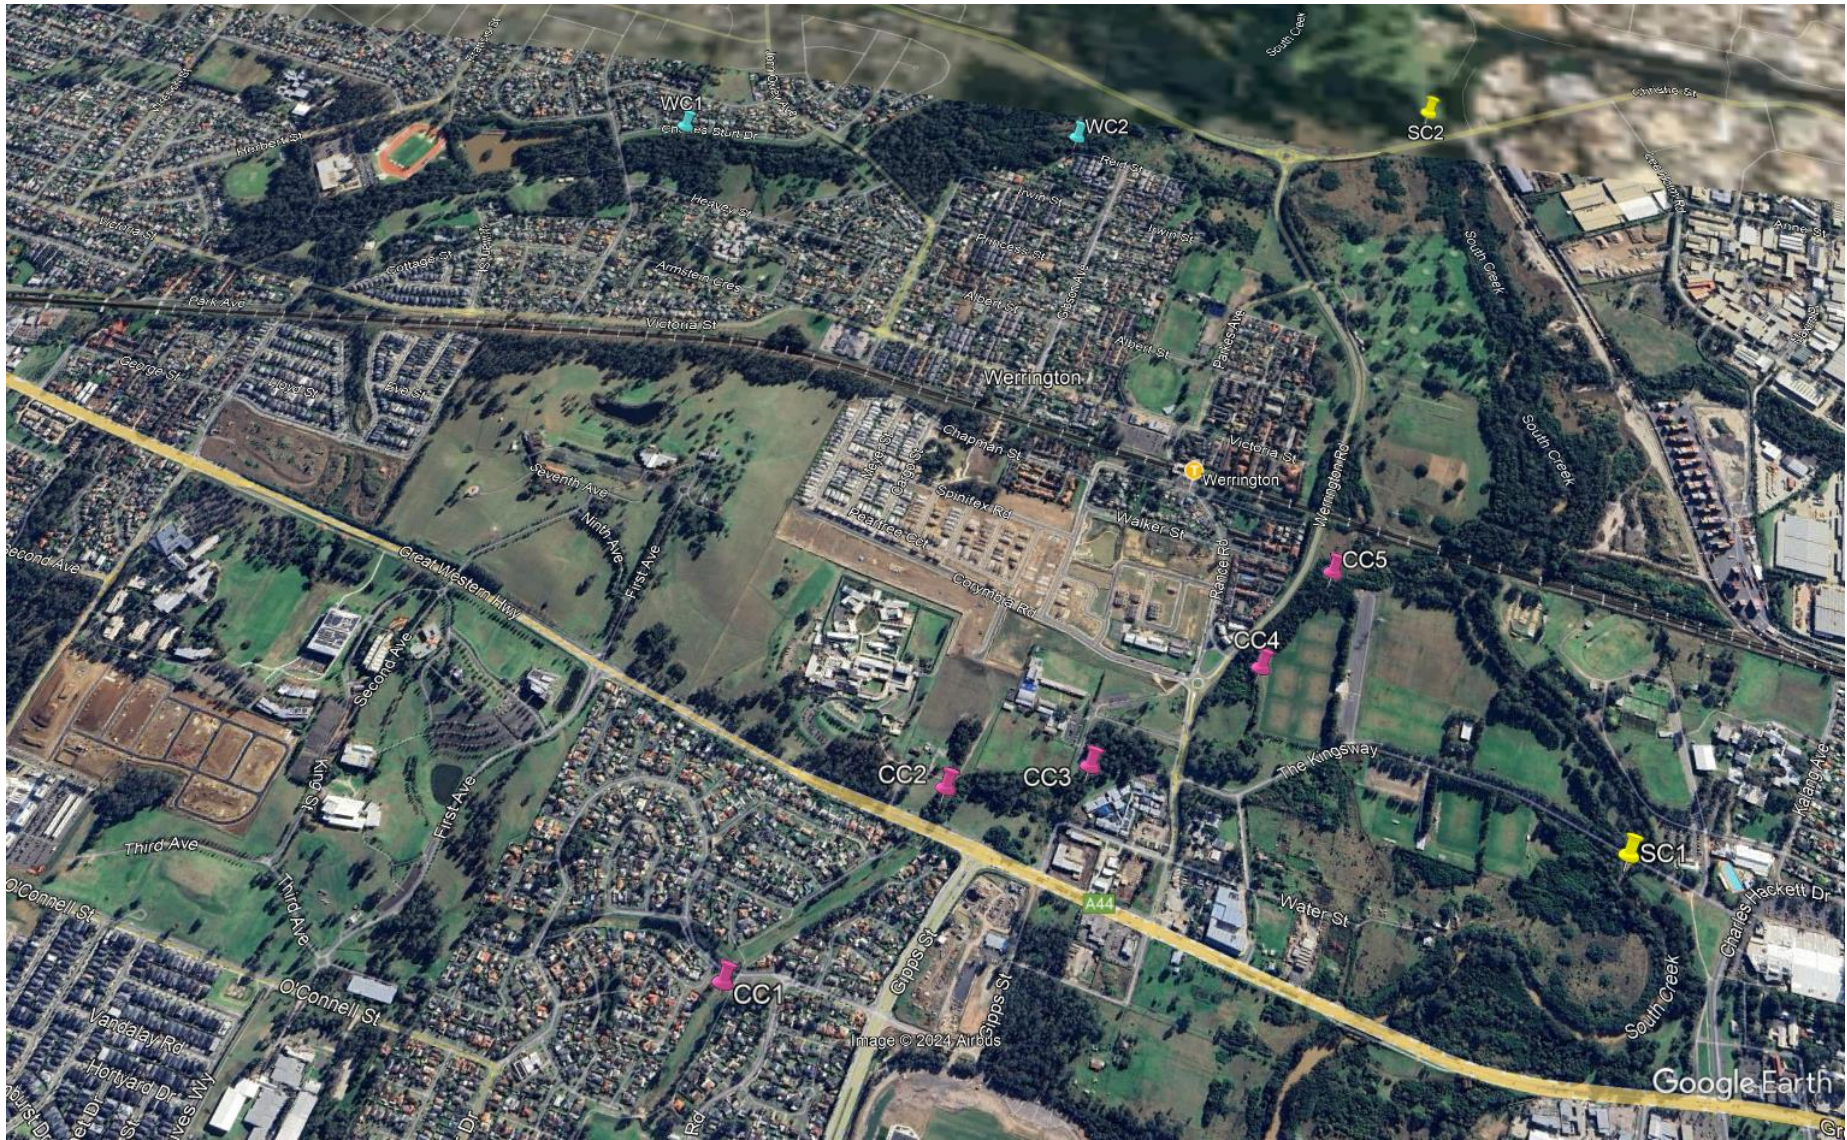
**Figure 2. Survey sites situated within Claremont Creek (CC1-CC5), South Creek (SC1&SC2) and Werrington Creek (WC1&WC2). Image provided by Google Earth.**

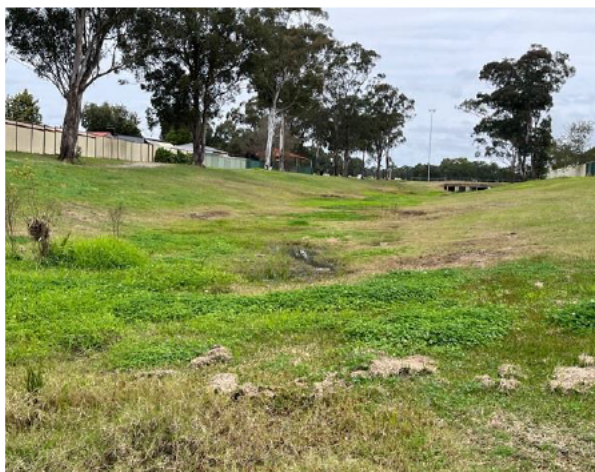
Plate 1: Claremont Creek (CC1) (5 June 2024)

At Site CC1, situated upstream of the Great Western Highway, the stream channel has been highly modified by development and flood control activities. Riparian vegetation has mostly been cleared along this section the stream channel, and replaced by exotic grasses with occasional *Typha* sp., *Cyperus eragrostis* and *Persicaria decipiens*. Surface water habitat was present in occasional temporary, shallow (up to 20 cm deep) depressions. Conductivity of the water within these depressions ranged from 791 to 9,076  $\mu\text{S}/\text{cm}$ . This site received an RCE score of 14 (27%). Aquatic habitat was mostly absent and significant barriers to fish movement were present.

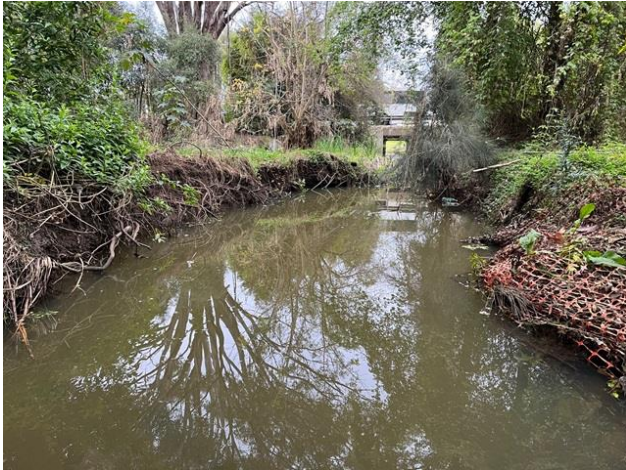
**Plate 3: Claremont Creek (CC2) (5 June 2024)**

Despite evidence of recent scouring by elevated flows, the stream banks appeared relatively stable, due to the presence of mature trees (predominantly Casuarina and Eucalyptus). Exotic weeds, including Privet (*Ligustrum* sp.), Ballon vine (*Cardiospermum grandiflorum*), Trad (*Tradescantia albiflora*) and grasses were common (Plates 3-10). The overall condition of aquatic habitats at site's CC2 to CC5 was classified as good, with an RCE score of 25 (48%). The downstream reaches of Claremont Creek are classified as Class 2, Type 2 (moderate) fish habitat according to the DPI (2013) classification.

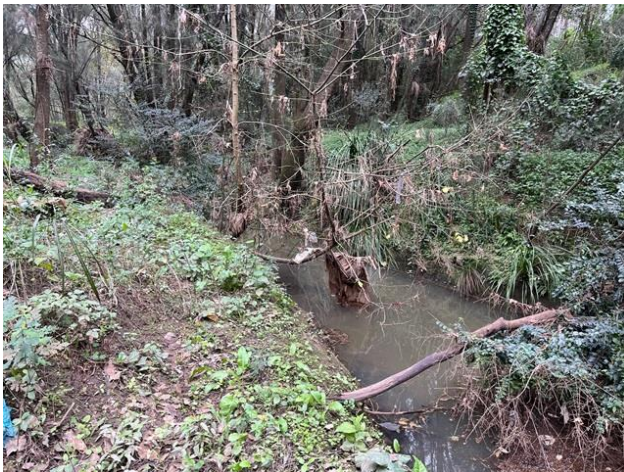
**Plate 15: Werrington Creek (WC1) (5 June 2024)**  
View upstream

, Trad and exotic grasses were common. The active channel zone (0.4 to 1.5 m wide) was composed of poorly sorted gravel overlain by fine-grained sediments. The native submerged macrophyte species, *Stuckenia pectinata* (Sago pondweed) and the introduced species, *Egeria densa* (Dense waterweed), were abundant at Site WC1 (Plate 16). Water clarity was considered poor at both sites. The overall condition of aquatic habitats at Site WC1 & WC2 was classified as fair, with an RCE score of 25 (48%).
