St Marys Station Validation Report

Sydney Metro Western Sydney Airport Station Boxes and Tunnelling Works

Project number	WSA-200-SBT
Document number	SMWSASBT-CPG-STM-SN100-EN-RPT-295310
Revision date	7/09/2023
Revision	D

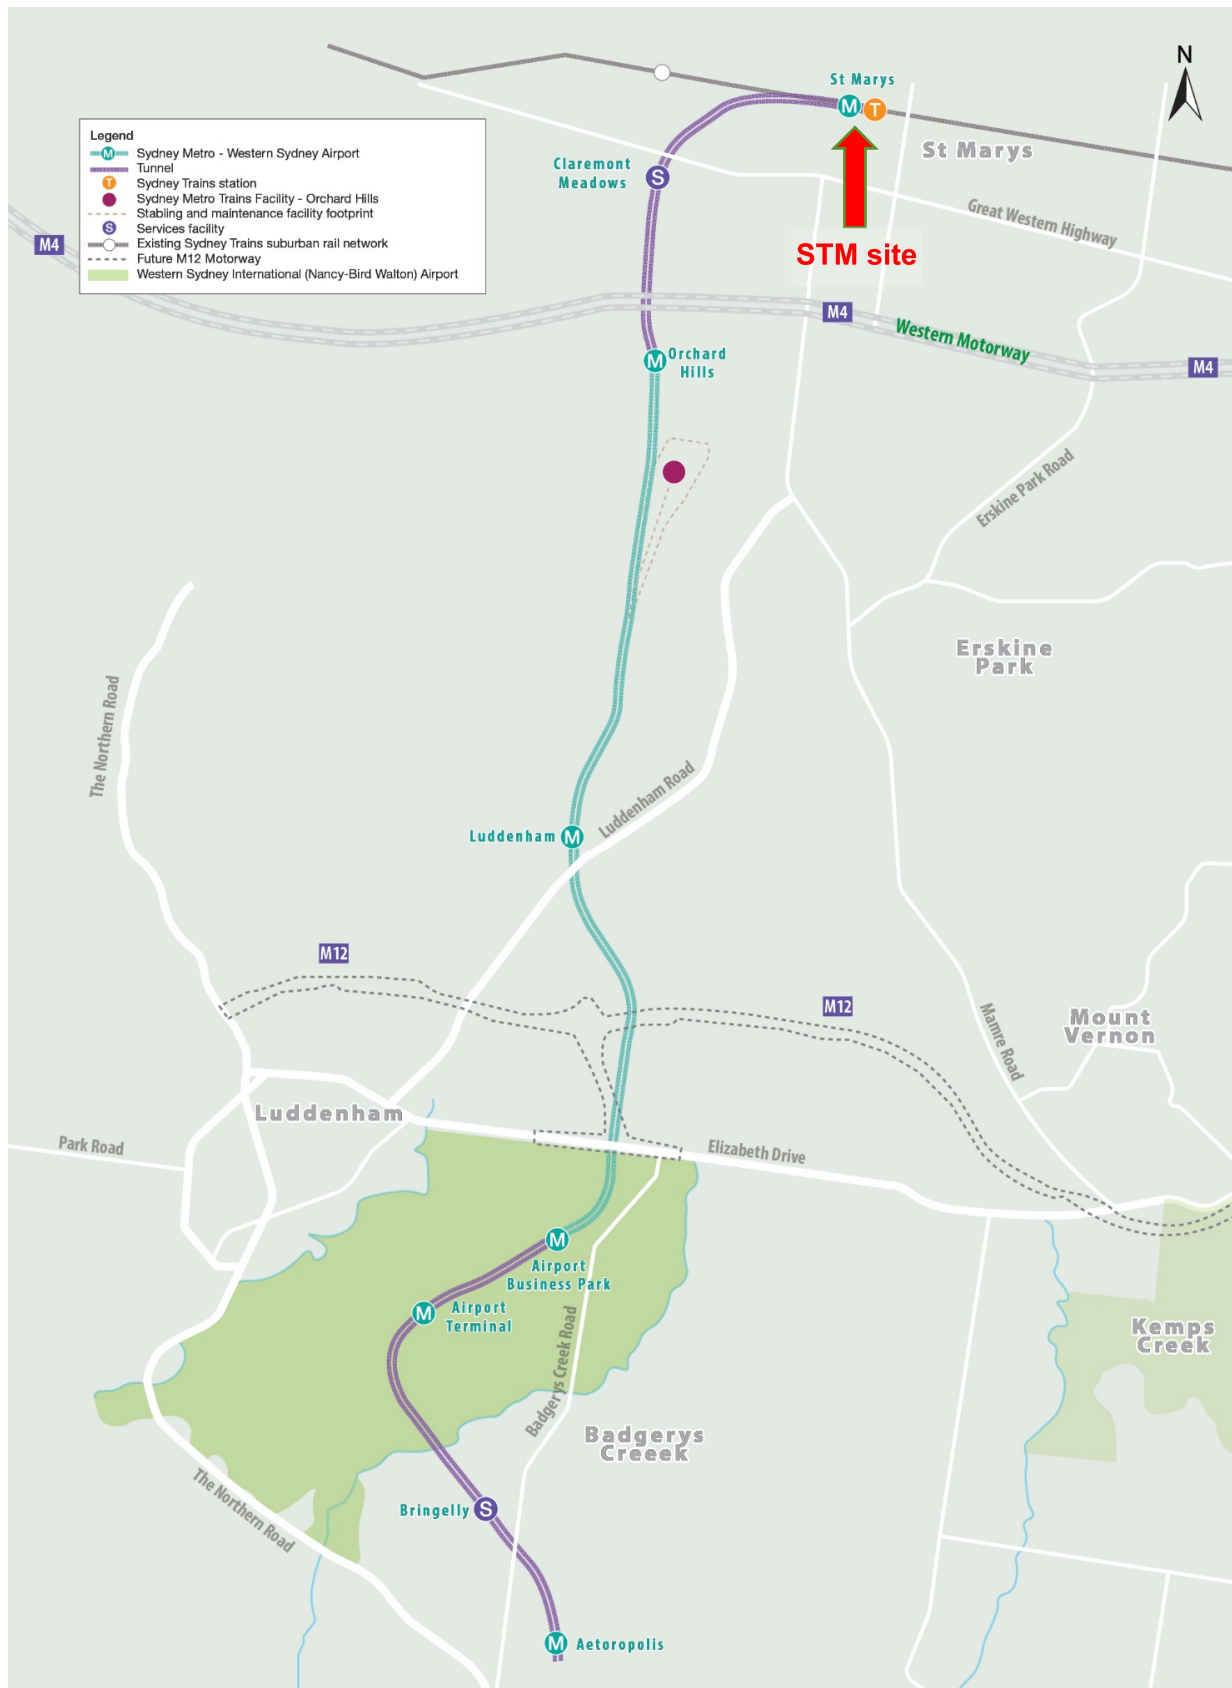
Figure A: Overview of SBT Works

The SBT Works involves the construction and operation of a new 23 km metro rail line from the existing Sydney Trains suburban T1 Western Line (at St Marys) in the north and the Aerotropolis (at Bringelly) in the south. The Project includes tunnels and civil structures, including a viaduct, bridges, and surface and open-cut troughs between the two tunnel sections. Figure A overleaf shows the proposed alignment and key features of the Project and the approximate location of the STM site.

The SBT Works are divided into two parts:

- SBT North: STM site to Orchard Hills Station. St Marys Station is an existing heritage-listed suburban rail station. Orchard Hills is a new station for the Sydney Metro line and will include the portal dive structure. Claremont Meadows Services Facility (CMF) is included along this alignment.
- SBT South: Airport business park dive structure to the Western Sydney Airport Aerotropolis station. This section of work is largely greenfield, with construction both on and off-airport land. The Airport Terminal Station (ATM) and Bringelly Services Facility (BSF) are included along this alignment.

Key elements on the SBT Works include:

- Two sections of twin tunnels with a combined length of approximately 9.8 km, plus associated portal structures. This includes one section from St Marys to Orchard Hills and the other under Western Sydney International (WSI) airport to the new Aerotropolis Station.
- Excavations at either end to enable trains to turn back, and stub tunnels to enable future extensions.
- Station box excavations with temporary ground support for four new Metro stations at St Marys (the STM site), Orchard Hills, Airport Terminal and Aerotropolis.
- Excavations for two intermediate services facilities, one in each of the tunnel sections at Claremont and Bringelly.
