# Aerotropolis Remedial Action Plan

## Sydney Metro Western Sydney Airport Station Boxes and Tunnelling Works

<b>Project number</b>	WSA-200-SBT
<b>Document number</b>	SMWSASBT-CPG-SWD-SW000-GE-RPT-040527
<b>Revision date</b>	5 June 2023
<b>Revision</b>	A04

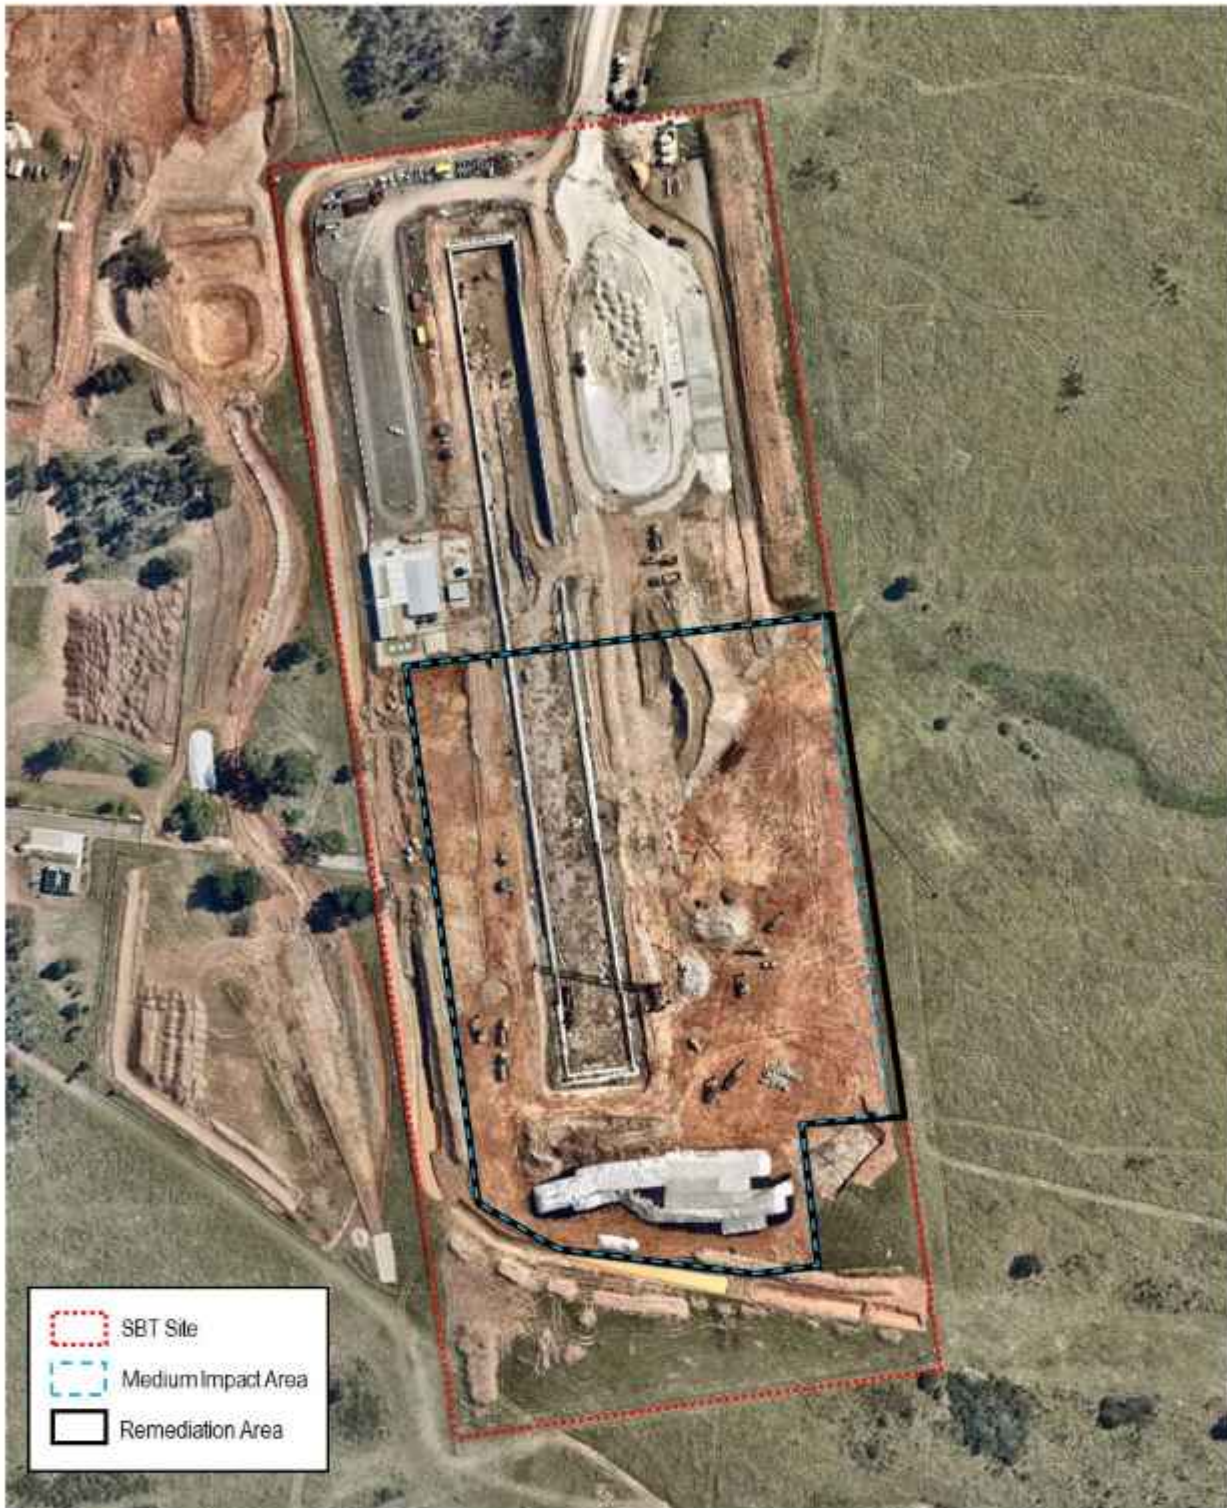
Figure D SBT Site, Medium Impact Area and Remediation Area

<sup>2</sup> The area of the SBT Site requiring remediation (Remediation Area) and the subject of this RAP is the Medium Impact Area and the strip of land between the eastern most boundary Medium Impact Area and the SBT Boundary. Remediation is not required in the Low Impact Areas.

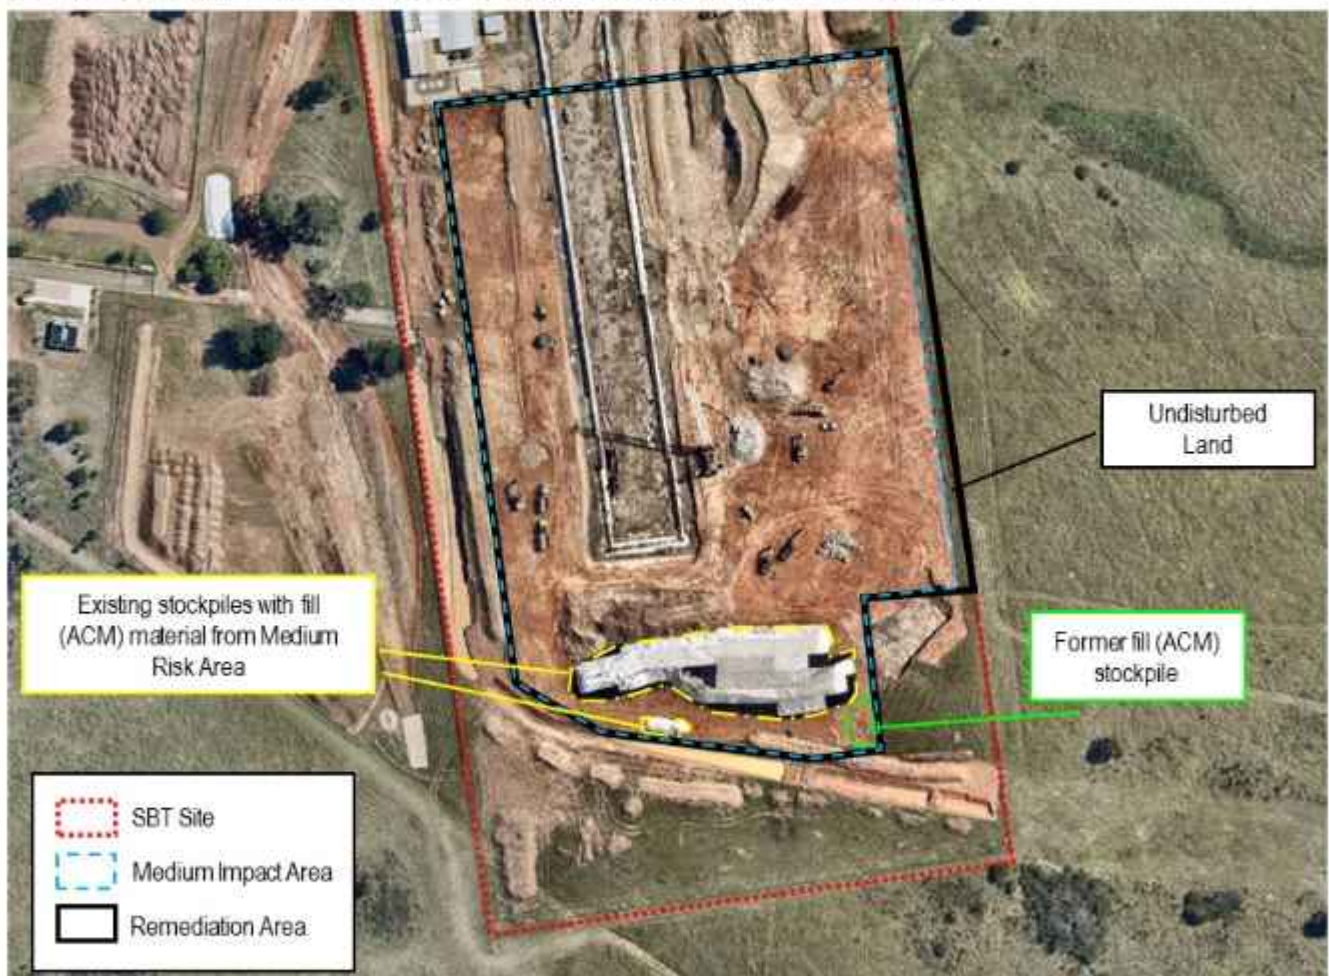
Figure E Existing Site Conditions

Within the Remediation Area there remains an undisturbed area between the Medium Impact Area and the boundary of the Remediation Area. This area is shown in Figure E.

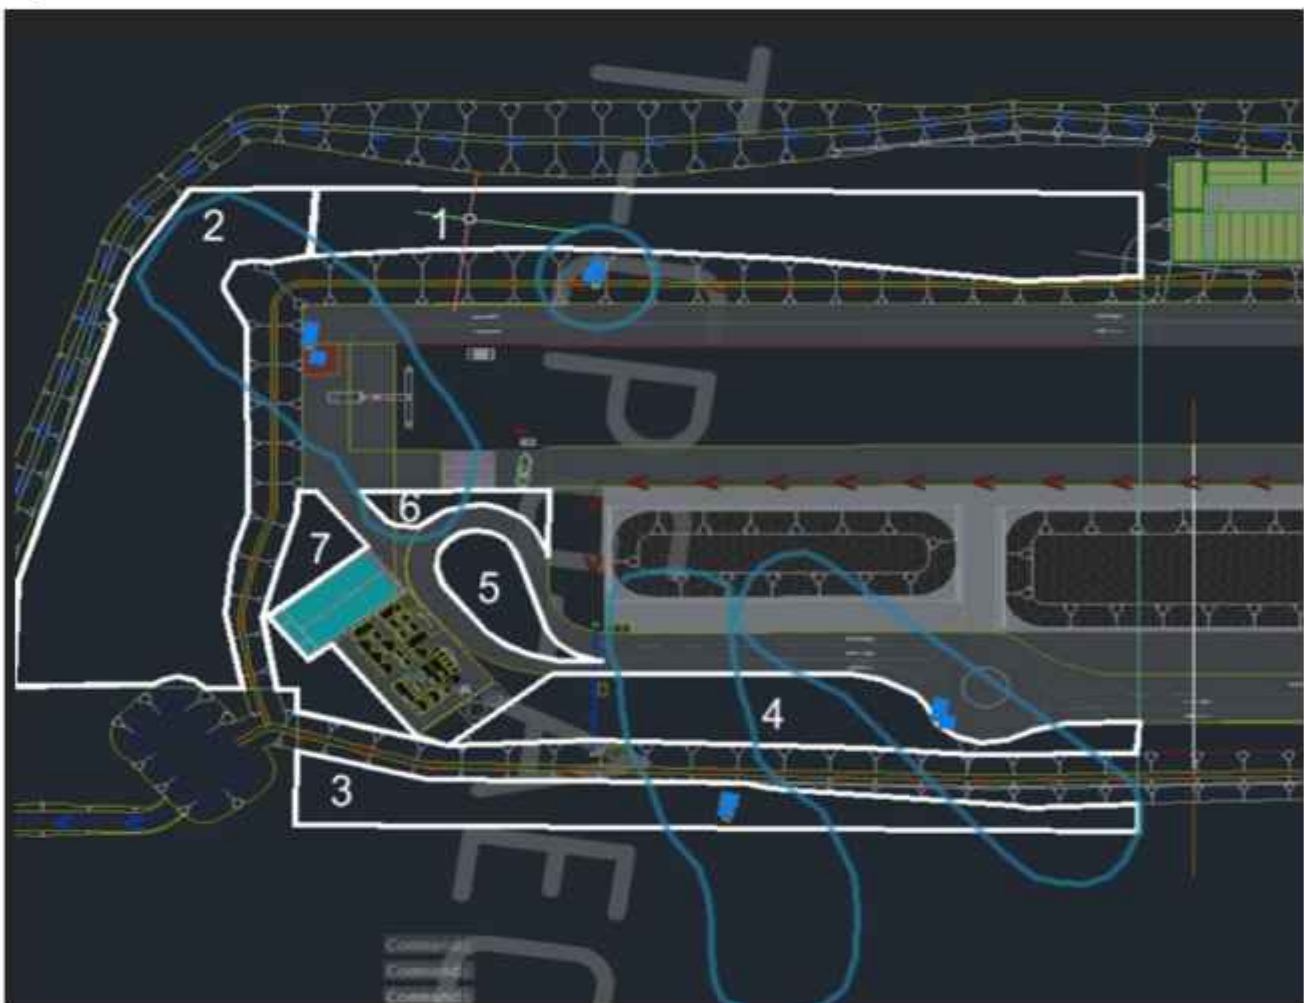
Figure 6.7.2 Stage 2 Excavation of Fill Materials (areas within the numbered polygons 1 to 7)

Sydney Metro instructed CPBG to excavate and stockpile all fill material from the Medium Impact Area and outside of the CPBG construction disturbance footprint (i.e. the balance of fill and disturbed natural materials in the Medium Impact Area following the removal of materials in Stage 1). Materials which have been excavated in Stage 2 are shown as the labelled polygons 1 to 7 in Figure 6.7.2.

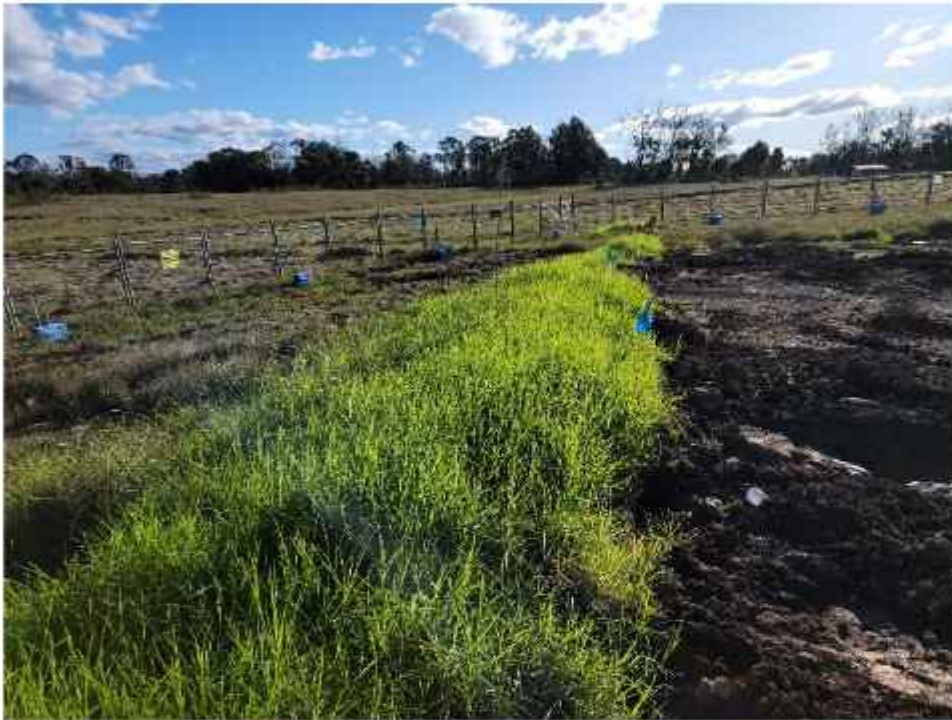
PAC 06 includes the former stockpile area. The southern extent of this area appears to be defined by a brick retaining wall / berm (refer to **Figure 8D, Appendix A**). Fill material on the northern side is approximately 1.1 m thick in SP01-TP92 and SP01-TP93. Previous investigations (GHD and TTC) have reported ACM and fibrous asbestos & asbestos fines in the fill material. Ground levels on the northern side of the wall are notably higher than the southern side as shown in the following photograph.

Plate 1: Photograph looking west with retaining wall present within grassed strip. Land on the northern side of the wall (right of grass strip in the photograph) is visibly higher than the southern side.

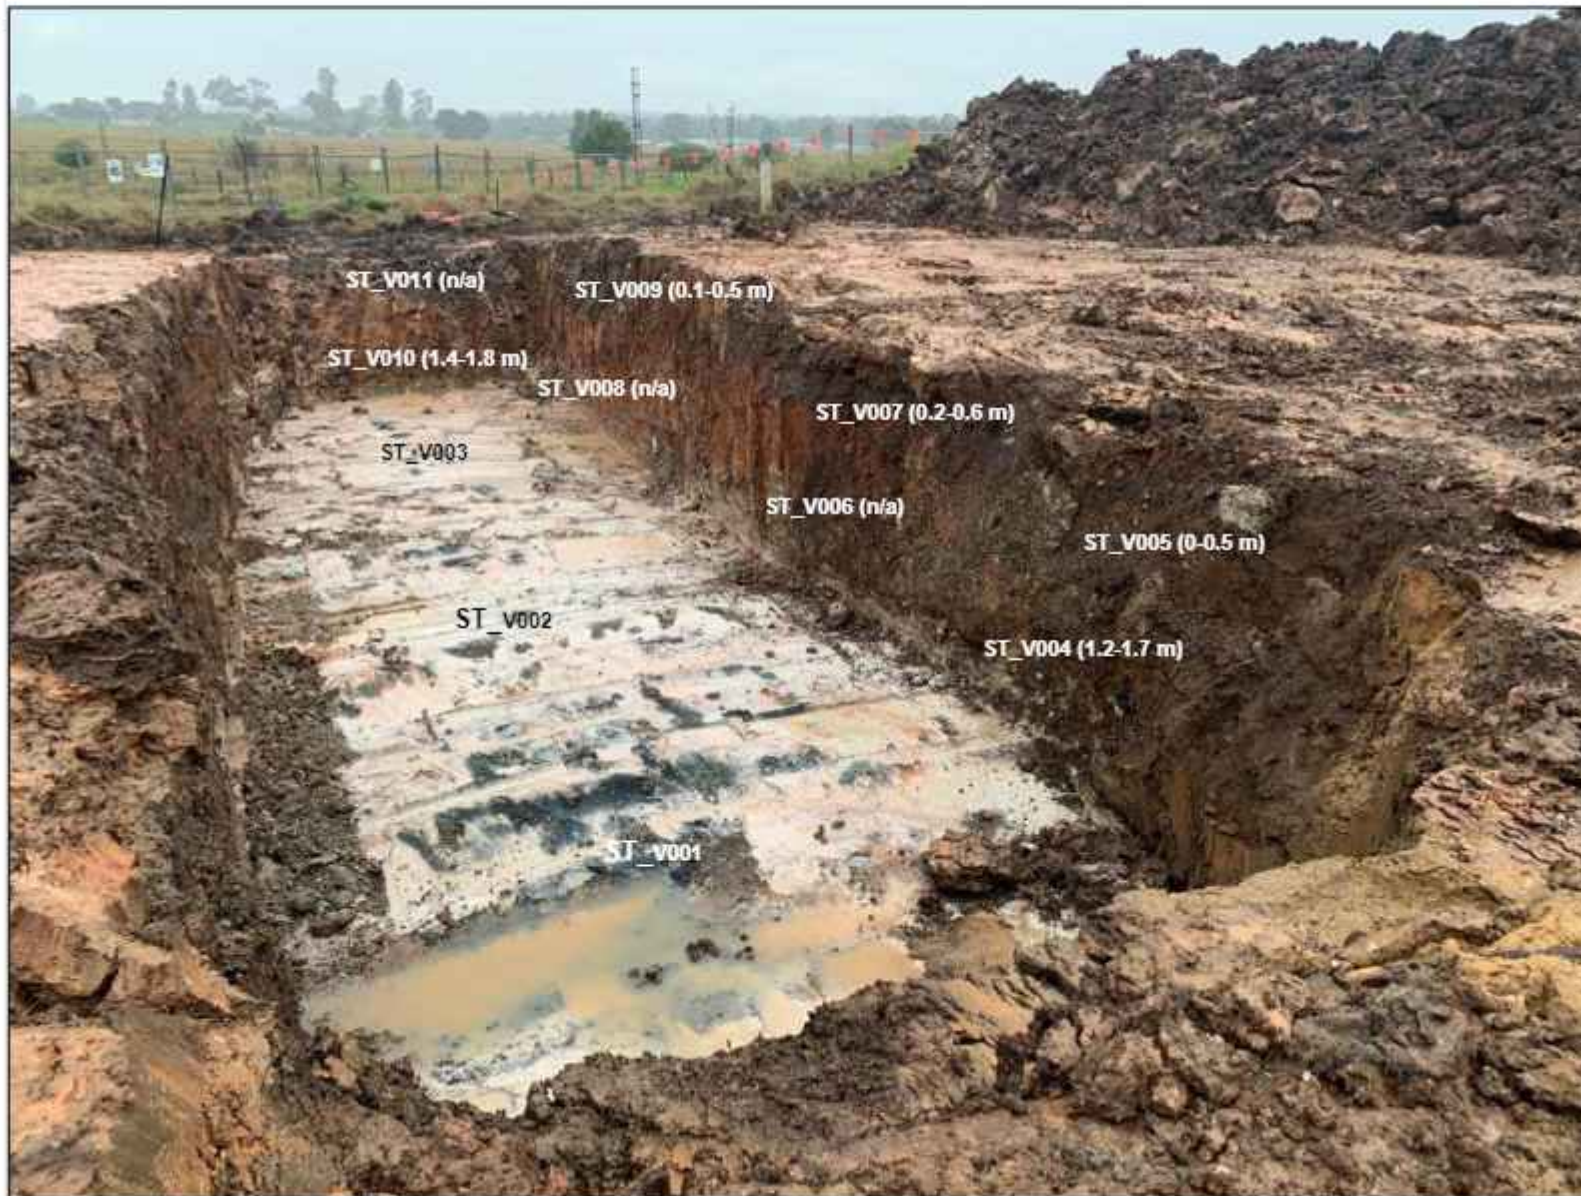
Photograph 2 –  
East wall and  
base (base  
samples 2.4 m)

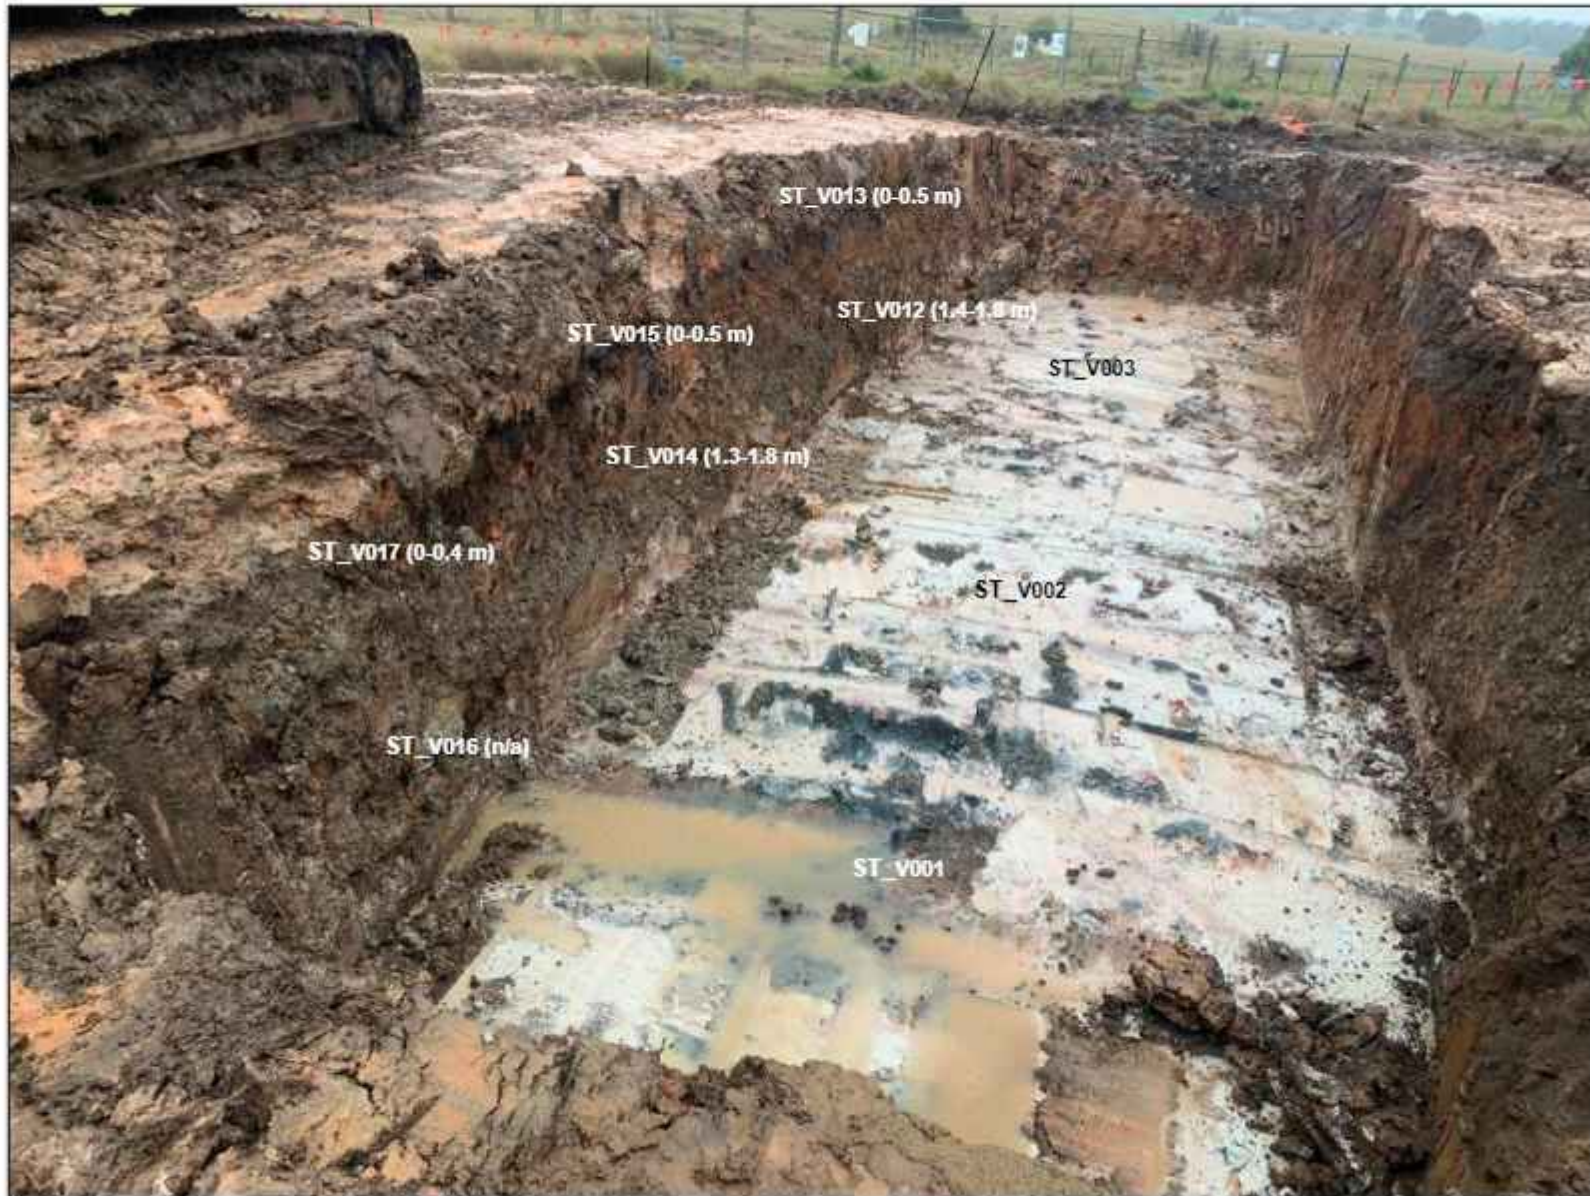
Photograph 3 –  
South Wall

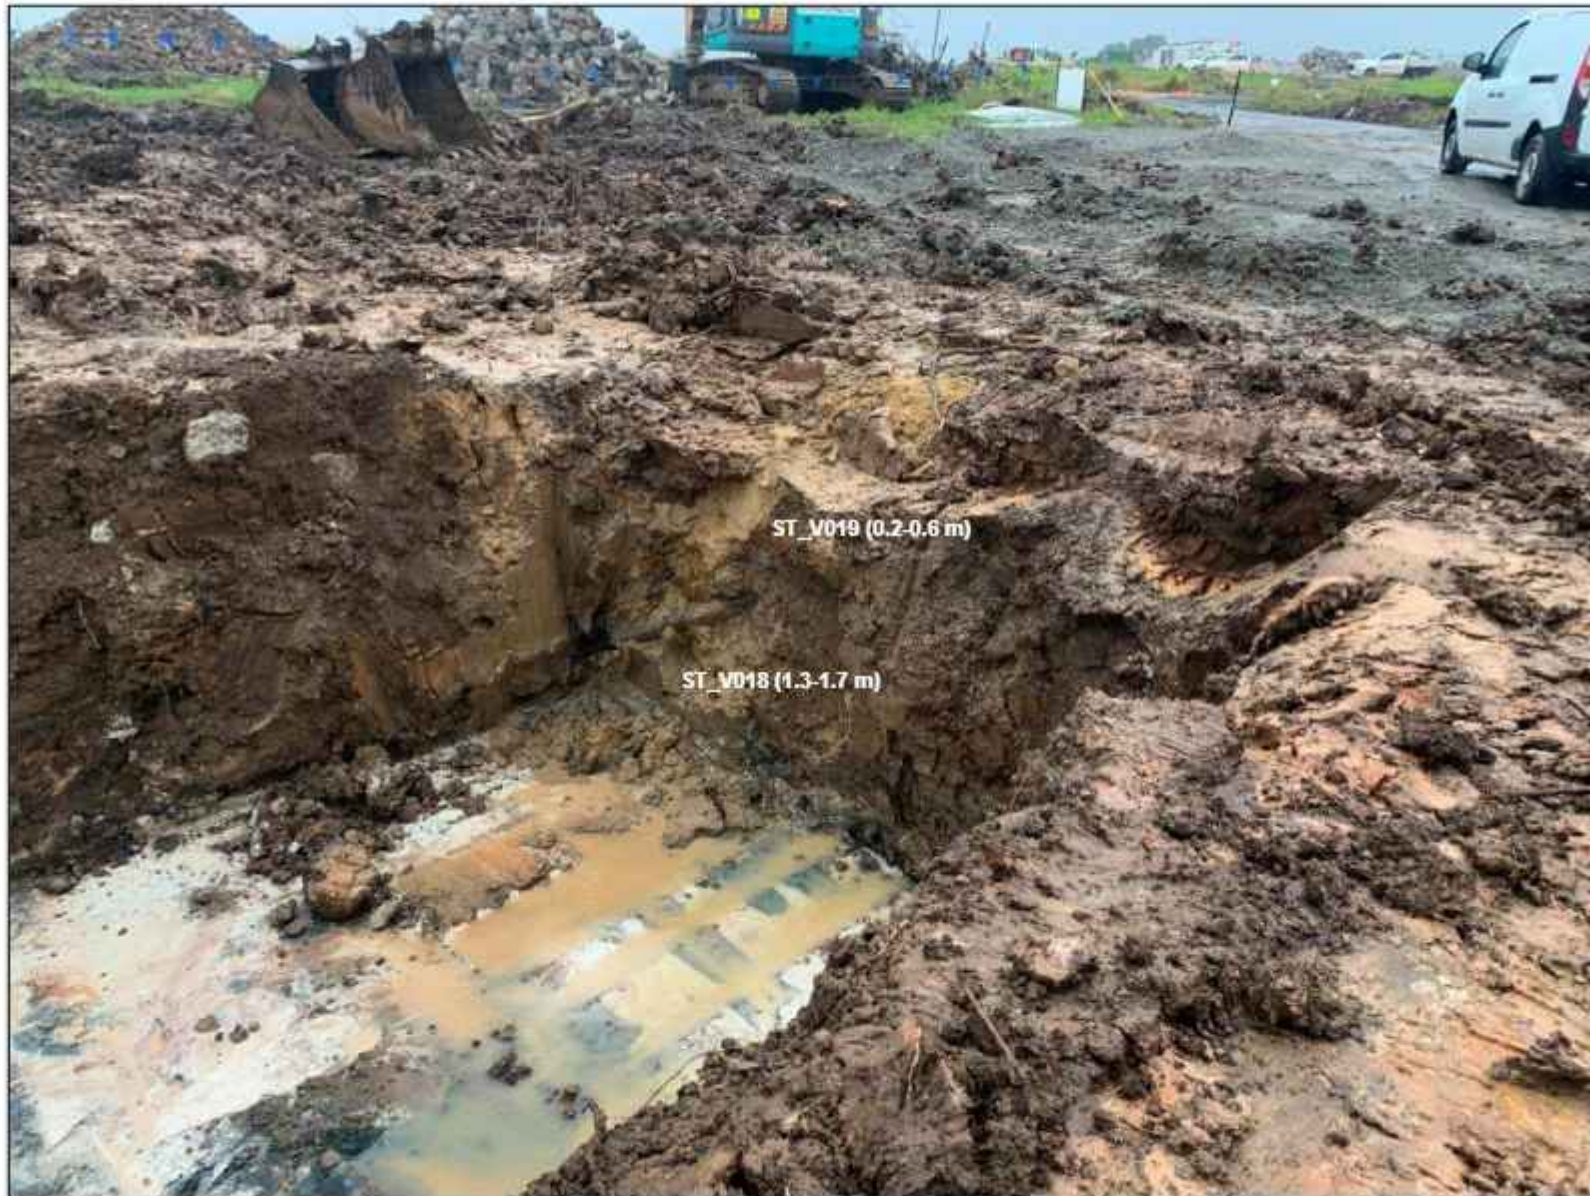
Photograph 4 –  
Associated  
pipework trench

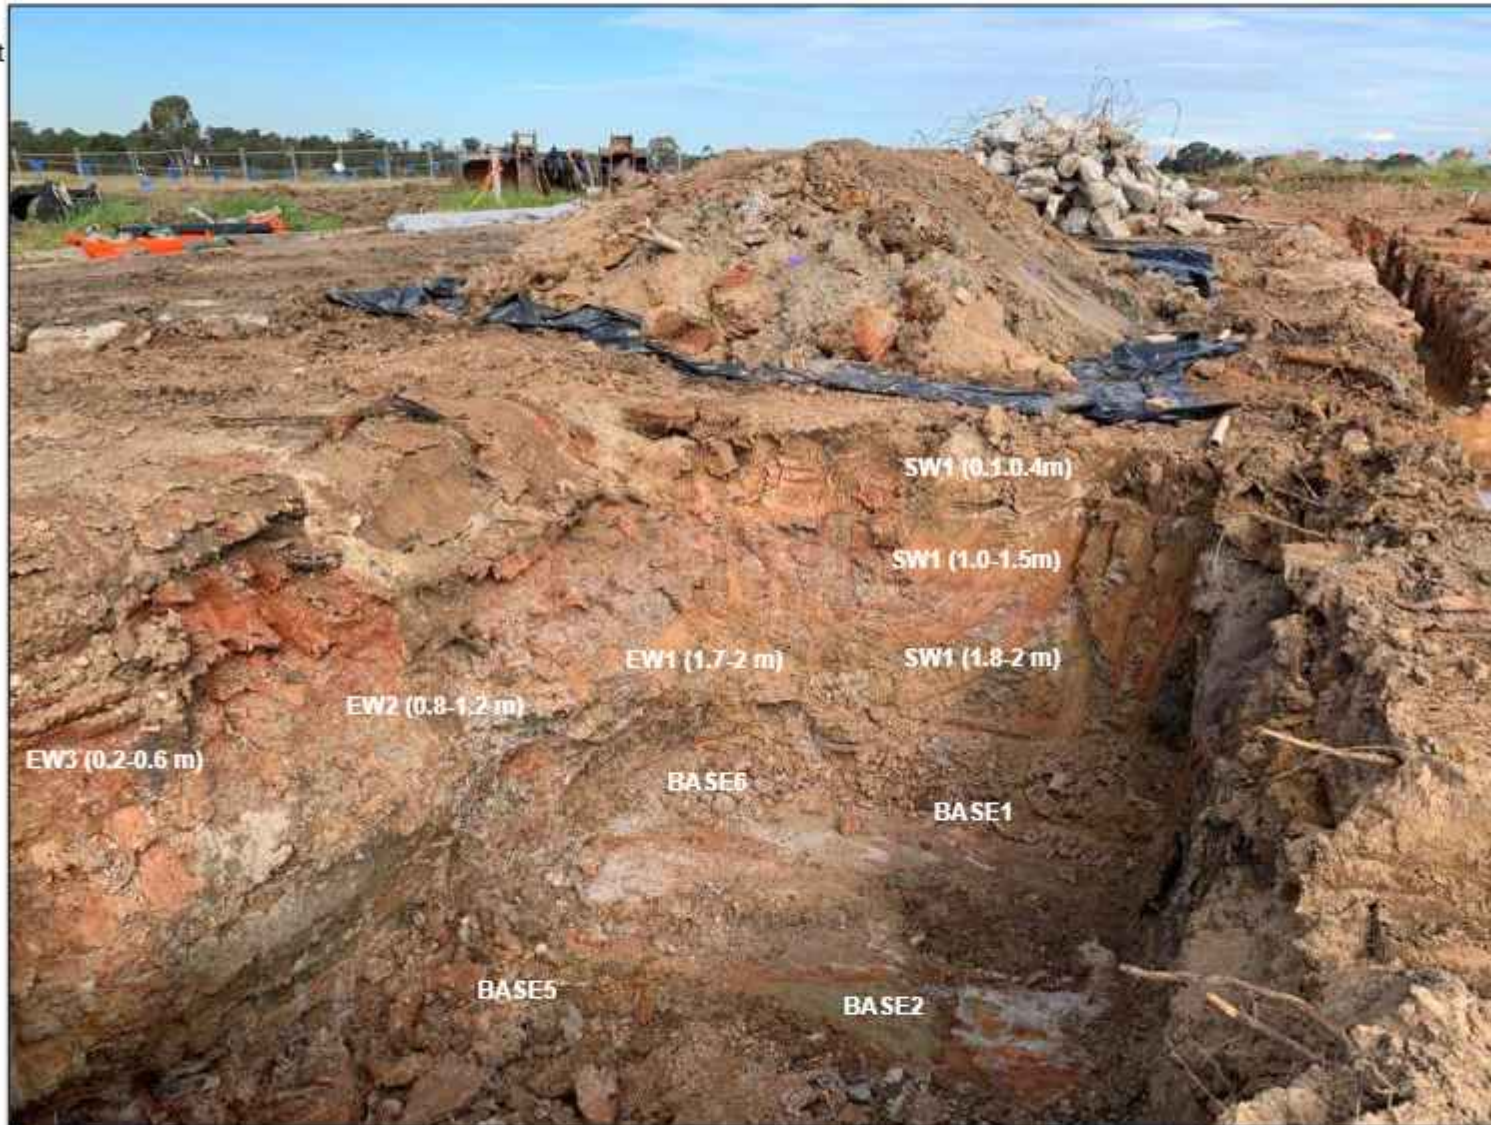
Photograph 1 –  
South Wall, east  
wall and partial  
base (base  
samples 2.4 m)

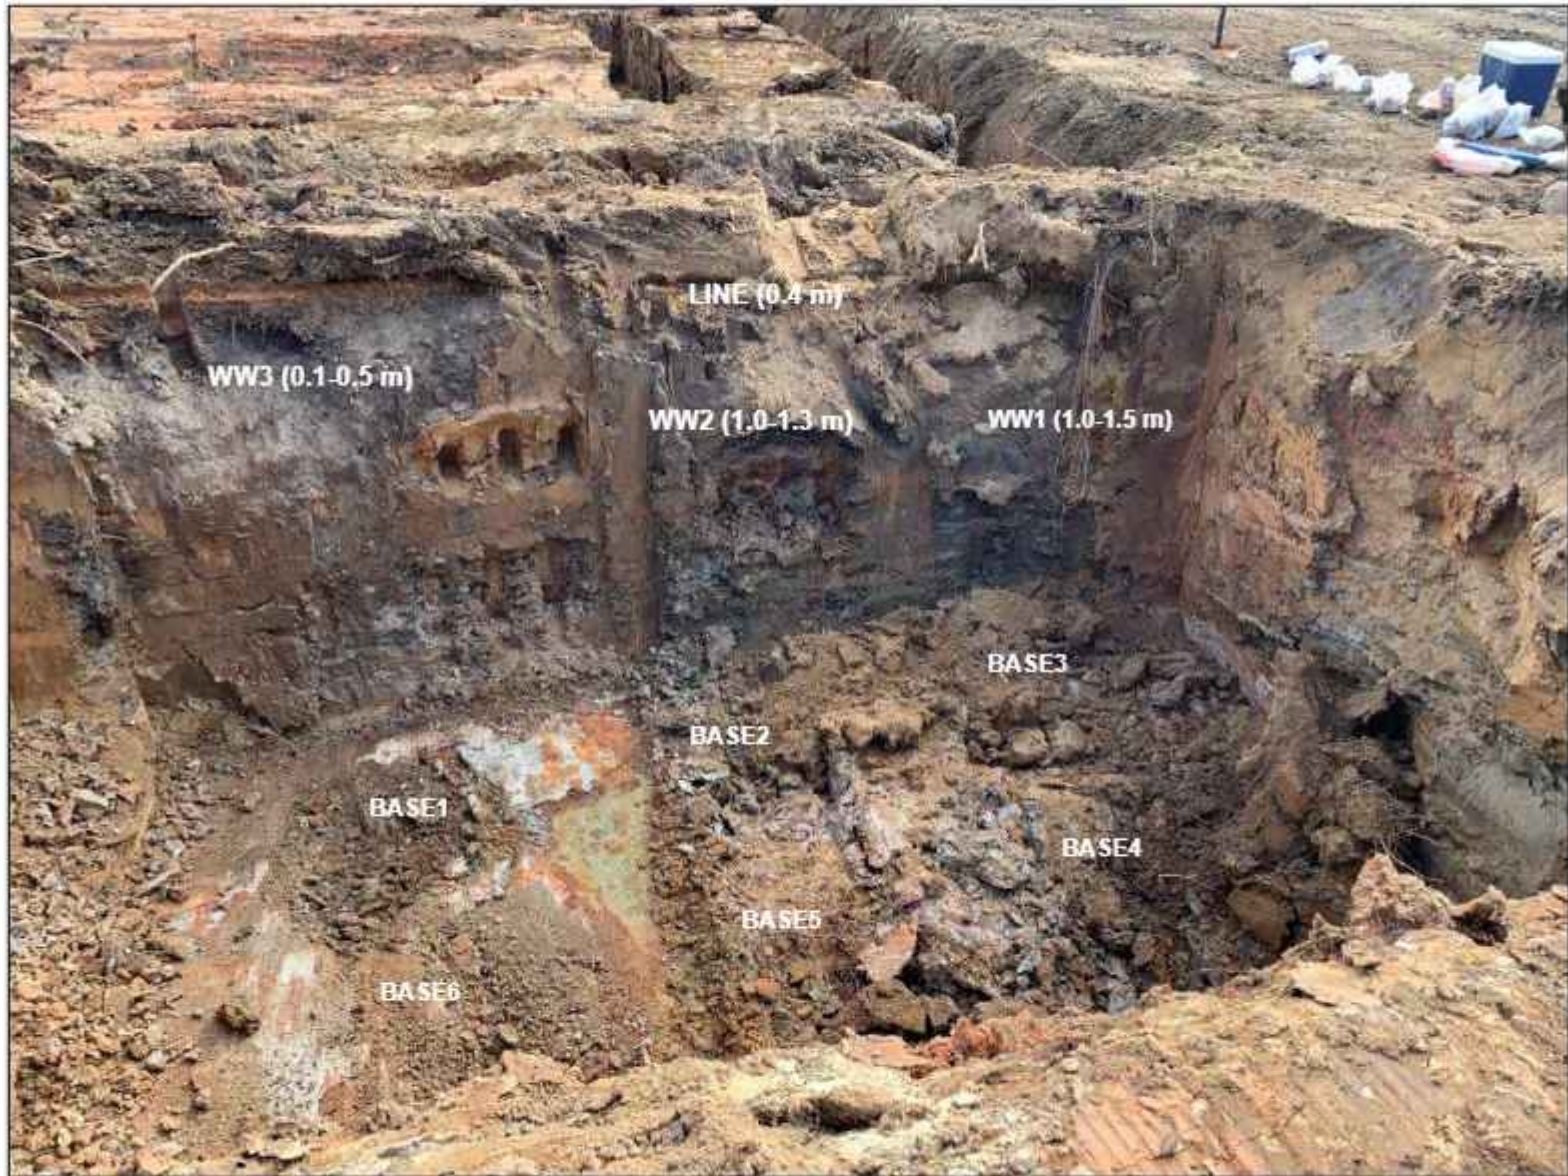
Photograph 2 –  
West wall and  
base (base  
samples 2.4 m)

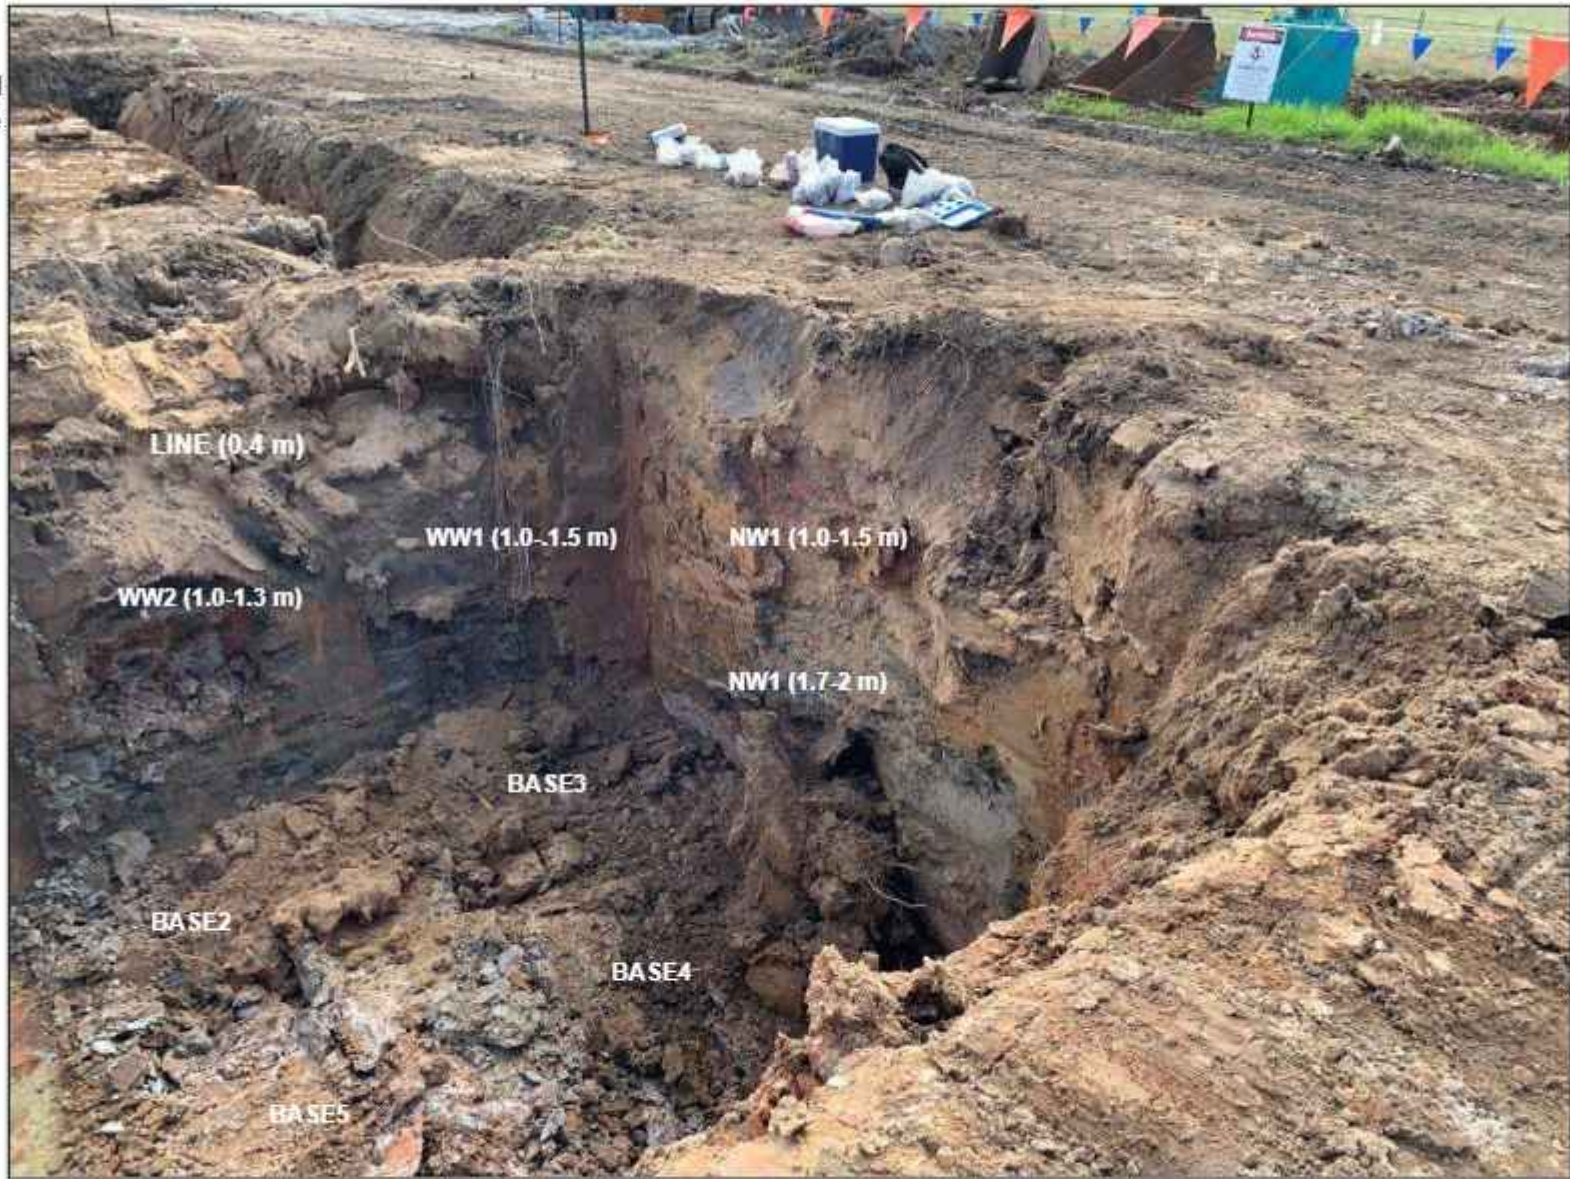
Photograph 3 –  
North Wall,  
partial west wall  
and partial base  
(base samples  
2.4 m)
