Bringelly Services Facility Remediation Action Plan

Sydney Metro Western Sydney Airport Station Boxes and Tunnelling Works

Project number	WSA-200-SBT
Document number	SMWSASBT-CPBG-SWD-SW000-GE-RPT-040520
Revision date	21 October 2022
Revision	A.04

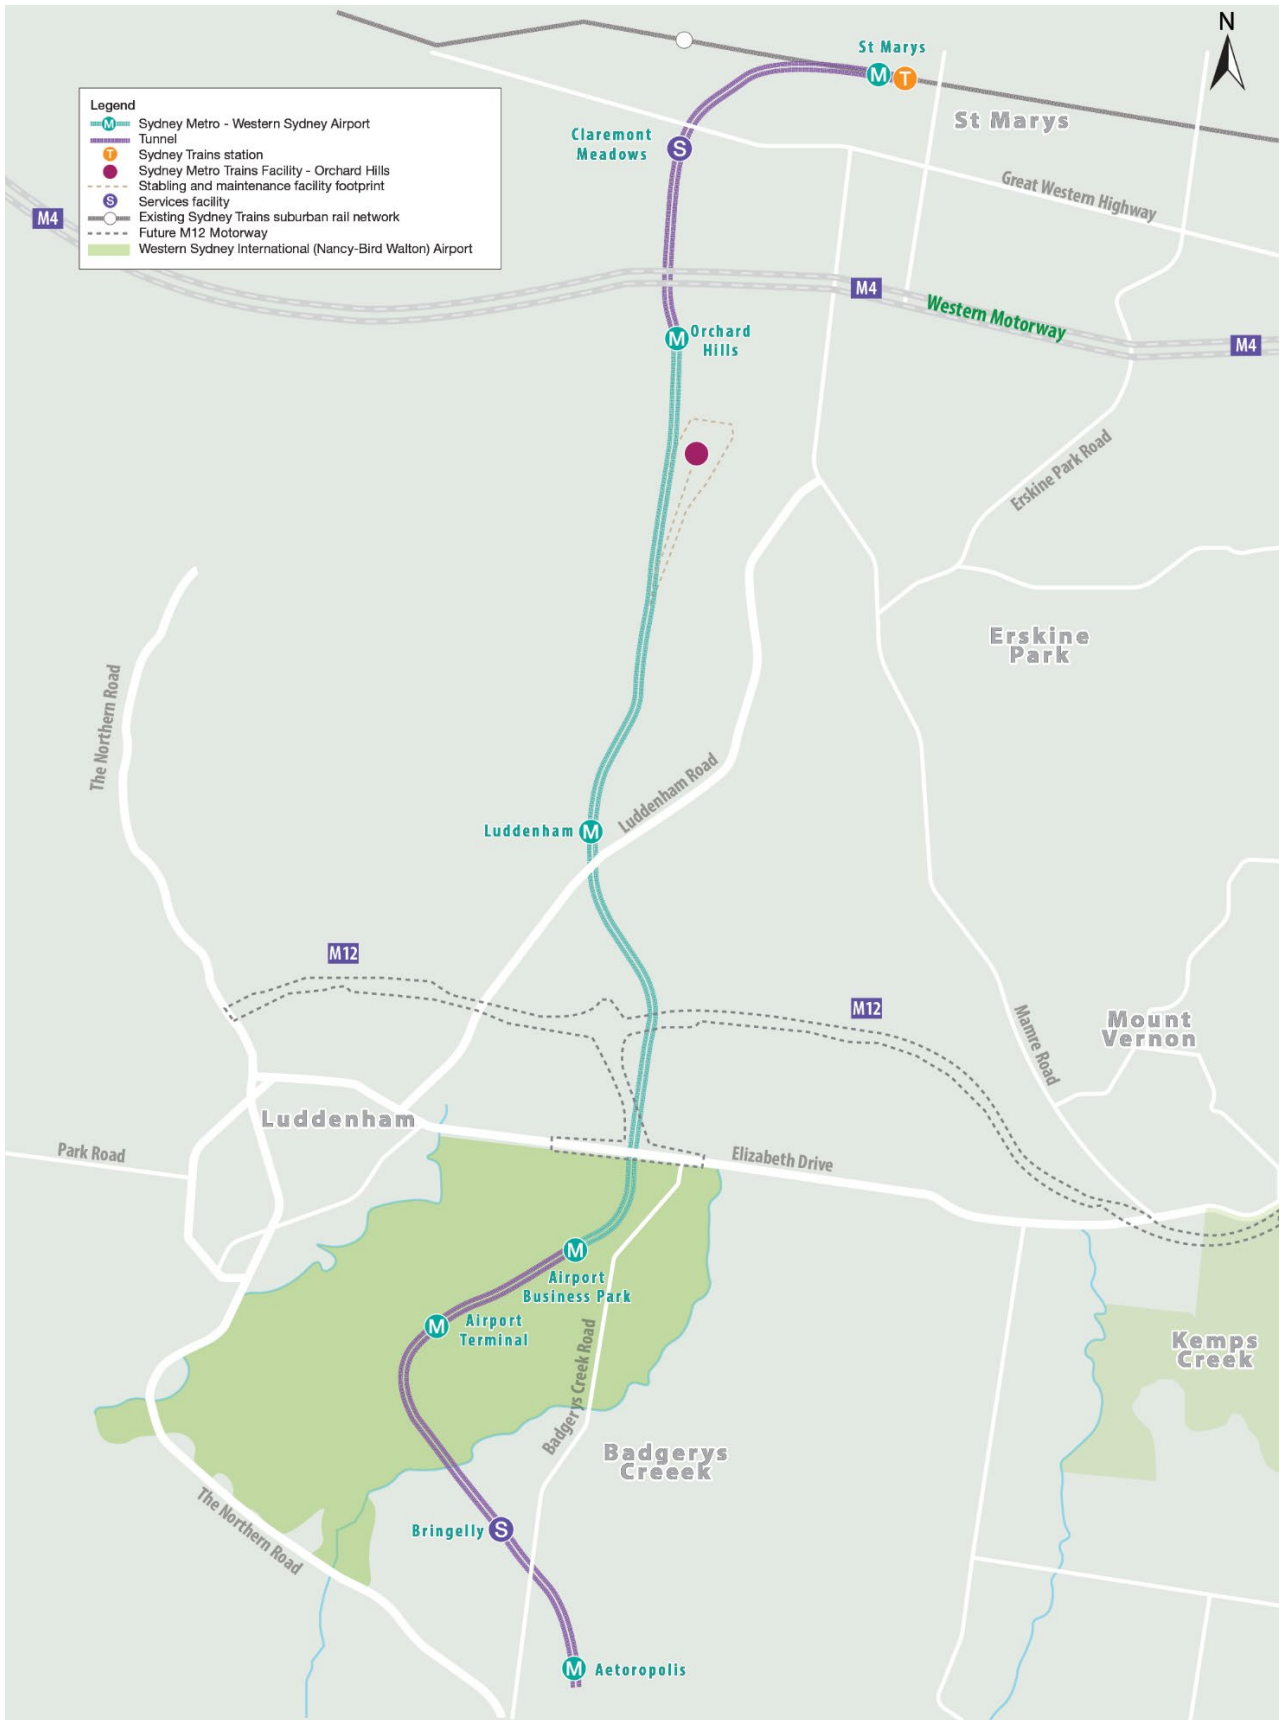
Figure 1.1 Overview of SBT Works

The SBT Works involves the construction and operation of a new 23km metro rail line from the existing Sydney Trains suburban T1 Western Line (at St Marys) in the north and the Aerotropolis (at Bringelly) in the south. The Project includes tunnels and civil structures, including a viaduct, bridges, and surface and open-cut troughs between the two tunnel sections. **Figure 1.1** shows the proposed alignment and key features of the Project.

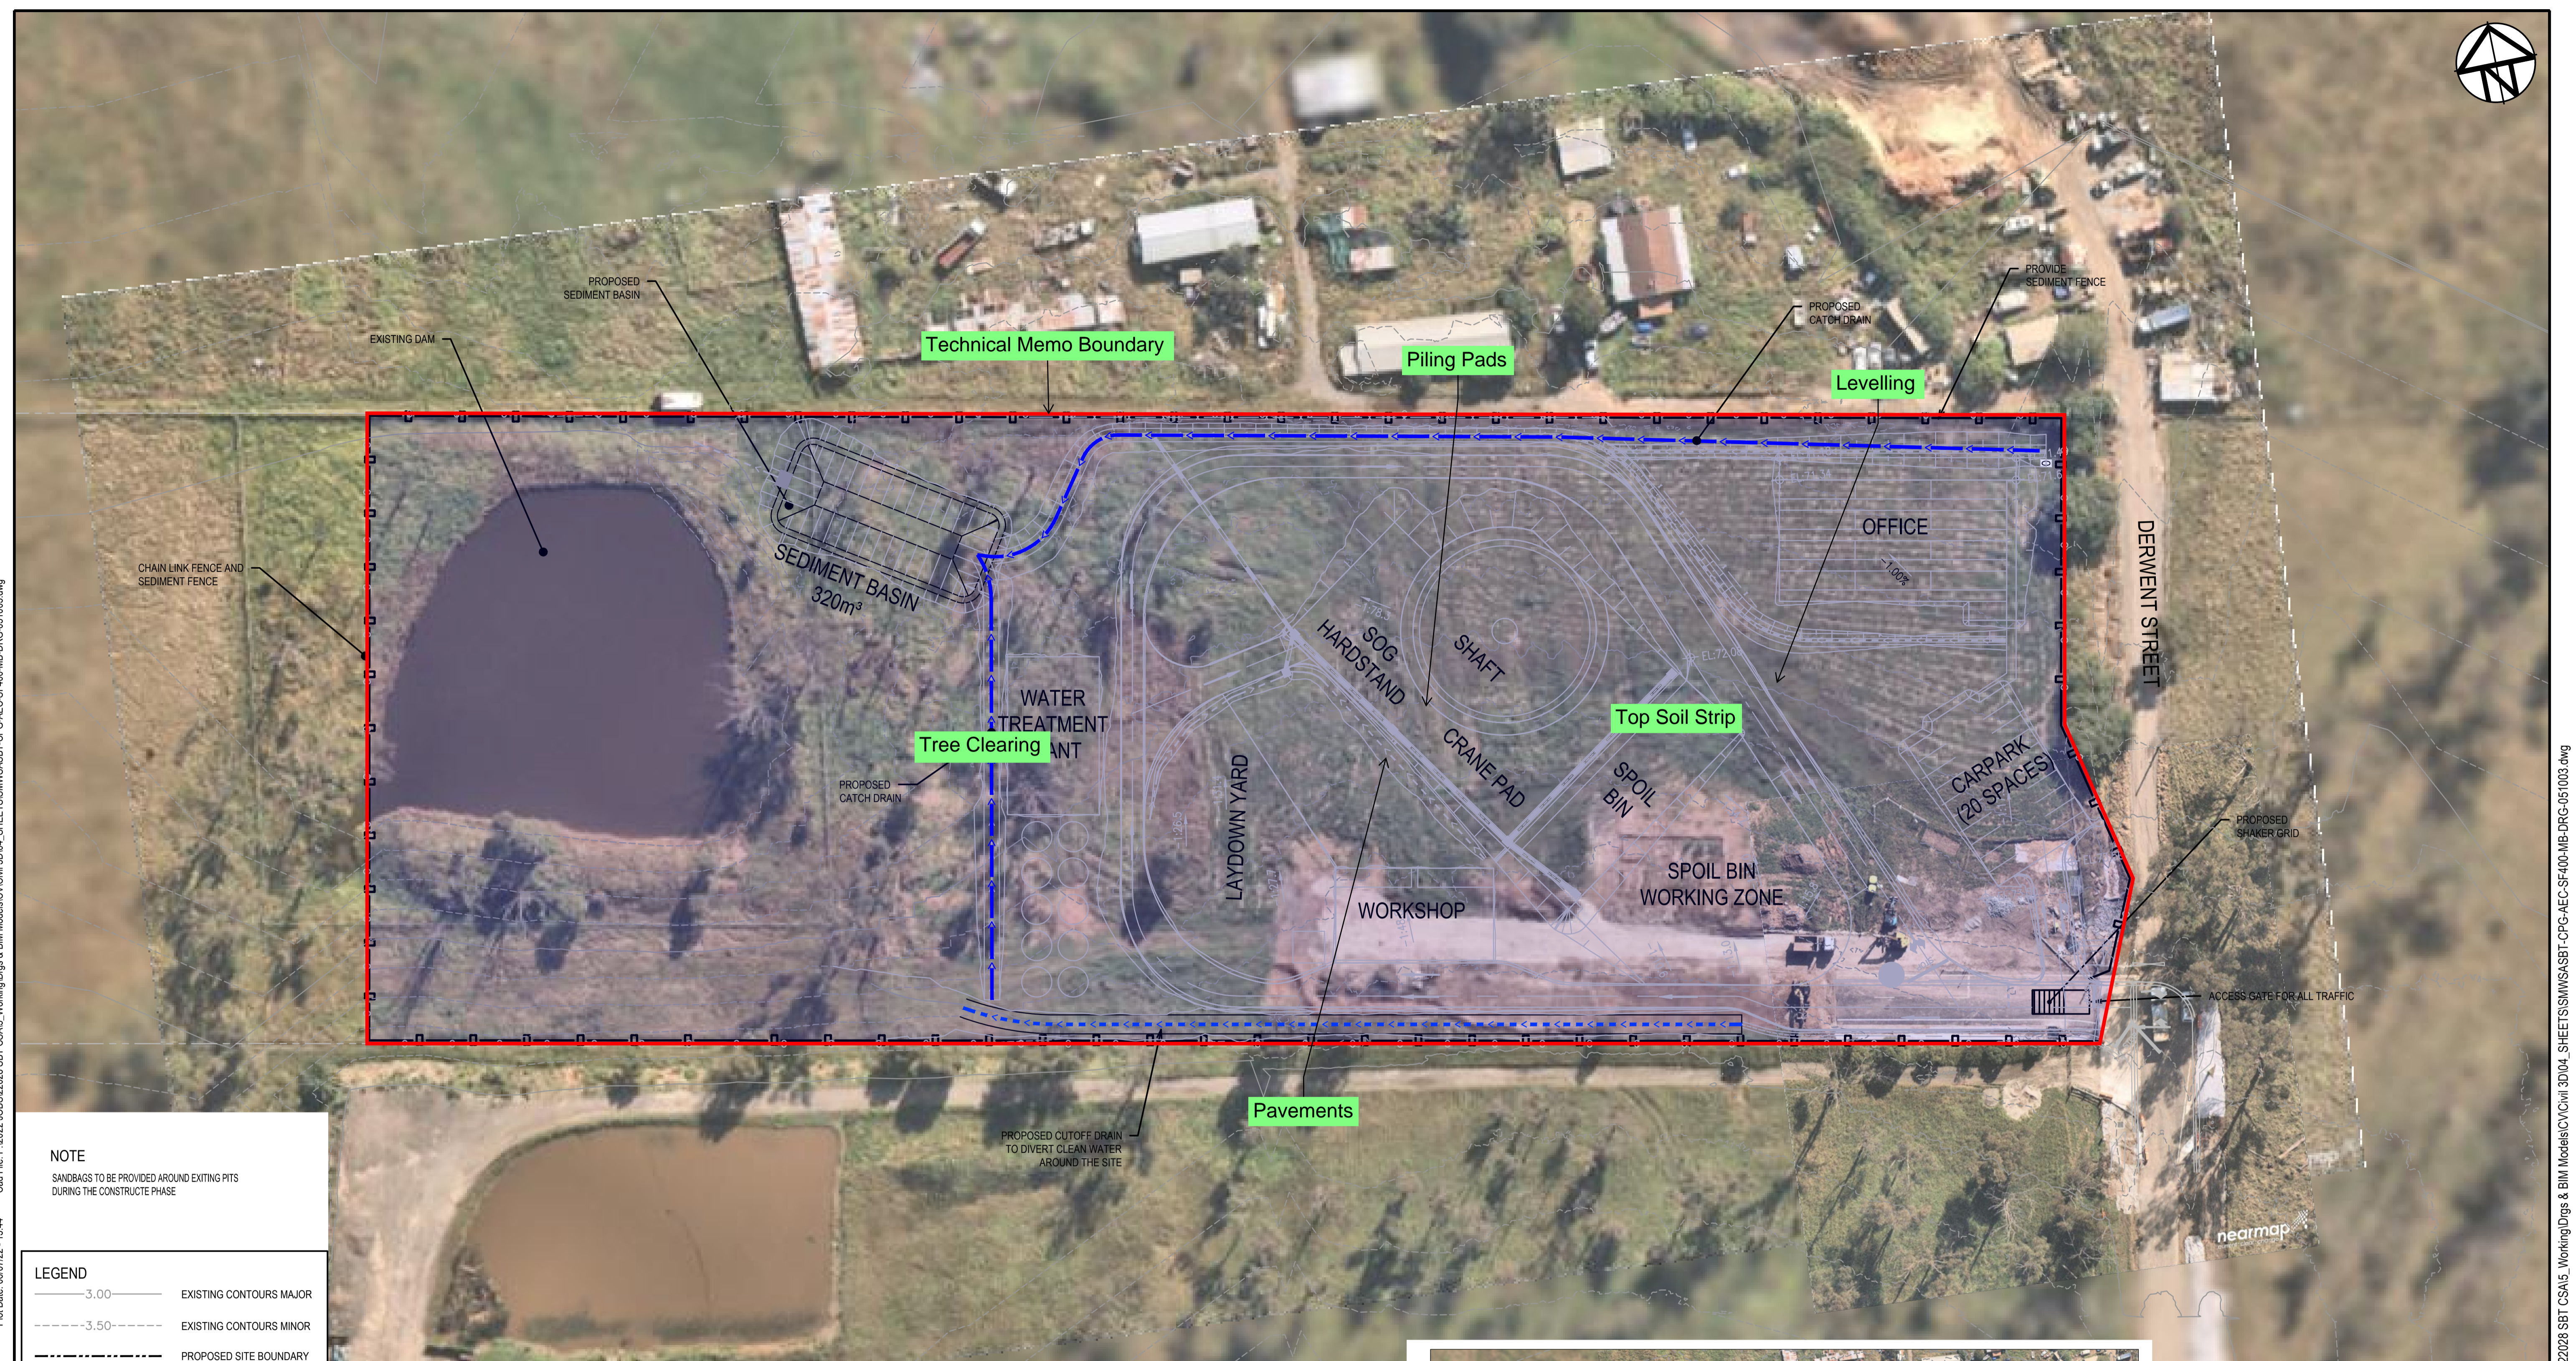
FILE No: -	SHEET: 1 OF 1
STATUS: APPROVED FOR CONSTRUCTION	EDMS No: "EDMS NO"
DRG No. SMWSASBT-CPG-AEC-SF400-MB-DRG-051003	REV 00
	VER 1.1

The proposed layout of the site during construction is provided in Drawing SMWSASBT-CPBG-AEC-SF400-MB-DRG-051003 (Rev. 00; Version 1.1) provided in **Appendix 1**. Construction of the site for the SBT Works includes the following:

NOTE
SANDBAGS TO BE PROVIDED AROUND EXITING PITS DURING THE CONSTRUCTIVE PHASE

- Construction of a shaft which has a diameter of 27 m in the centre of the site. Construction of the shaft will require a top-down excavation to approximately 30 mbgs / approximately 42.5 m AHD and generate approximately 22,200 m³ of spoil (as in-situ volume) which requires off-site disposal. The shaft is to be undrained (tanked) and constructed using secant piles and top-down excavation methods.

- Construction of temporary construction work facilities including:
 - Water treatment plant
 - Crane pad and associated hardstands around the shaft
 - Laydown areas

- Workshop
 - Offices and car parks
 - Substation.
- Construction of the temporary works areas will require clearing and grubbing of vegetation and surface soils. It is intended that soil materials stripped for the construction of the temporary works will be stockpiled in the northern portion of the site (and north of the existing dam) for subsequent reuse on-site post construction. Materials which cannot be reused on-site will be removed from site as waste, or beneficially reused as fill at the WSA FS01 site (refer to Section 1.2.3).
