**Remediation Action Plan –  
1 - 17 Gipps Street Claremont Meadows NSW**

Environmental Earth Sciences NSW was engaged by Road & Rail Excavations Pty Ltd (Road & Rail) on behalf of CPB Contractors-Ghella Joint Venture (CPBG) to prepare this remediation action plan (RAP) for 1-17 Gipps Street, Claremont Meadows, NSW (the “site”).

The site is being used to support the delivery of the Sydney Metro – Western Sydney Airport (SM-WSA) Station Boxes and Tunnels (SBT) project (the “project”).

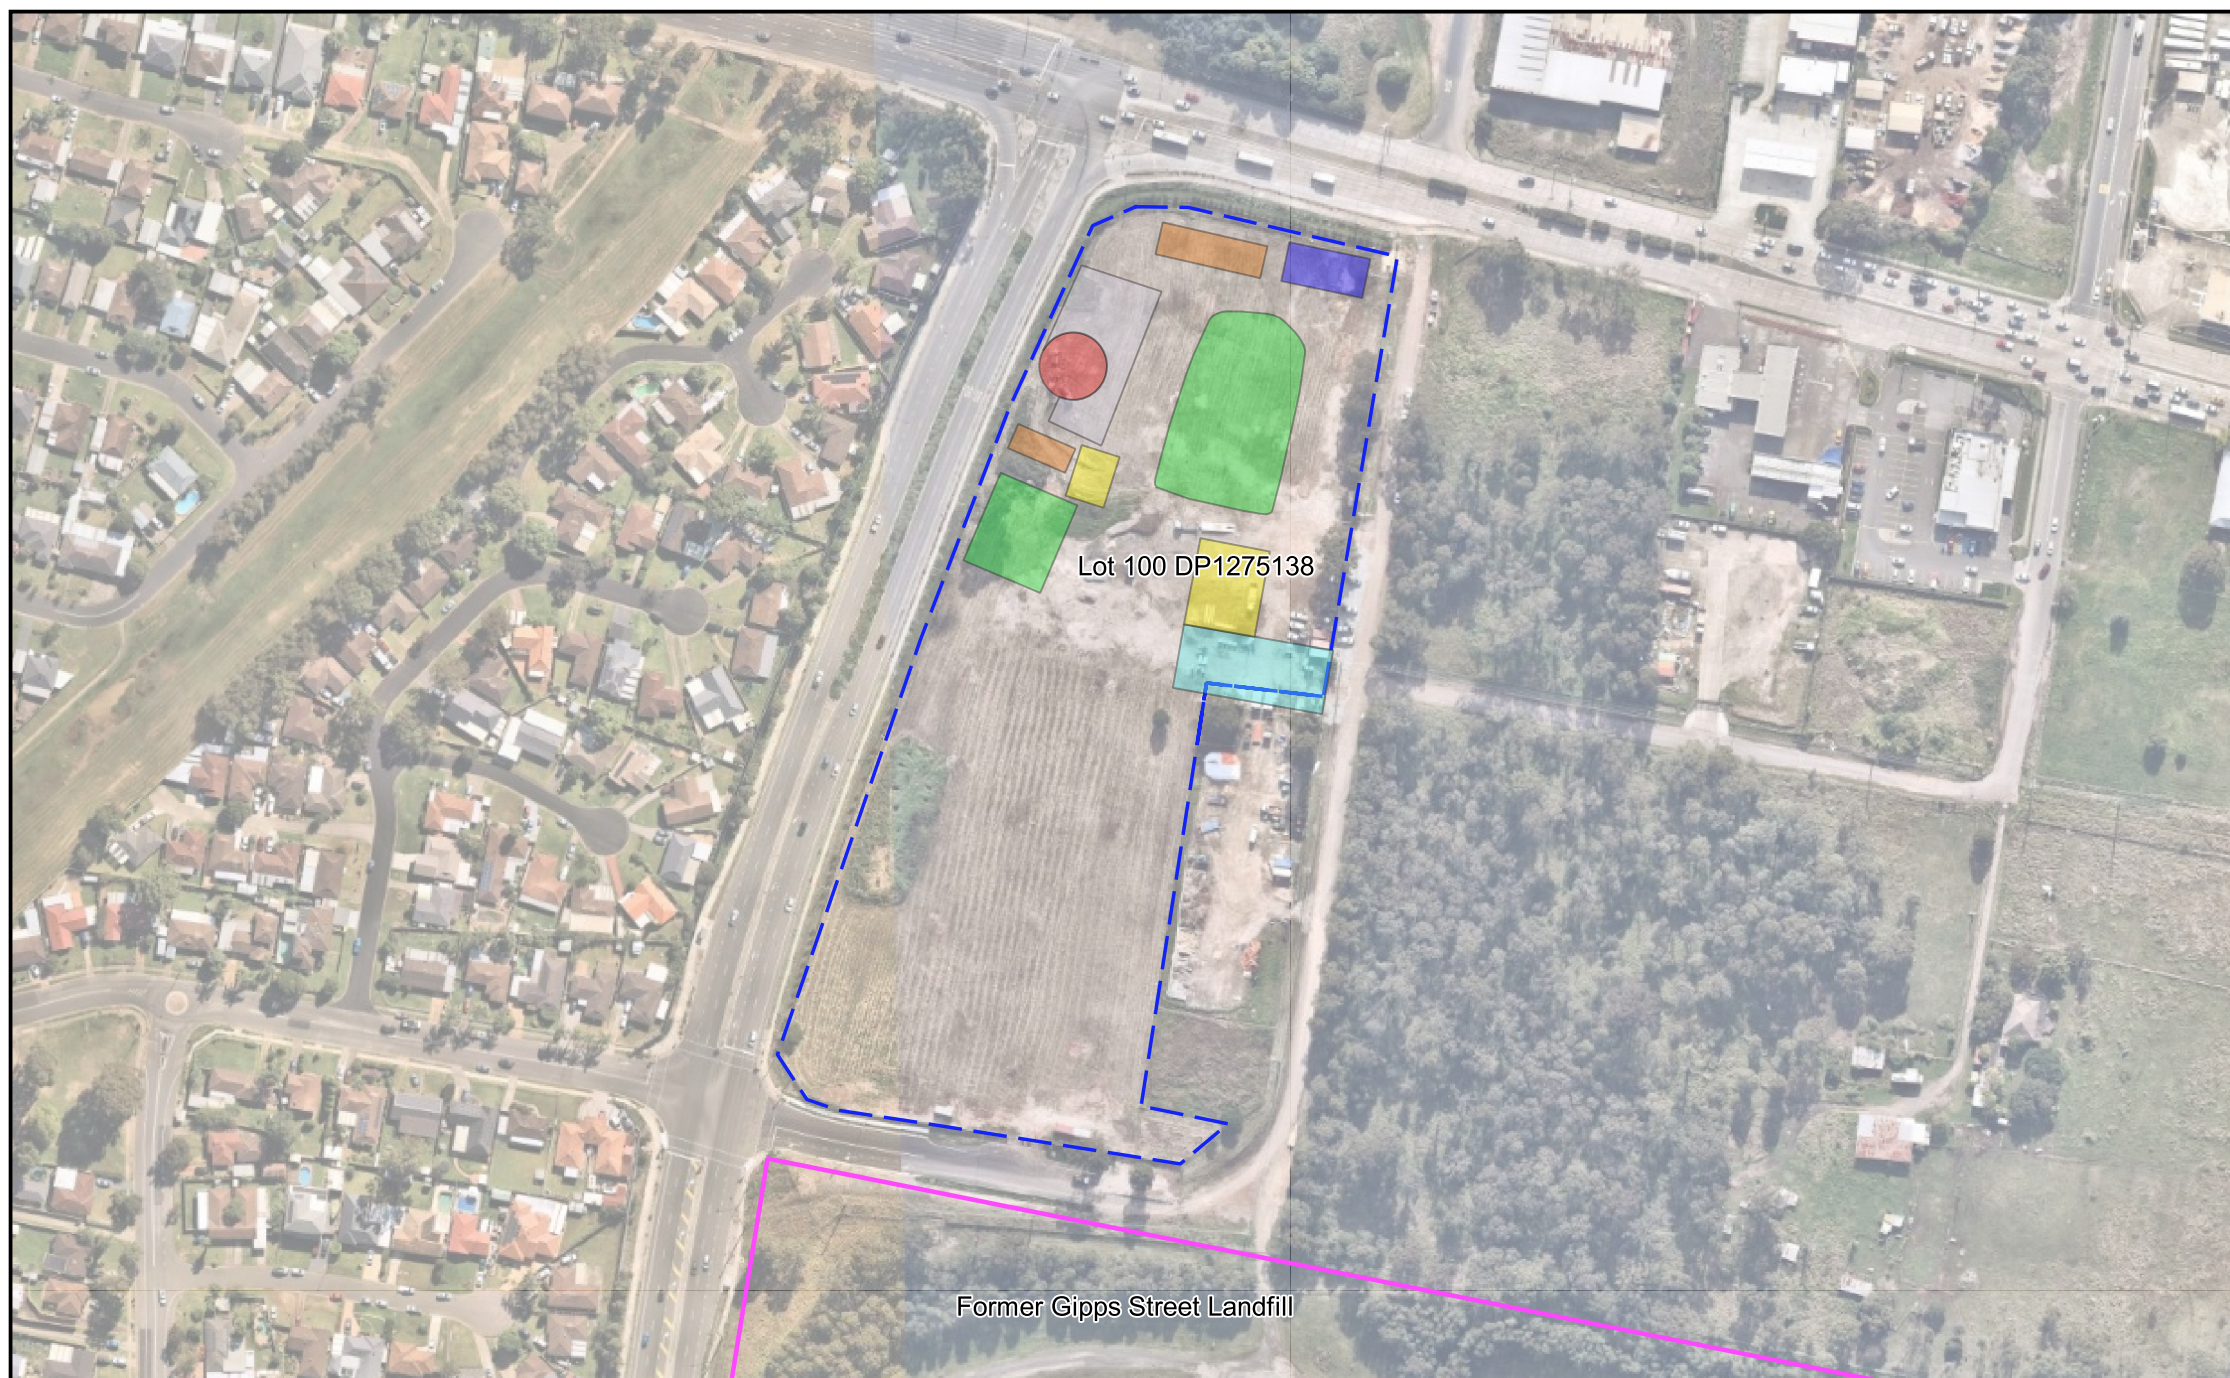
**Figure 2**

Title: Proposed Site Layout	
Client: Road and Rail Excavations	
Scale: As Shown	Job No: 122045
Date: August 2022

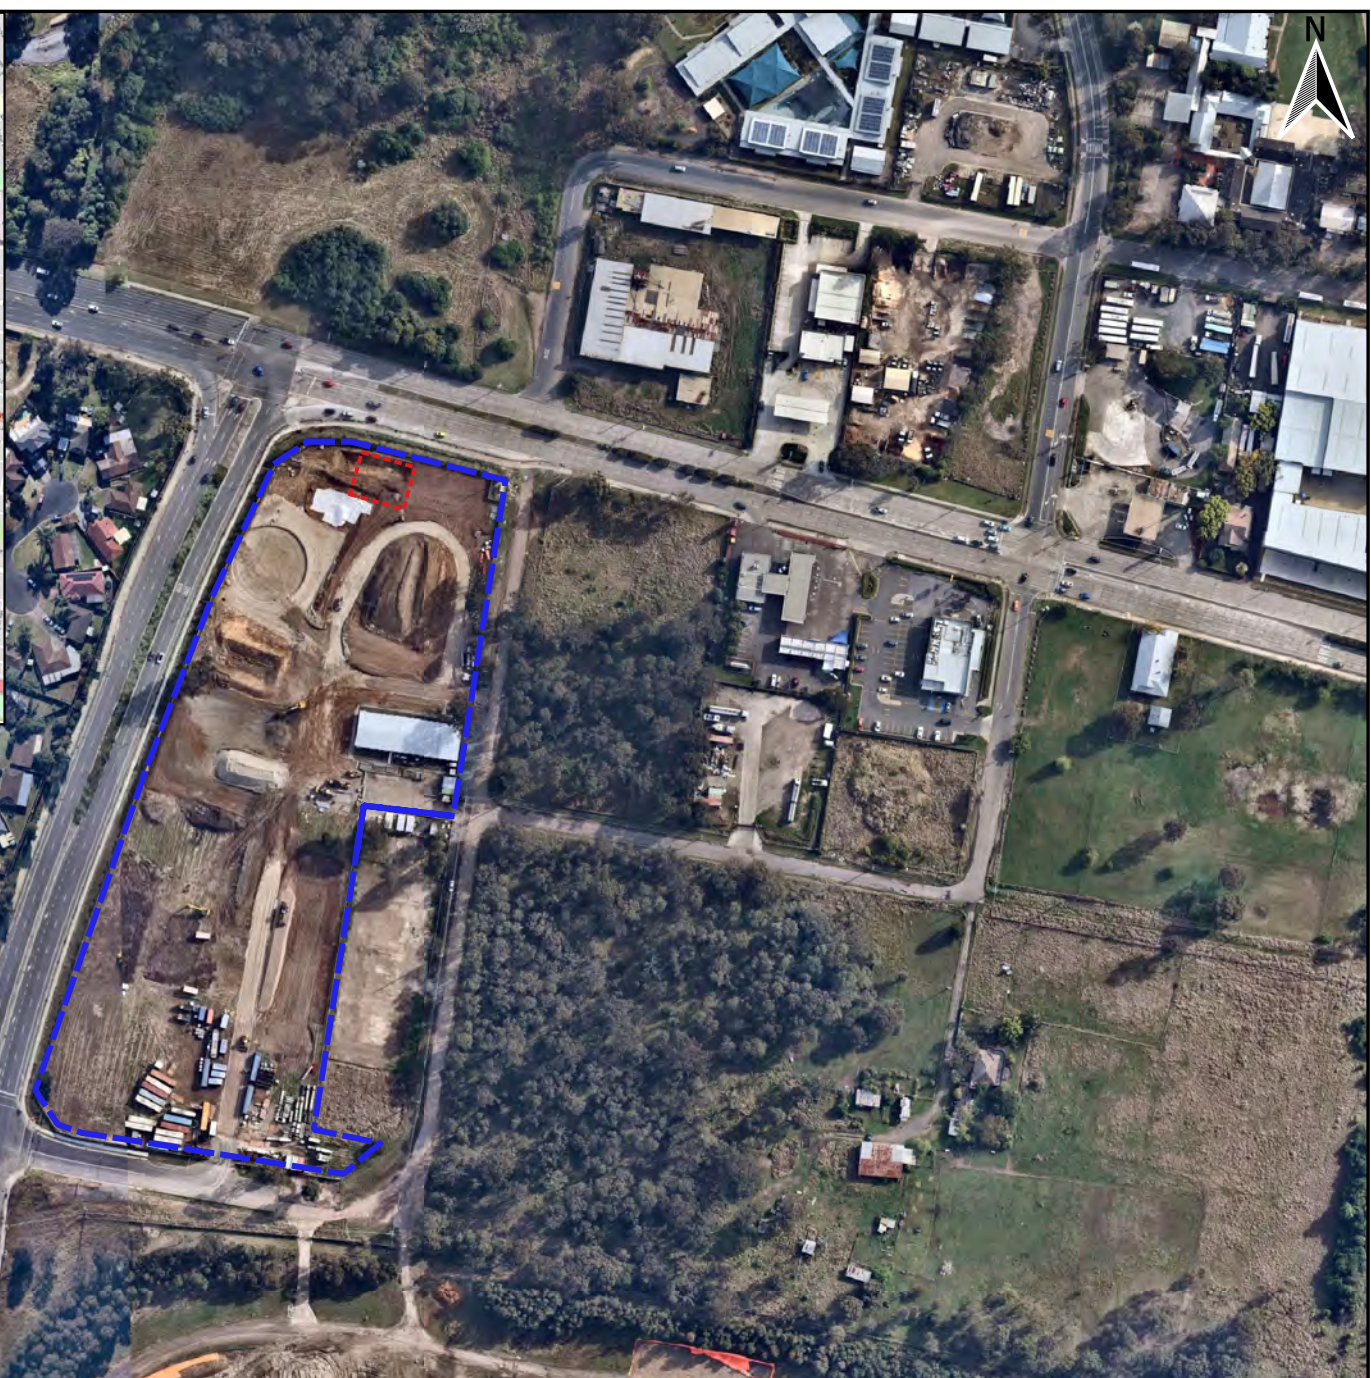
Figure 2

- Area of concern (AOC) - Approximate footprint of potential historical service station
- Site boundary

The intrusive investigation was completed on 9 September 2022 with six boreholes (IDs: BH1 – BH6) advanced using a 350 mm diameter auger mounted on an excavator. The location of boreholes is presented in **Figure 2** and were advanced as follows:

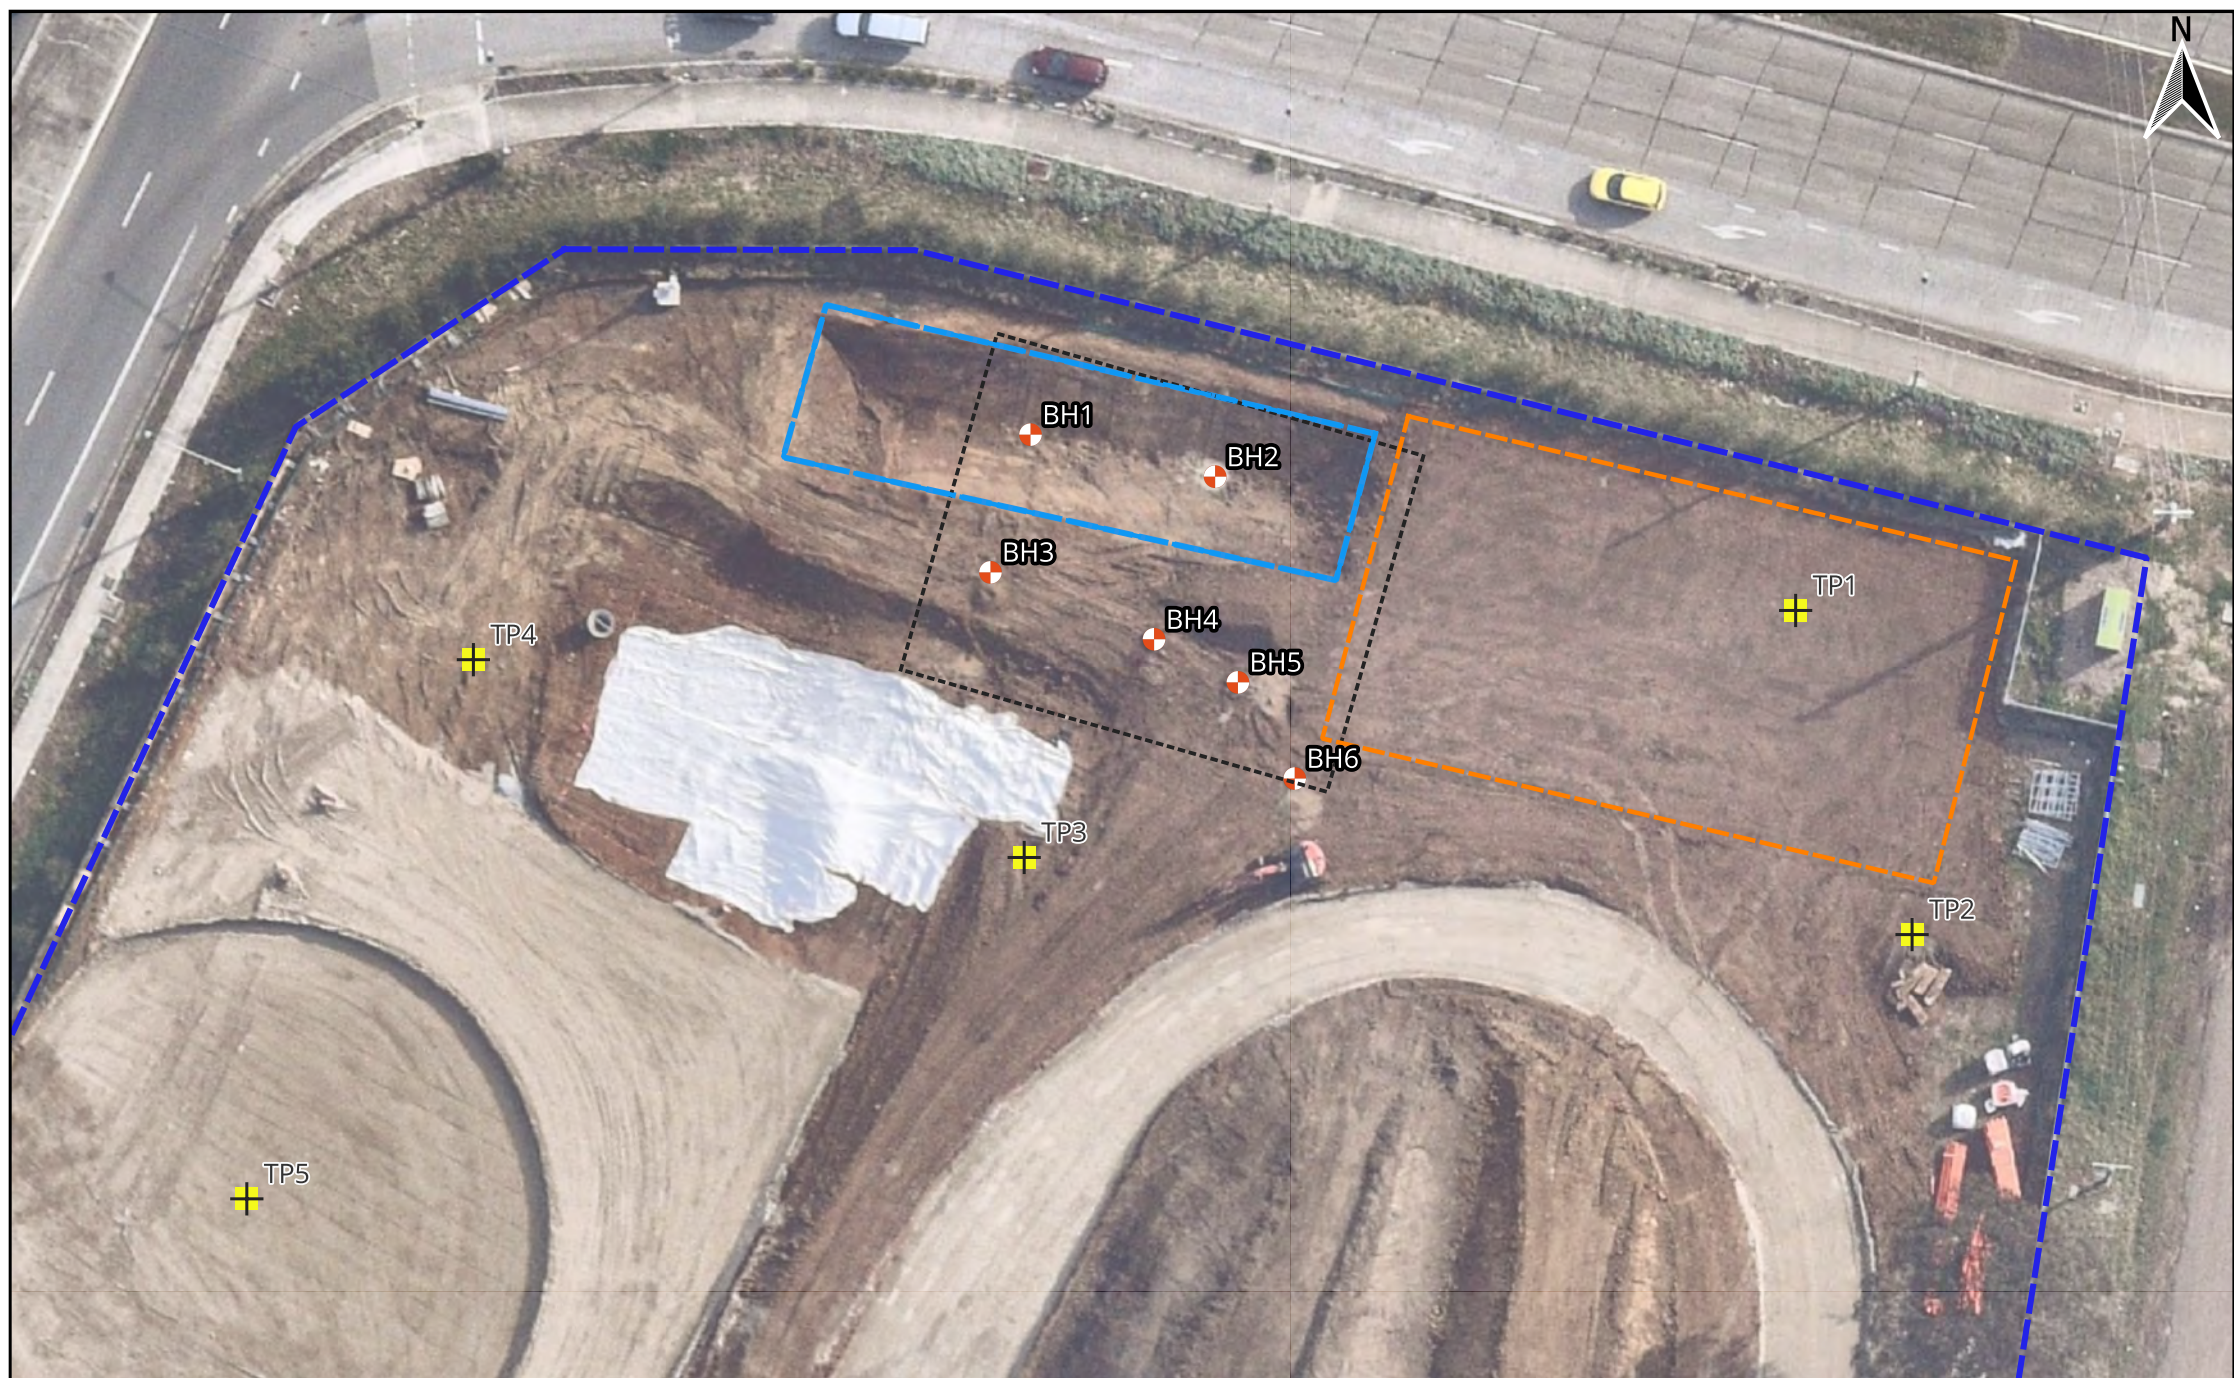
Legend	
	Borehole locations - Data gap investigation
	Test pit locations (EES, Mar 2022)
	Approximate footprint of potential historical service station
	Trench
	Location of proposed water treatment plant
	Site boundary
