Site Audit Report and Site Audit Statement – Claremont Meadows Service Facility

Sydney Metro Western Sydney Airport Station Boxes and Tunnelling Works

SITE AUDIT REPORT

CLAREMONT MEADOWS SERVICES FACILITY SBT WORKS, SYDNEY METRO WESTERN SYDNEY AIRPORT

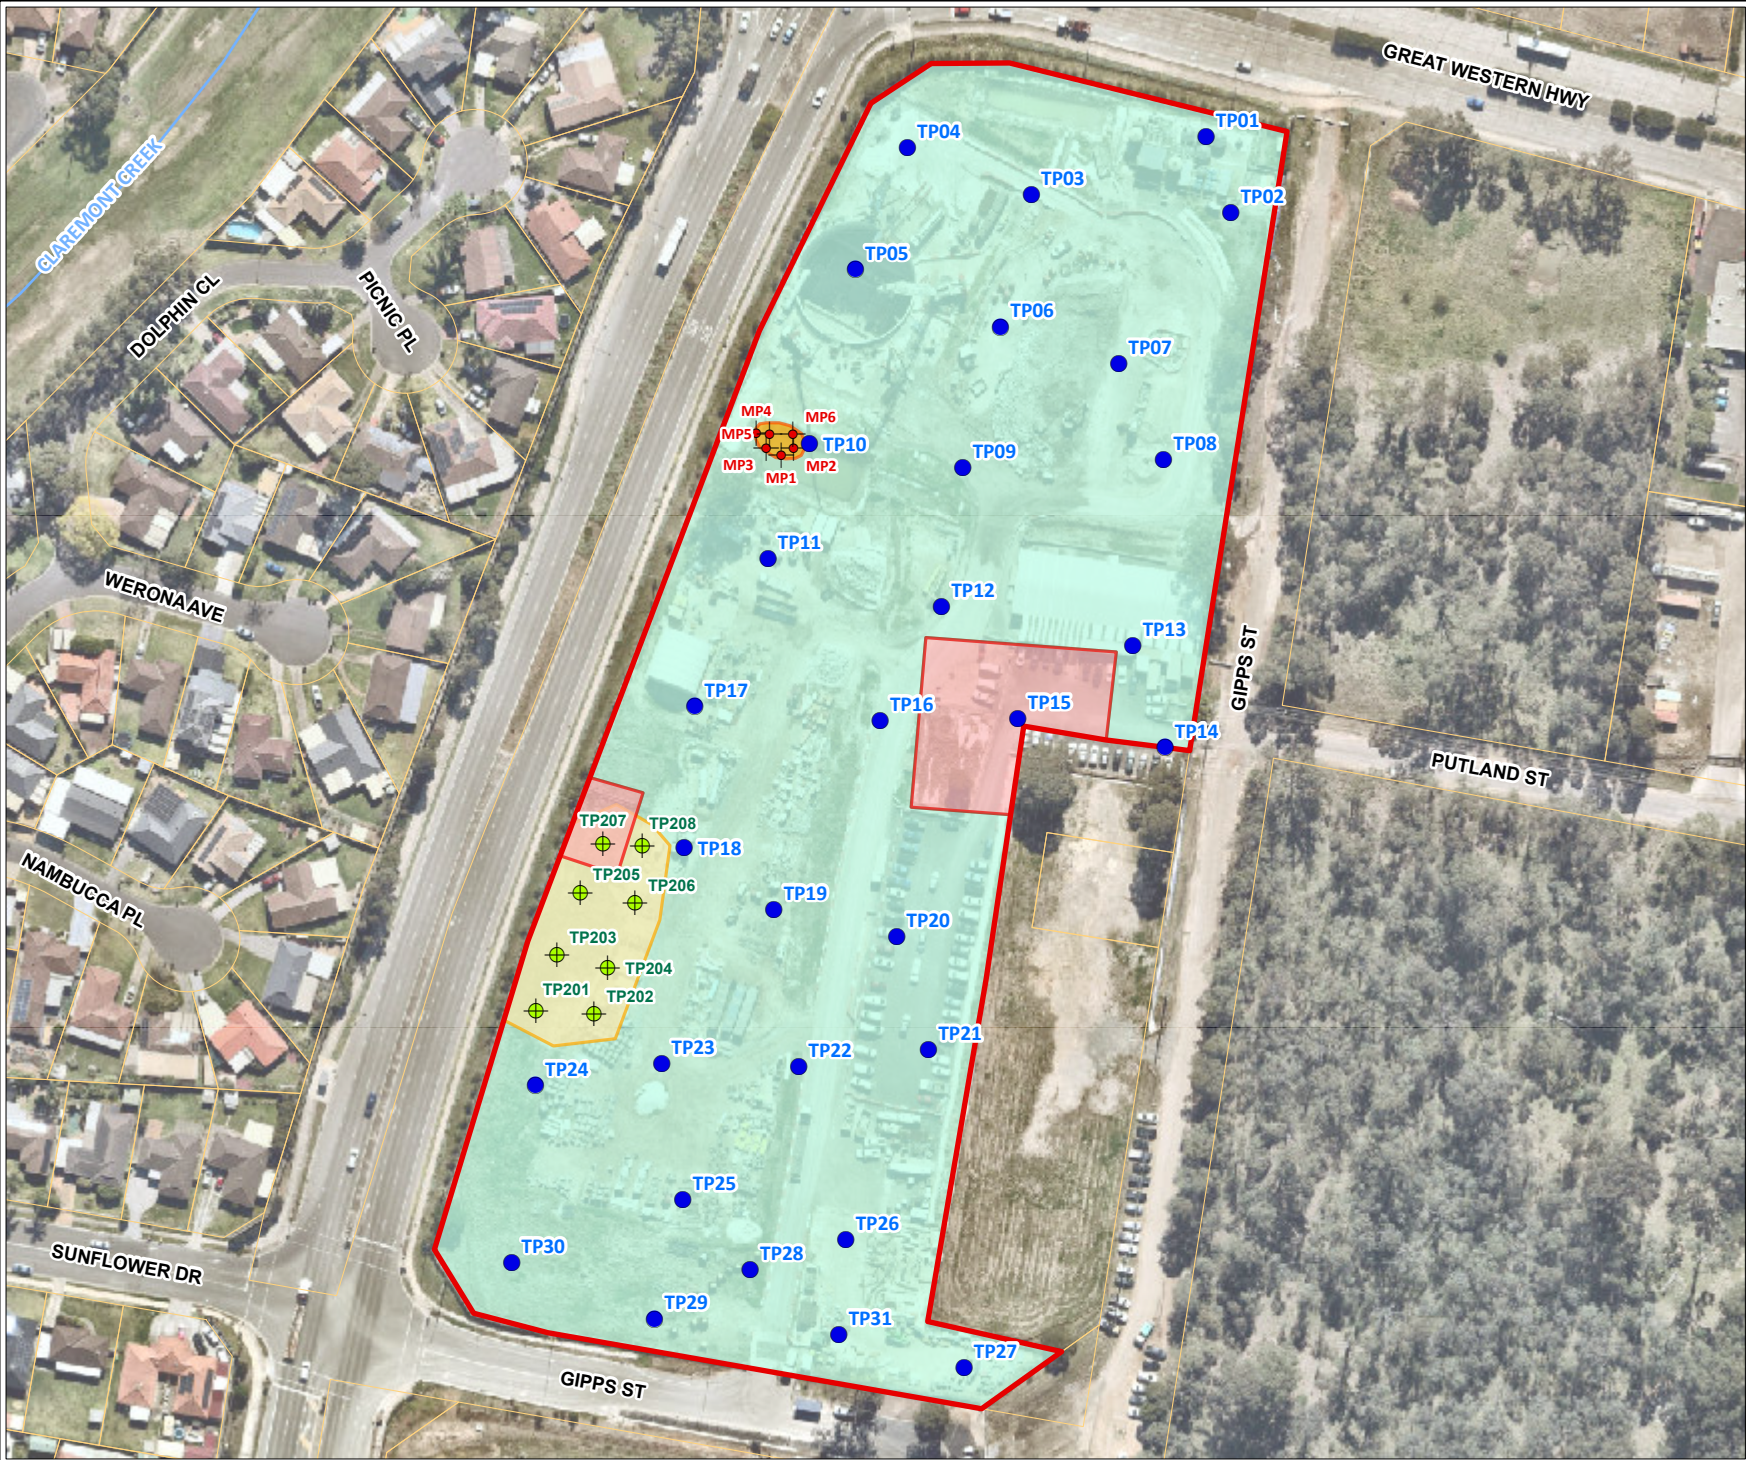
FIGURE 3

Job No: 63723	
Client: CPB Contracting	
Version: R13 Rev A	Date 11/09/2024
Drawn By: IA	Checked By: EH
Scale 1:1,800	
Coord. Sys. GDA 1994 MGA Zone 56	
1-17 Gipps Street Claremont Meadows, NSW	
SAMPLE LOCATIONS AND WASTE CLASSIFICATION AREAS

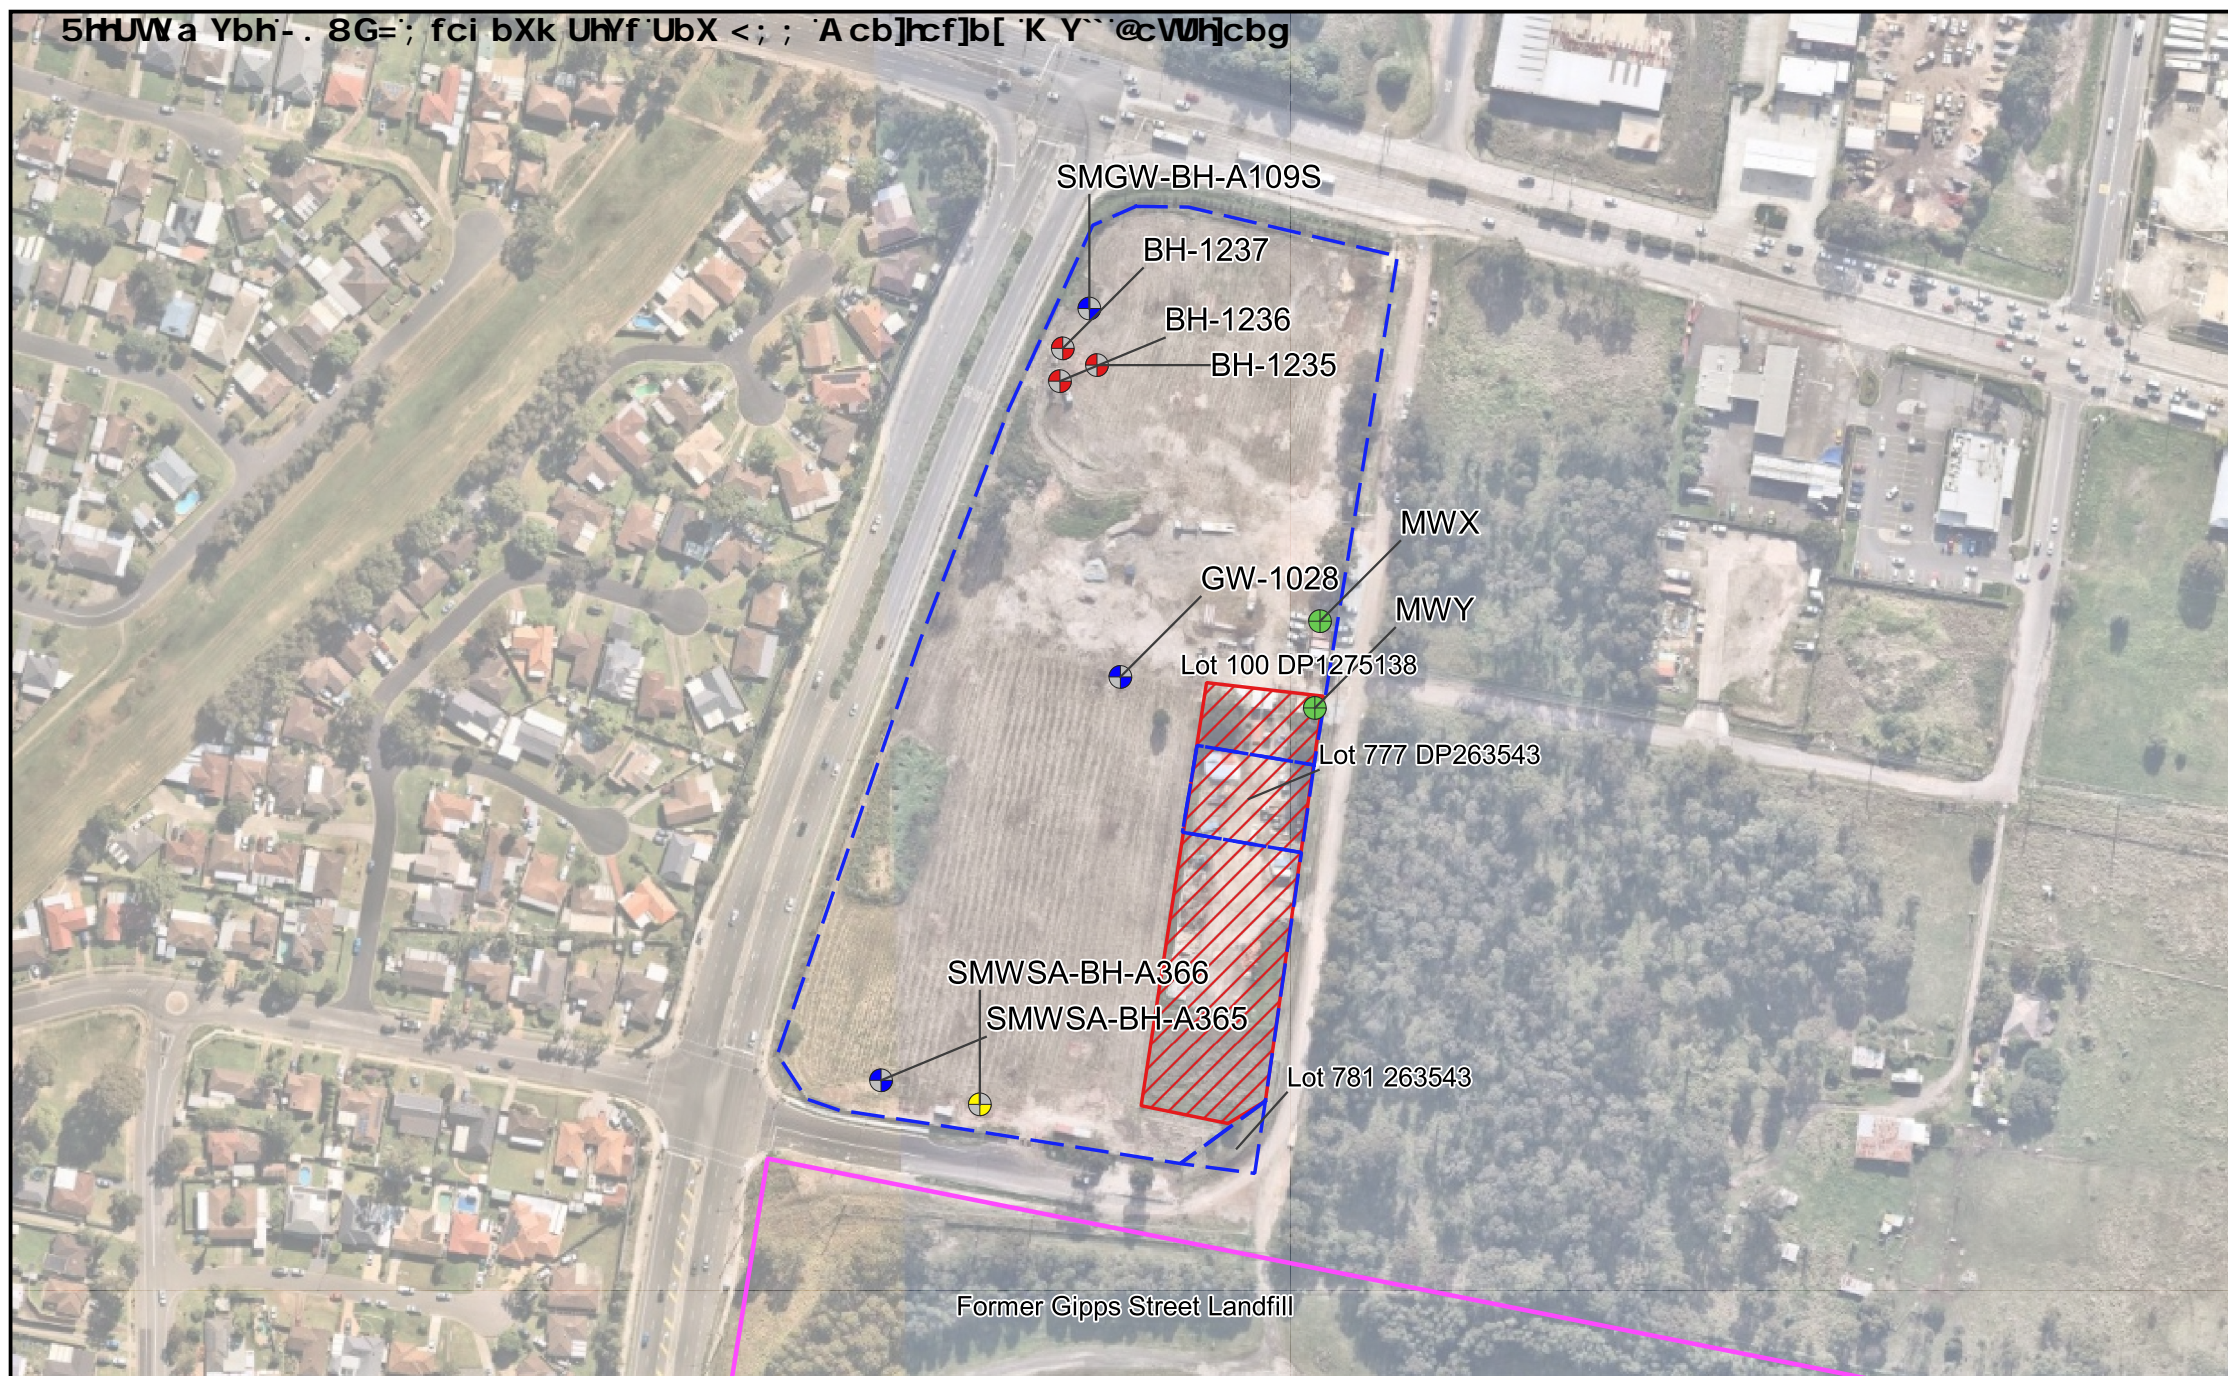
- Site Boundary
- Excluded Area
- Groundwater Bore
- Soil/ Rock Bore
- Gas Bore
- Unknown Bores
- Former Gipps Street Landfill (approximate)

EES recommended that an assessment of HGG is undertaken in accordance with NSW EPA (2020b) and as a result undertook the HGGRA. The HGGRA included installation of four soil gas boreholes (GBH1 to GBH4) to maximum depths of approximately 4.15 mbgl along the southern boundary of the site, closest to the offsite former Gipps Street Landfill (**Attachment 8, Appendix A**). HGG monitoring was undertaken in one location (GBH1) using a Ambisense GasFlux continuous monitoring system which recorded concentrations of gases (methane, carbon dioxide, oxygen, carbon monoxide, hydrogen sulfide), barometric pressure and borehole flow at approximately 1-hour intervals for a total duration of 30 days (16 January 2023 to 16 February 2023). A summary of the Ambisense results is provided in Figure 5.1 of IAA15 in **Appendix C**. EES noted that from approximately 1:13 am 18 January 2023 to approximately 12:15 am 20 January 2023 no readings were collected by the unit due to a technical issue (server issue), however EES noted that there was no impact on the subsequent data collected and no calibration was required. Graphic representation of the dataset across the monitoring period is included as Attachment 4 of IAA15 in **Appendix C**. In addition, two existing groundwater wells (SM-WSA-BH-A365 and GW-1028) were sampled for dissolved gases C₁-C₄ (methane, ethene, ethane, propene, propane, butene, butane). The results were less than the laboratory detection limit.

The Cessation Letter included a consolidated data set review from six locations (GAS 5, GAS 6 and GBH1 to GBH4) obtained from Douglas and EES spanning from 30 March 2017 to 6 September 2023. This data was considered by EES to be representative of ground gas conditions to the north of the former landfill. Review of the data indicates that the methane and carbon dioxide concentrations were fairly consistent over time and between wells, with some minor variability. Methane concentrations appeared relatively low while carbon dioxide concentrations were elevated in the monitored boundary wells (and were typically greater than carbon dioxide concentrations found in BH103 located within the landfill).

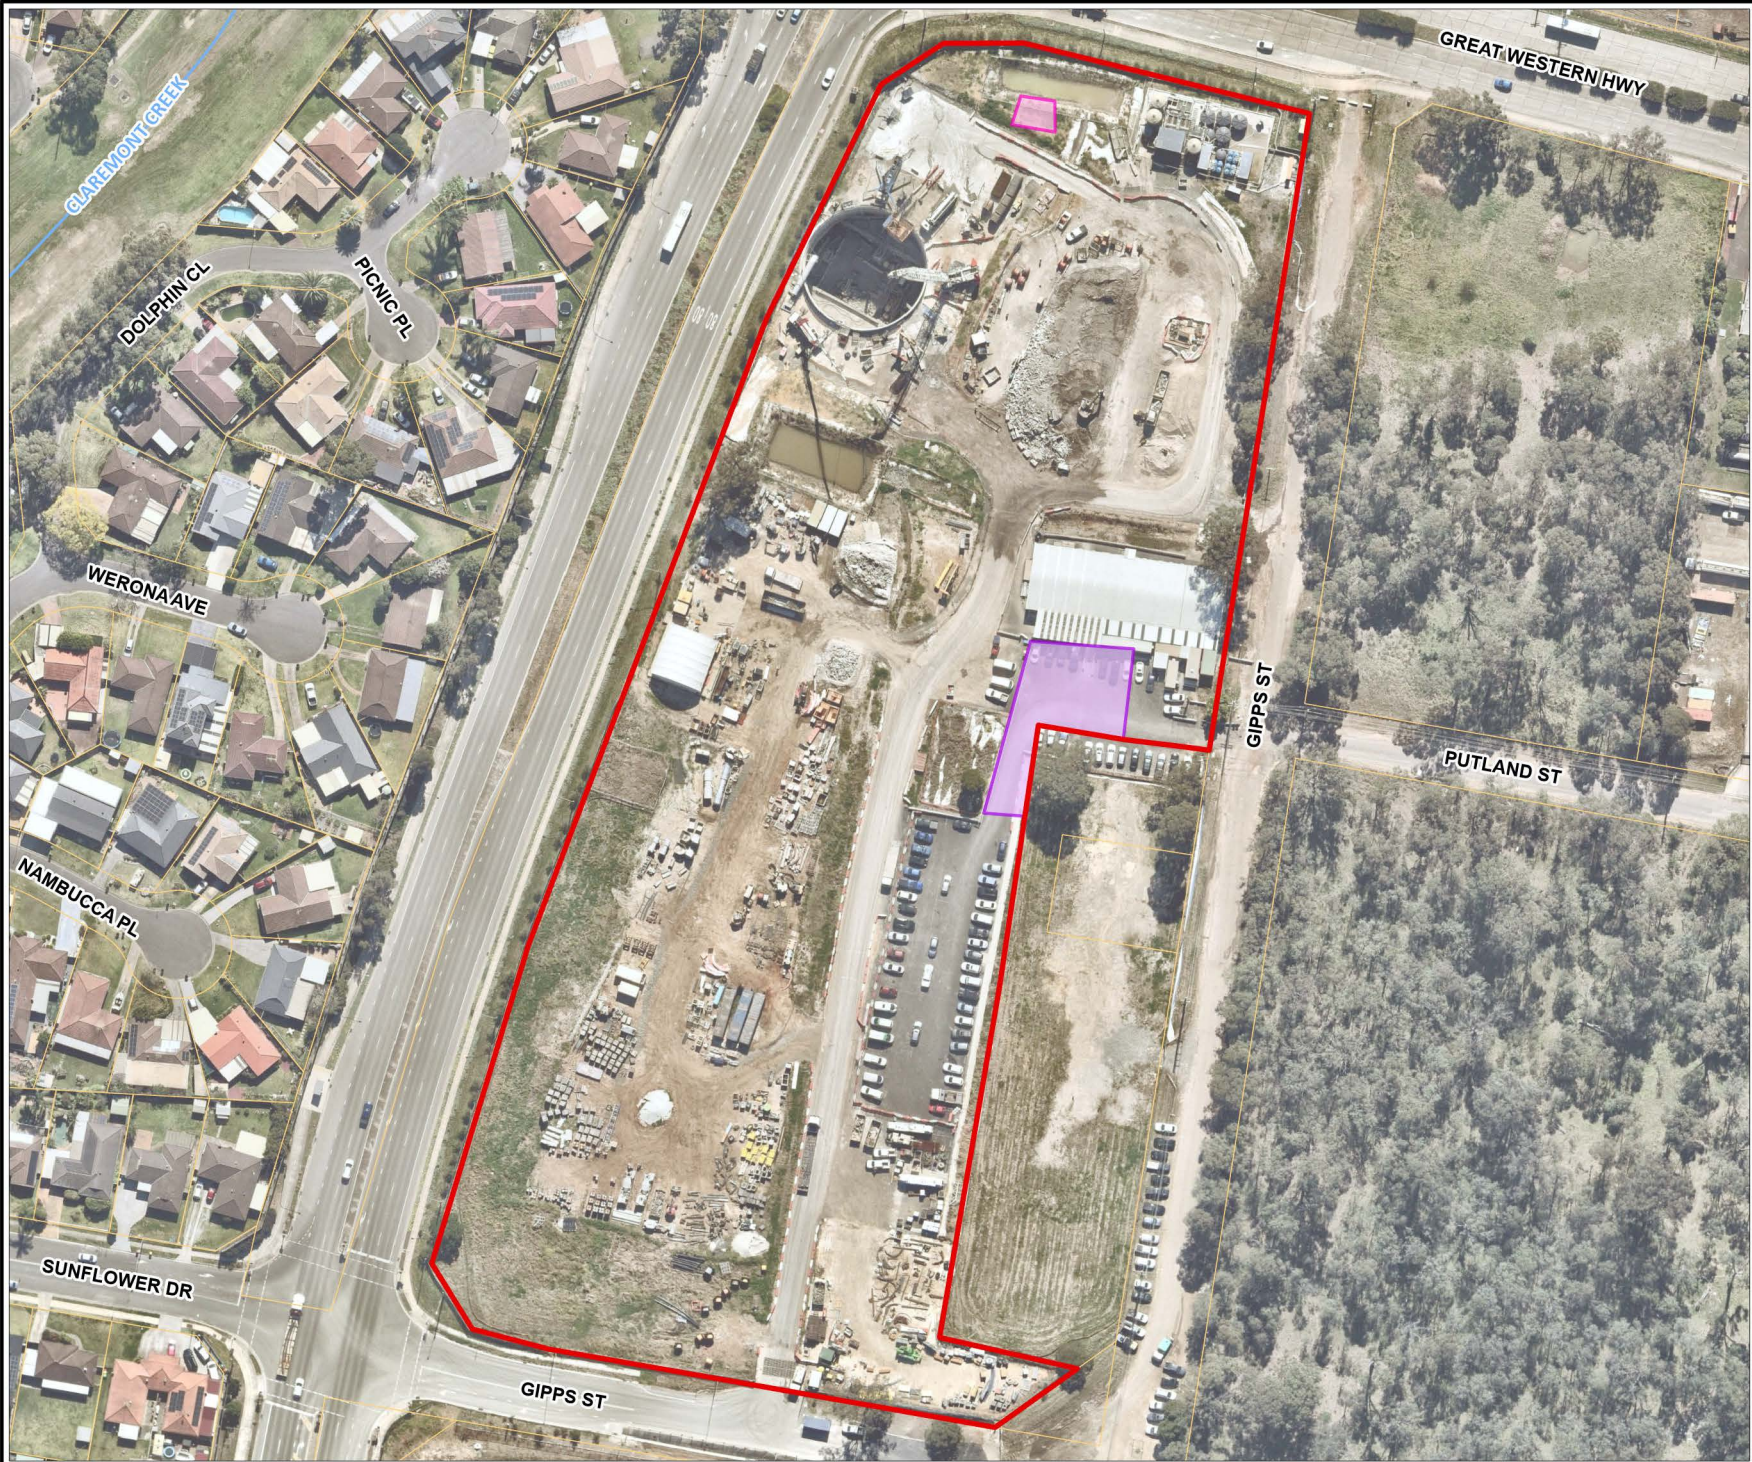
Attachment 10: Location of Unexpected Finds

- Legend
- Approximate Site Boundary
 - Unexpected Finds
 - Car Park CMSF
 - North Area CMSF

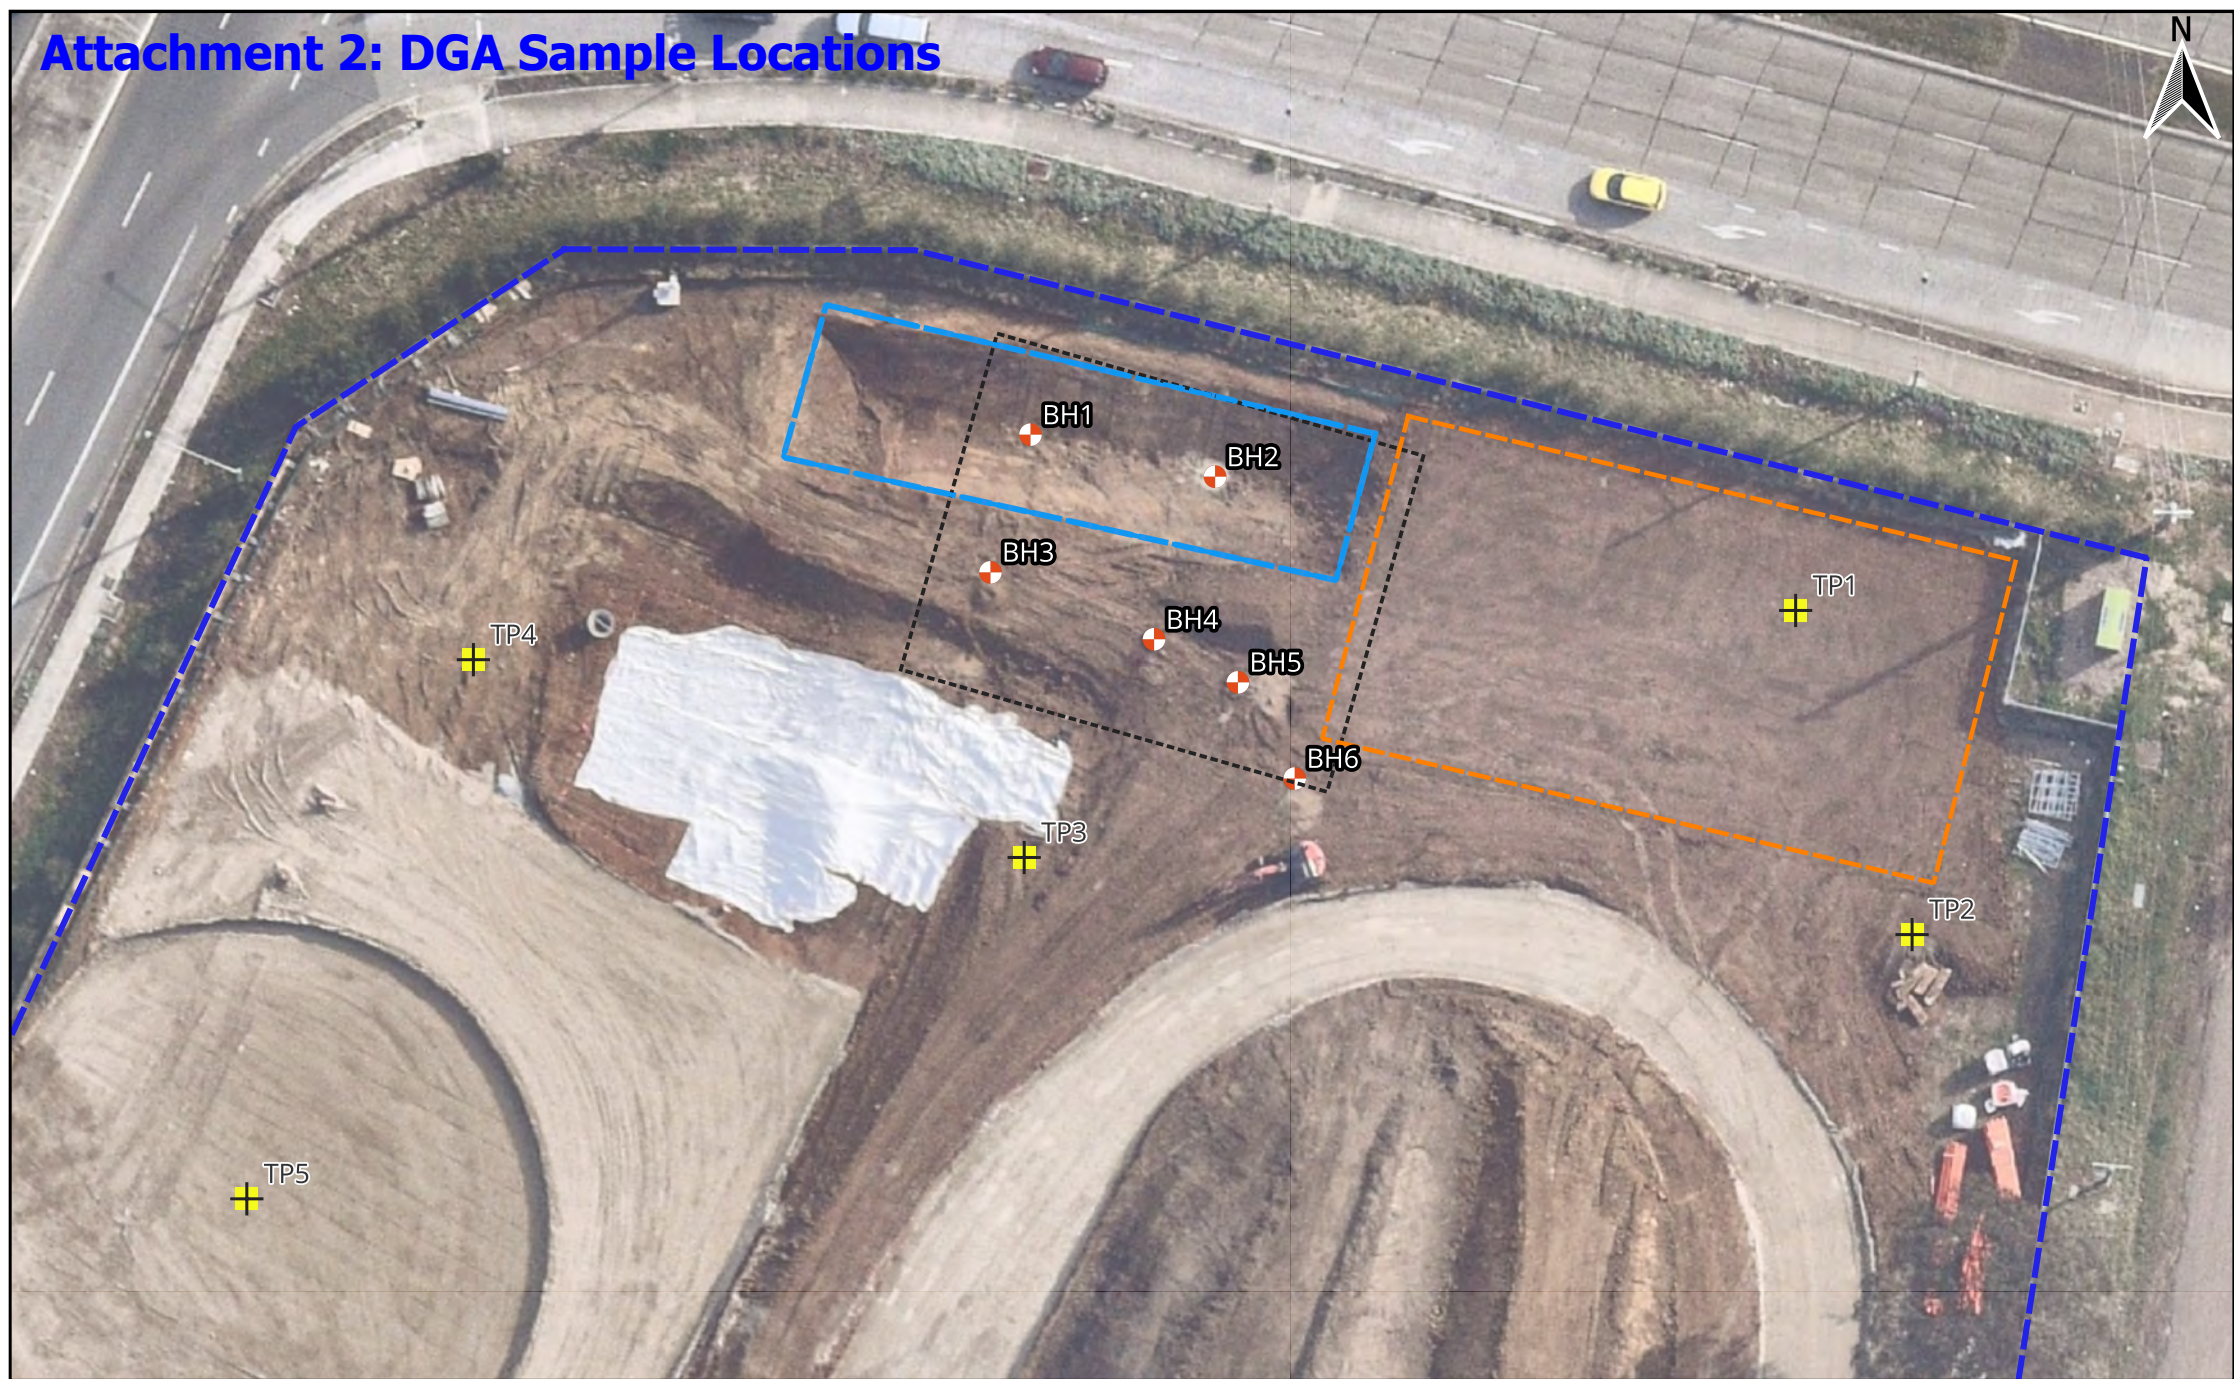
Attachment 2: DGA Sample Locations

Borehole locations - Data gap investigation

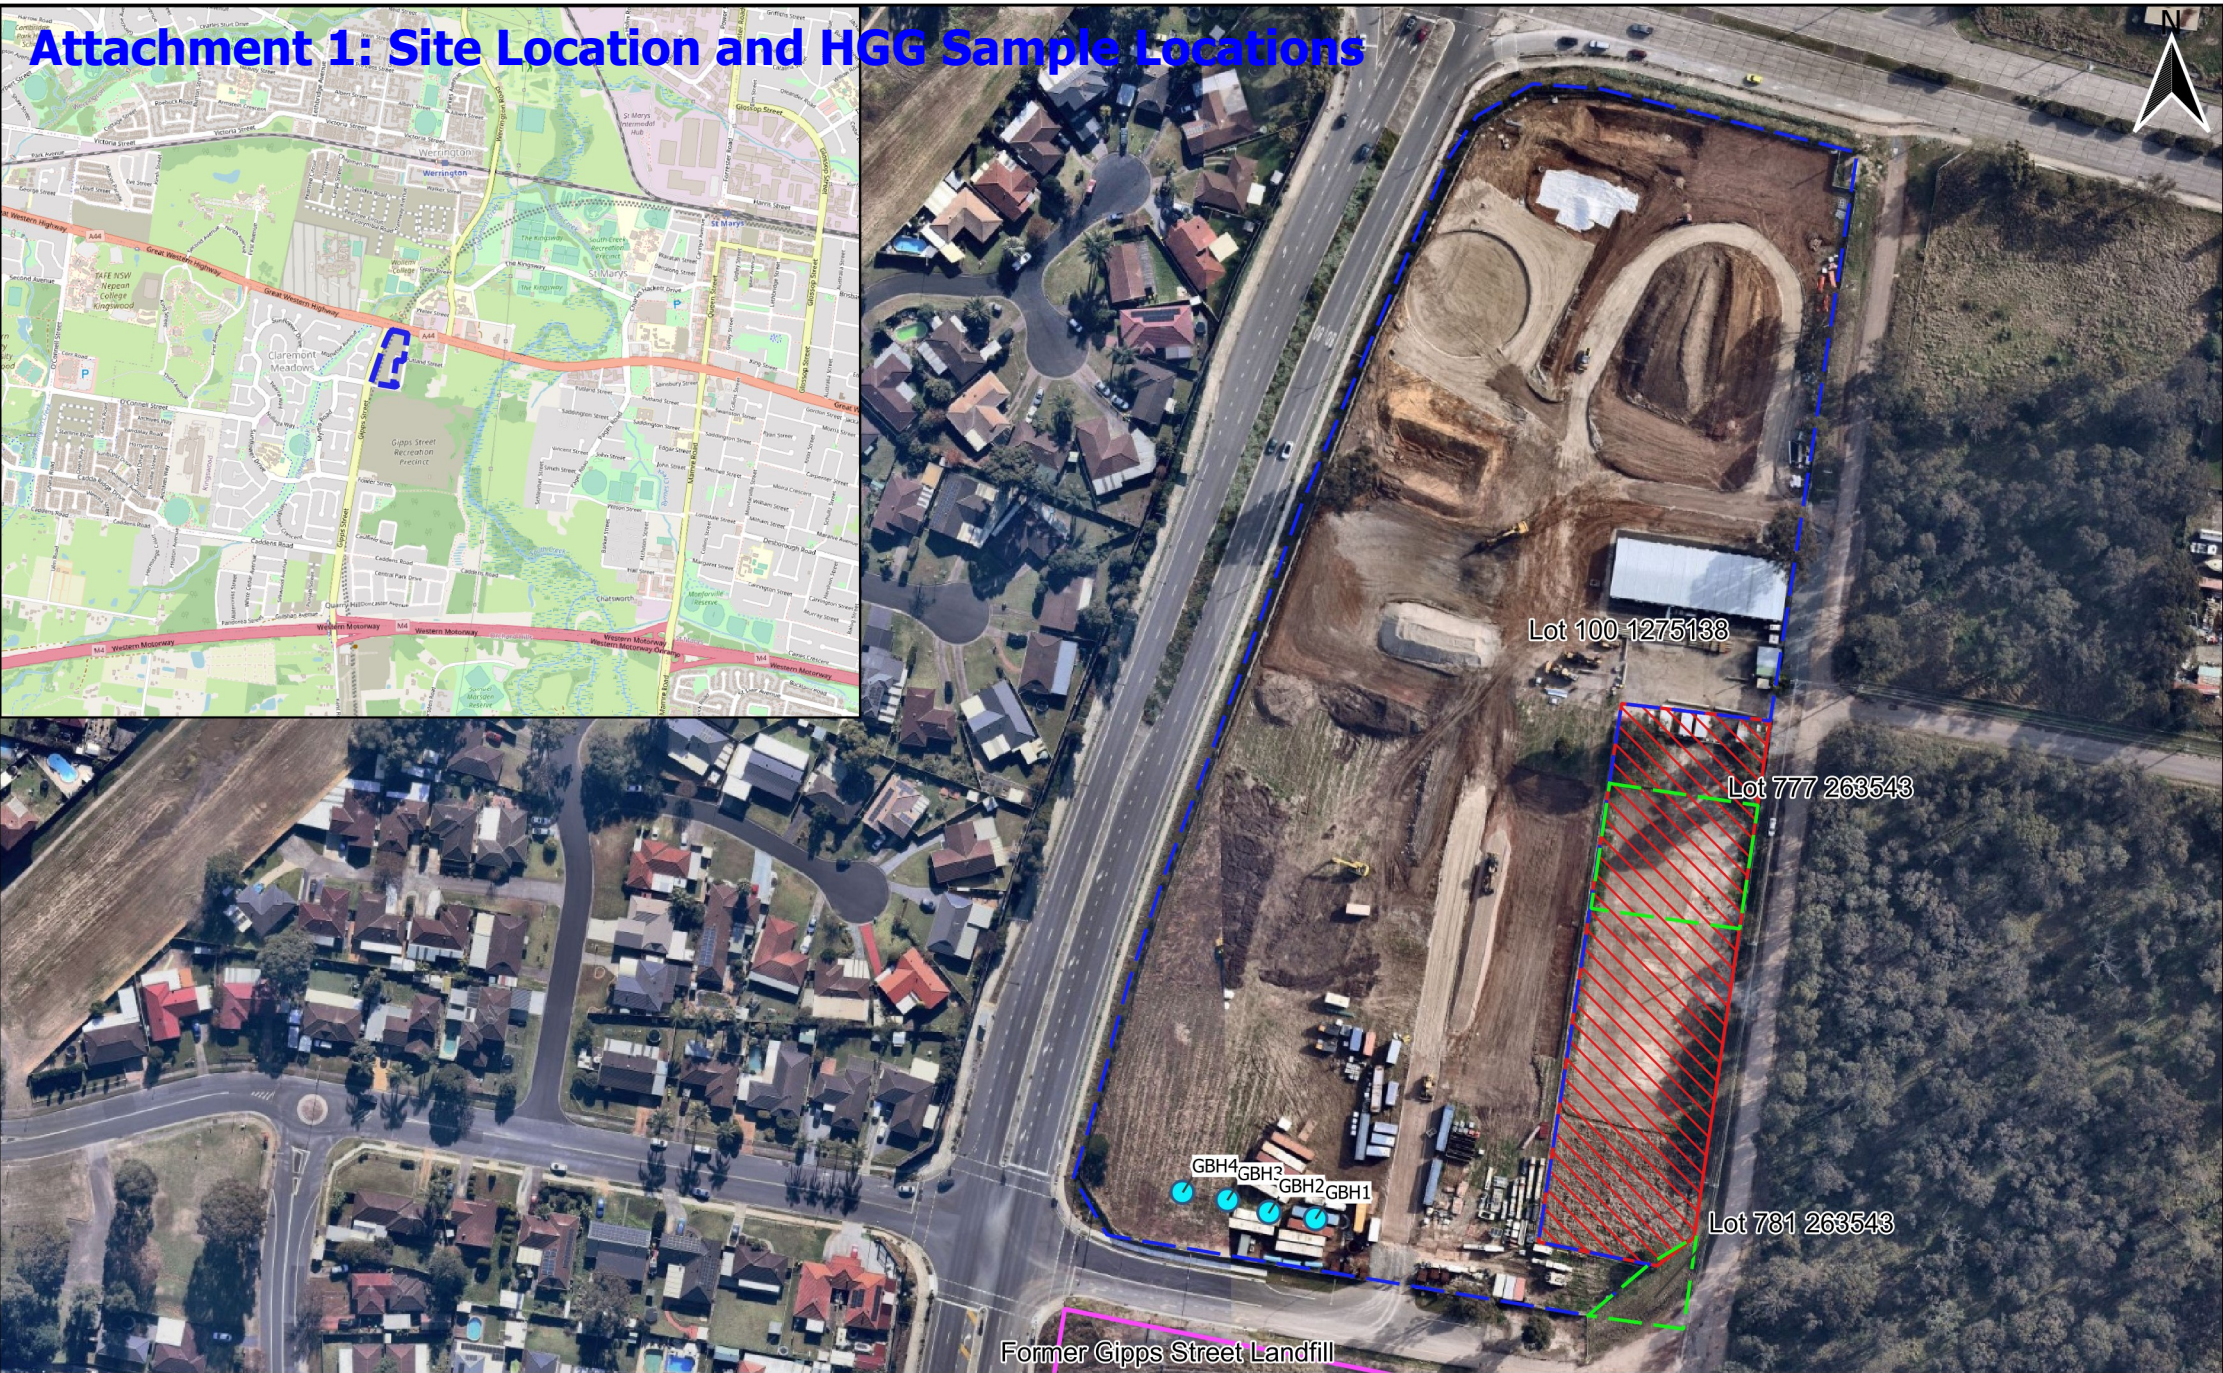
Attachment 1: Site Location and HGG Sample Locations

- Site boundary
- Leachate trench
- ⊕ Borehole
- ⬮ DP 2020 Targeted GG bores
- ⊕ Gas bores installed by EES
- Toilet blocks
- Amenities building
