St Marys Site Audit Report and Site Audit Statement for Validation Report

Sydney Metro Western Sydney Airport Station Boxes and Tunnelling Works

Project number	WSA-200-SBT
Document number	SMWSASBT-CPG-STM-SN100-EN-RPT-295307
Revision date	16 February 2024
Revision	01

SITE AUDIT REPORT

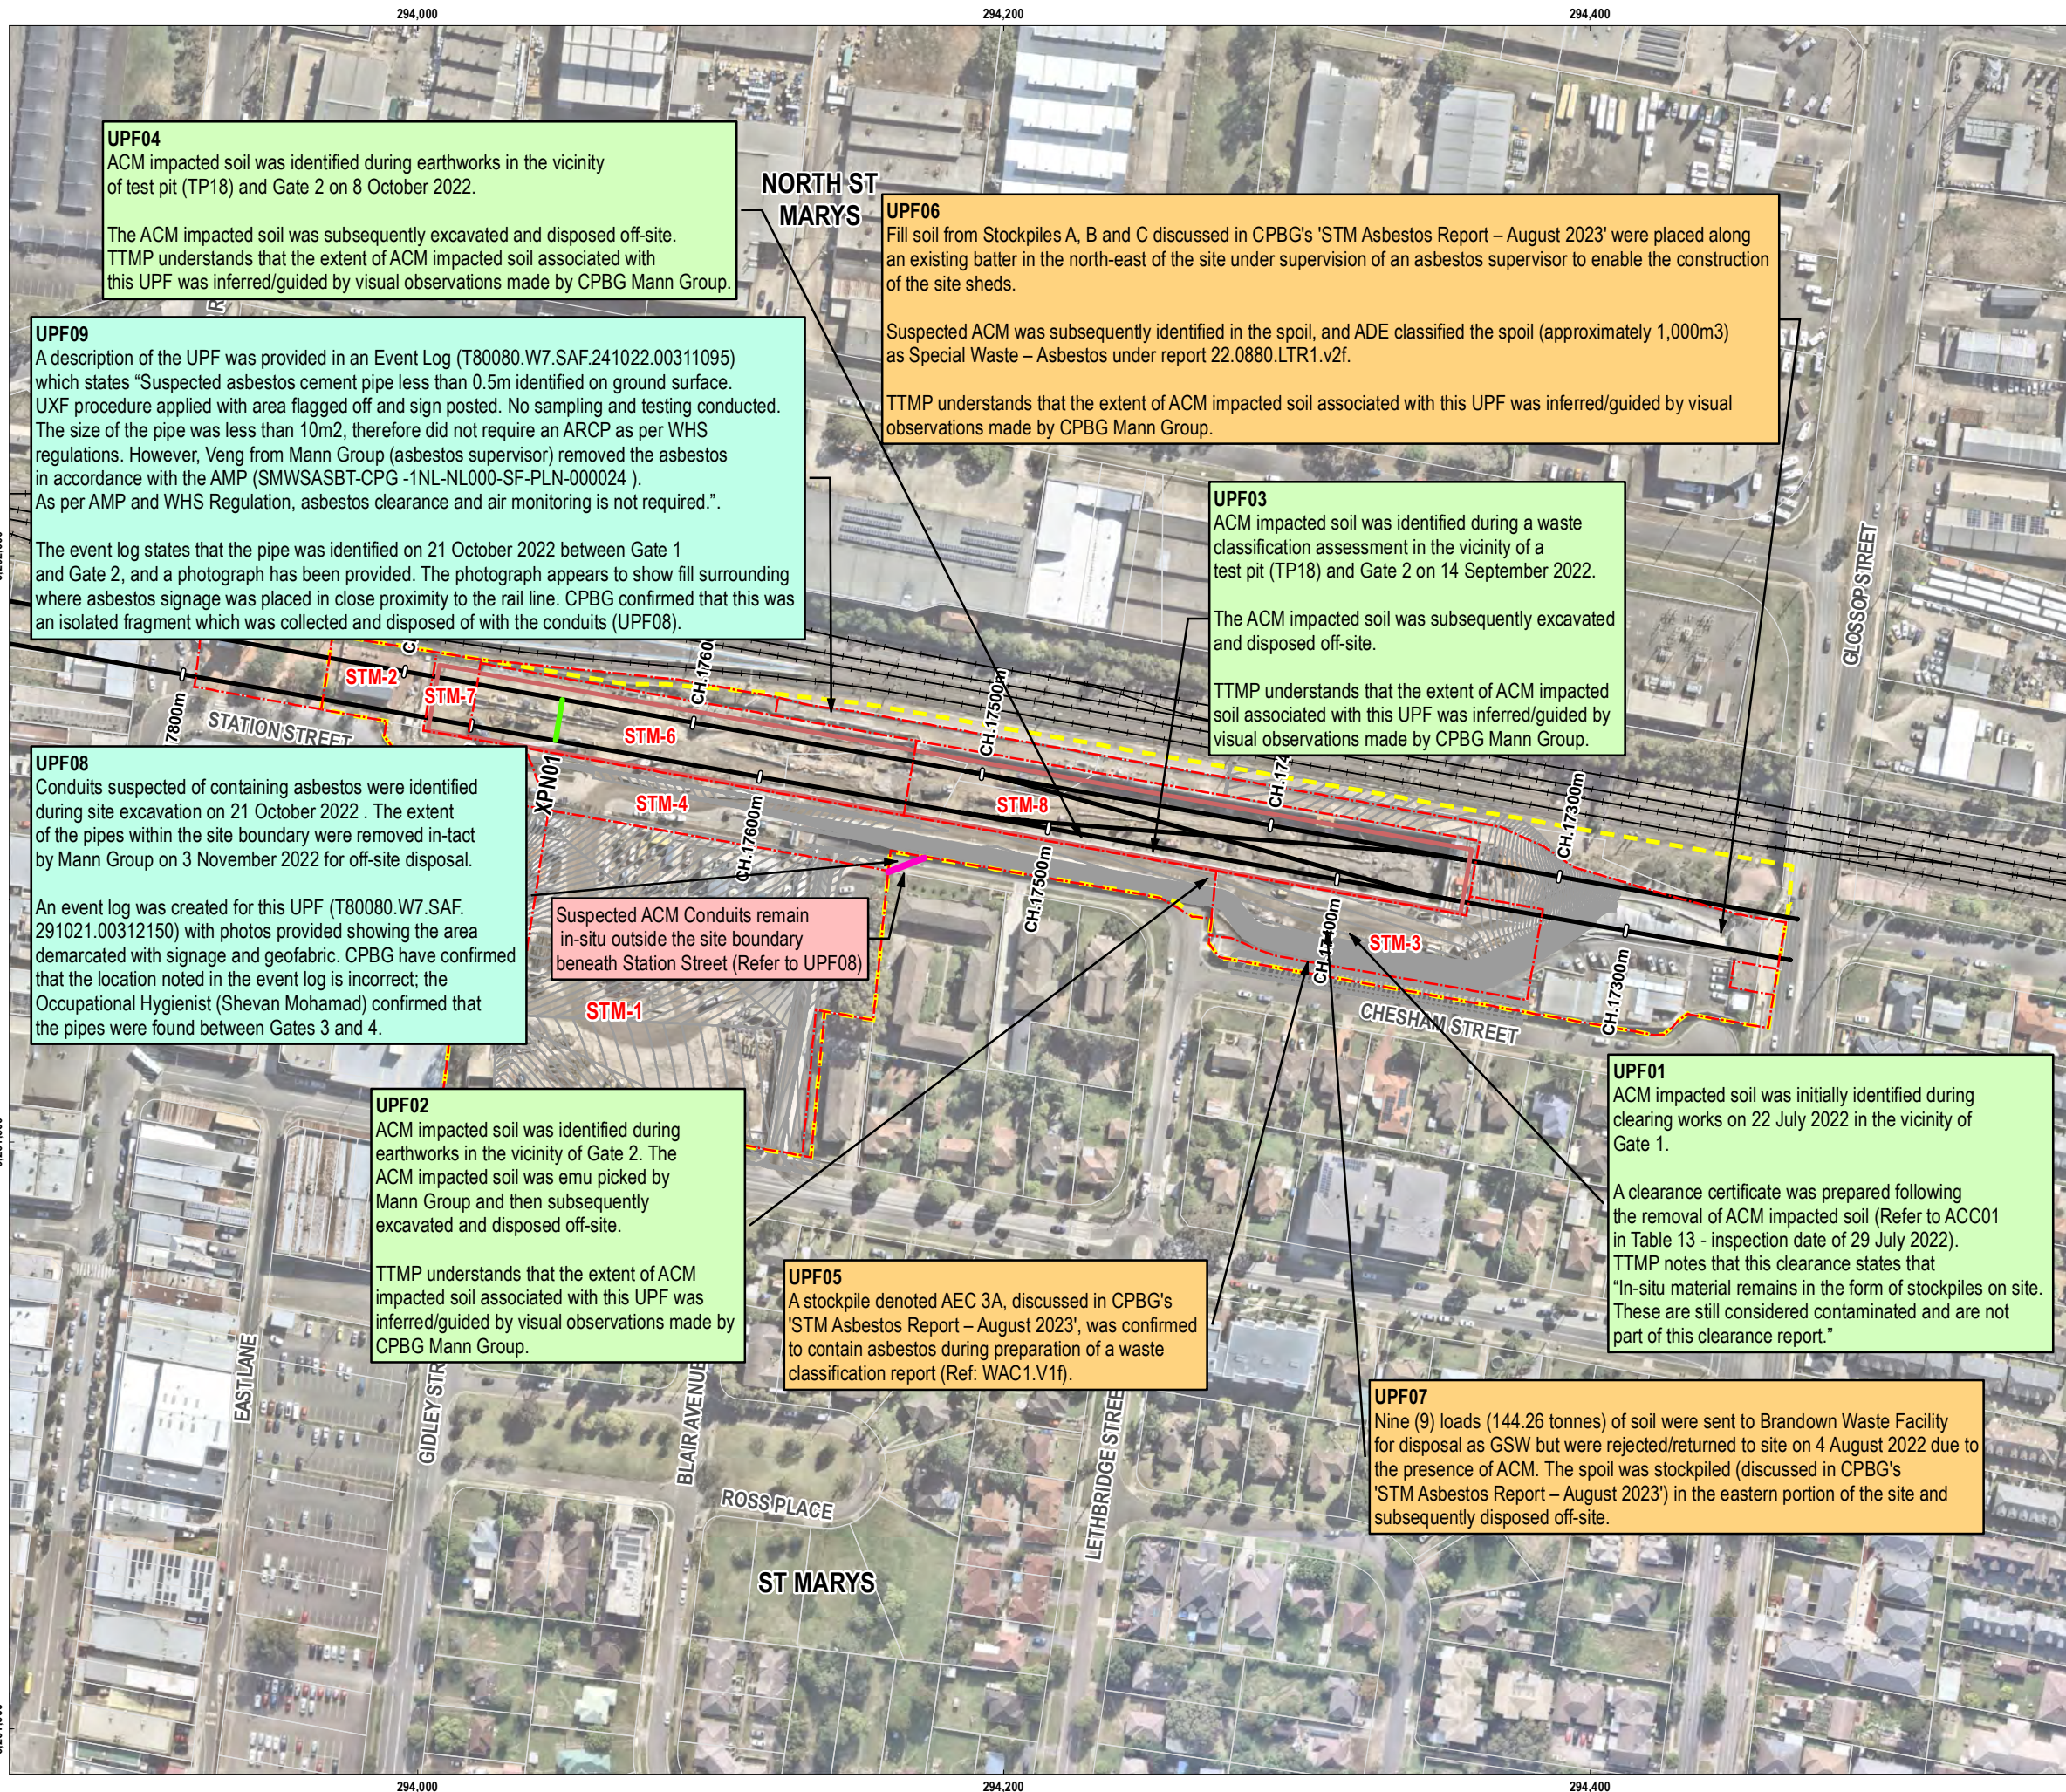
UPF04
ACM impacted soil was identified during earthworks in the vicinity of test pit (TP18) and Gate 2 on 8 October 2022.

The ACM impacted soil was subsequently excavated and disposed off-site. TTMP understands that the extent of ACM impacted soil associated with this UPF was inferred/guided by visual observations made by CPBG Mann Group.

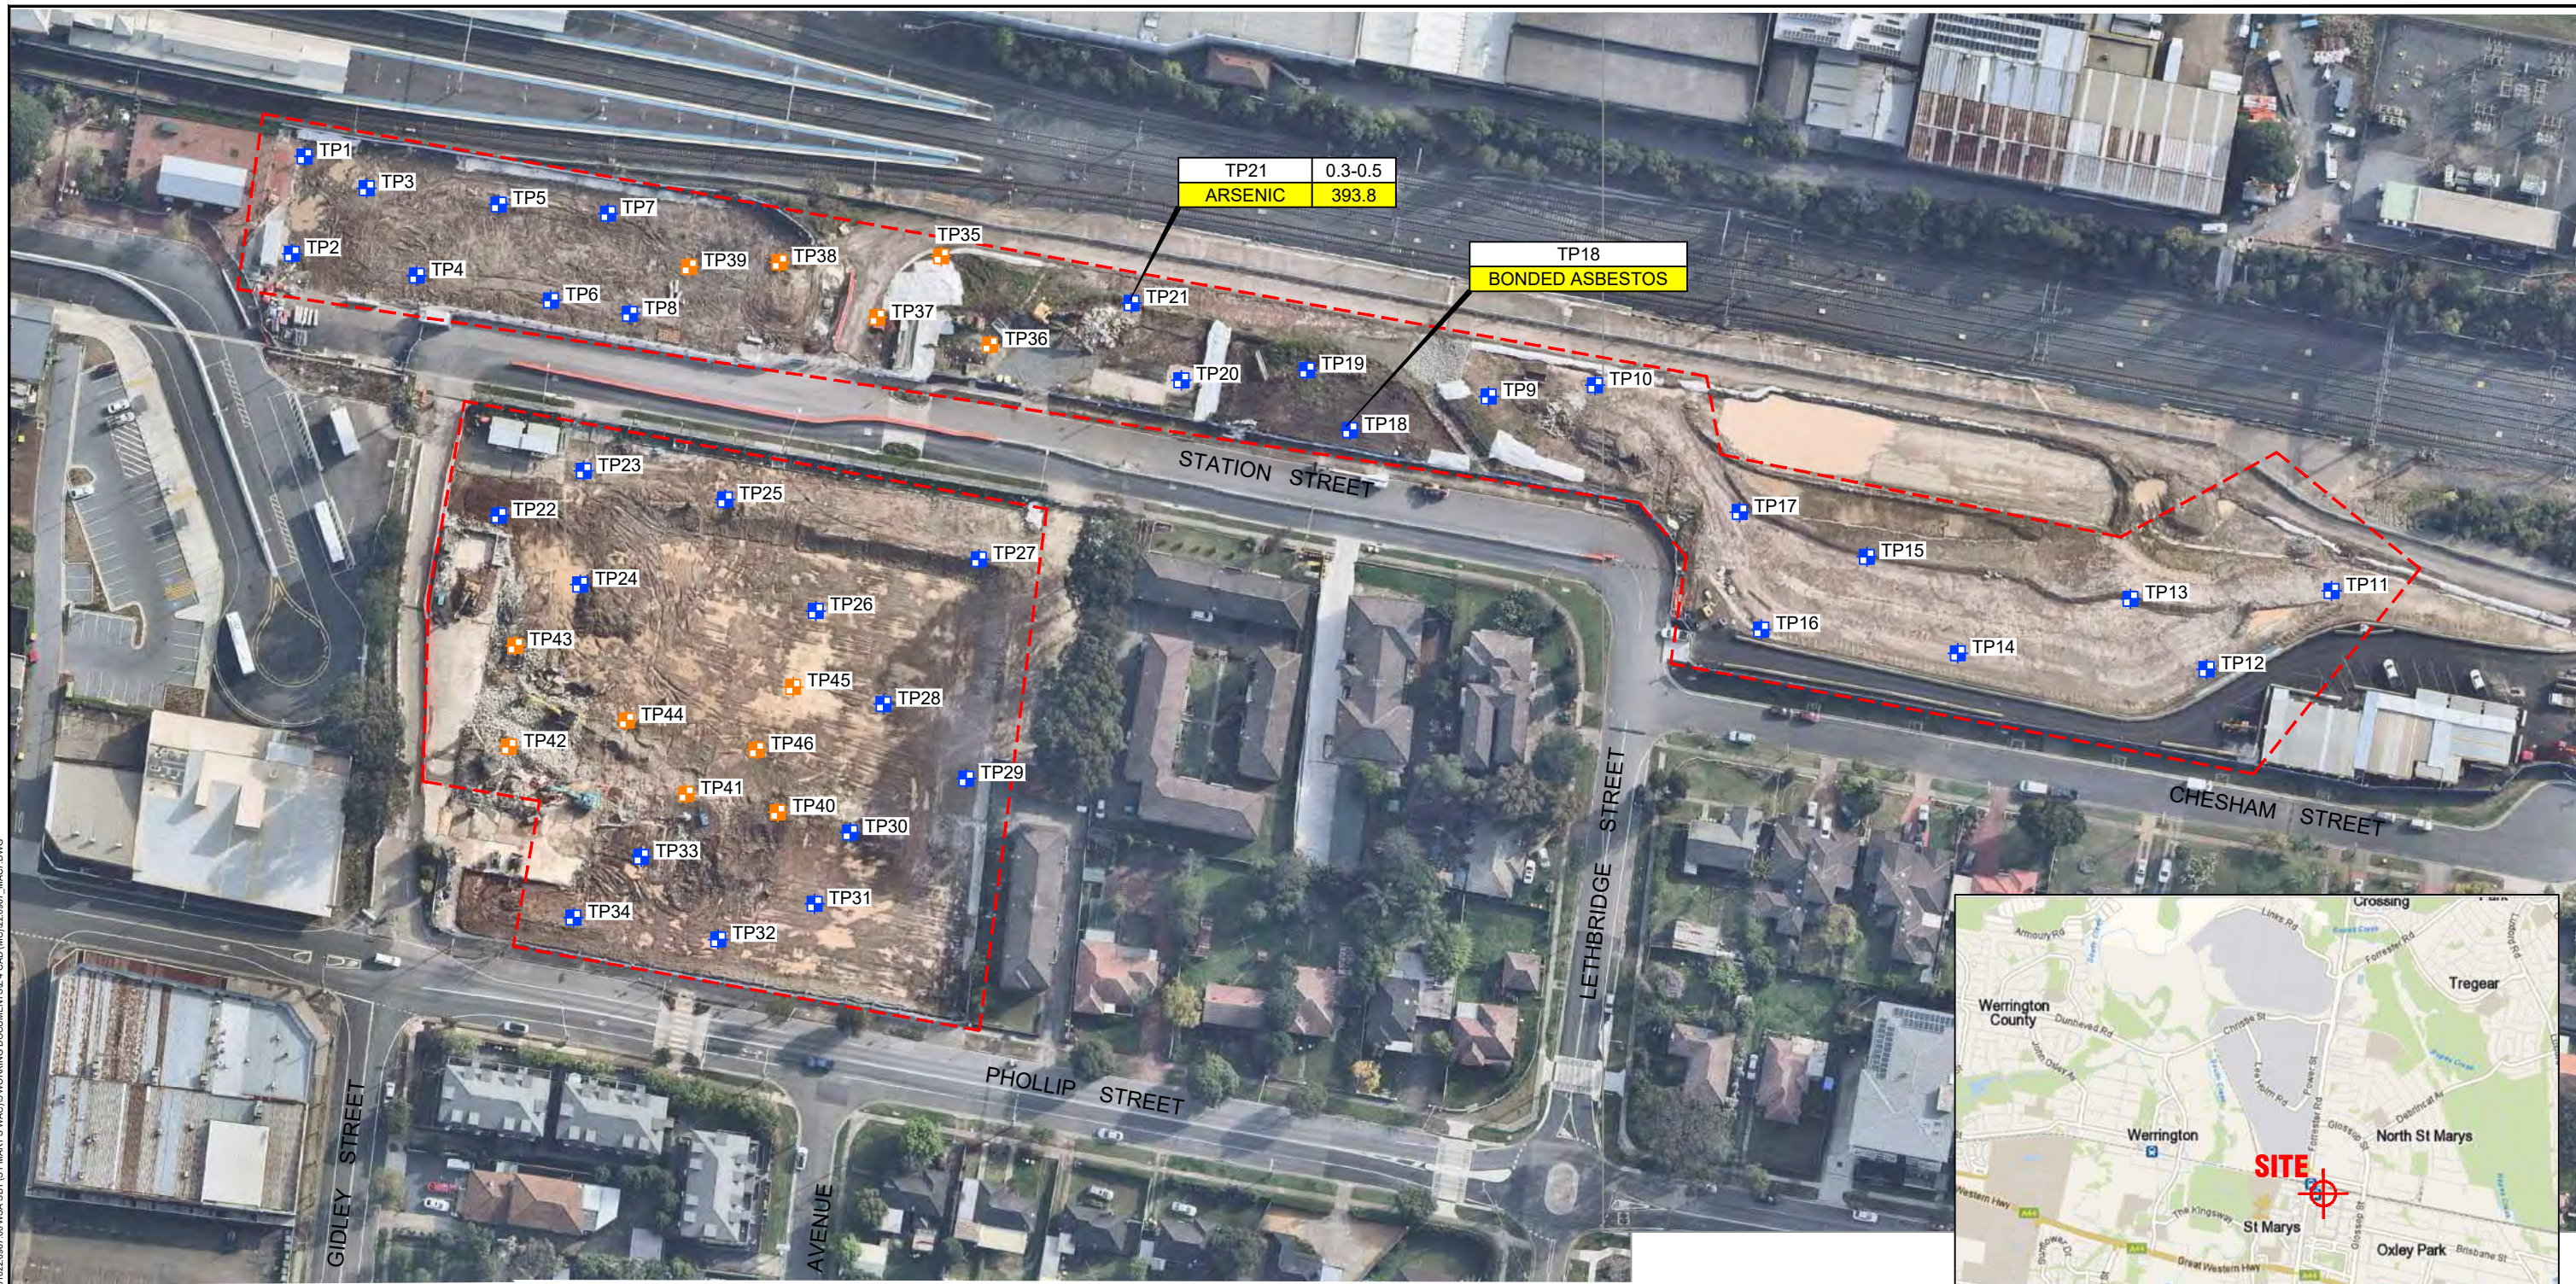
Attachment 9: ADE Sample Locations

SAMPLE ID	DEPTH (metres)
TP21	0.3-0.5
ARSENIC	393.8

SOIL CONTAMINATION ABOVE SAC NEPM GENERIC EIL (mg/kg)
